Report on  
Geotechnical Investigation

Proposed Helicopter Facility  
89-151 Old Castlereagh Road, Penrith

Prepared for  
Colliers International Pty Ltd

Project 204635.00  
October 2021

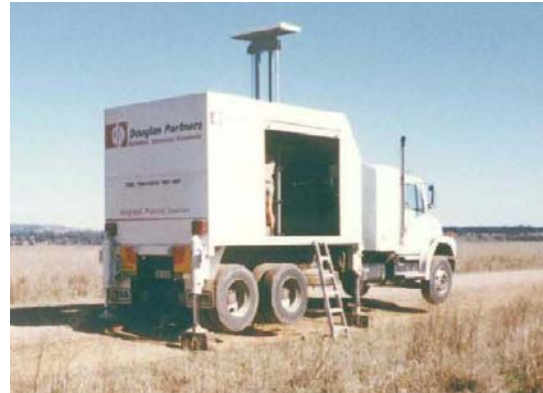
Figure 2: Purpose built CPT rig

The cone is thrust into the ground at a steady rate of about 20 mm/sec, usually using the hydraulic rams of a purpose built CPT rig, or a drilling rig. The testing is carried out in accordance with the Australian Standard AS1289 Test 6.5.1.
