Our ref: 6543-G2
13 September 2021

Proposed Cruiser Blue Mountain Bike Trail, Thredbo NSW Geotechnical Assessment

Proposed Cruiser Green & Blue
Mountain Bike Trails
Thredbo NSW
for
EVT / Kosciuszko Thredbo Pty Ltd

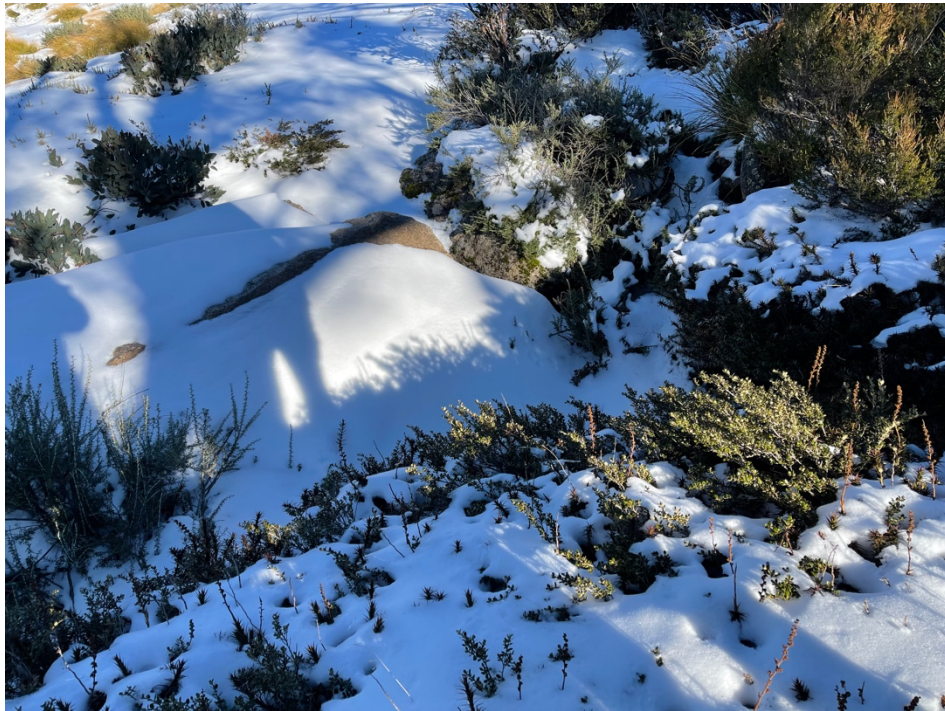
Photo 1

Intermittent creek crossings are proposed at two locations. Typical photos of the terrain for the creek crossings are shown in Photos 1 and 2. A typical photo of natural terrain is shown in Photo 3.

Typical terrain in
platform area over
watercourse

1. Footings for platforms over intermittent creeks should be taken into the decomposed granite (dense medium to coarse sand) and may be designed for a maximum allowable bearing pressure of 200 kPa.

2. Alternatively, additional rocks (boulders) could be placed to provide sufficient surface area to then build a surfacing over the intermittent creeks. Boulders should be placed such that they are laid flat and not exhibit movement under the action of a minimum 3 tonne hydraulic excavator.

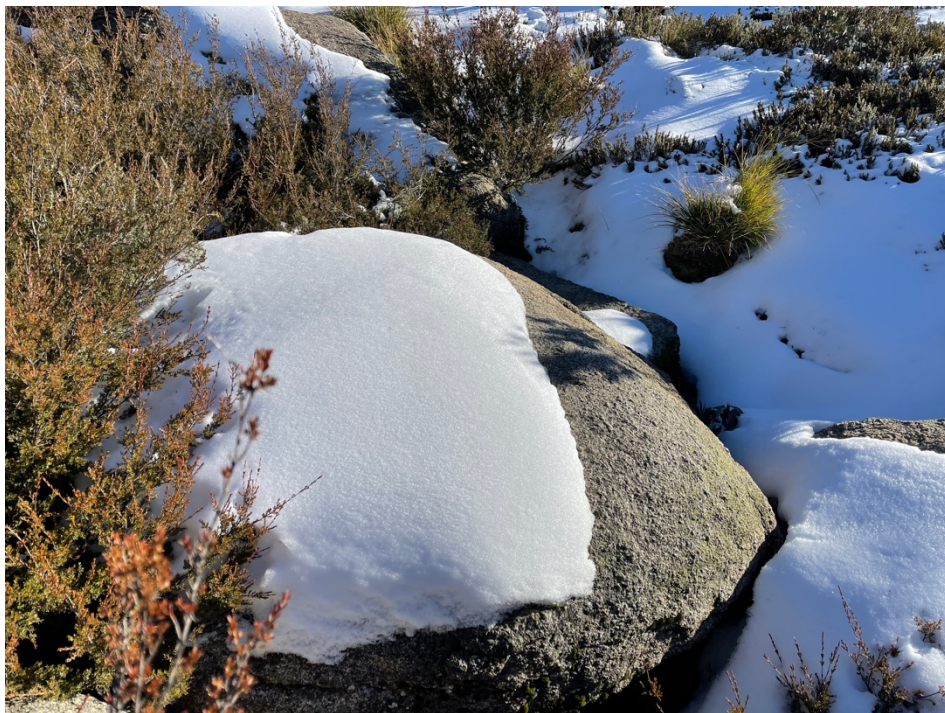
Photo 2

Typical terrain in
platform area over
watercourse
