Our ref: 6543-G2
13 September 2021

Proposed Cruiser Blue Mountain Bike Trail, Thredbo NSW Geotechnical Assessment

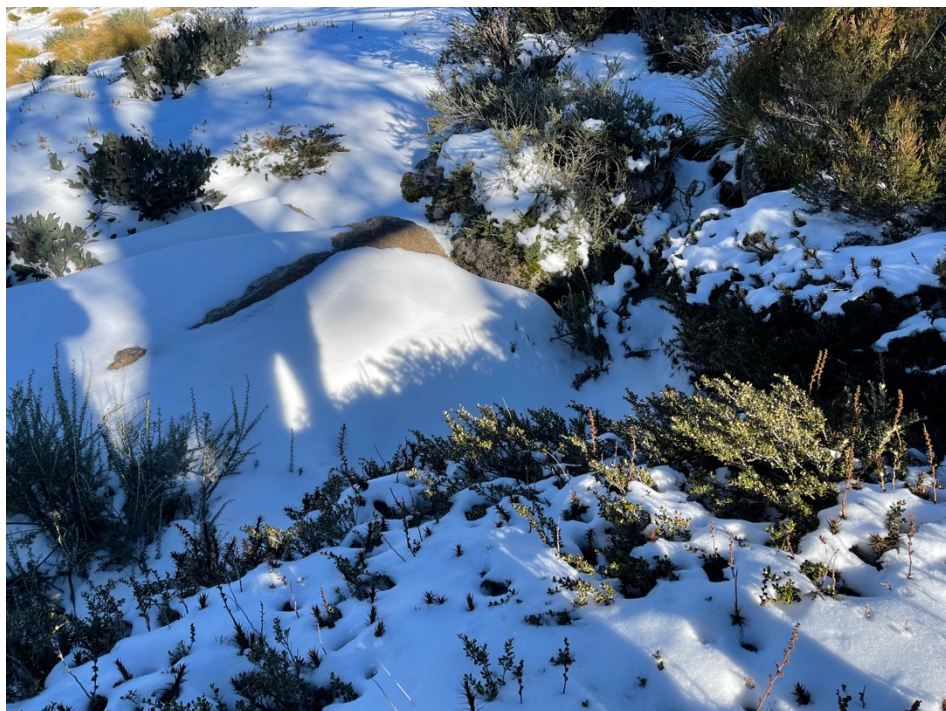
Photo 1

Intermittent creek crossings are proposed at two locations. Typical photos of the terrain for the creek crossings are shown in Photos 1 and 2. A typical photo of natural terrain is shown in Photo 3.

Typical terrain in
platform area over
watercourse

1. Footings for platforms over intermittent creeks should be taken into the decomposed granite (dense medium to coarse sand) and may be designed for a maximum allowable bearing pressure of 200 kPa.

2. Alternatively, additional rocks (boulders) could be placed to provide sufficient surface area to then build a surfacing over the intermittent creeks. Boulders should be placed such that they are laid flat and not exhibit movement under the action of a minimum 3 tonne hydraulic excavator.

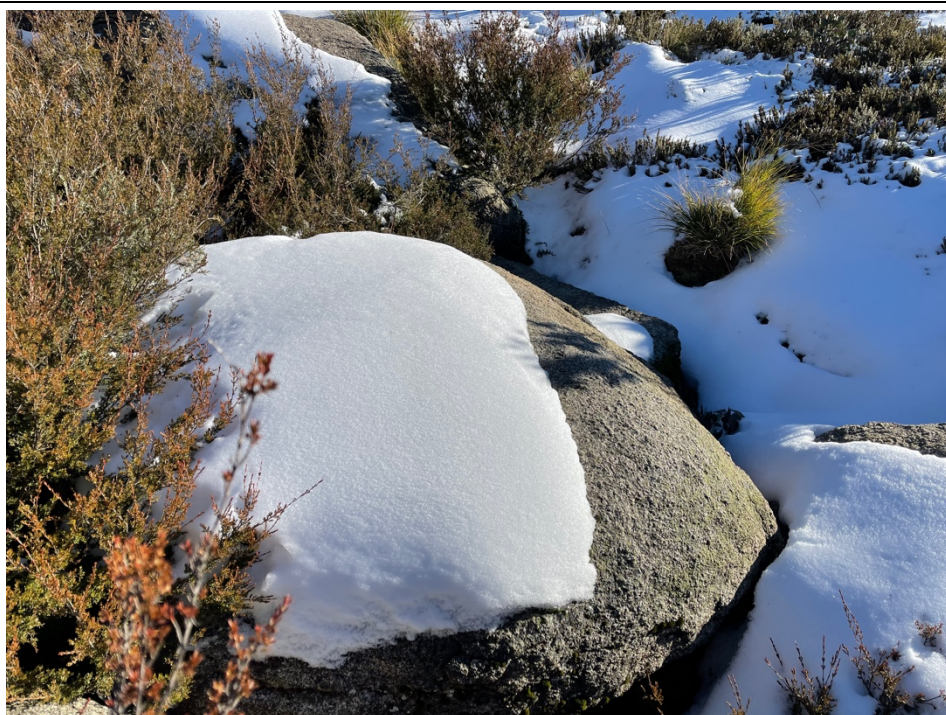
Photo 2

Typical terrain in
platform area over
watercourse

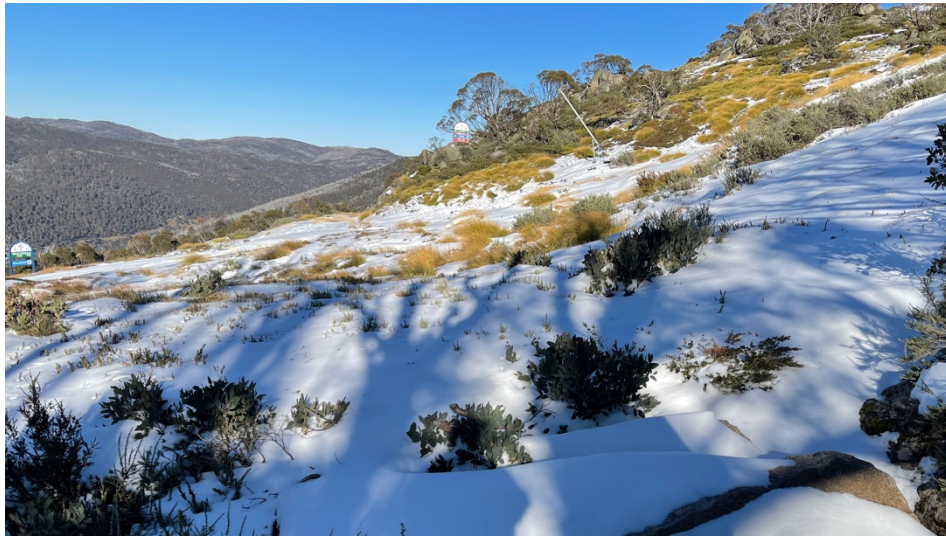
Photo 3
Typical terrain for
MTB trail
