**Report Type:**  
**Targeted Groundwater Assessment**

**Project Address:**  
**51 Masons Road, Point Frederick NSW**

**25 October 2021**  
**Report No: 10827-ER-1-3 Rev 2**

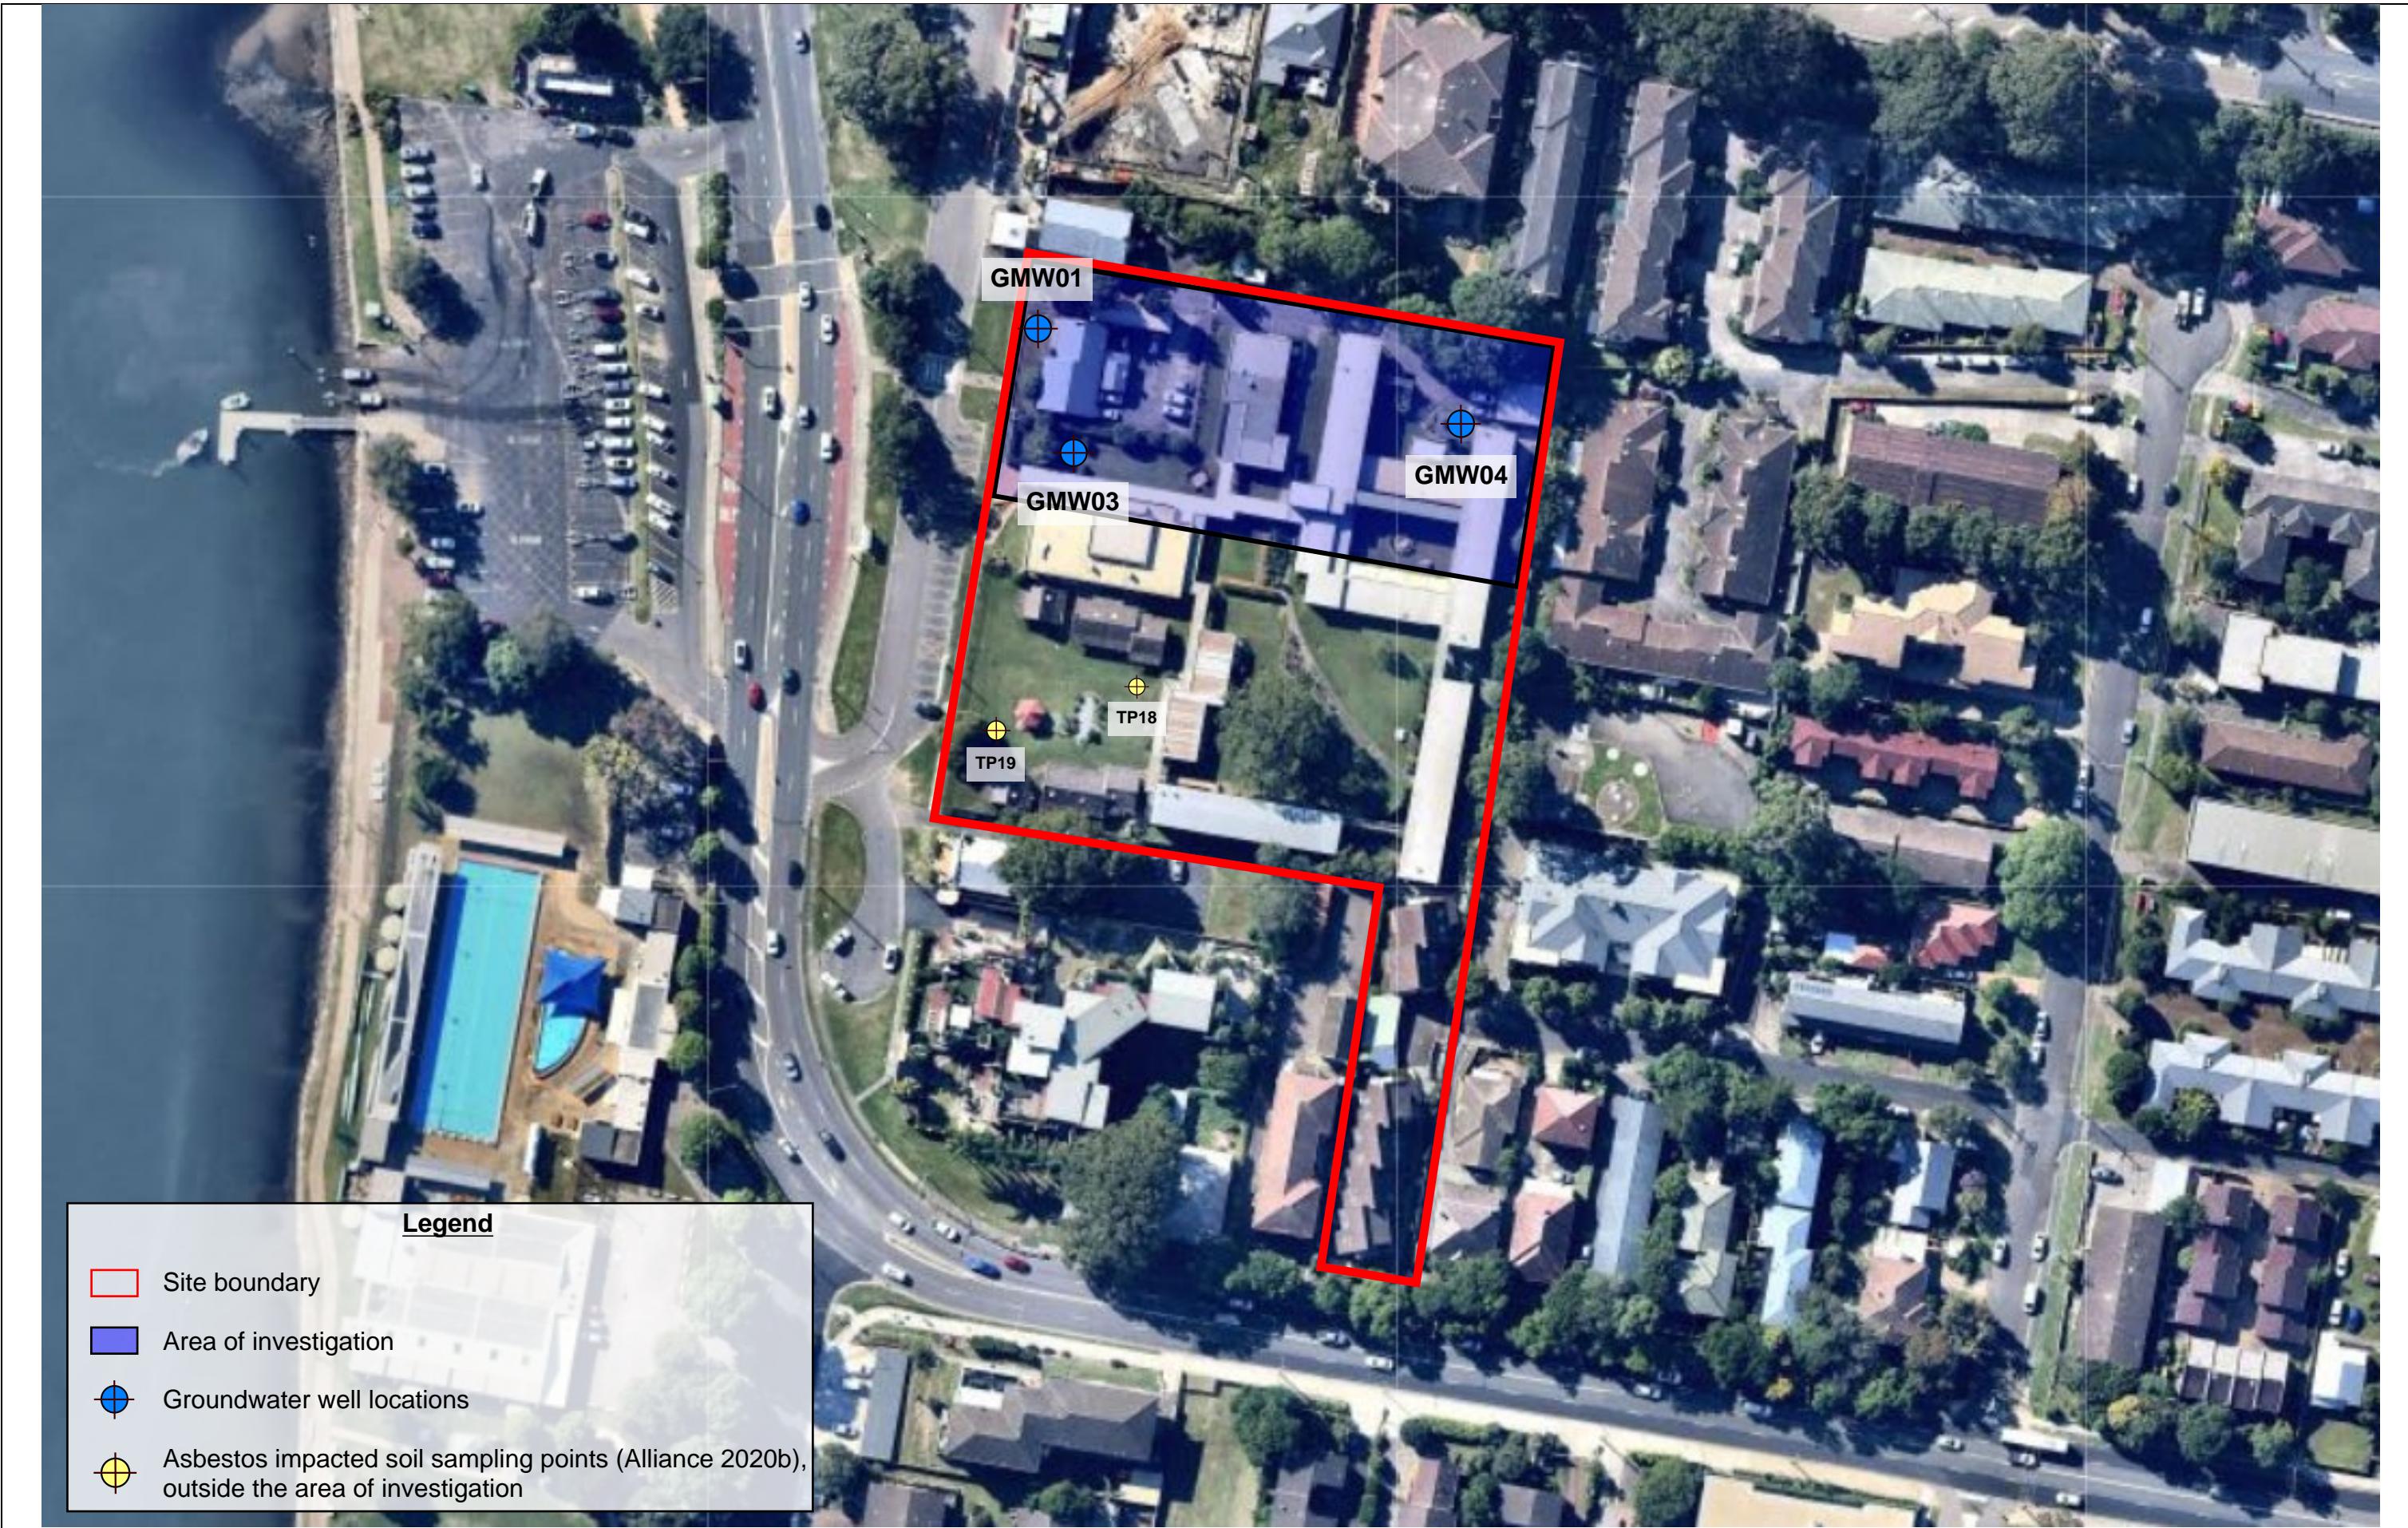
Groundwater Well Sampling Locations

- Site boundary
- Area of investigation
- Groundwater well locations
- Asbestos impacted soil sampling points (Alliance 2020b), outside the area of investigation

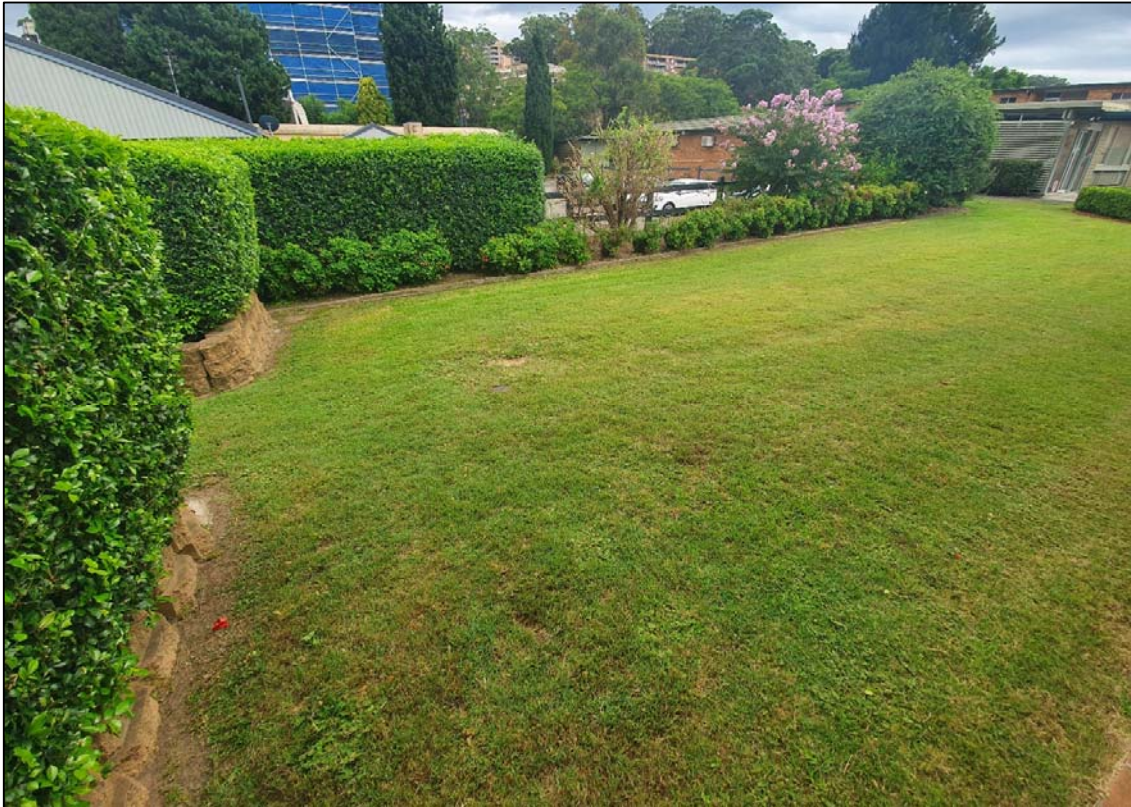
**Image 4 View of GMW03, within the central western portion of the site.**

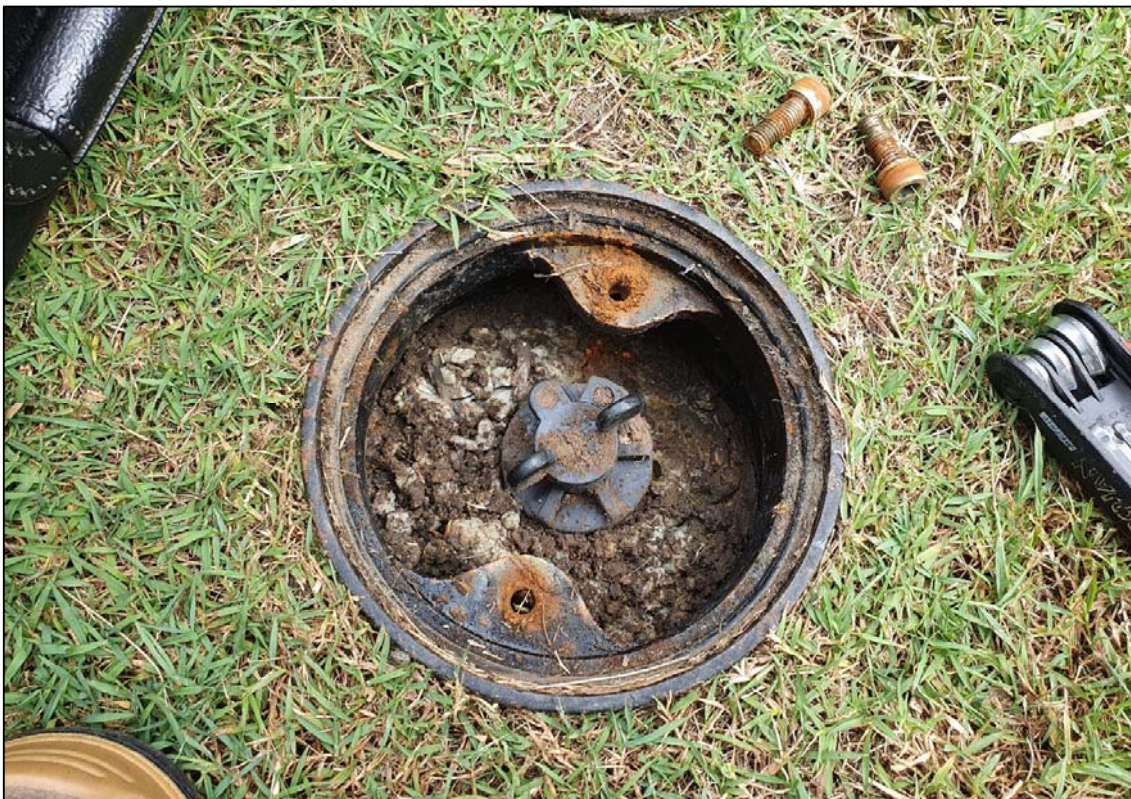
**Image 5 View of monitoring well GMW01 prior to sampling.**
