ARBORICULTURAL IMPACT  
ASSESSMENT |  
26 MOOREFIELDS RD.  
KINGSGROVE

Prepared For Morfosis Architects C/o Jean Ligadu

8.06.21

Prepared By Liam Strachan

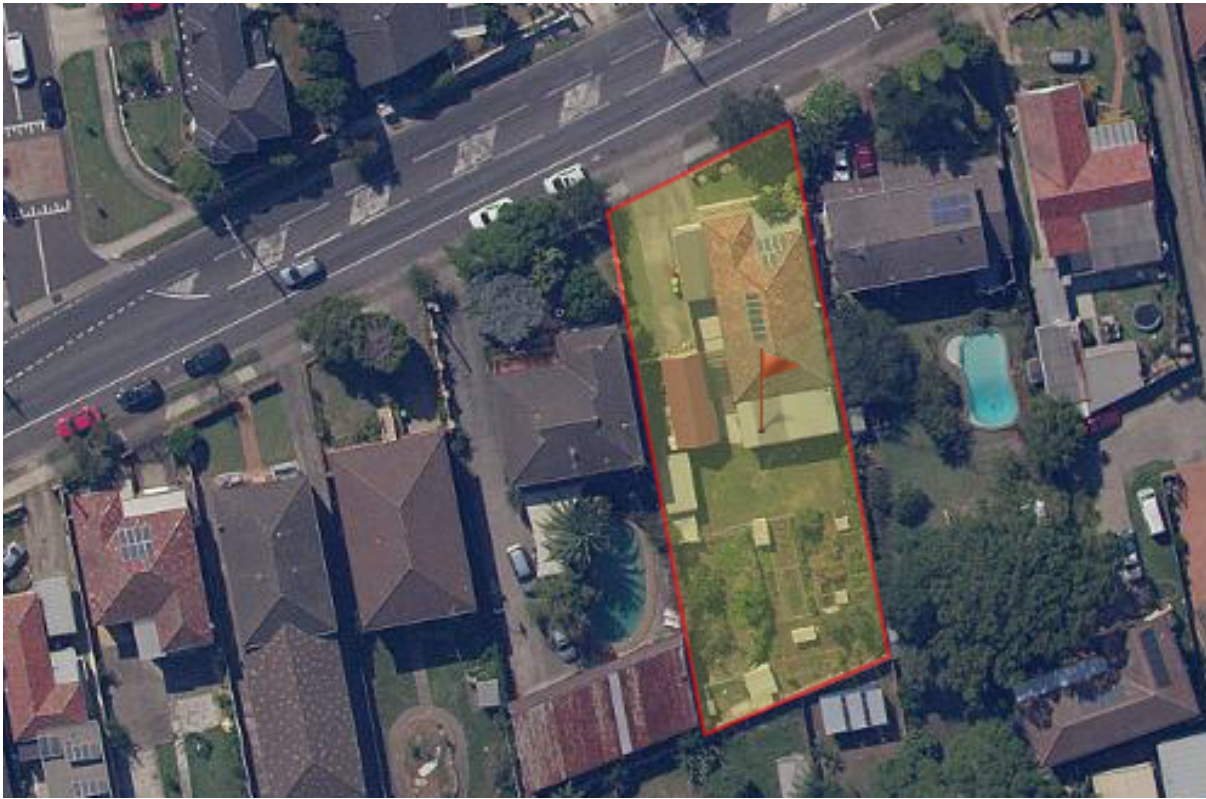
### 5.1 THE SITE

The site contains one single storey stand-alone dwelling.

Site topography is level and pre-development soil is classified as 9130bt Blacktown residual soil.

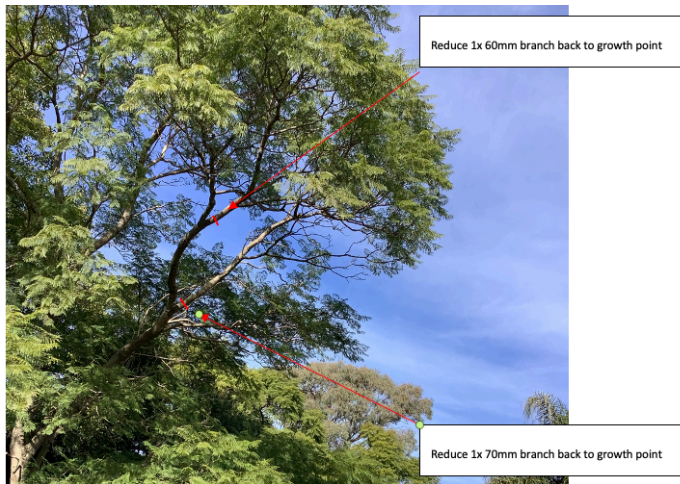
No excavation is taking place within the TPZ of T8, The TPZ has been expanded to include the canopy of the tree. Some minor reduction pruning should be undertaken to prune the tree back to the boundary in order to prevent branches being torn and damaged. Please see Appendix 6 Pruning Specification.

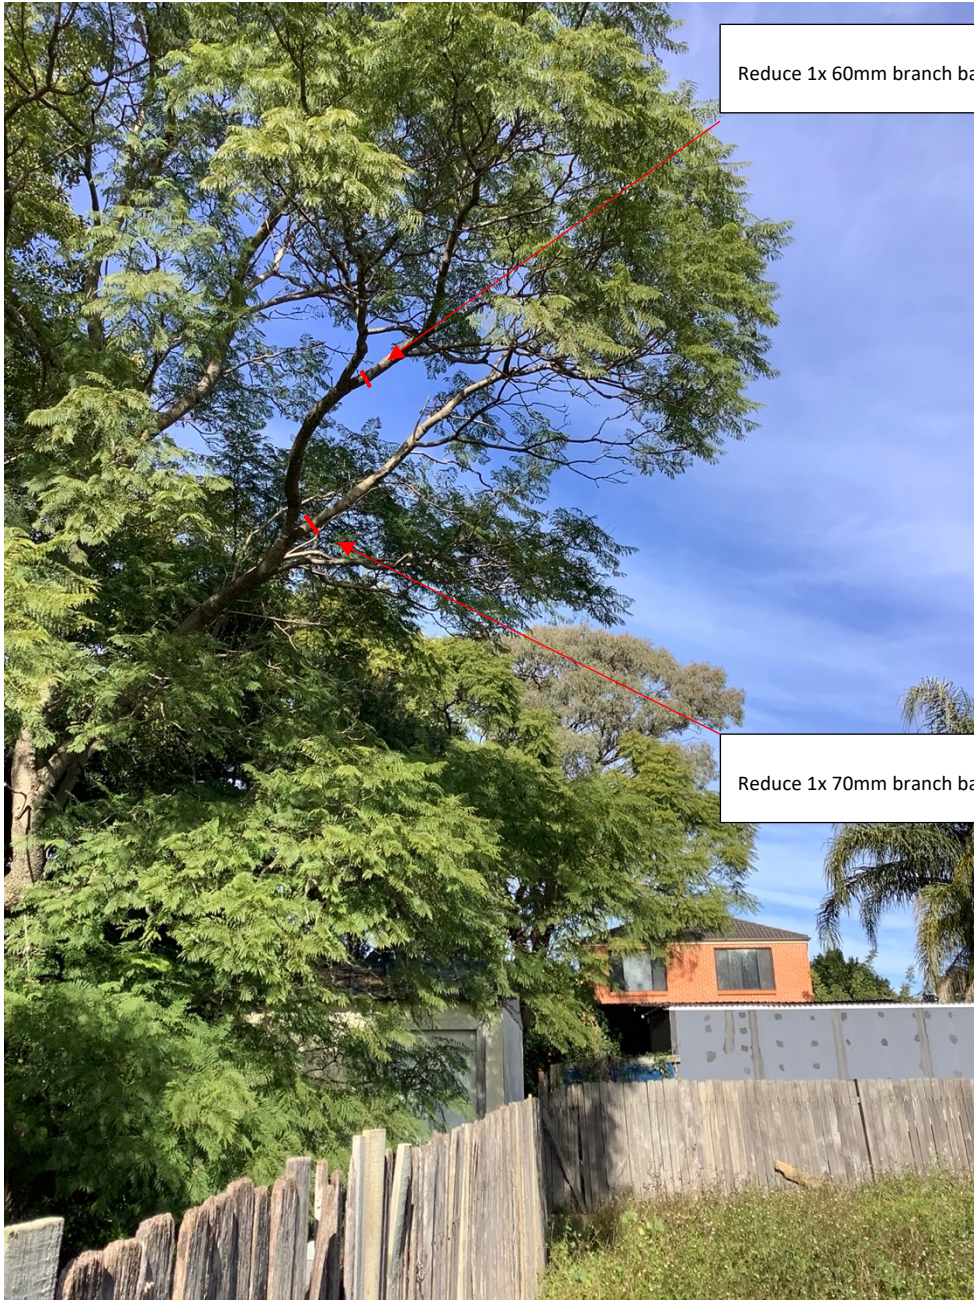
15 APPENDIX 6: PRUNING SPECIFICATION

Reduce 1x 60mm branch back to growth point

Reduce 1x 70mm branch back to growth point
