Acid Sulfate Soils Assessment

25 George Street, North Strathfield NSW

Report No: E24421.E14_Rev0

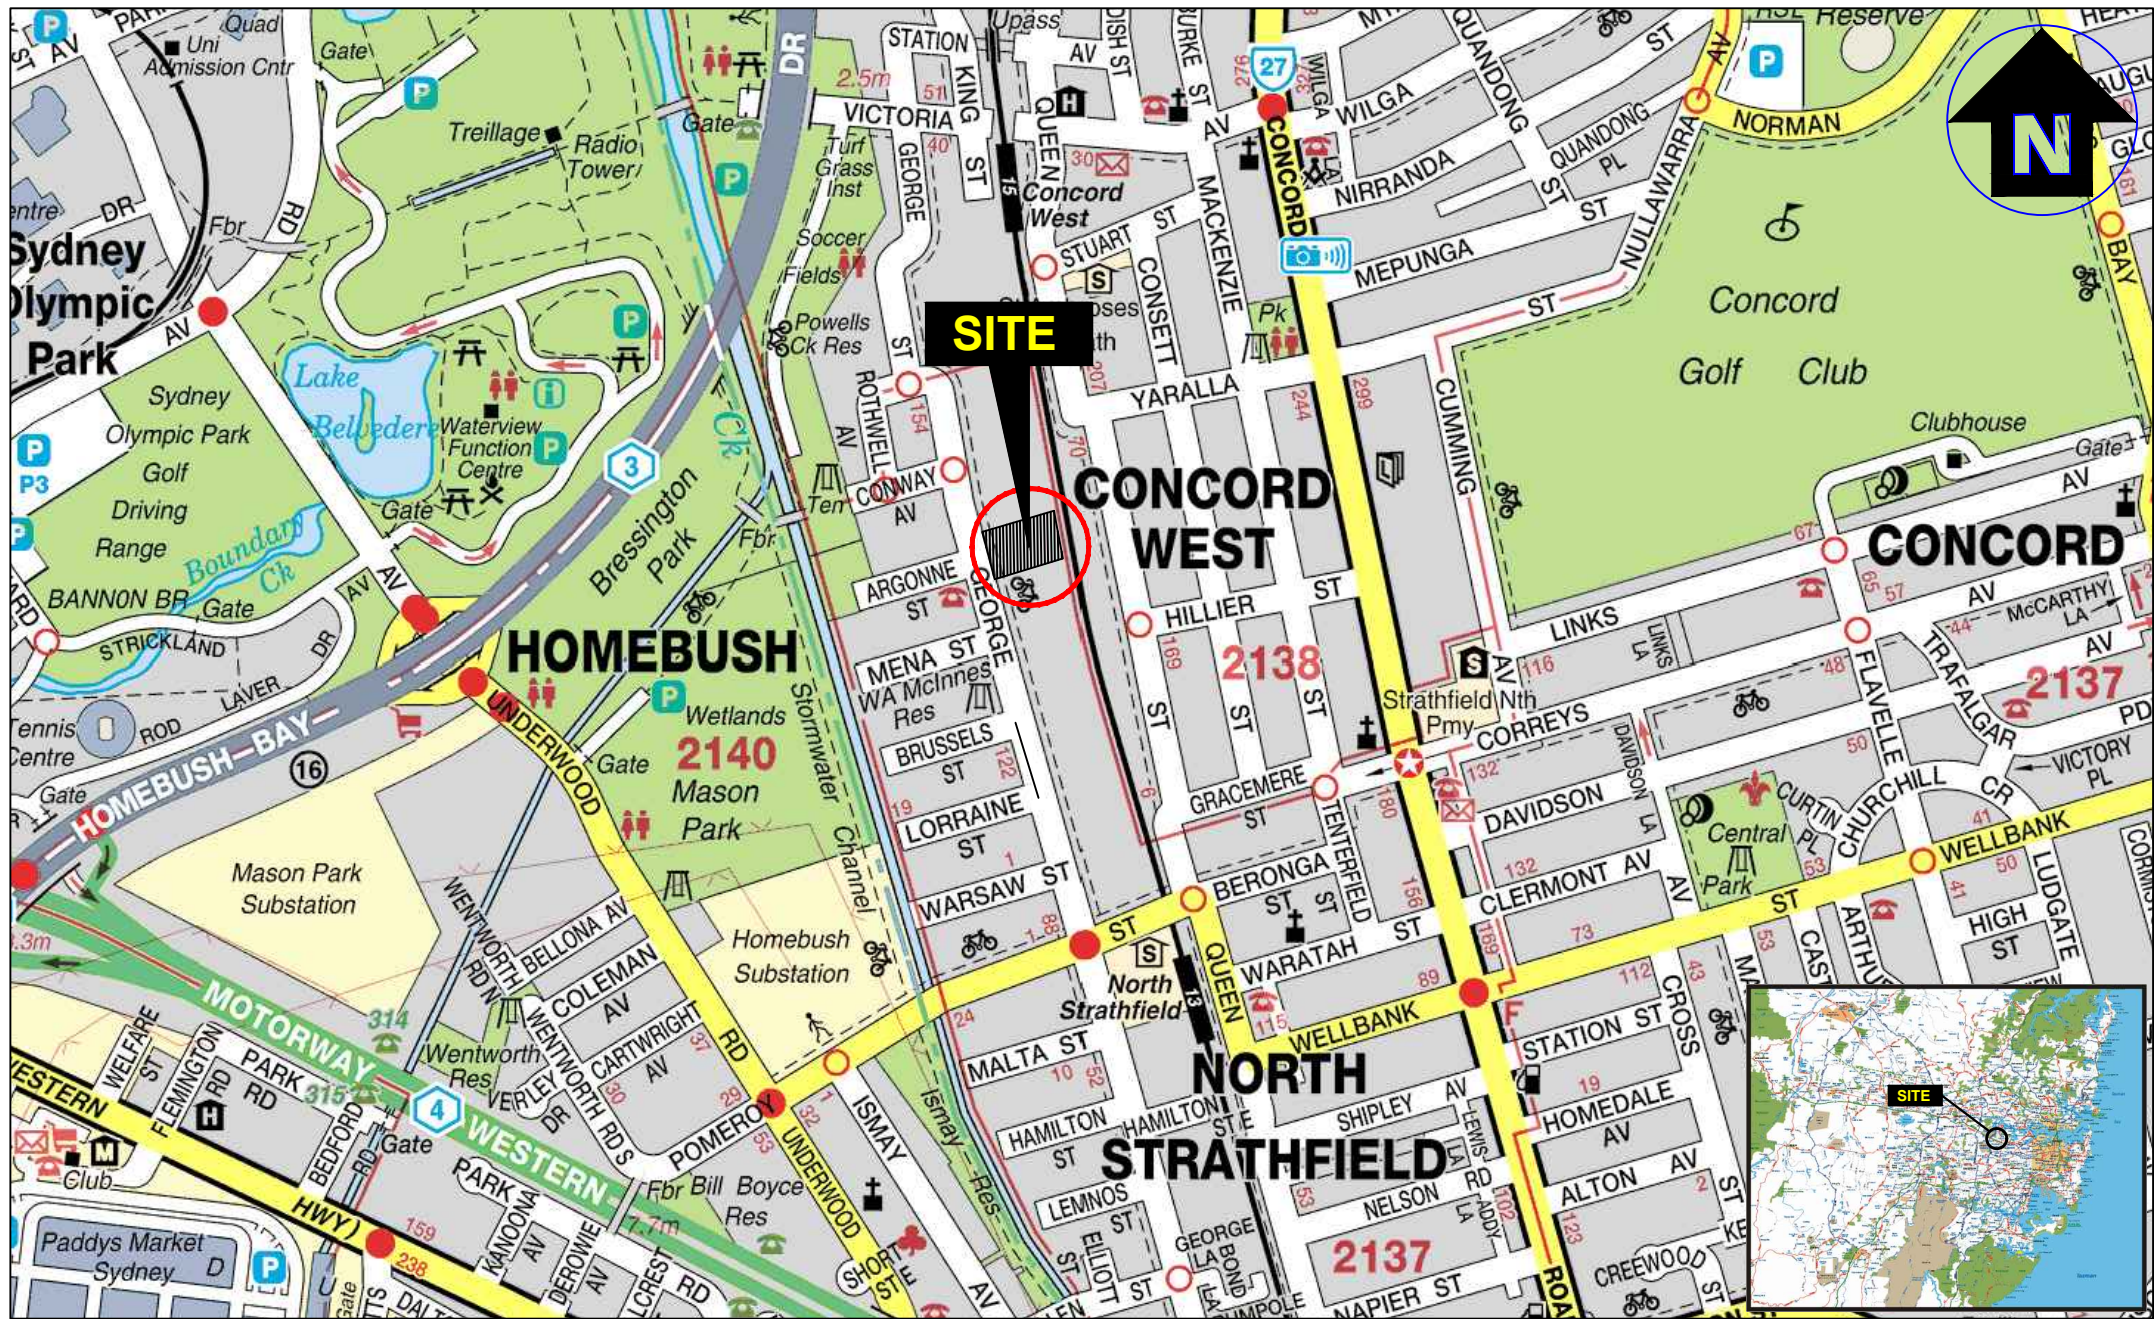
1

The site identification details and associated information are presented in **Table 2-1**, while the site locality is shown in **Figure 1** (See **Appendix A**).

This site is located approximately 11.km west of the Sydney Central Business District (CBD) and is located within the Local Government Area of City of Canada Bay Council (**Figure A.1**). It is comprised of CP/ - /SP22302, covering a total area of 7,750 m², as depicted in **Figure A.2**. It is currently occupied by an industrial business park housing a number of operation businesses, including, but not limited to, *Eurella Packaging & Assembly, Car Repair & Deco and Strathfield Automotive*.

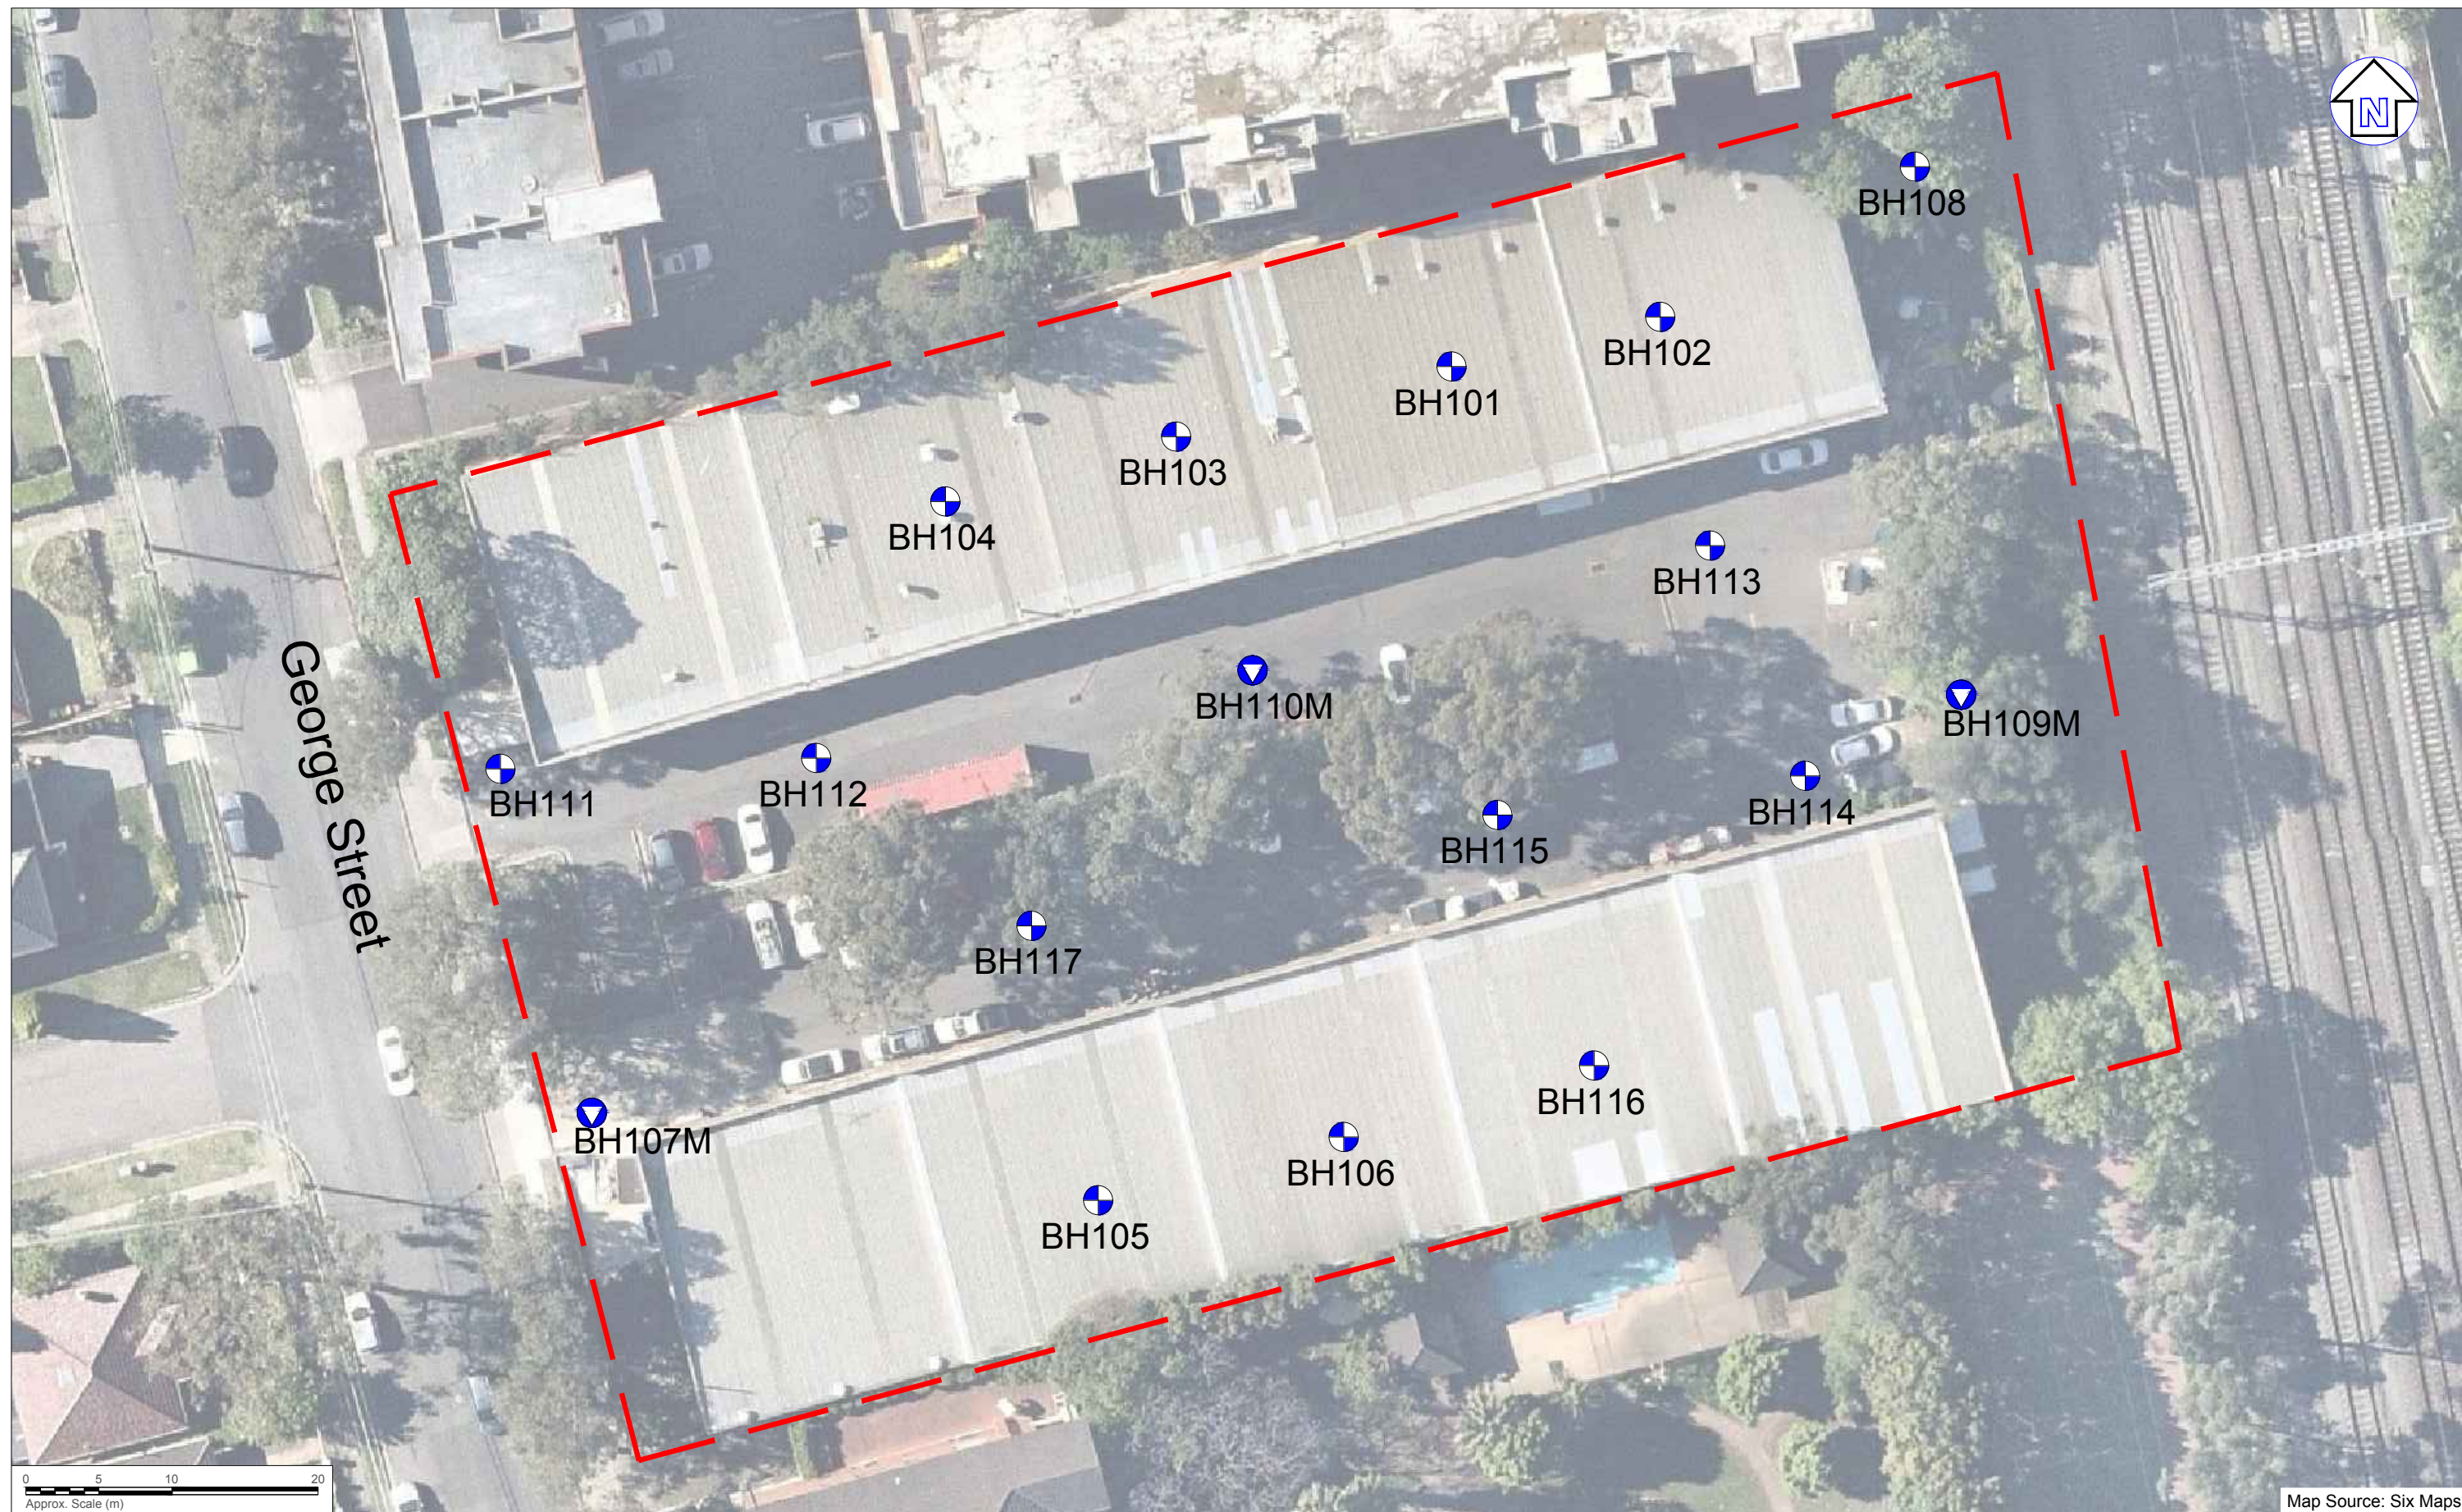
Sub-surface inspections and associated soil sampling was conducted at three (3) test borehole locations on 25 October 2019. Sampling locations were distributed in a triangular pattern throughout the central portion of the site. Stone et al (1998) indicate a minimum of four boreholes are required for investigation of sites up to 1 ha in area. Given the site is approximately 0.75 ha, three (3) borehole locations were considered sufficient for the purposes of this investigation. The borehole locations are presented in **Figure 2**.

Project Detailed Site Investigation
 Location 25 George Street, North Strathfield NSW
 Position Refer to Figure 2
 Job No. E24421.E02
 Client North Strathfield One Pty Ltd
