Friday Flat & Middle Slopes Fan Gun Project Thredbo NSW

Geotechnical Assessment

Our ref: 6725-G1
10 December 2021

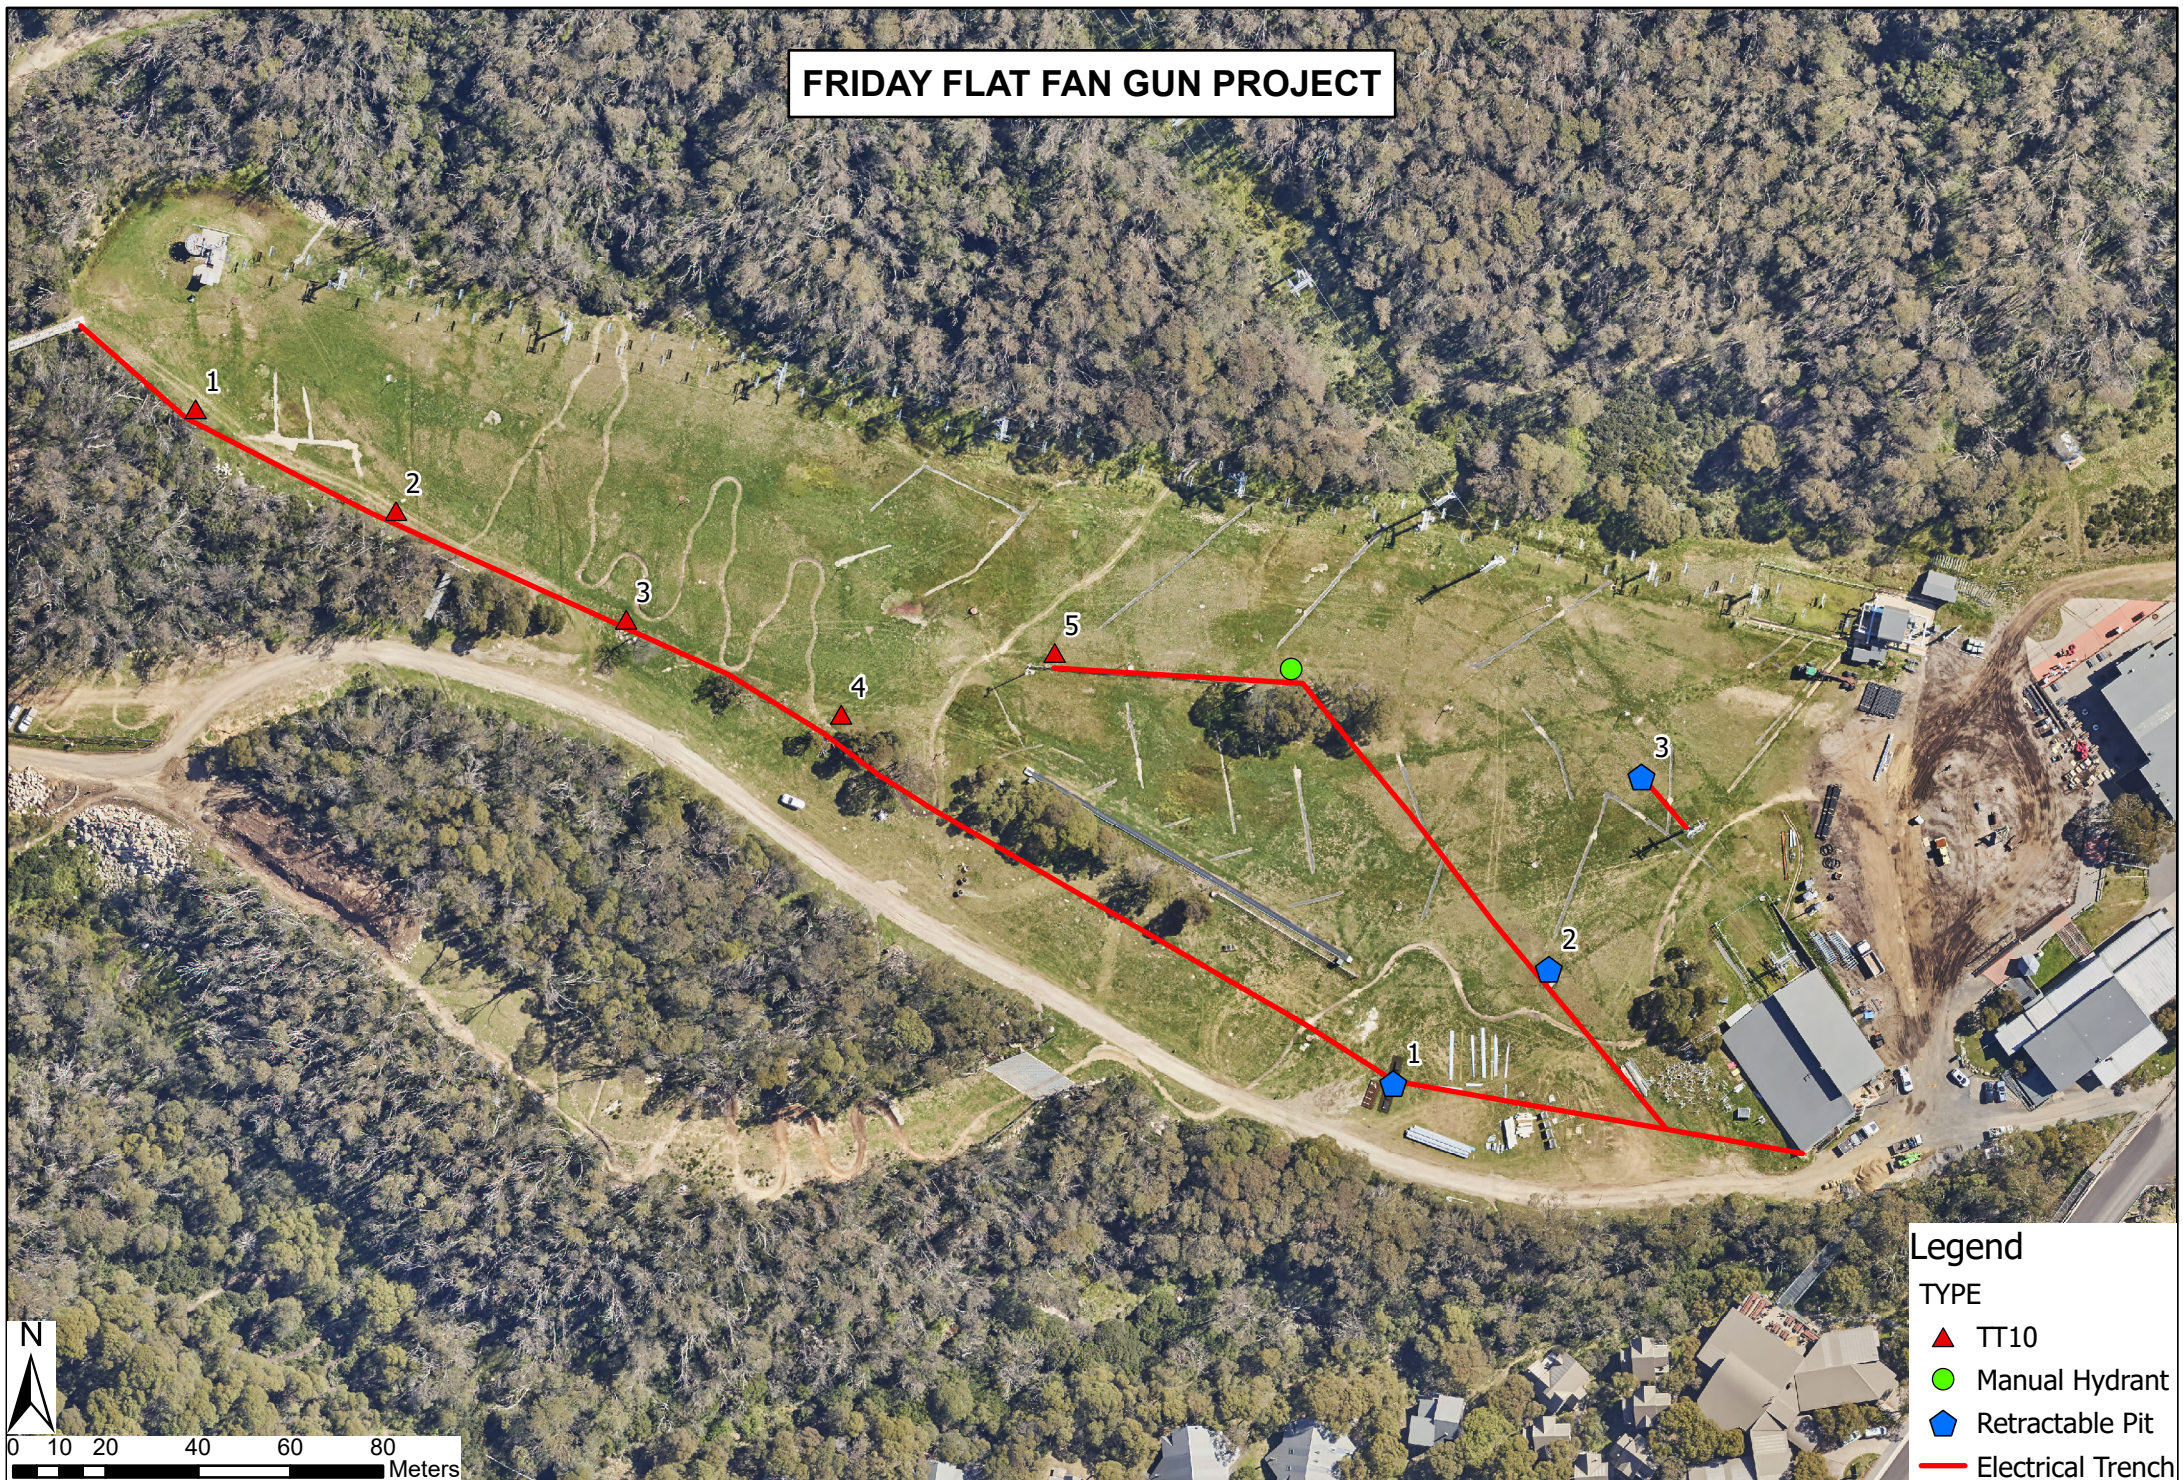
FRIDAY FLAT FAN GUN PROJECT

N.B Due to the age of many of the services in the village locations shown represent our best estimation.

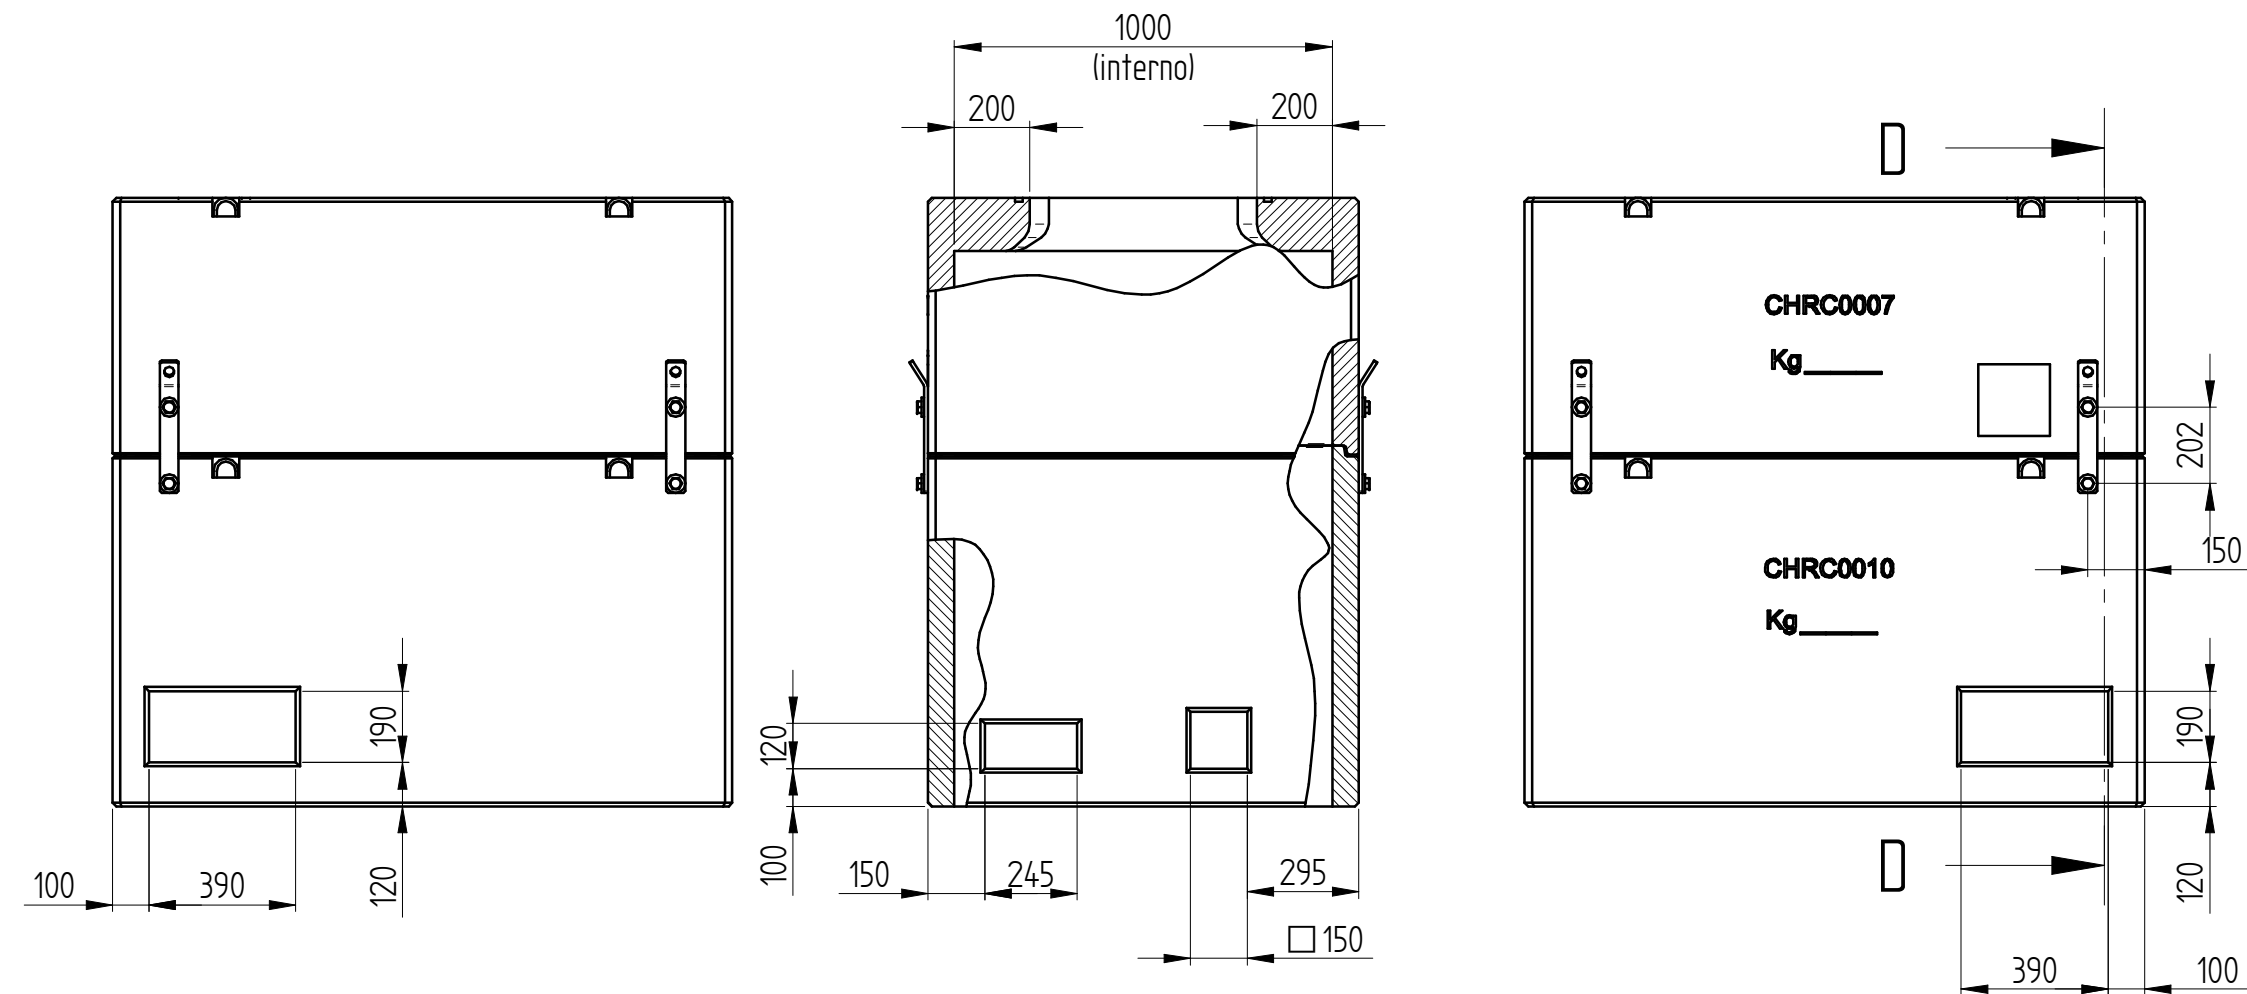
Sez. A-A

Einstiegs Luke
Chiusino
Entrance
Capot de regard

Lift 4.5m / Lanze / Turm 1.6m
Lift 4.5m / Lancia / Torre 1.6m
Lift 4.5m / Lance / Tower 1.6m
Lift 4.5m / Lance / Tour 1.6m

smooth surface treatment

Create date 19.03.2021	Approval date 19.03.2021	Description Pit for Lift 4.5m – 2 holes (entrance 600x600) H				Page 1/1	IDOC "dfr" 3999985
TECHNO LPIN®								ISO 16016

- Excavation sides may be cut vertically for the trenches, up to maximum 1m depth. Excavation for the concrete boxes may also be cut vertically up to maximum 1.6m depth due to the limited lateral extent.

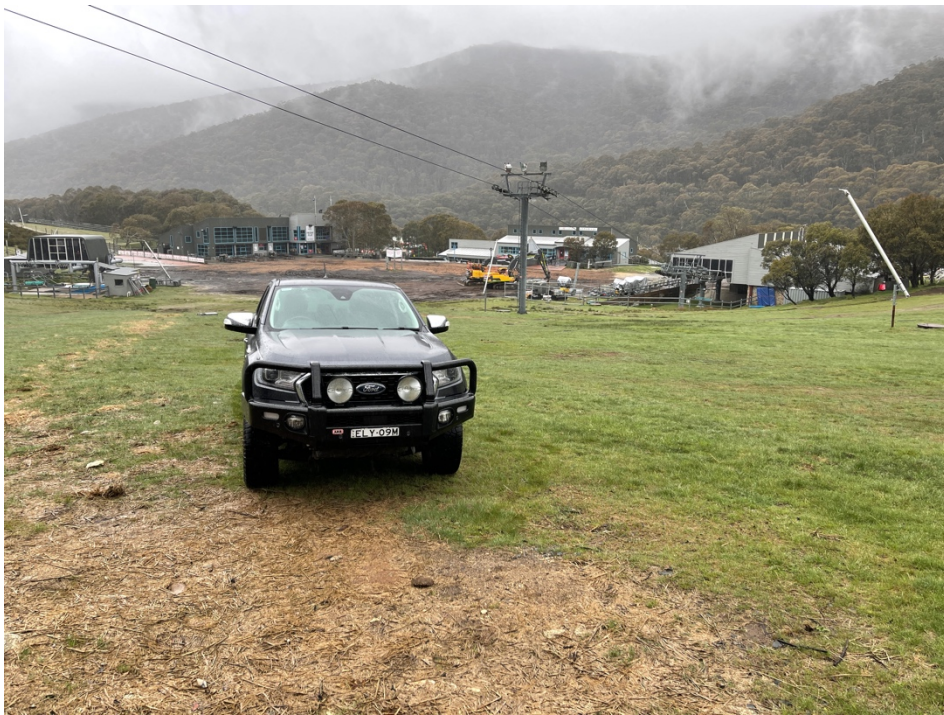
Photo 1

View of lower part of
Friday Flat
snowmaking.

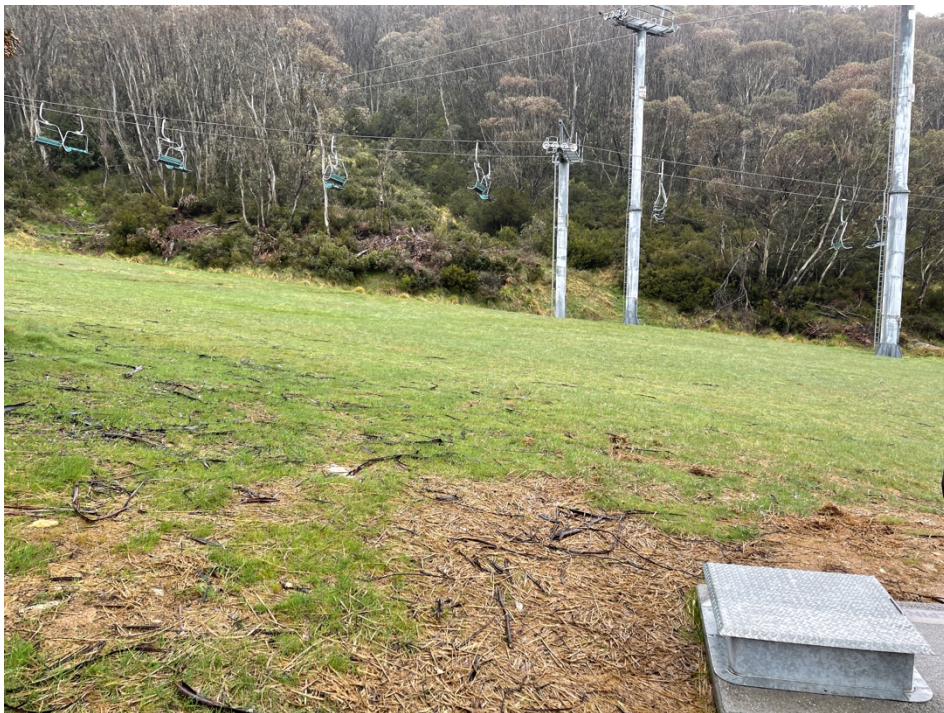
Photo 6
Continuation of
previous photo in
panoramic
sequence. Edge of
concrete pit beneath
snow making gun in
foreground.

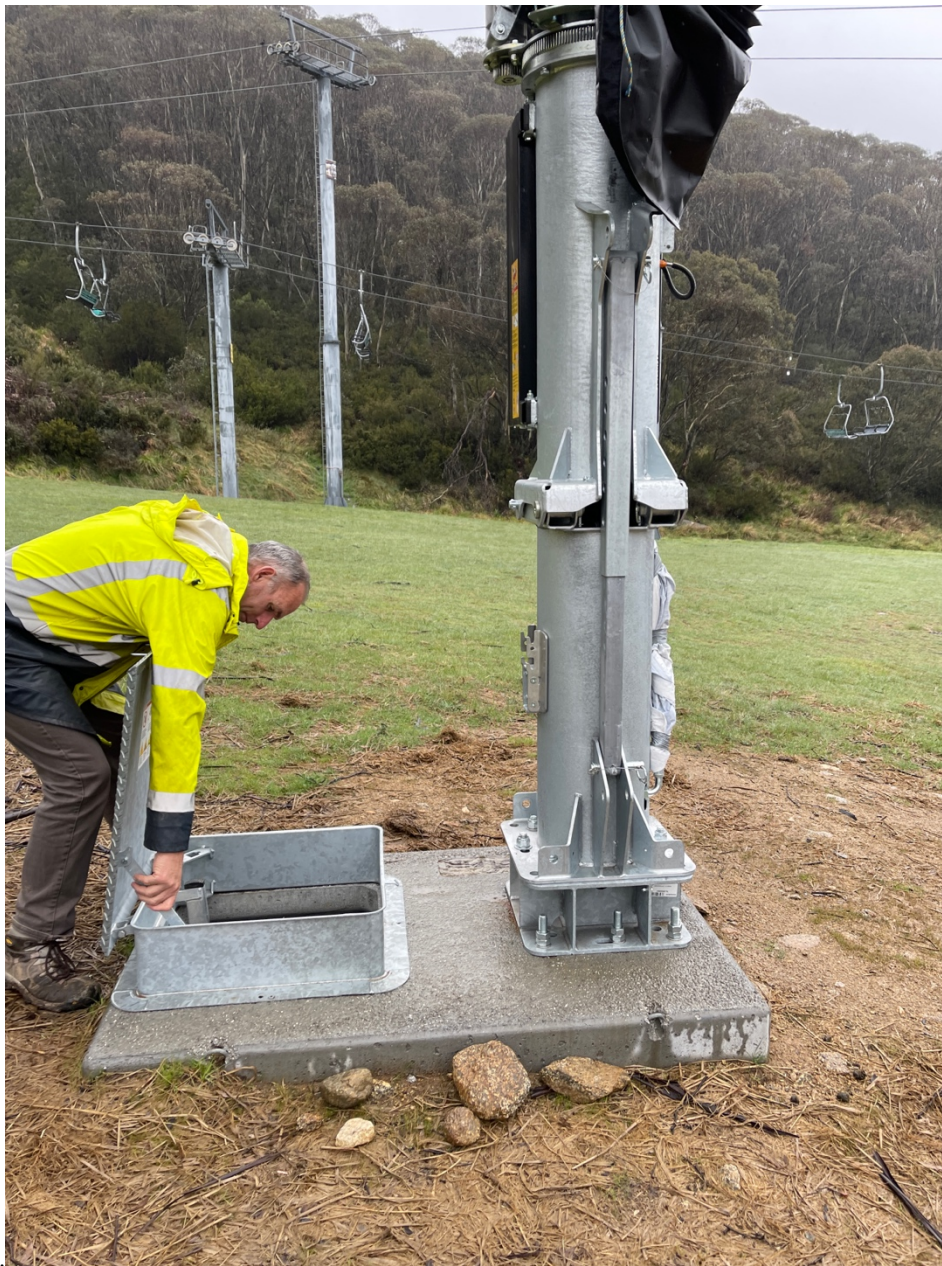
Photo 7
Example of
snowmaking gun on
top of concrete pit

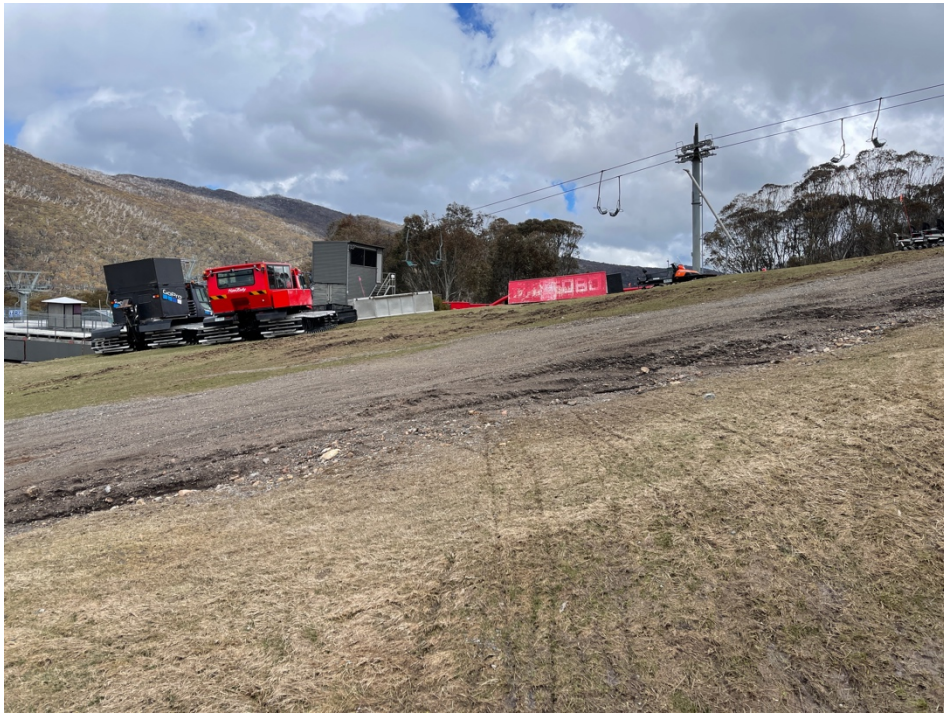
Photo 8

View of ridgeline
looking towards
buildings – Mid
Slopes snowmaking.
