Statement of Environmental Effects

Thredboland and Freeriders Beginner Zone

Thredbo Alpine Resort
Kosciuszko National Park, NSW
July 2022

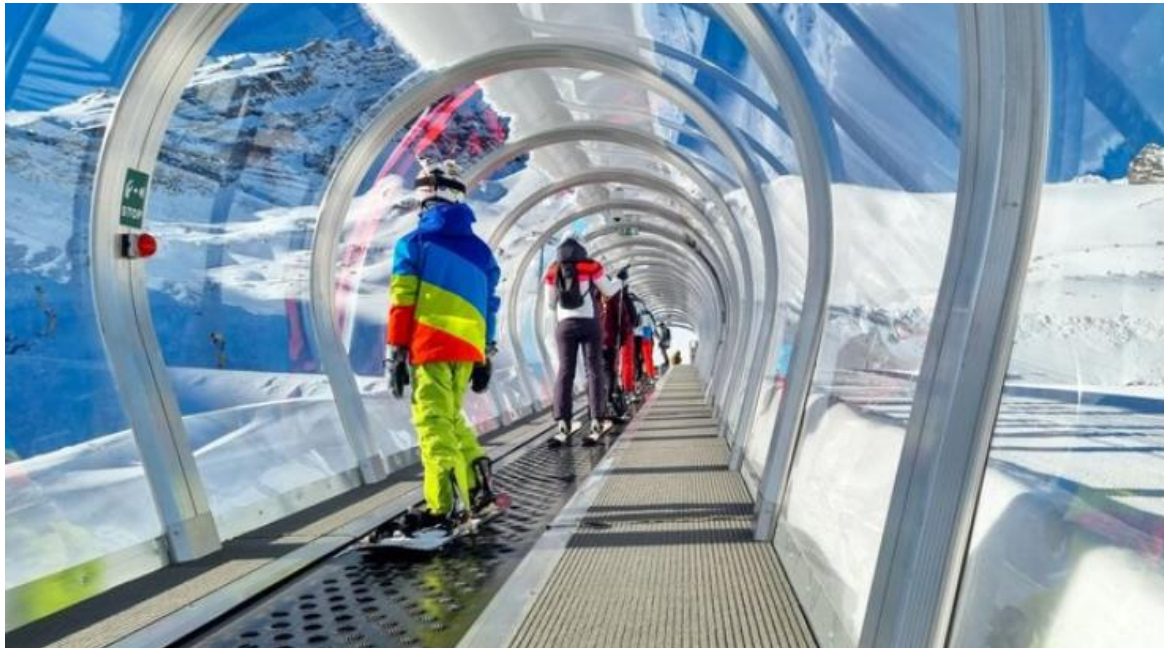
Figure 6: Example of snowrunner (Source: Sunkid 2022)

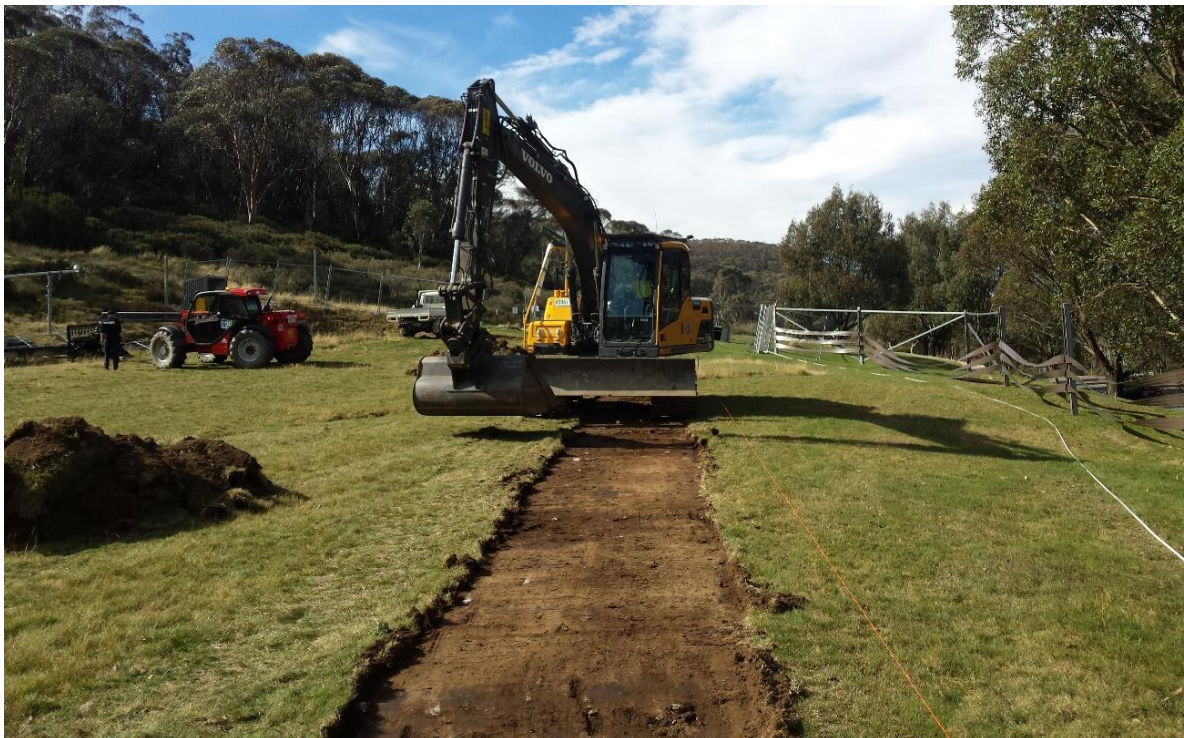
Figure 7: Snowrunner ground preparation

The snowrunner does not require a permanent foundation, making it easy to install with minimal ground preparation.

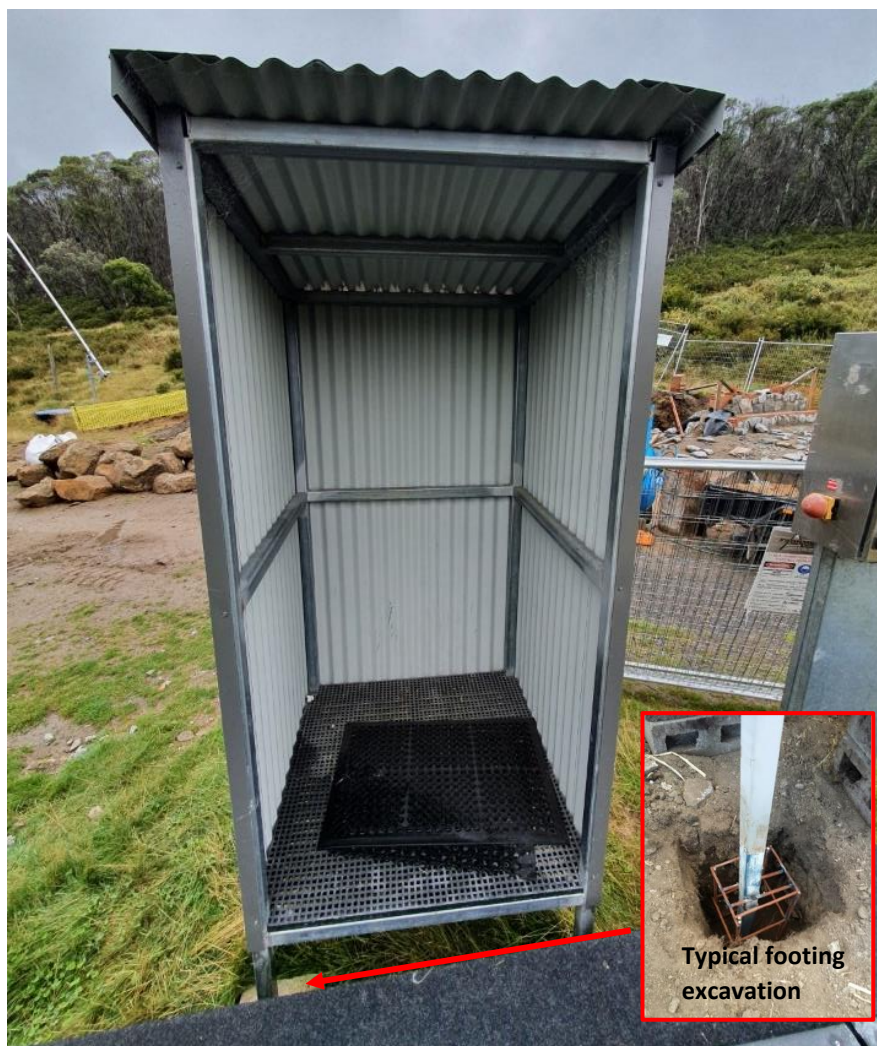
Figure 8: Example of Operator Hut

Two (2) operator huts (top and bottom of snowrunner) (**Figure 8**) will also be installed. The huts are approximately 1100 mm x 1100 mm x 2850 mm high. The hut footings (short concrete piers) require minimal excavations. Design plans are provided in **Appendix B**.

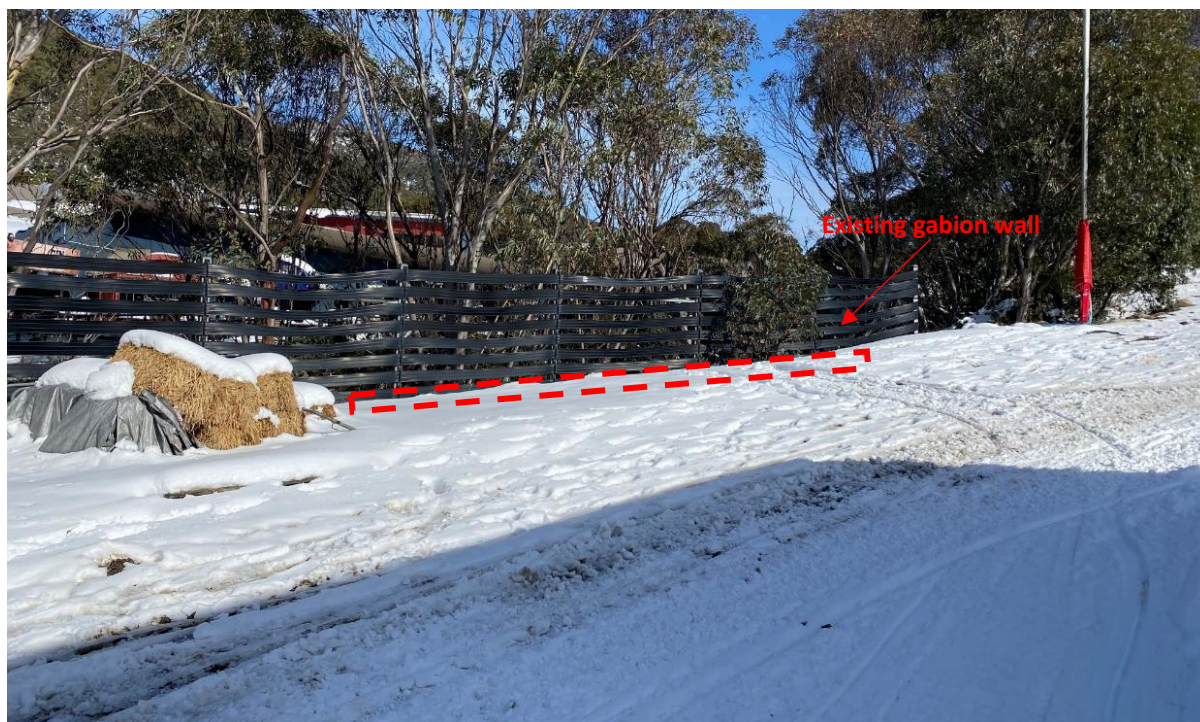
Figure 9: Proposed Stairway Location

The existing gabion wall at this location will also be extended as a rock wall.

After the stairs, guests will turn right across the Mountain access road toward the check-in location. Barrier nets will be installed along the southern end of Gunbarrel bottom station to guide guests to the check-in location.

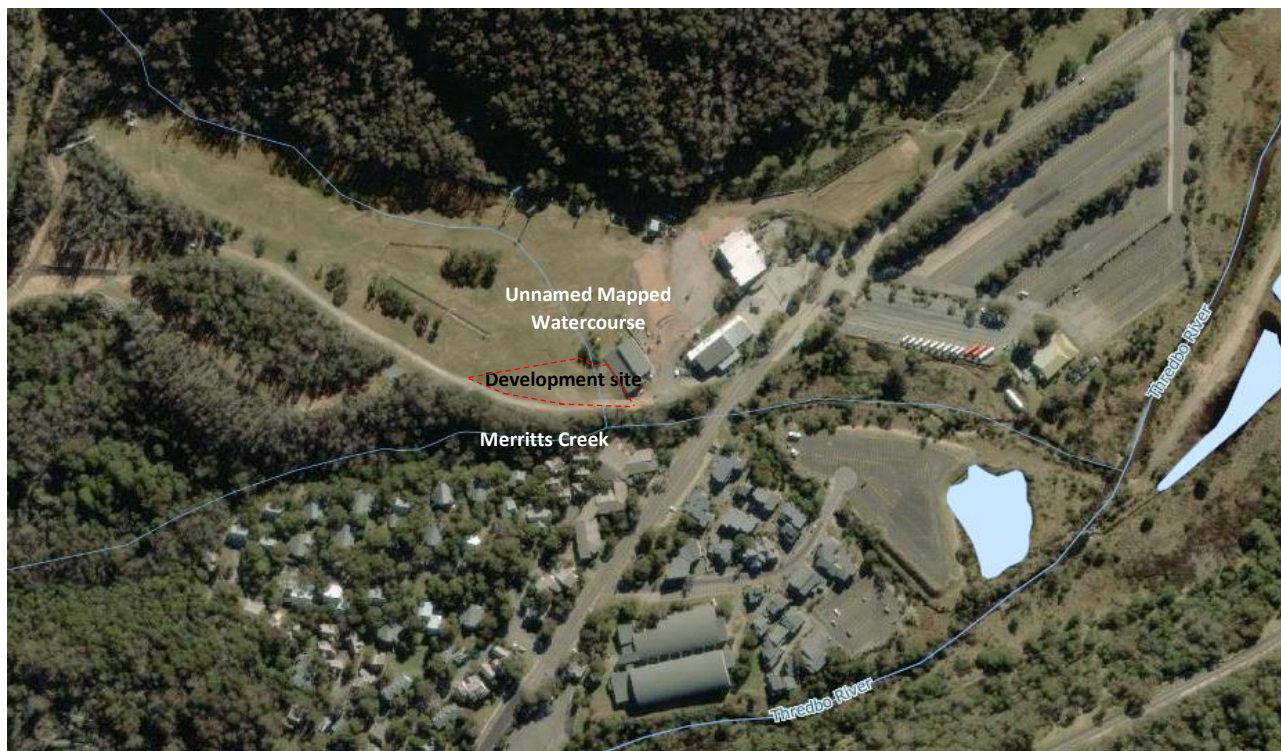
Figure 11: Mapped Watercourses (Source: NSW Government 2022c)

As shown on the *Water Management (General) Regulation 2018 hydroline spatial data 1.0* map (NSW Government 2021c), two mapped watercourses are located within close proximity of the site (Figure 11).

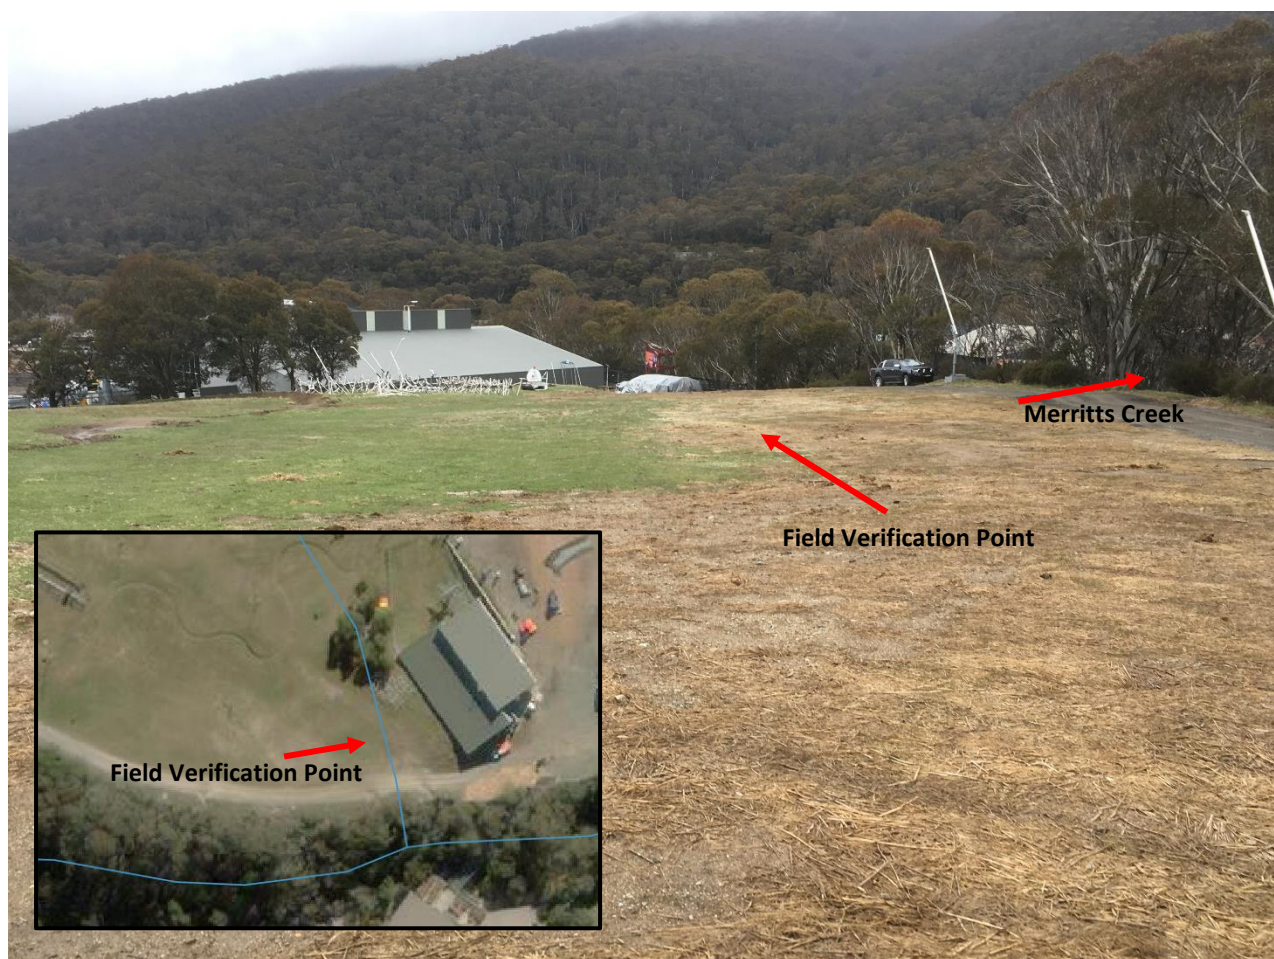
Figure 12: Unmapped Watercourse Field Verification

The portion of the unnamed mapped watercourse which traverses the Development site does not exhibit the features of a defined channel with bed and banks, as shown on **Figure 12**. This drainage line was diverted in the 1980s when Friday Flat was first developed. The diversion resulted in the drainage line being diverted around the ski slope area (approximately halfway down the slope), below the Easy Does It Quad lift (to the north-north-east) into a network of underground pipes, including several inlets/drains (refer **Figure 13** and **Figure 14**). As such, it is determined the mapped watercourse is not waterfront land for the purposes of the WM Act. Therefore, no further assessment is required.

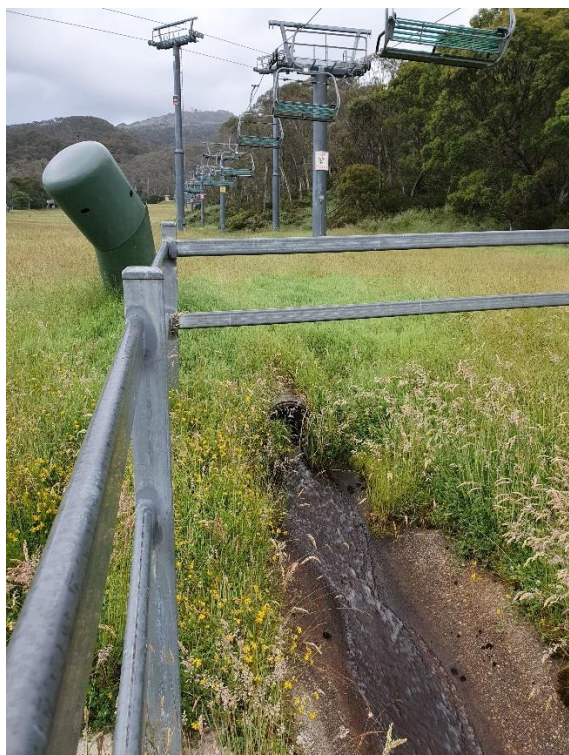
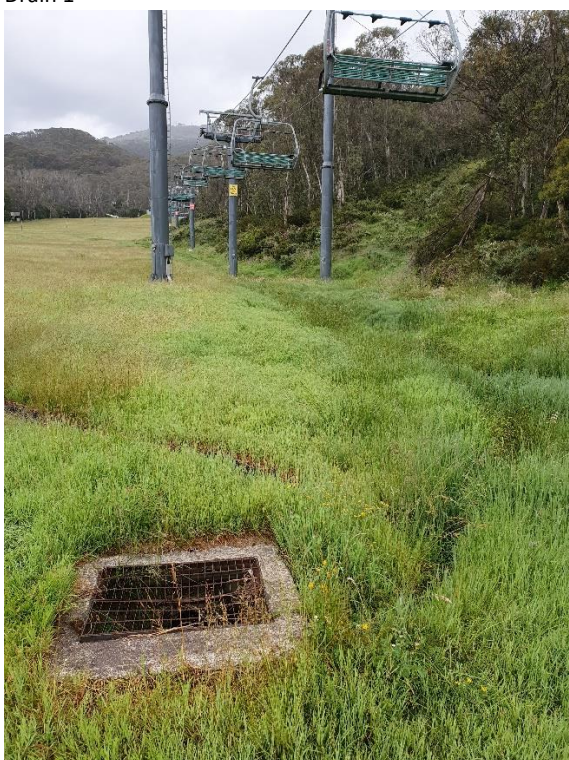
Figure 14: Inlets within diverted drainage line below Easy Does It Quad Lift

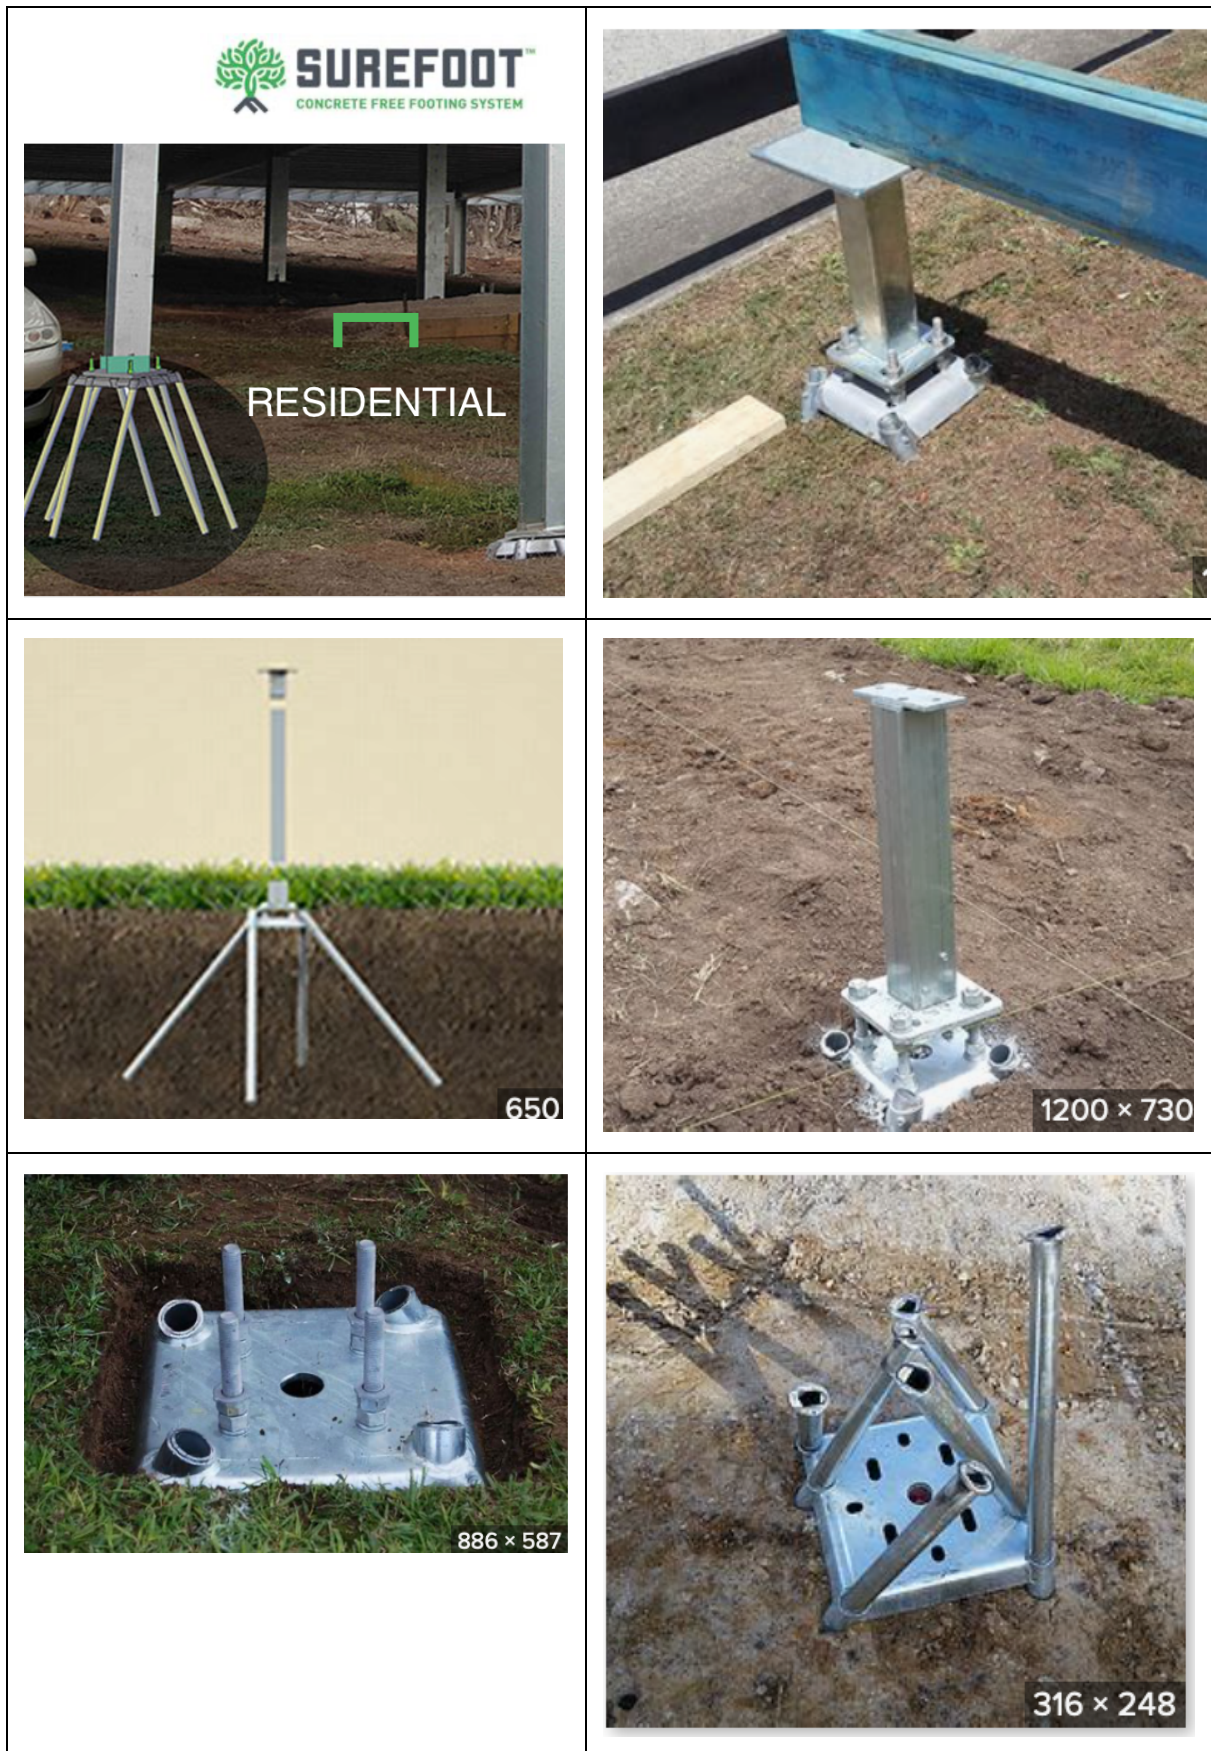
Typical Operators Hut
