Preliminary Site Investigation

51 Drummond Street, Belmore NSW

Report No: E25284.E01_Rev0

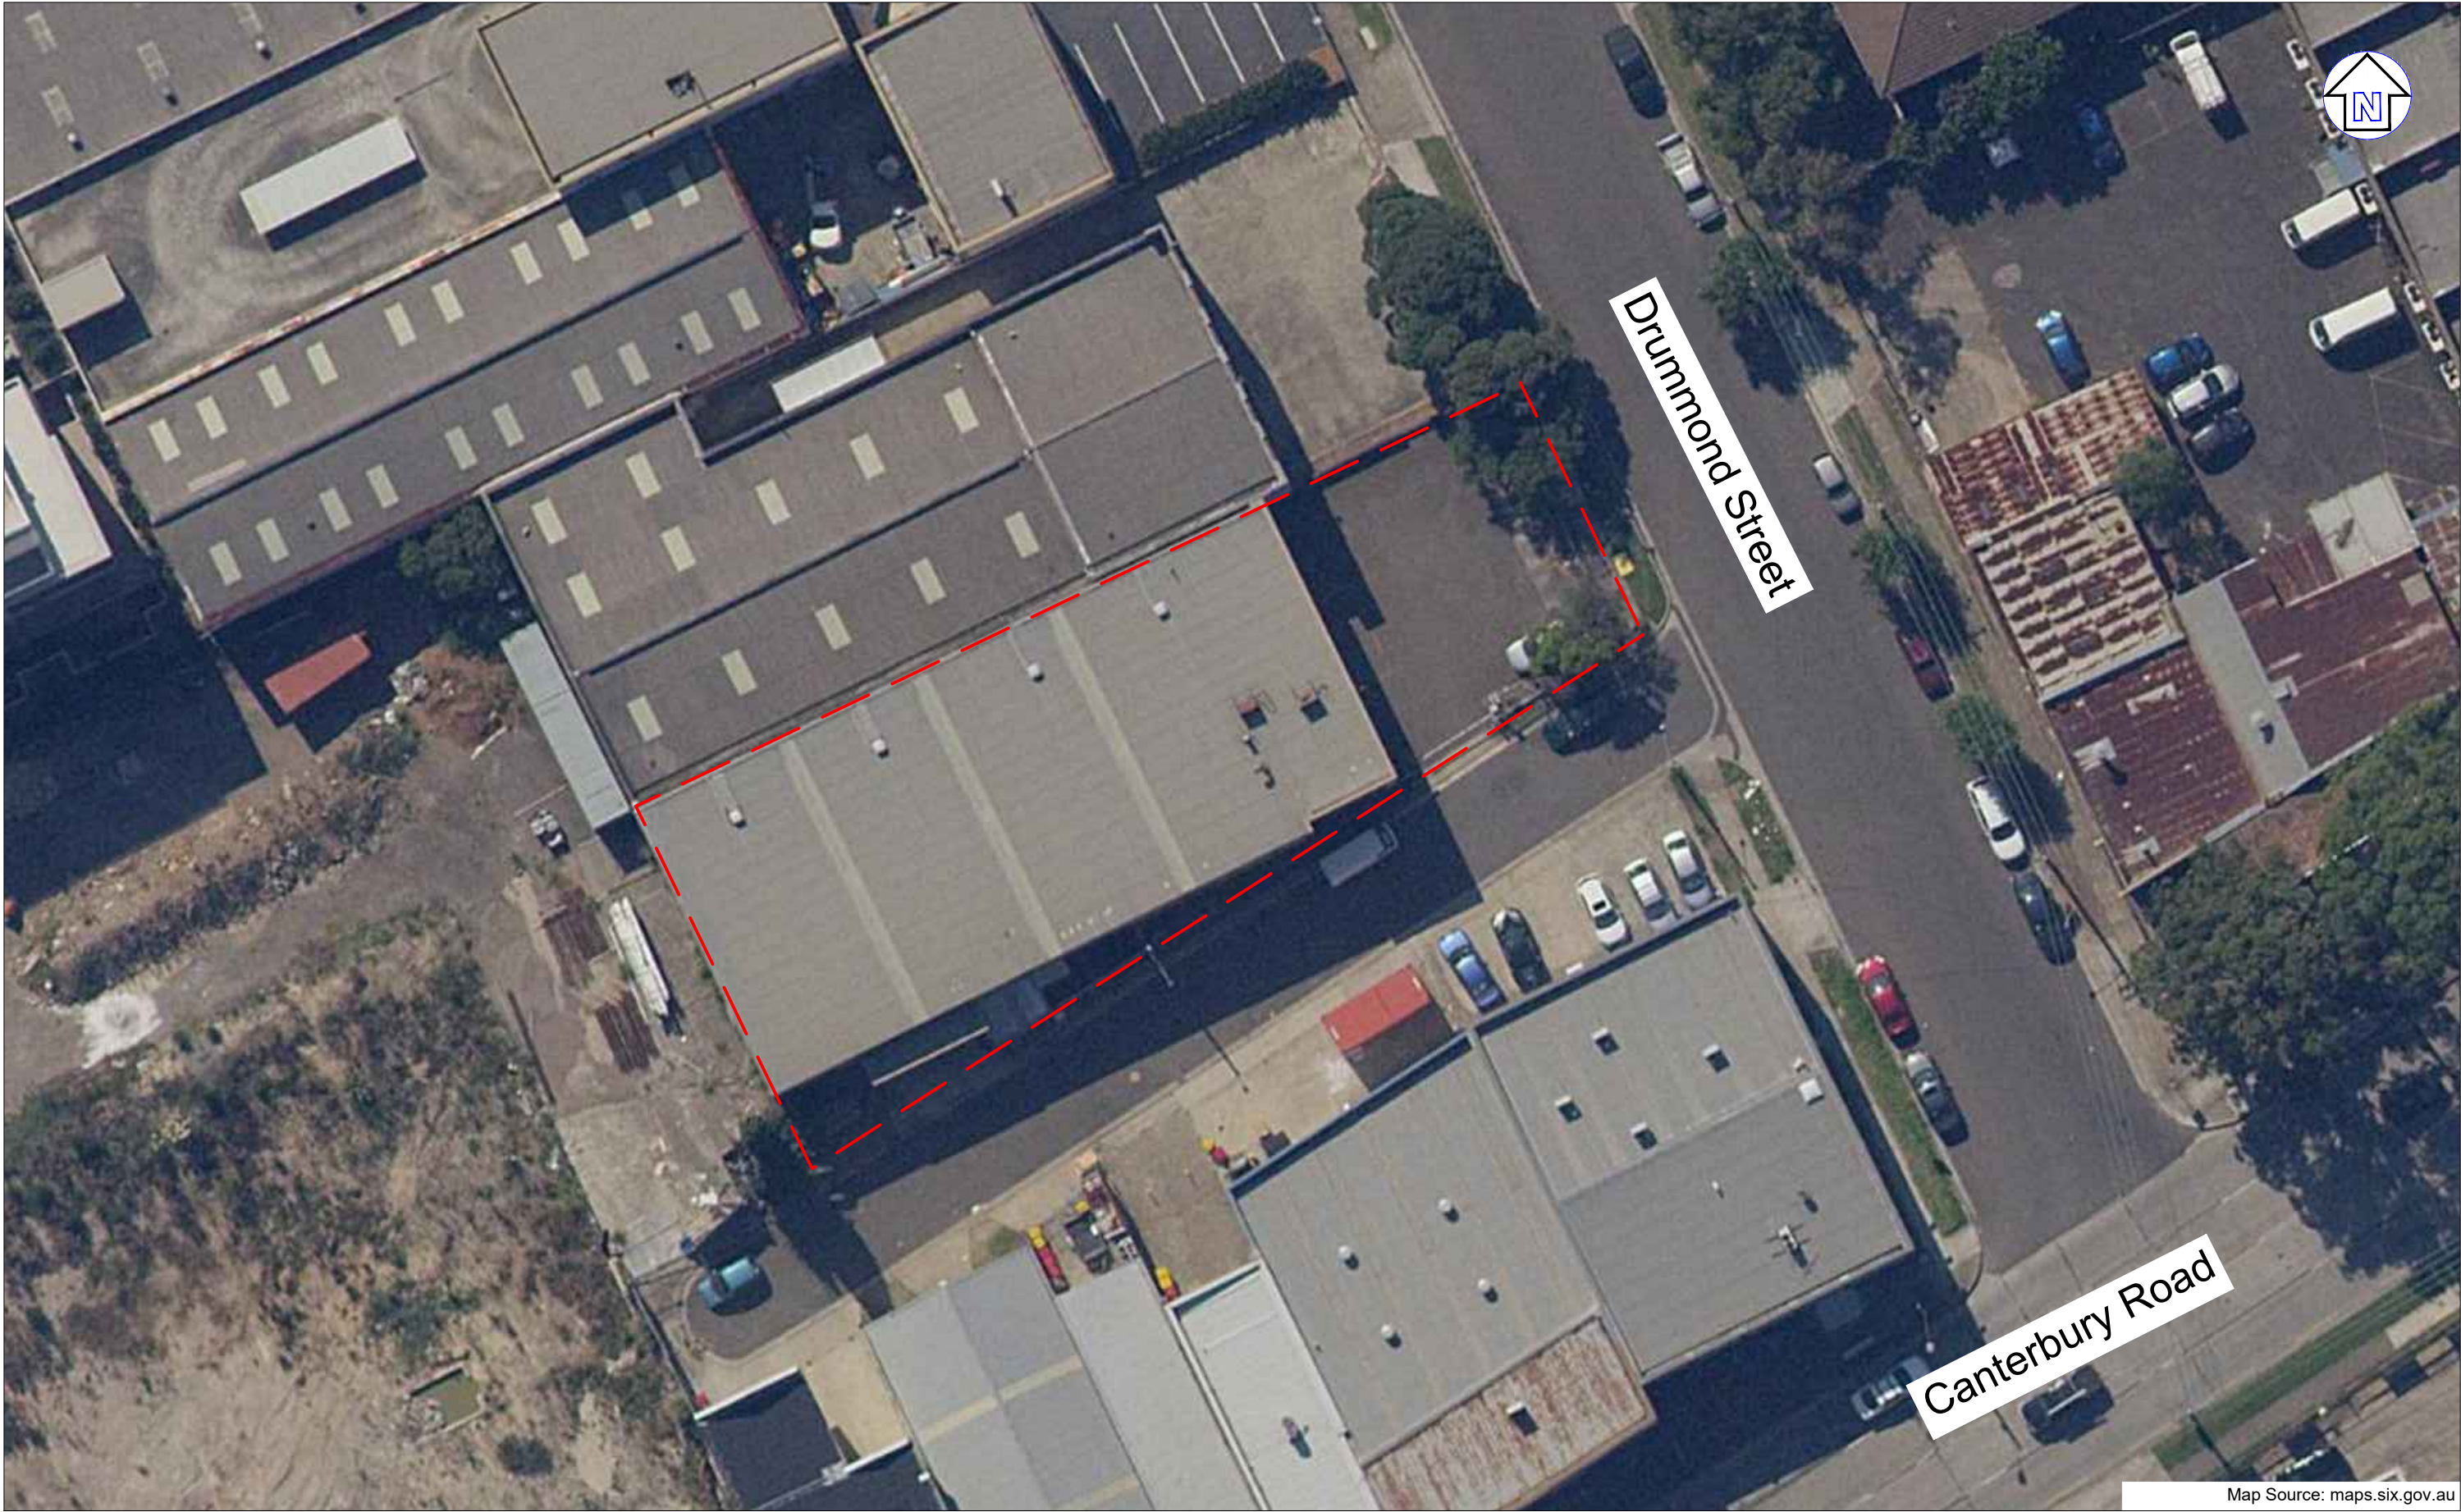
Figure:
2
Project: E25284
E01_Rev0

The location of site buildings is presented on the site layout diagram in **Figure 2, Appendix A**.

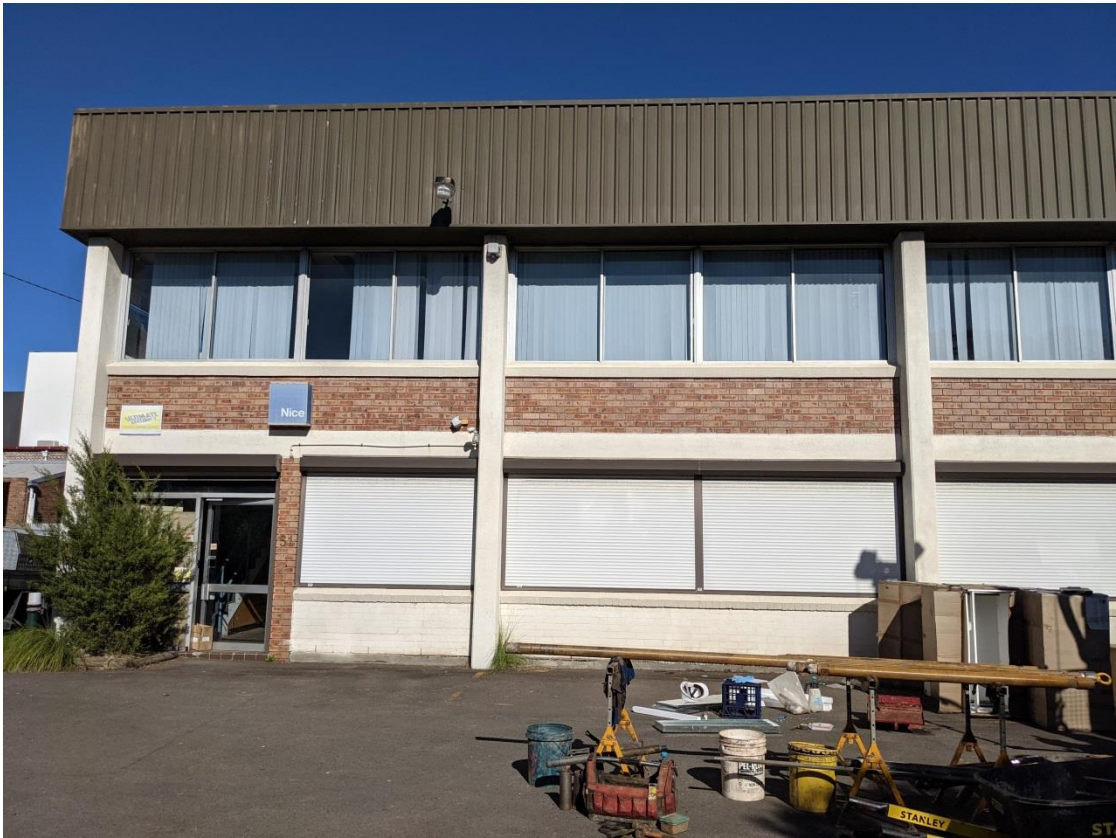
Photograph 1: 51 Drummond Street, Belmore NSW (26-08-2021)

- The site was occupied by a two storey commercial warehouse with a sheet metal roof and concrete sealed car park in the front portion of the property (**Photograph 1**);

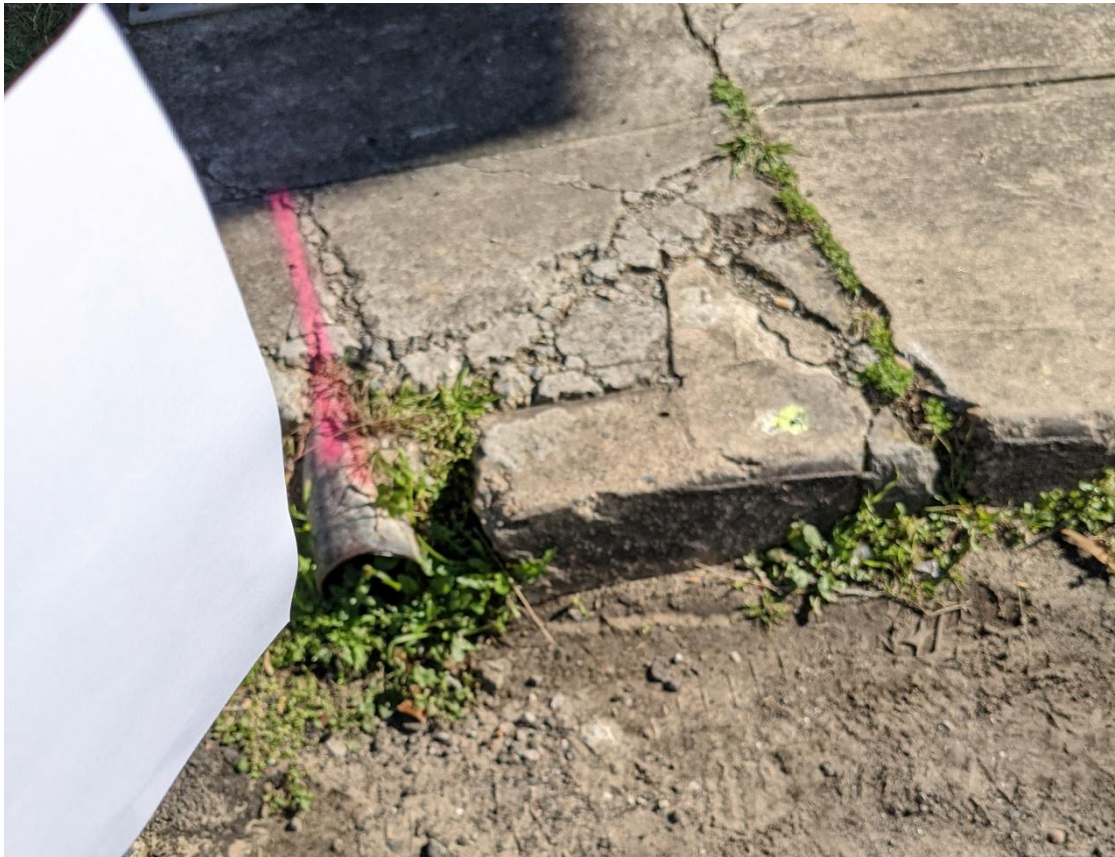
- The warehouse appeared to be in moderate conditions, with very minimal cracking on the building walls;
- The sealed concrete surfaces around the warehouse exterior was in moderate to poor condition, with several significant cracks and indicators of erosion visible (**Photograph 2**);

Photograph 2: 51 Drummond Street, Belmore NSW (26-08-2021)
[Sealed surfaces around building exterior in moderate to poor condition]

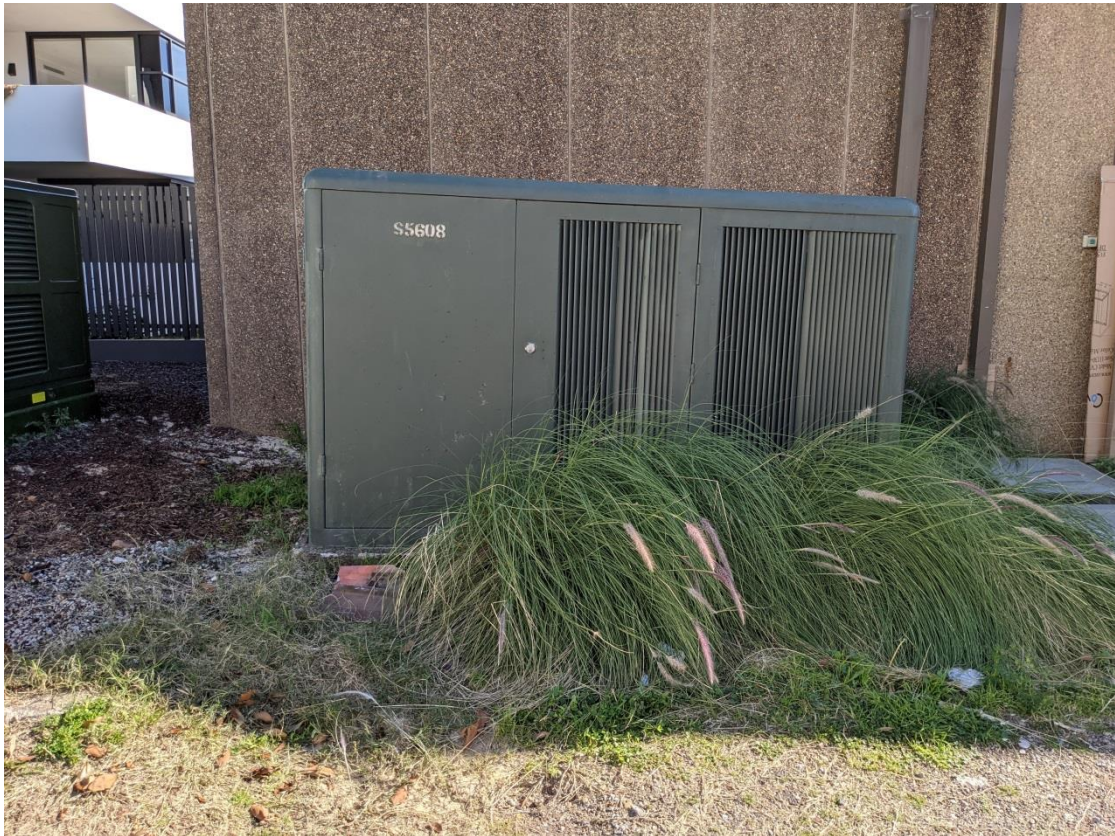
- A small grass area was located at the south western corner of the site. The grass was overgrown in areas, with some barren areas also visible (**Photograph 3**);

Photograph 3: 51 Drummond Street, Belmore NSW (26-08-2021)
[Grassed area along SW lot boundary with some barren areas and visible die back]

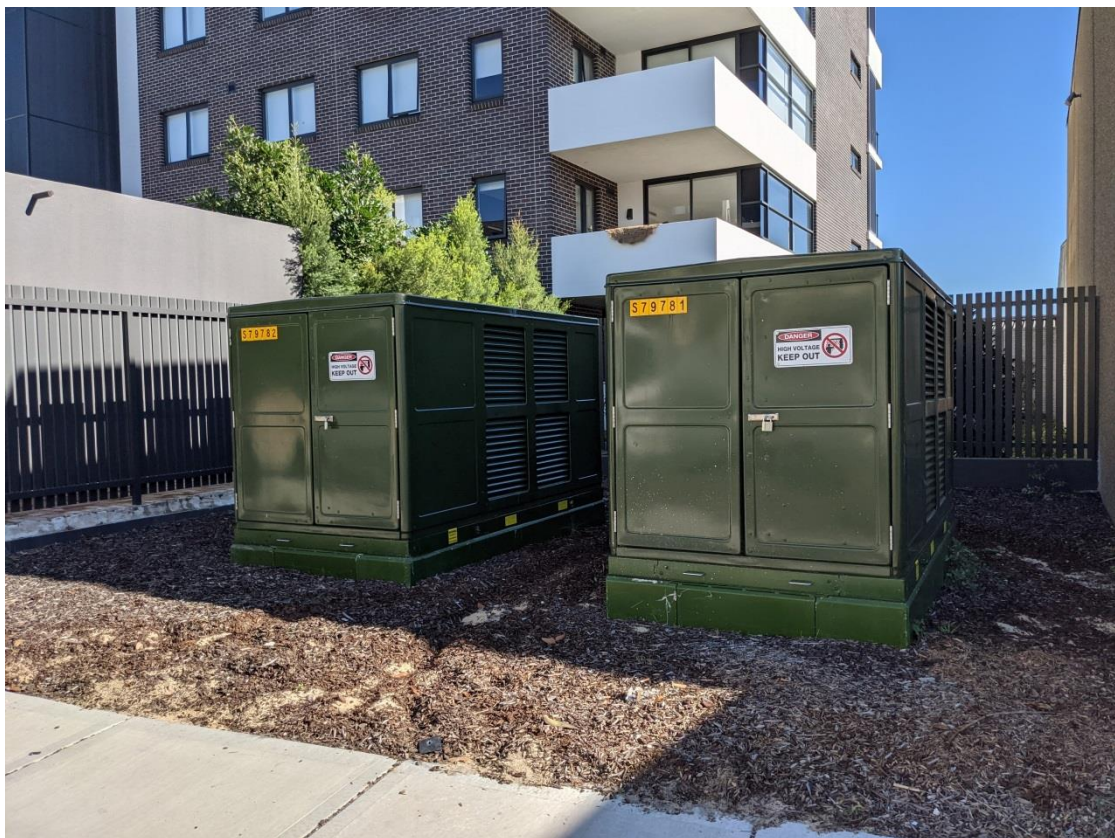
- Three electrical substations were located along the south western site boundary (**Photographs 3 & 4**);
- A sewer and gas access point, and a Telstra service pit was located along the southern lot boundary (**Photographs 5 & 6**);

Photograph 4: 51 Drummond Street, Belmore NSW (26-08-2021)
[soil surfaces around substations where covered with mulch]

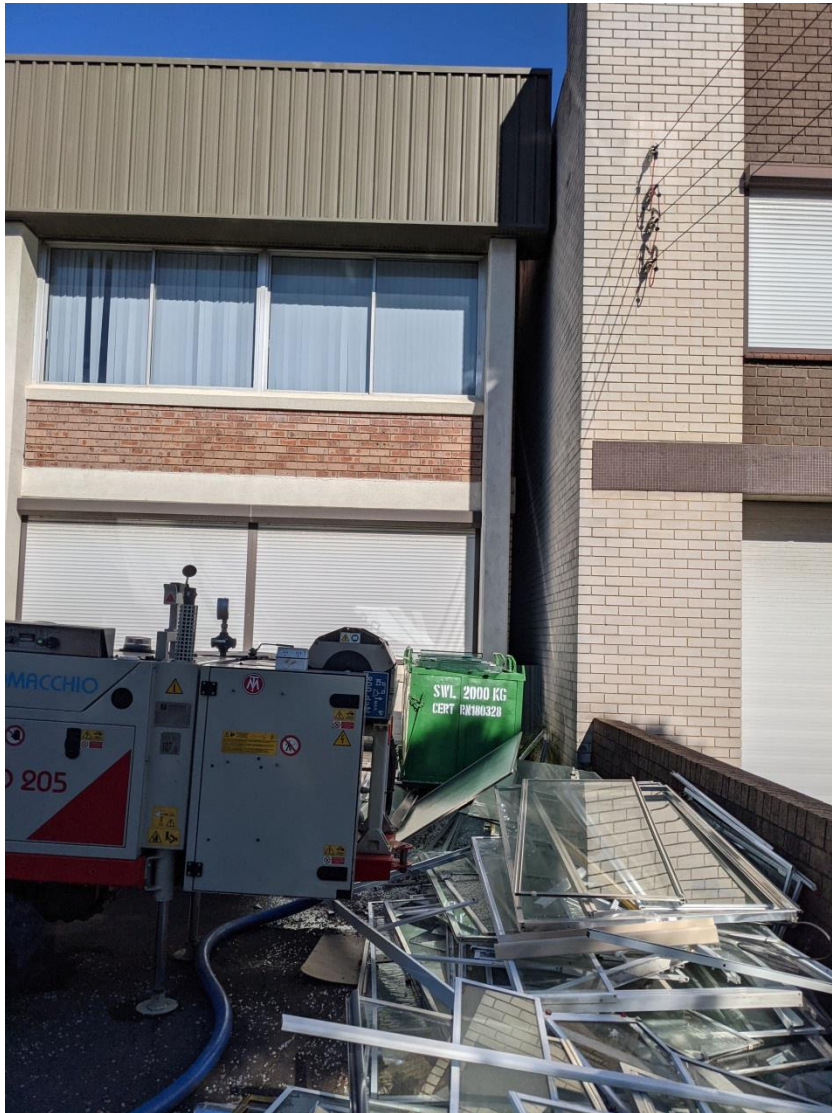
Photograph 7: 51 Drummond Street, Belmore NSW (26-08-2021)
[Waste stockpiled along the NW site boundary]

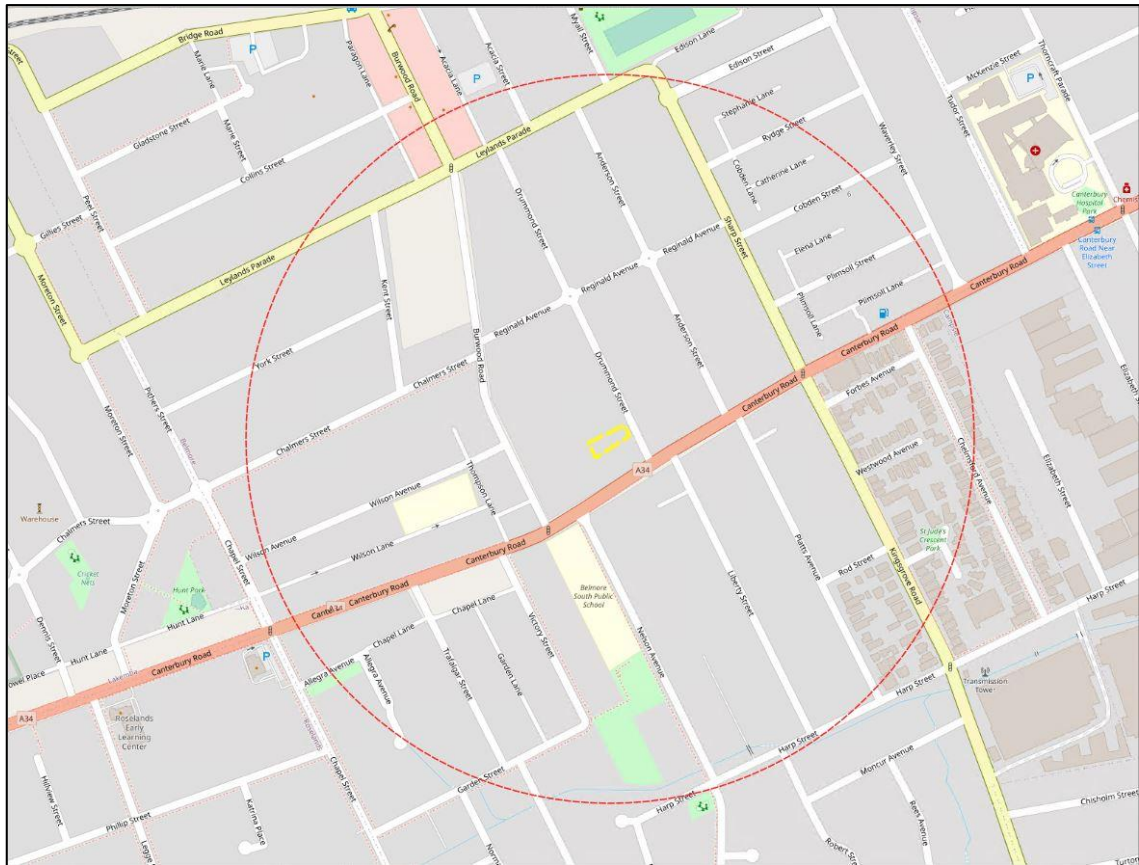
An online search of registered groundwater bores was conducted by EI on 3 August 2021 through the WaterNSW (Ref. <https://realtimedata.waternsw.com.au/water.stm>). There were no registered bores within a 500 m radius of the site (**Appendix D**). GIS data was used to view and export WaterNSW data for the purposes of this report (Ref. <http://qgis.osgeo.org>)

Figure C: Local groundwater monitoring wells. No wells were found within a 500m radius of the site (Ref. <http://qgis.osgeo.org>).
