MEROOL HOLIDAY PARK – MOAMA NEW SOUTH WALES

ABORIGINAL CULTURAL HERITAGE DUE DILIGENCE
ASSESSMENT

FINAL REPORT

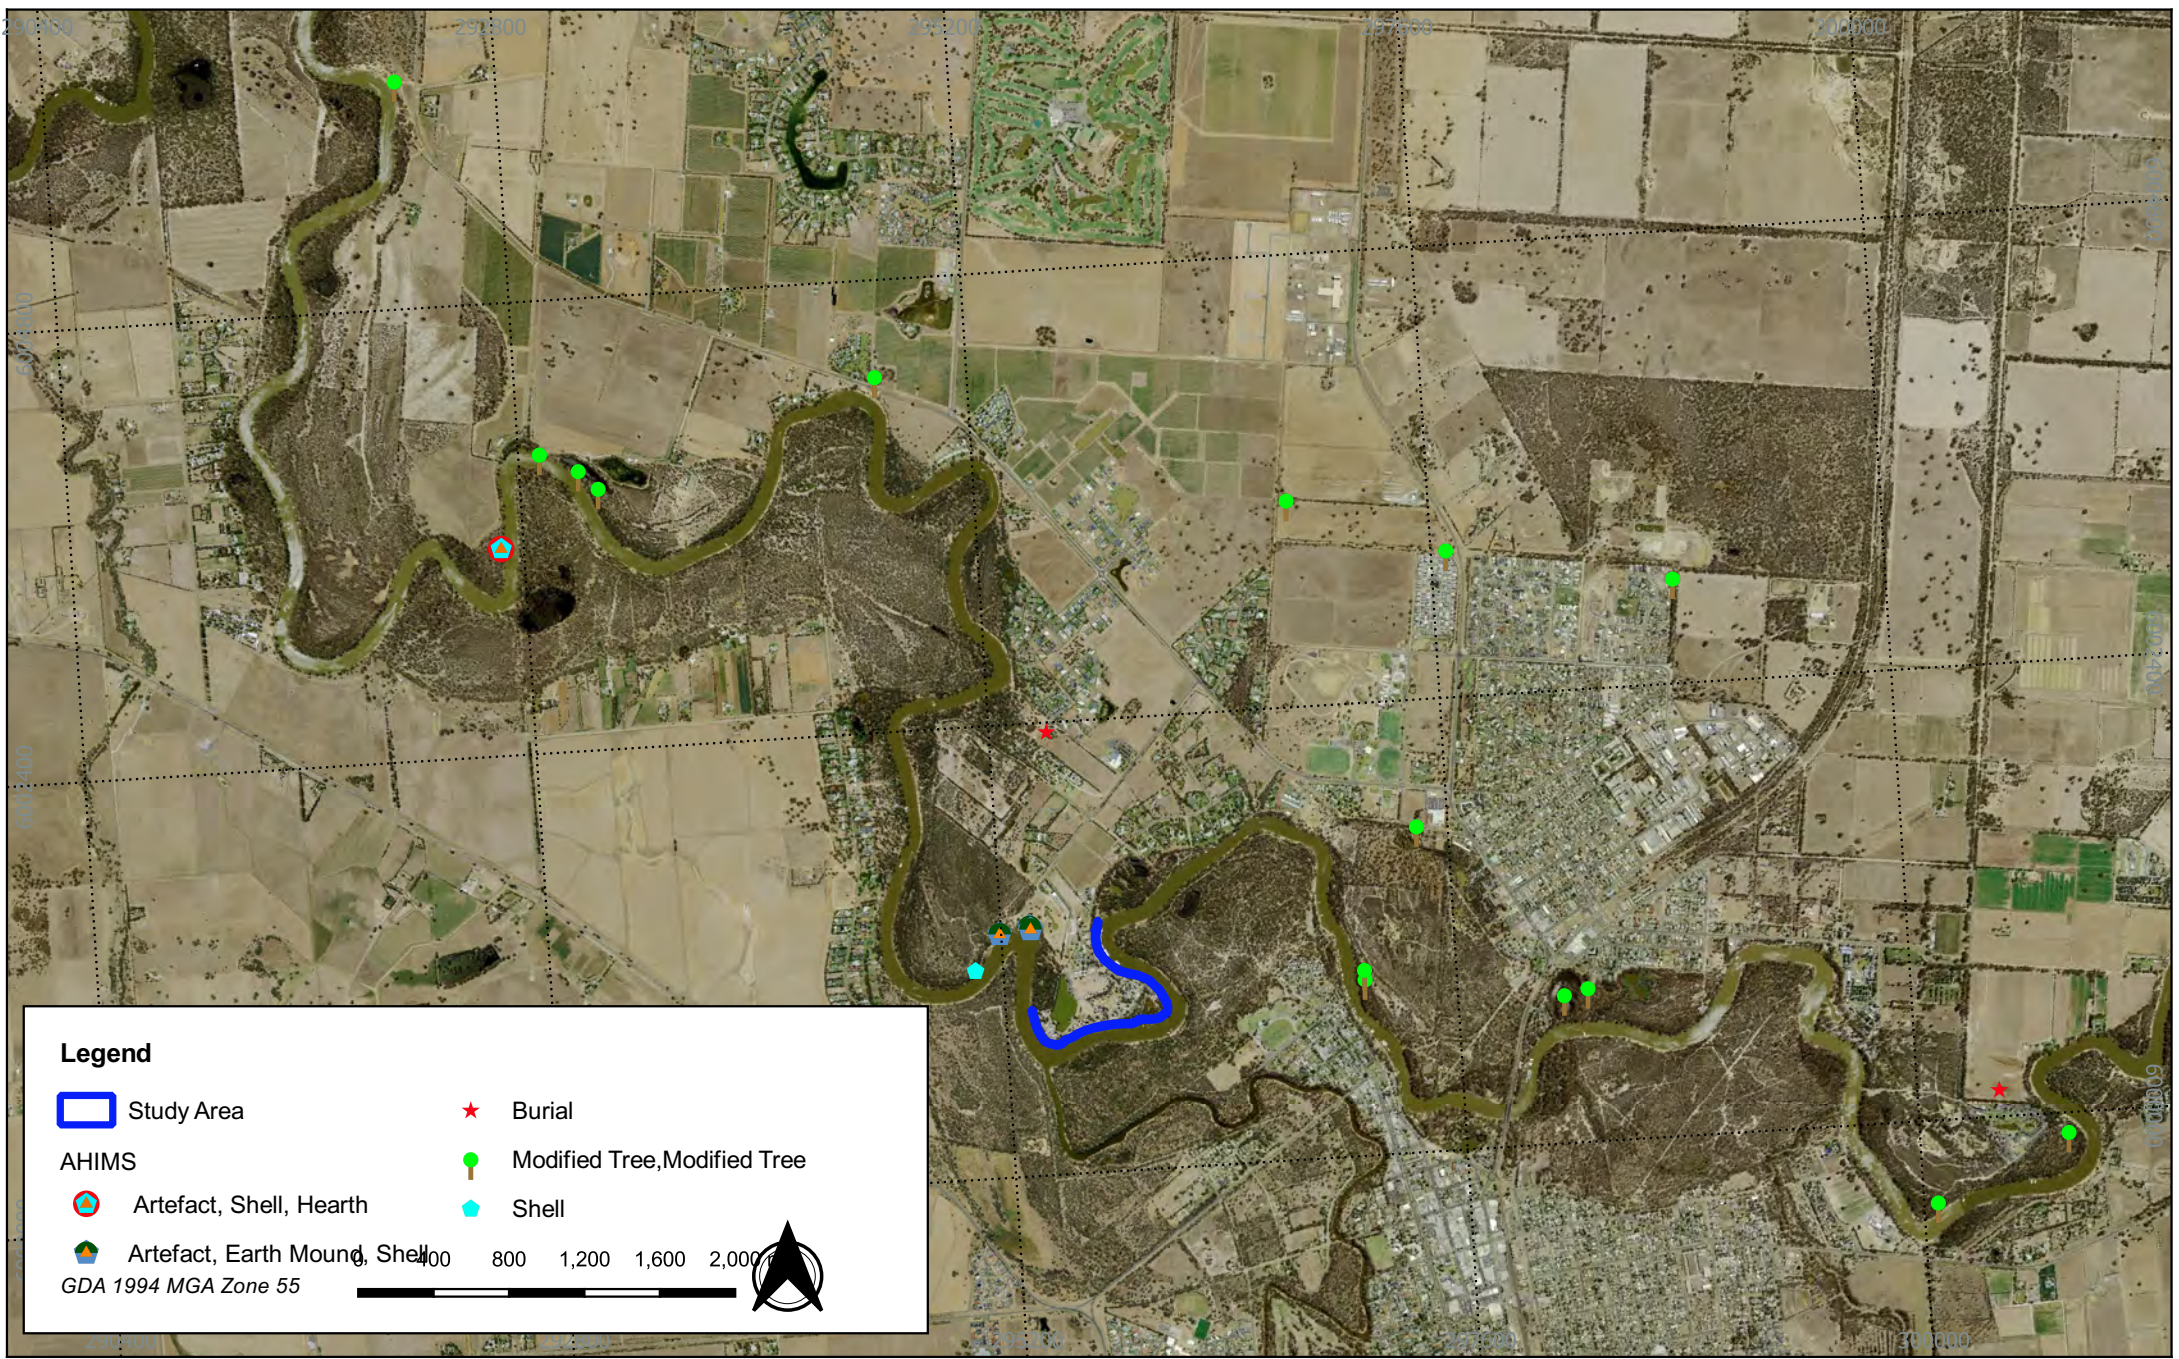
In NSW, there is a strong correlation between proximity to water and the presence of Aboriginal sites. The data in Table 1 shows a variety of site types associated with the Murray River at Moama, with the most common site type being modified trees. There are 3 earth mound – shell – artefact sites and 2 burials along with one shell-artefact-hearth site and one shell site. The closest site type identified was the earth mound-shell-artefact which was located approximately 336 metres east of the current study area.

Figure 3 - AHIMS sites in relation to the study area

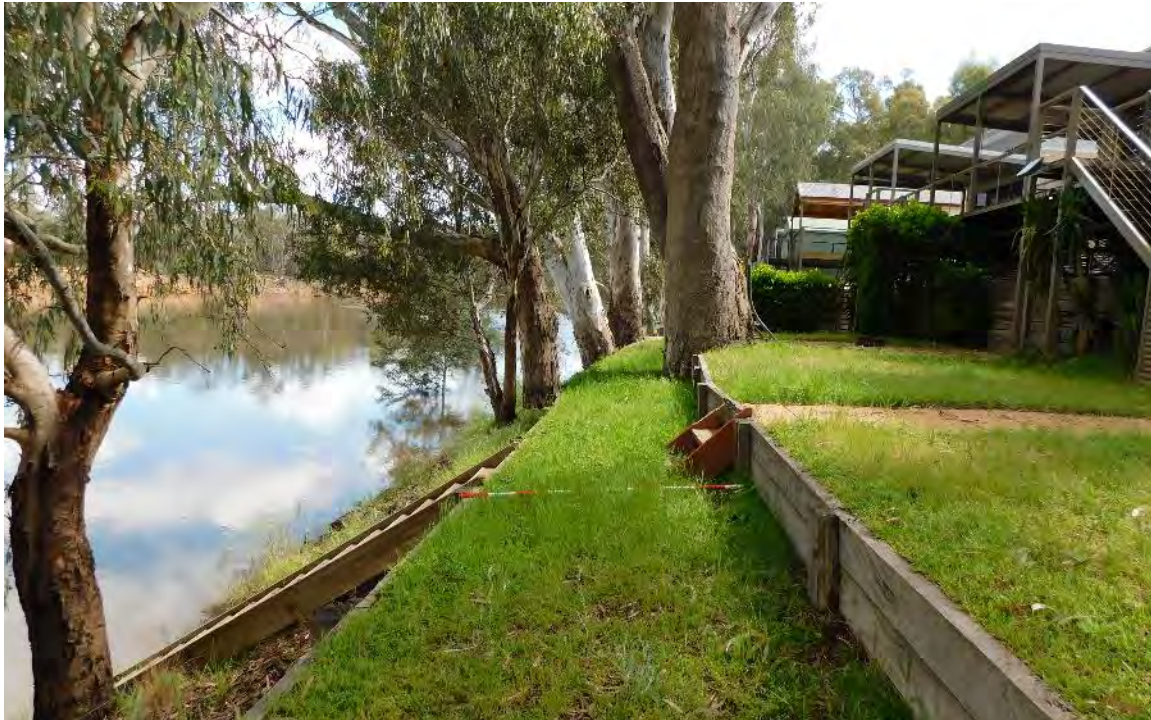
During the inspection, it was identified that there was heavy disturbance to the riverbank. This was evident by the height of the bank, which was significantly higher than the surrounding land, with some areas around the cabins up to 3 metres higher than other areas (Figure 9). This may have been built up during the levelling of the park and the excavation of the dams, which are located near the south-eastern section of the study area. Other disturbances in the study area were often associated with the cabins and access to the rivers and included decking, pipelines, pontoons, fencing and stairs (Figure 6 to Figure 9).

Figure 6 North facing view of disturbance to riverbank

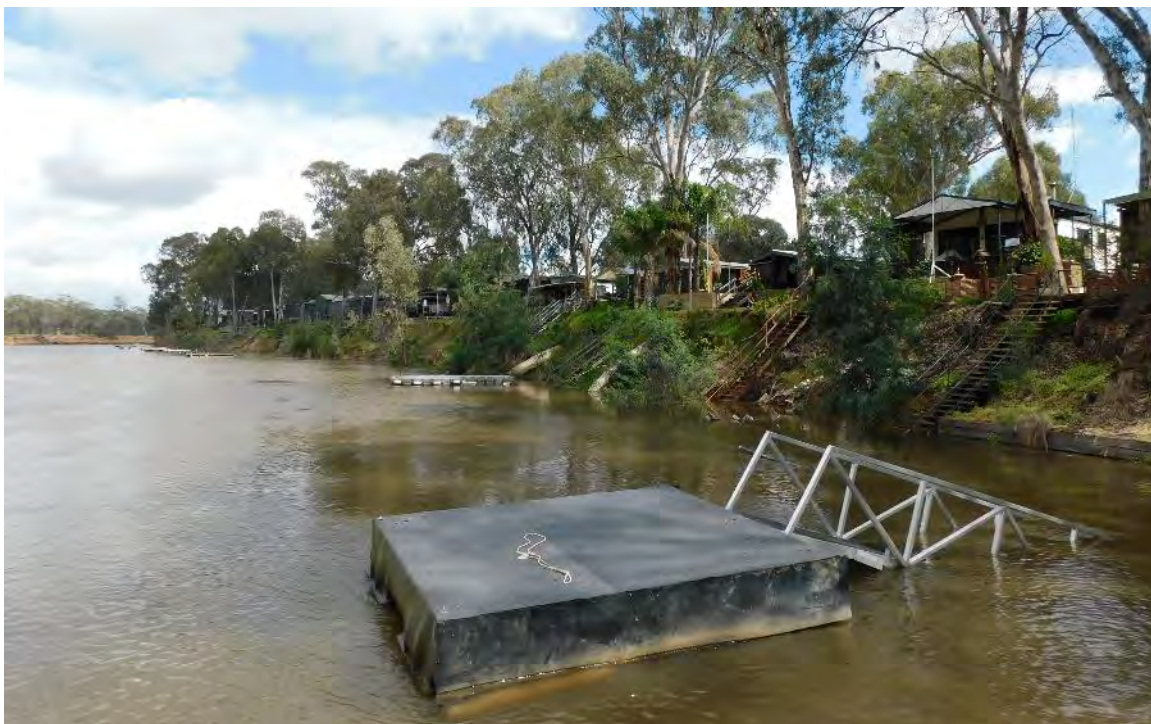
Figure 7 West facing photograph of riverbank and pontoons

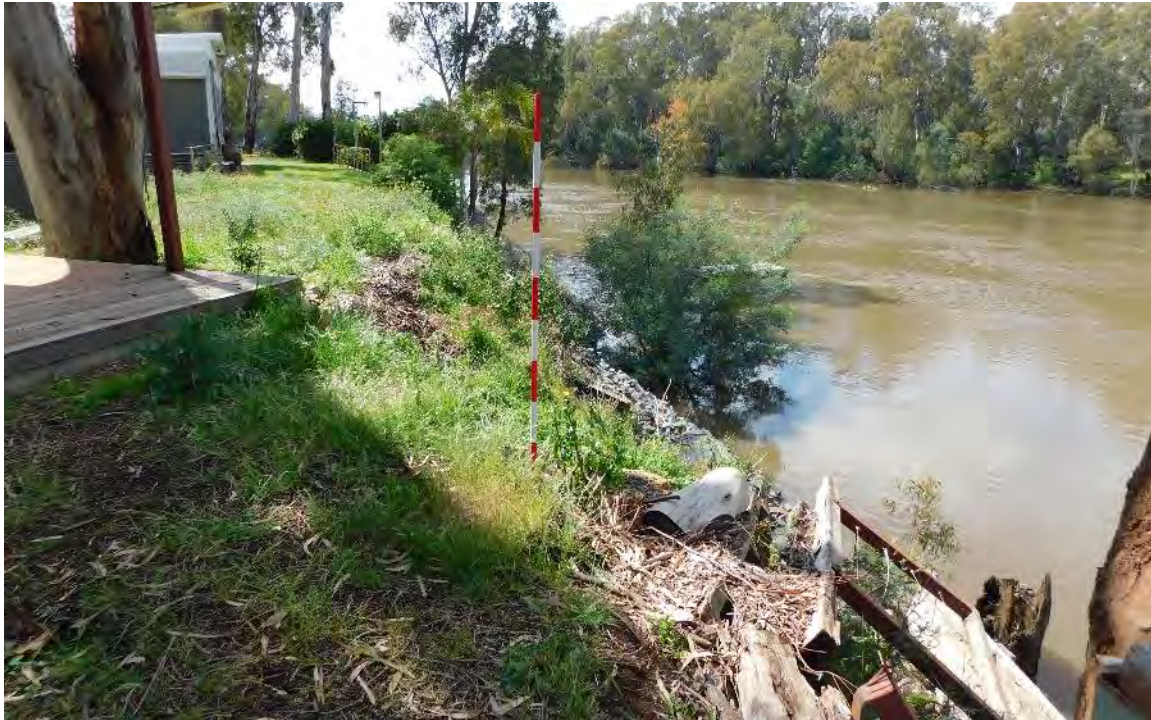
Figure 8 South-west of riverbank with a rock embankment

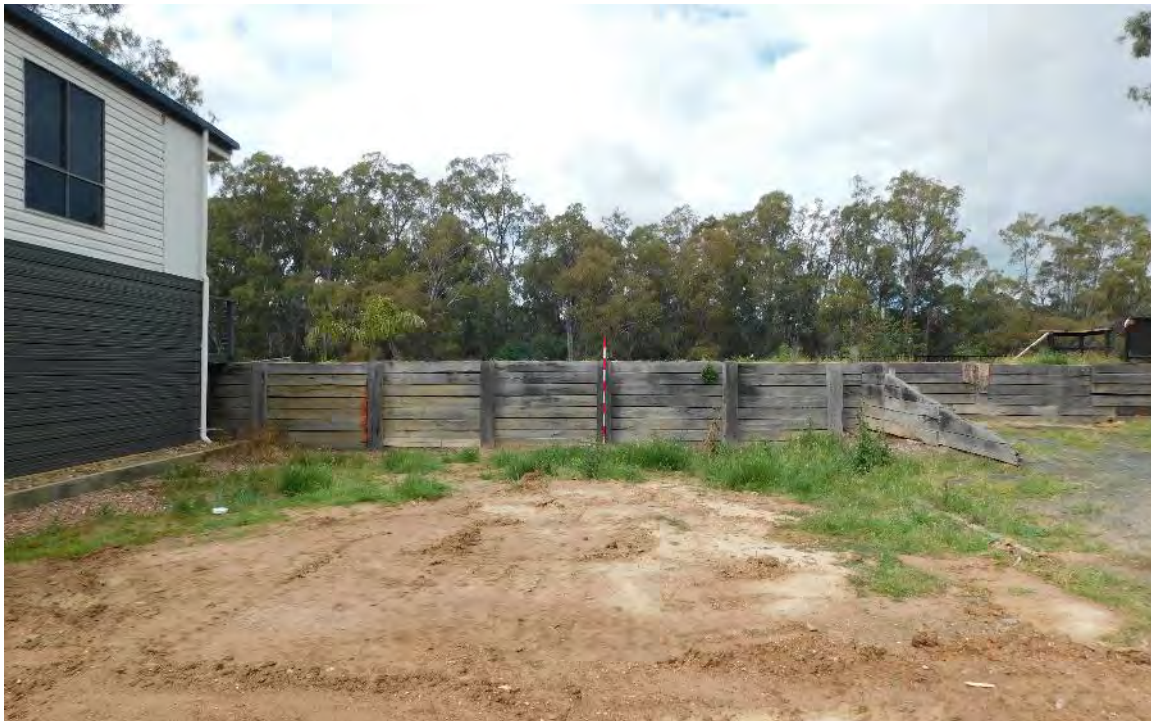
Figure 9 East facing view of the disparity between the riverbank and the holiday park

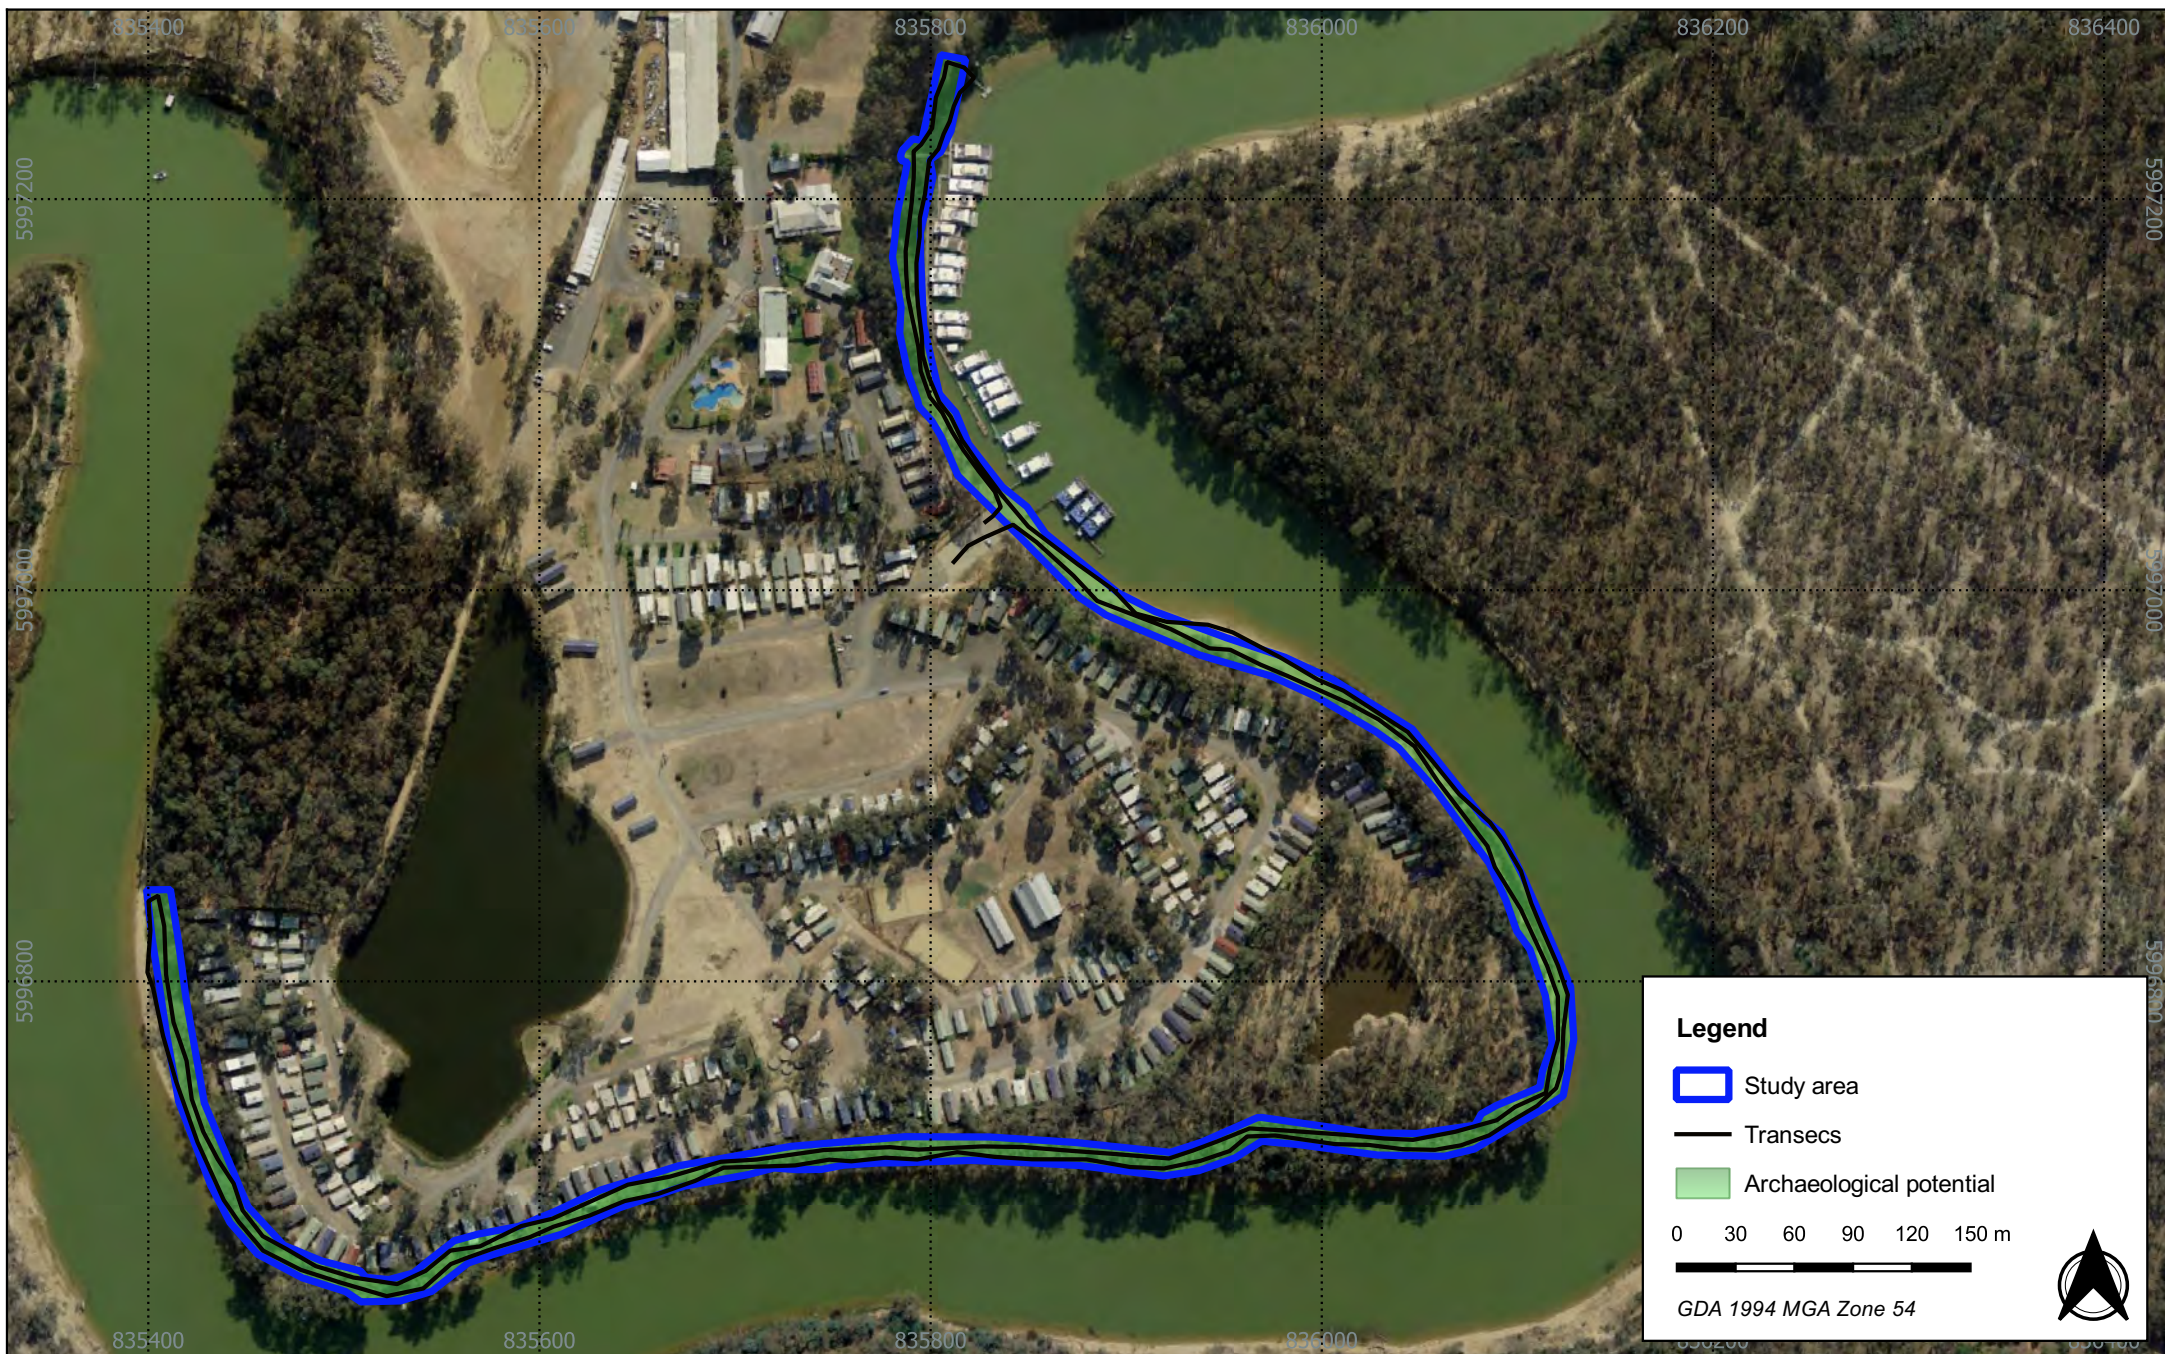
A majority of the study area has been disturbed through the previous developments, maintenance activities and the ongoing use of the study area as a holiday park. Despite Aboriginal sites being associated with the Murray River, the inspection noted that there was no identified Aboriginal heritage located within the study area. The results of the visual inspection are outlined in Figure 10.

Figure 10 Archaeological Potential and survey tracks within the study area
