Approved Section 4.56 Modification Application

Geotechnical Investigation Report

Project
**Proposed Apartments – Black Bear
30 Diggings Terrace, Thredbo NSW**

Report No
13526-GR-1-1 Rev F

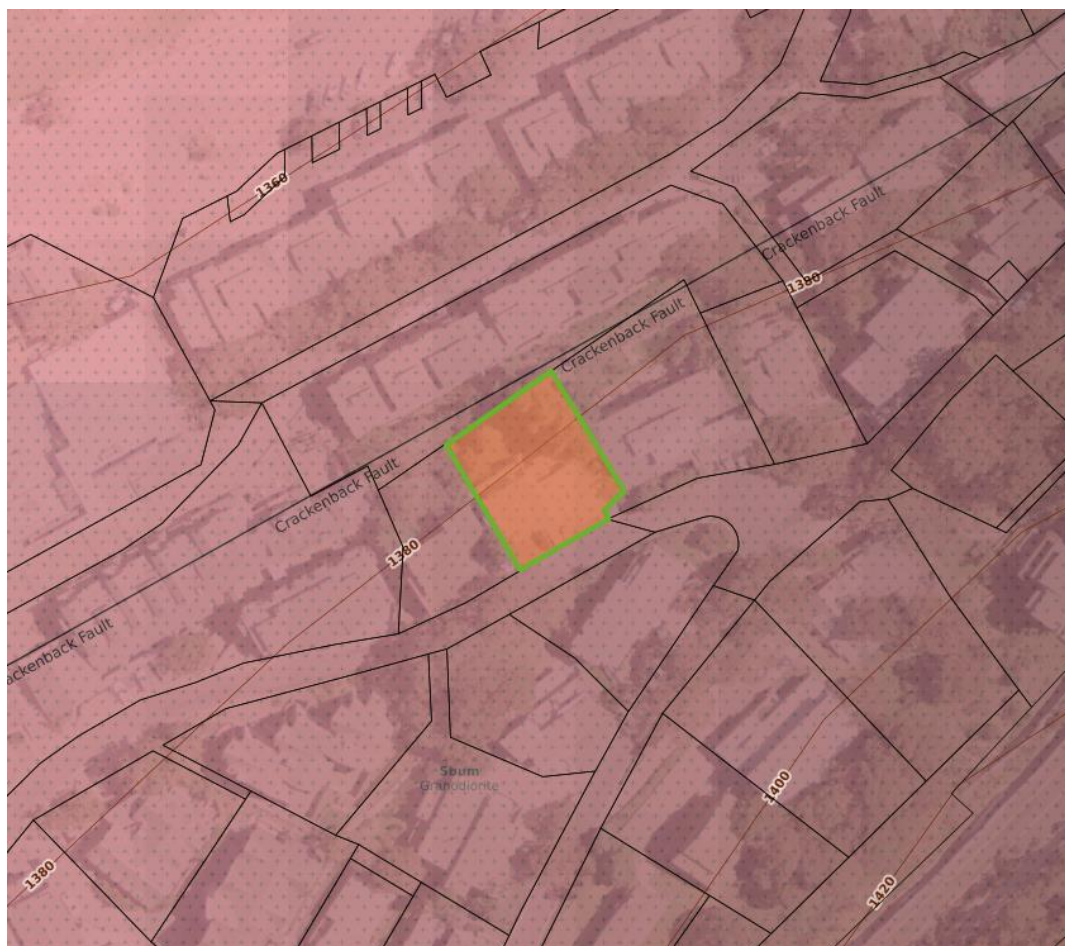
Figure 2: Site boundary with respect to the NSW Seamless Geology Map and 20m contours
(extracted from minview.geoscience.nsw.gov.au)

The NSW Seamless Geology Project (May 2021) indicates the site is underlain by Mowambah Granodiorite (*Sbum*). Granodiorite is a medium to coarse grained intrusive igneous rock, similar to granite, containing quartz and plagioclase feldspar as its primary constituents.

We note the Crackenback Fault runs parallel and very close (less than 10 m) to the northern boundary of the site. This could locally impact the integrity of the bedrock at the site.
