Black Bear Inn – Lot 794, Digging Terrace – Thredbo Alpine Resort – Kosciusko National Park – Temporary Anchors

Statement of Environmental Effects – March 2022

The proposal relates to the proposed new temporary ground anchors to support the construction of DA 10064 for *'Demolition of existing building and erection of a 7-storey building comprising four dual key apartments (or eight self contained apartments); four traditional two-bedroom apartments; car parking; all to be used as tourist accommodation at 30 Diggings Terrace, Thredbo Village'*.

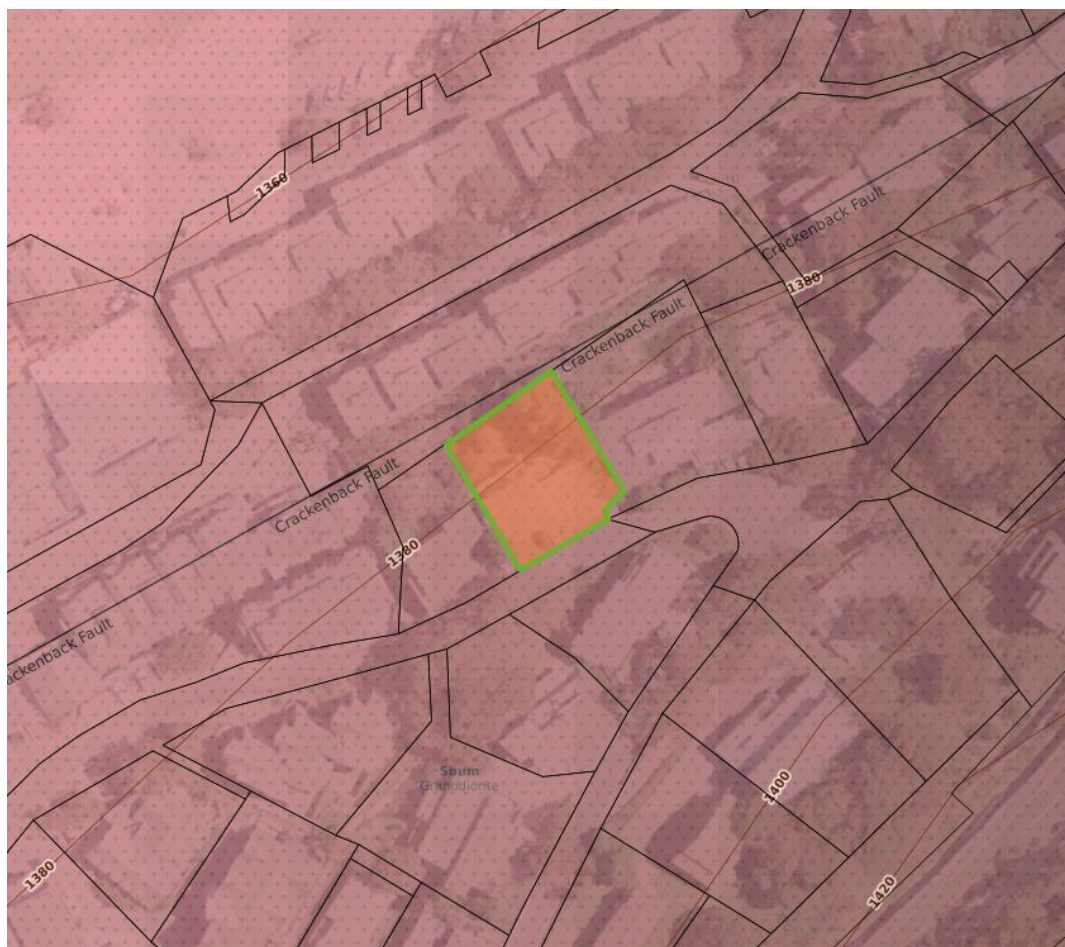
**Figure 2: Site boundary with respect to the NSW Seamless Geology Map and 20m contours
(extracted from minview.geoscience.nsw.gov.au)**

The NSW Seamless Geology Project (May 2021) indicates the site is underlain by Mowambah Granodiorite (Sbum). Granodiorite is a medium to coarse grained intrusive igneous rock, similar to granite, containing quartz and plagioclase feldspar as its primary constituents.

We note the Crackenback Fault runs parallel and very close (less than 10 m) to the northern boundary of the site. This could locally impact the integrity of the bedrock at the site.

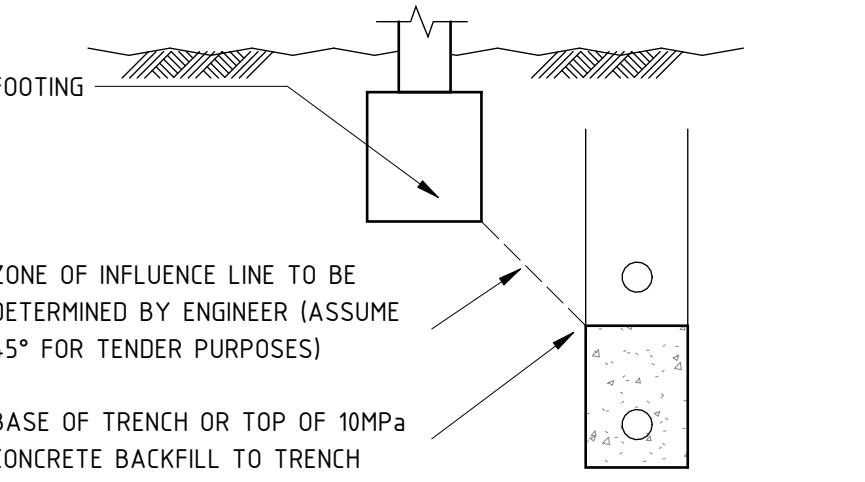
<p>FOOTING</p> <p>ZONE OF INFLUENCE LINE TO BE DETERMINED BY ENGINEER (ASSUME 45° FOR TENDER PURPOSES)</p> <p>BASE OF TRENCH OR TOP OF 10MPa CONCRETE BACKFILL TO TRENCH</p>

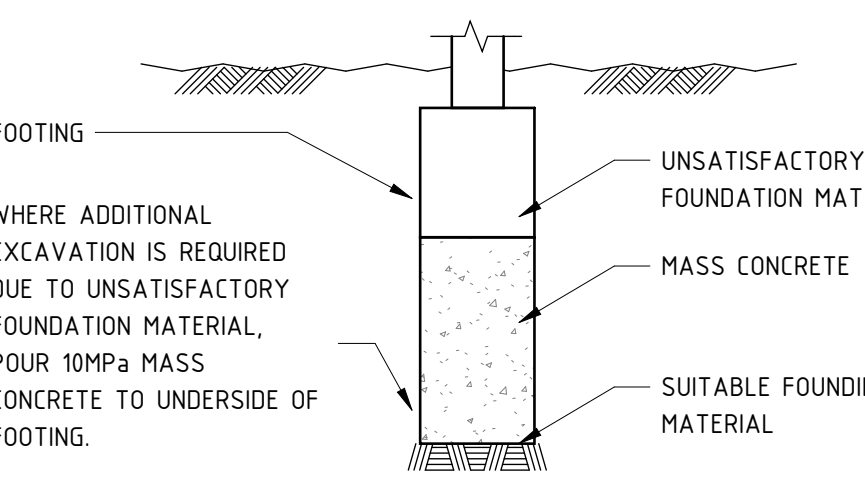
<p>FOOTING</p> <p>WHERE ADDITIONAL EXCAVATION IS REQUIRED DUE TO UNSATISFACTORY FOUNDATION MATERIAL, POUR 10MPa MASS CONCRETE TO UNDERSIDE OF FOOTING.</p> <p>UNSATISFACTORY FOUNDATION MATERIAL</p> <p>MASS CONCRETE</p> <p>SUITABLE FOUNING MATERIAL</p>
