Approved Application No DA 22/4825

# Black Bear Inn – Lot 794, Diggings Terrace – Thredbo Alpine Resort – Kosciusko National Park – Temporary Anchors

Statement of Environmental Effects – Revision A 09  
May 2022

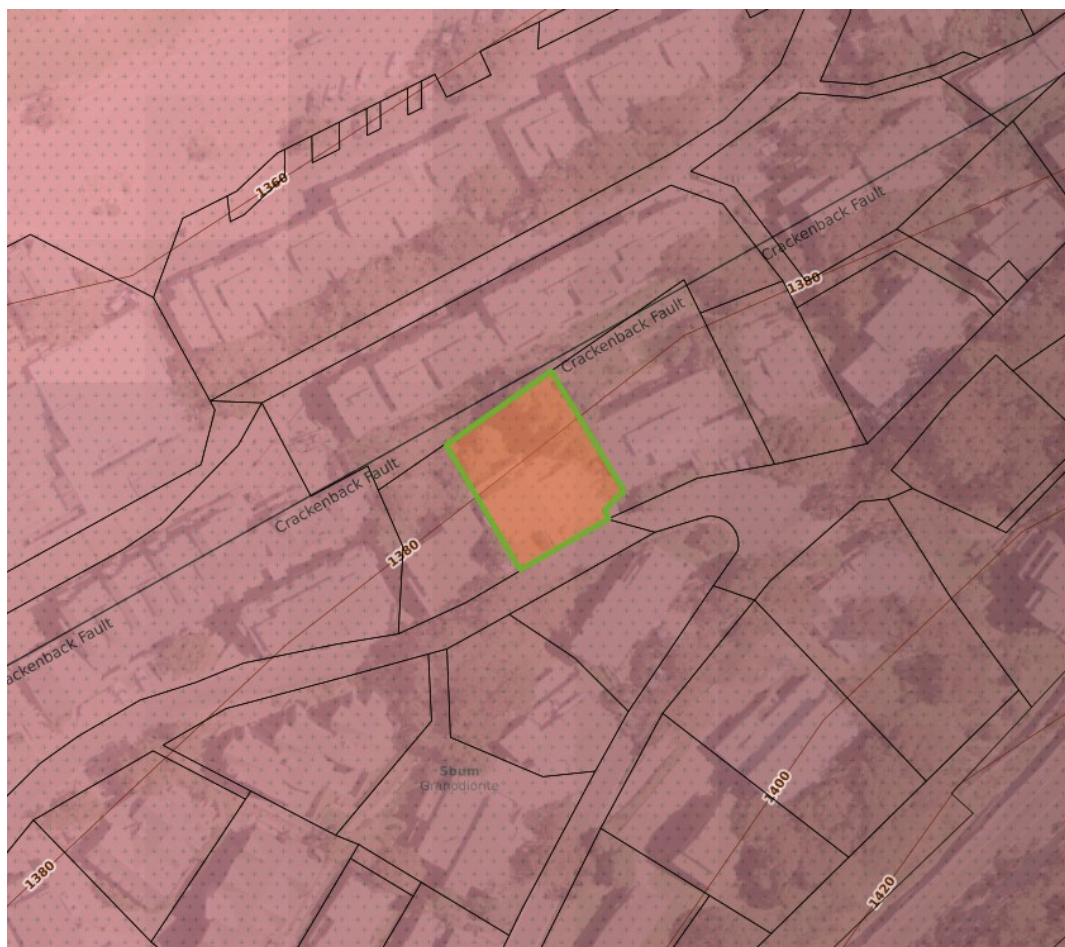
The NSW Seamless Geology Project (May 2021) indicates the site is underlain by Mowambah Granodiorite (*Sbum*). Granodiorite is a medium to coarse grained intrusive igneous rock, similar to granite, containing quartz and plagioclase feldspar as its primary constituents.

We note the Crackenback Fault runs parallel and very close (less than 10 m) to the northern boundary of the site. This could locally impact the integrity of the bedrock at the site.

**Figure 2: Site boundary with respect to the NSW Seamless Geology Map and 20m contours  
(extracted from [minview.geoscience.nsw.gov.au](http://minview.geoscience.nsw.gov.au))**
