**SELWYN SNOW RESORT REDEVELOPMENT**

**KINGS CROSS ROAD, CABRAMURRA, NSW**

**GEOTECHNICAL INVESTIGATION & SLOPE STABILITY RISK ASSESSMENT**

**JULY 2020**

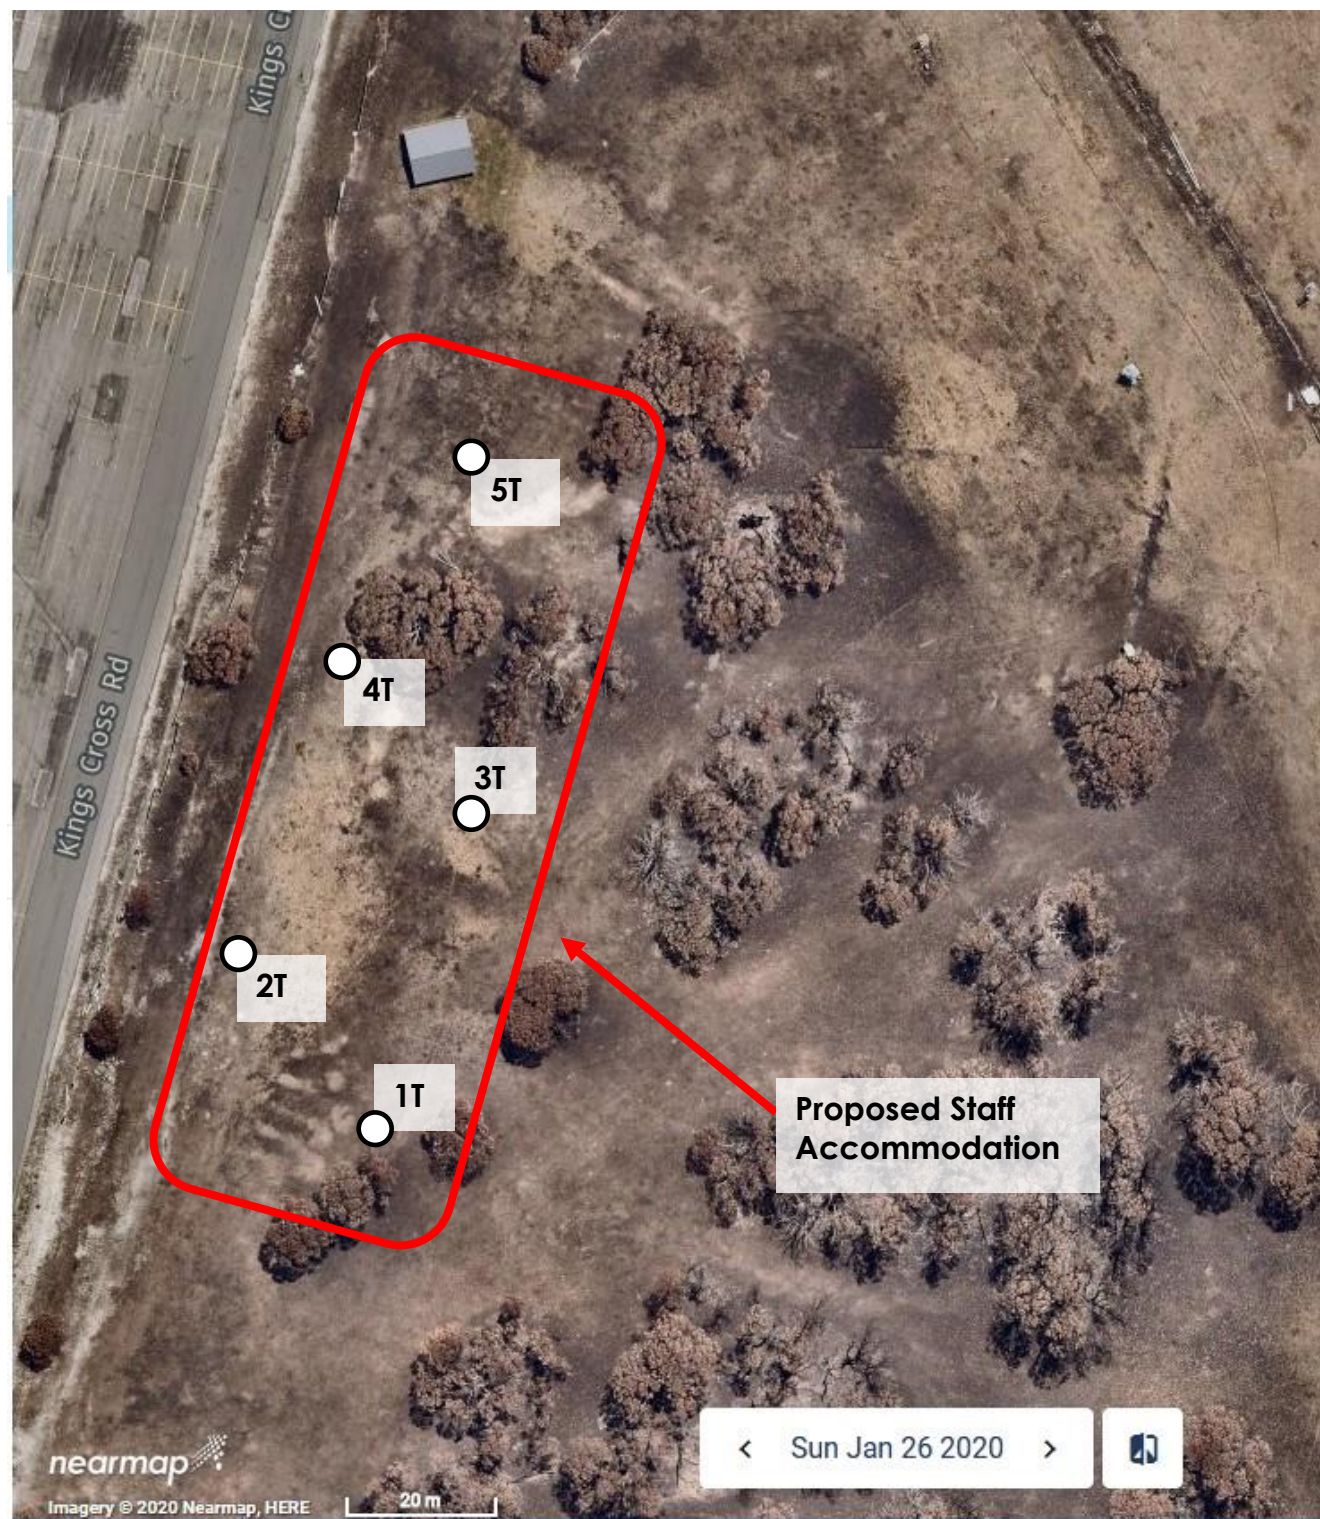
**FIGURE 3**

○ - Location of Test Pit

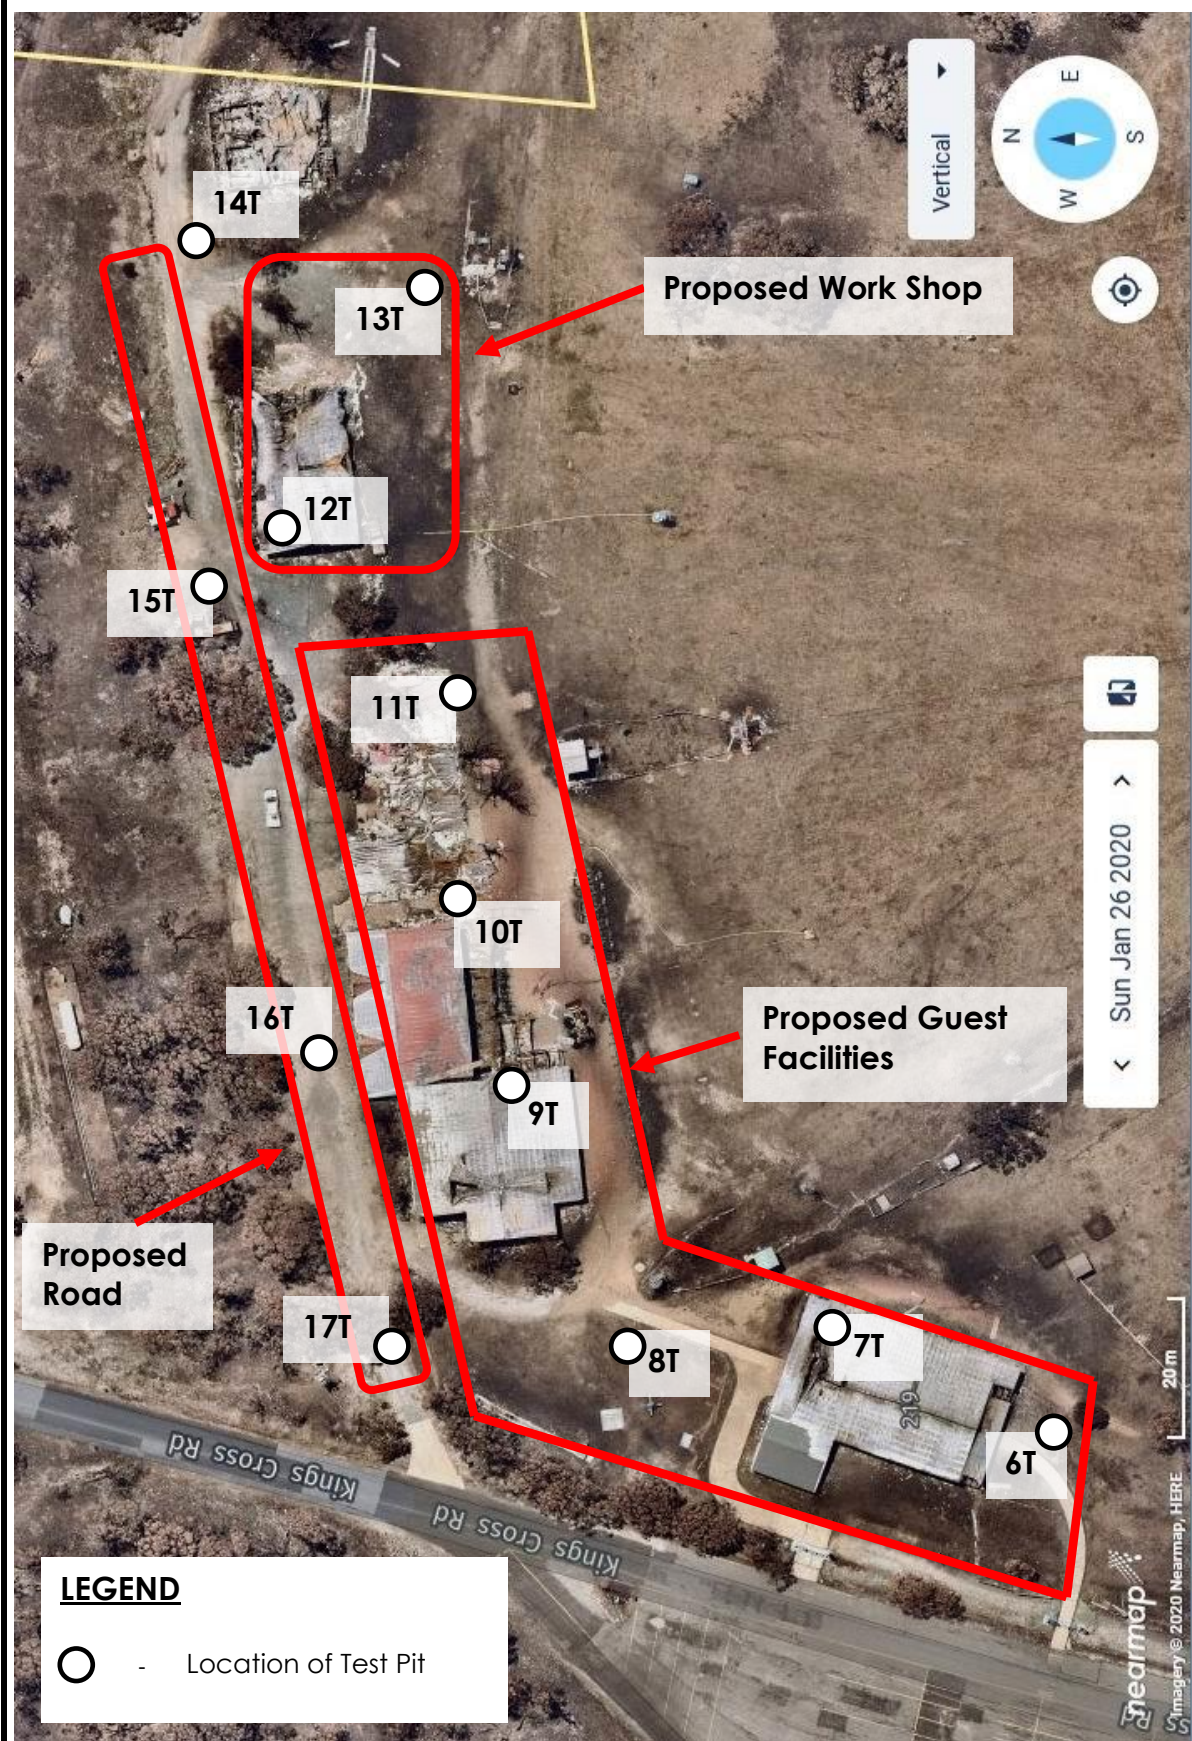
**TSA MANAGEMENT  
SELWYN SNOW RESORT REDEVELOPMENT  
LOCATION OF BOREHOLES – ROAD, WORK SHOP & GUEST FACILITIES**

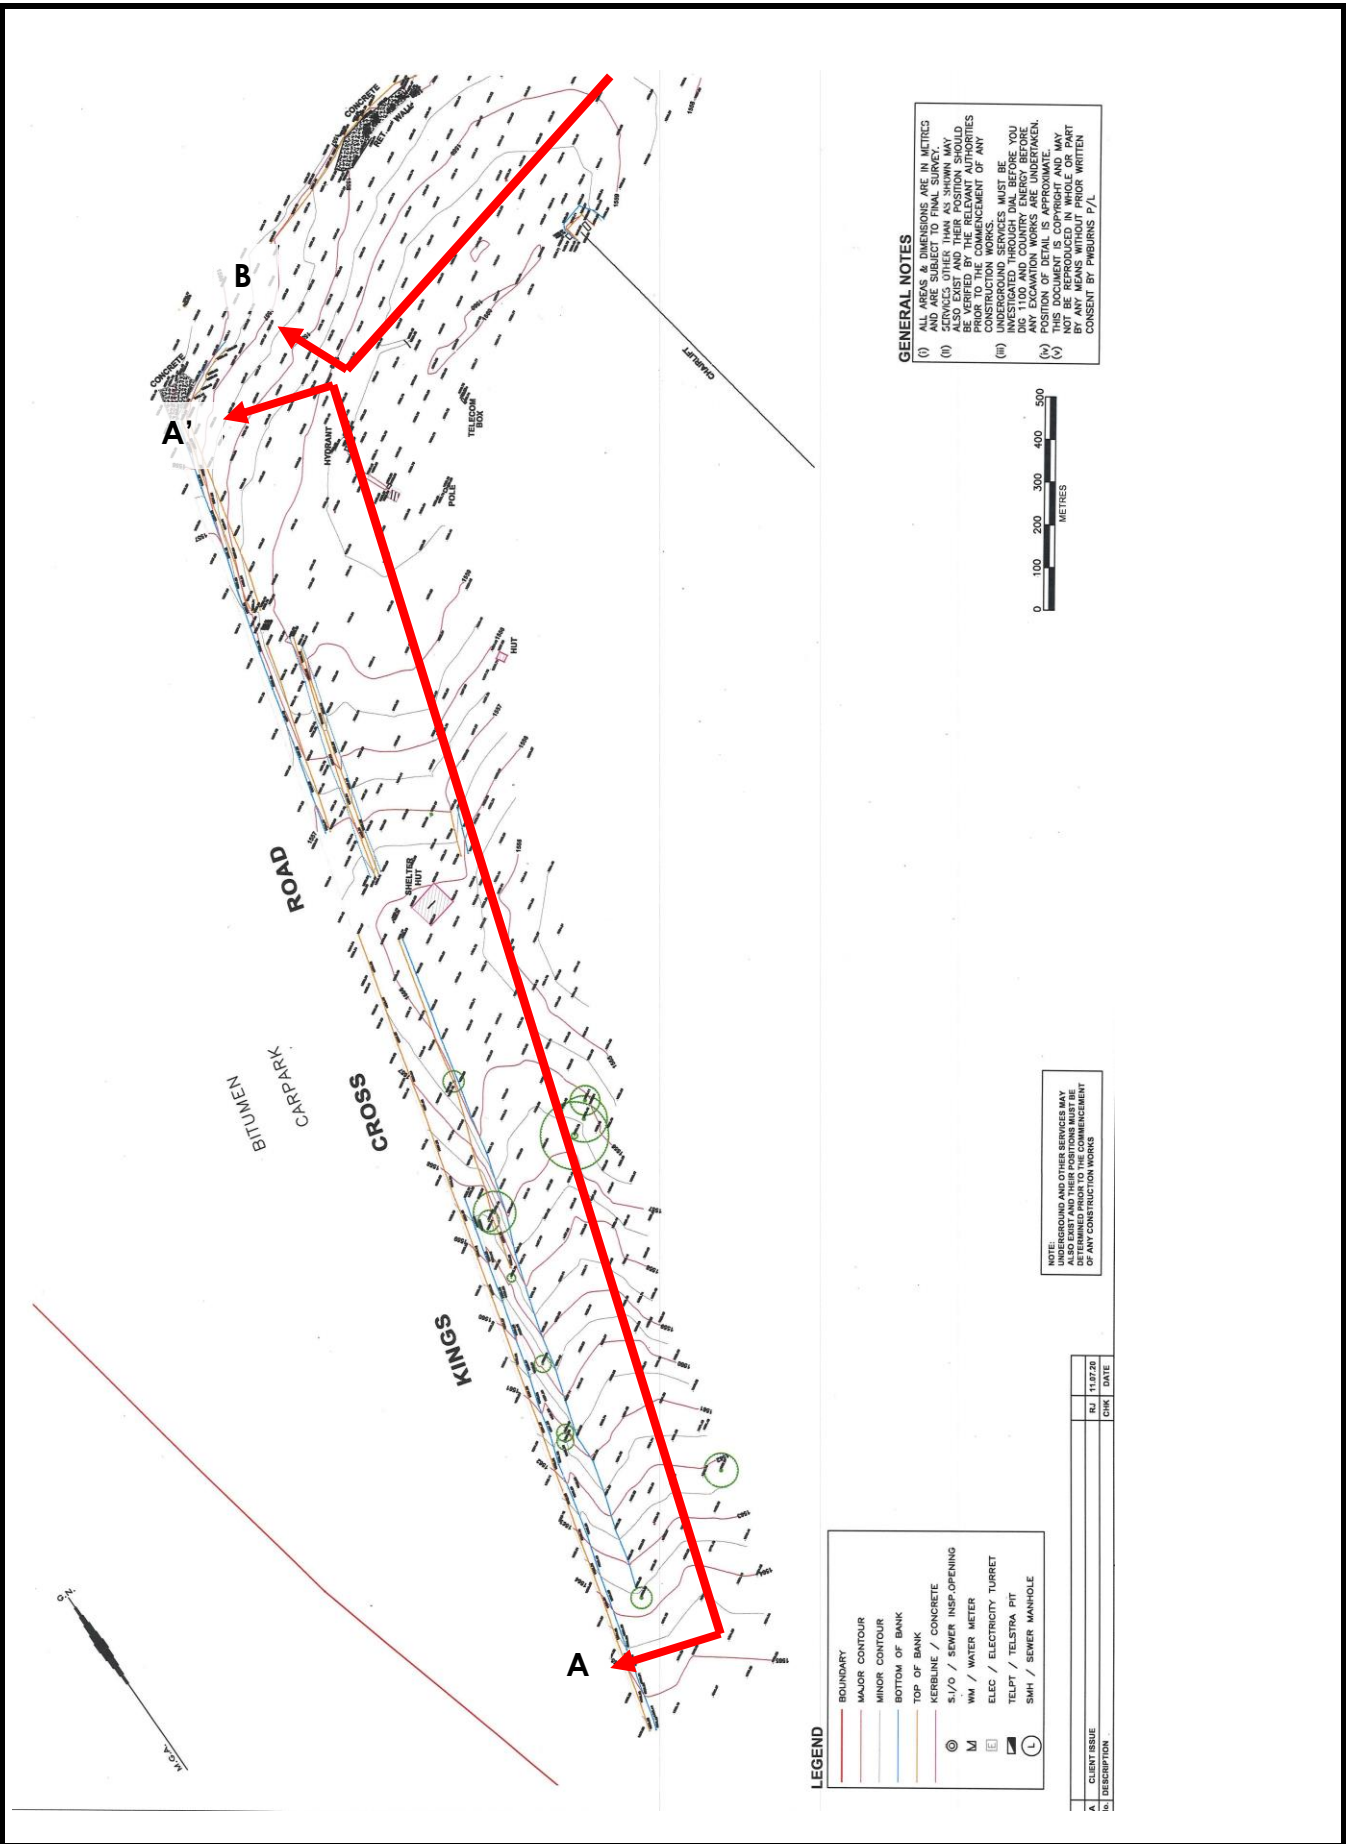
**TSA MANAGEMENT  
SELWYN SNOW RESORT REDEVELOPMENT  
SURVEY PLAN – STAFF ACCOMMODATION & GUEST FACILITIES**

| <b>Policy Section</b> | <b>Policy Requirement for Inclusion in Geotechnical Report</b> | <b>Section in This Report Covering the Requirement</b> |
|---|---|---|
| 4.1 (b) | Plans and sections of the site and related land form from survey and field measurements with contours and key features identified, including the locations of the proposed development, buildings/structures on both the subject site and adjoining site, stormwater drainage, sub-surface drainage, water supply and sewerage pipelines, trees, and other identifiable geotechnical hazards. | See “Aerial Photographs” in Figures 2 to 4, and Figure 5 “Survey Plan”. |

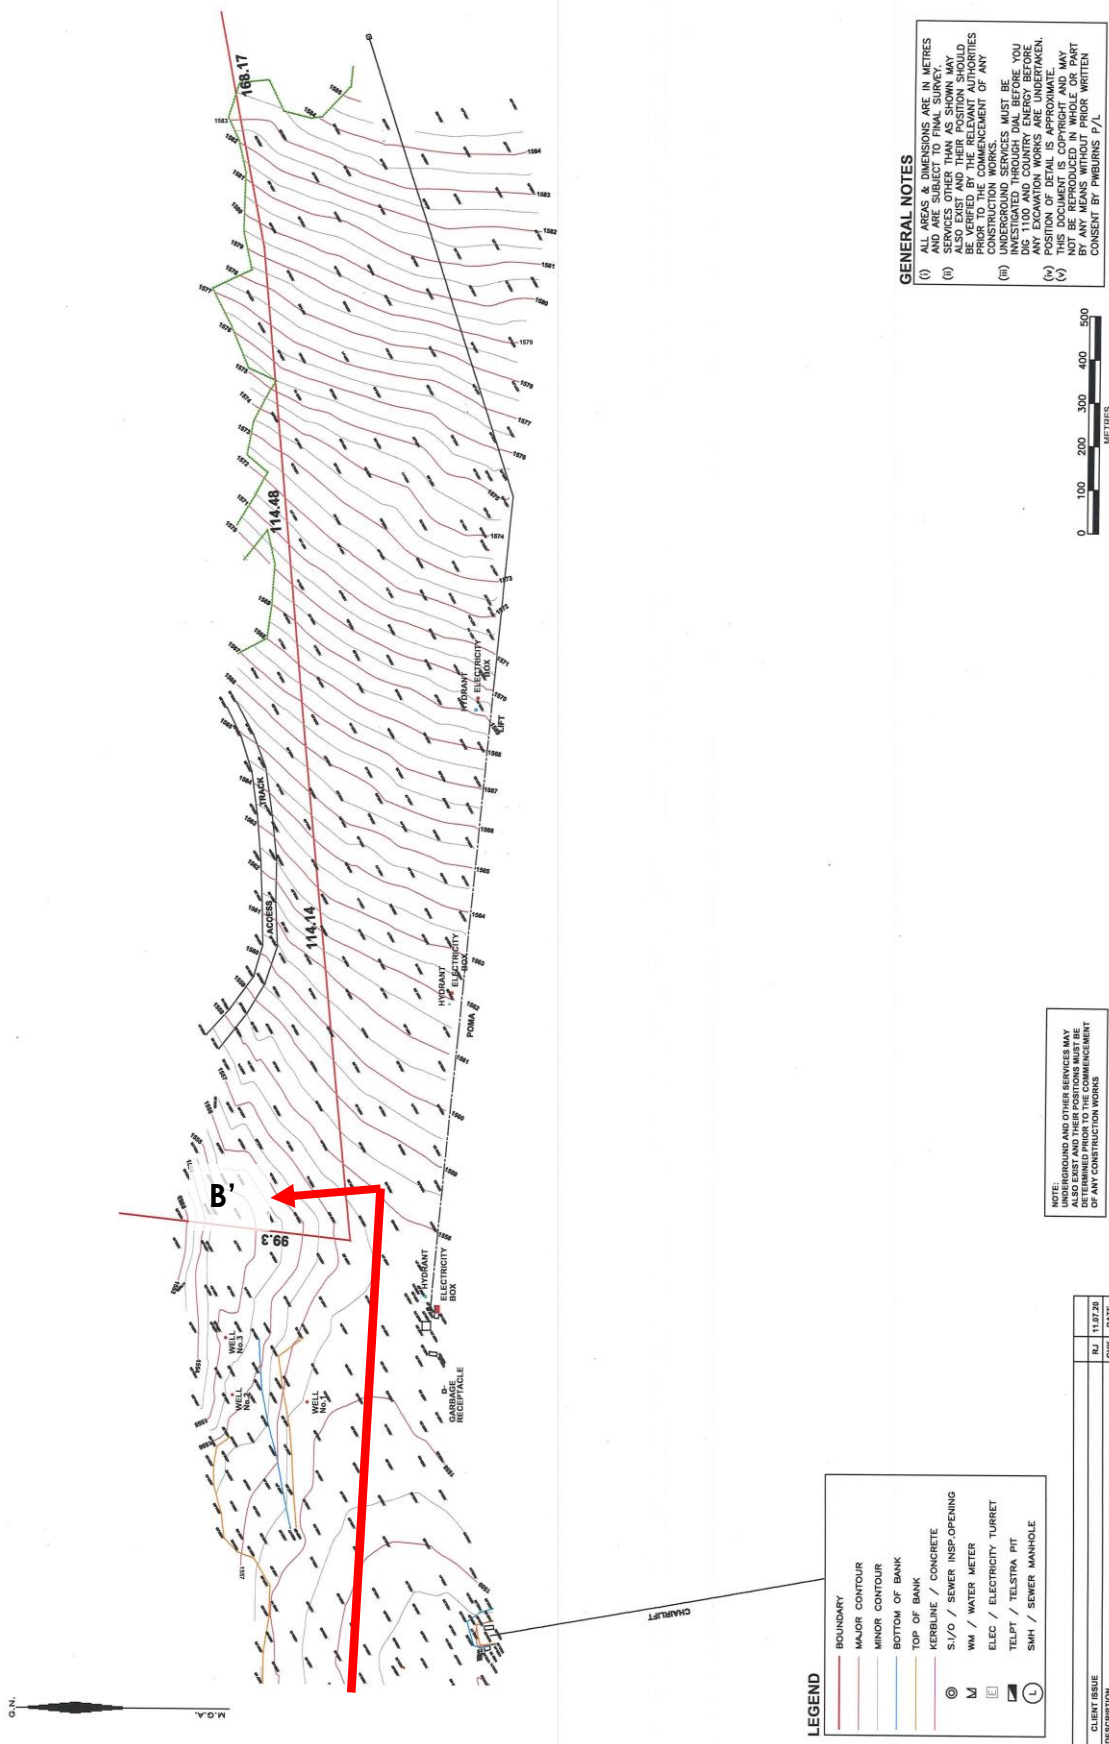
**TSA MANAGEMENT  
SELWYN SNOW RESORT REDEVELOPMENT  
SURVEY PLAN – ACCESS ROAD & WORK SHOP**

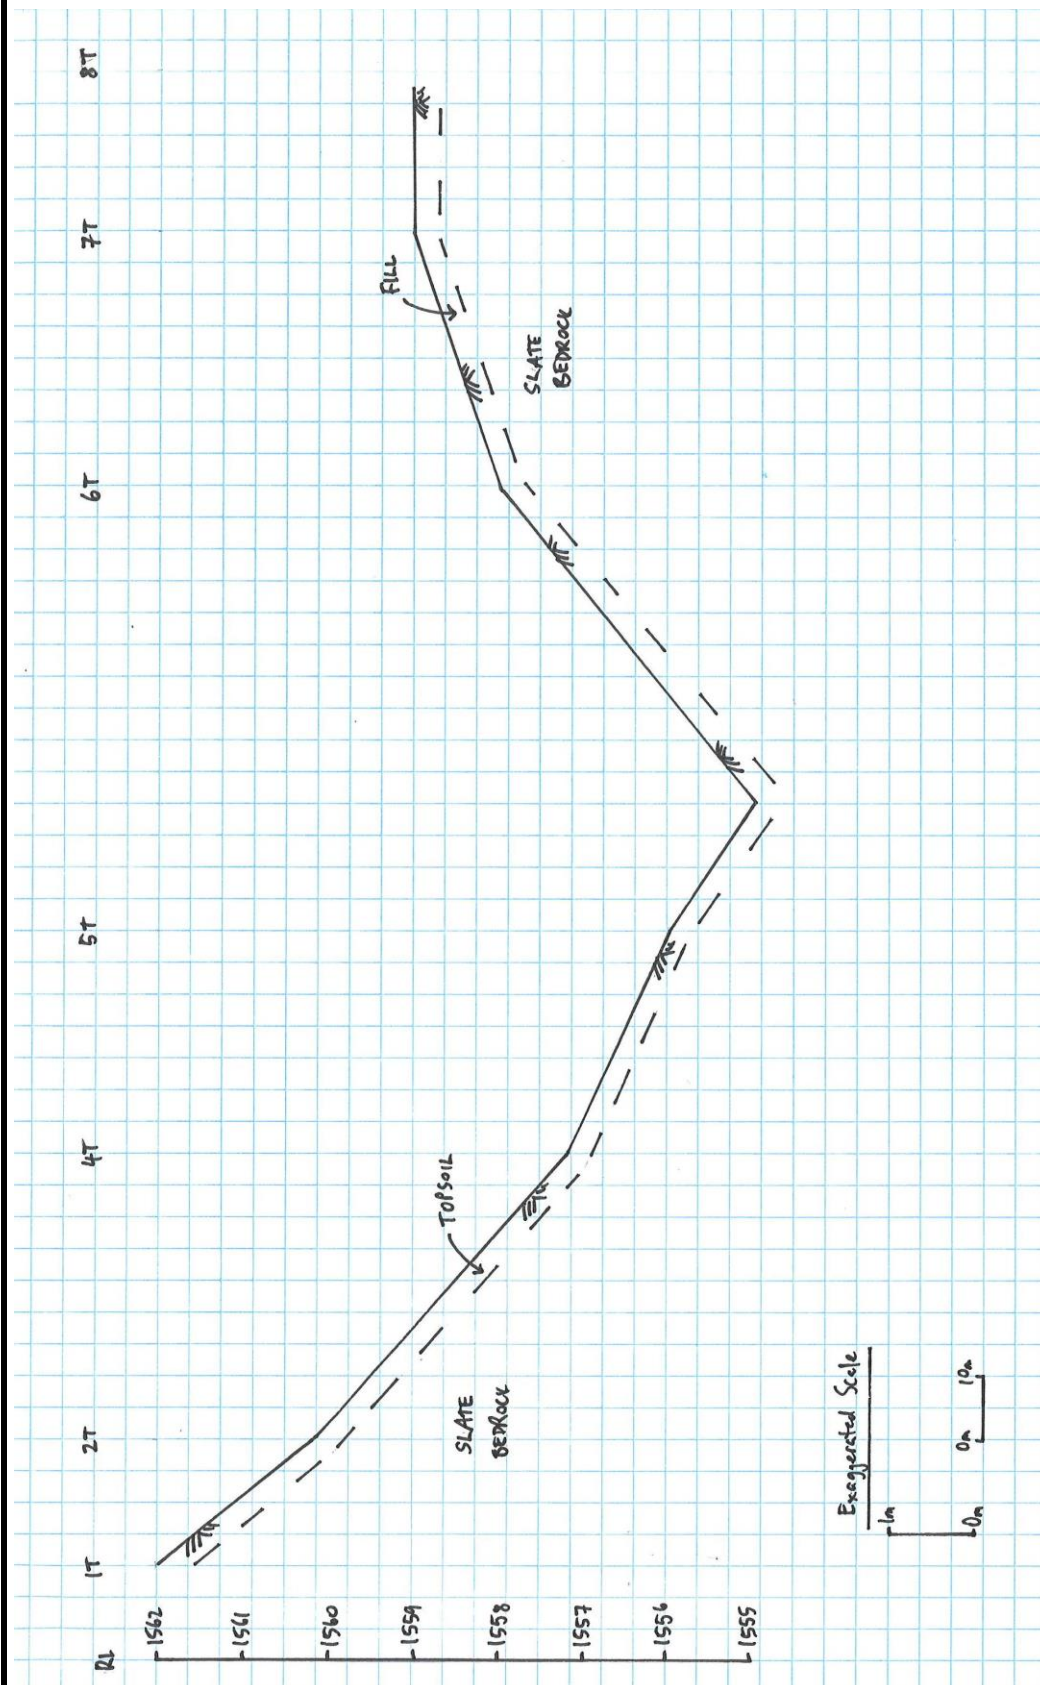
**TSA MANAGEMENT  
SELWYN SNOW RESORT REDEVELOPMENT  
GEOTECHNICAL MODEL – SUBSURFACE SECTION A-A'**

Sections 4.1.1 to 4.1.4 detail the subsurface conditions for the Staff Accommodation building, Guest Facilities building, Work Shop, and Access Road. Figures 6 and 7 provide geotechnical models of the site, showing subsurface sections through the site, as found by the investigation test pits.

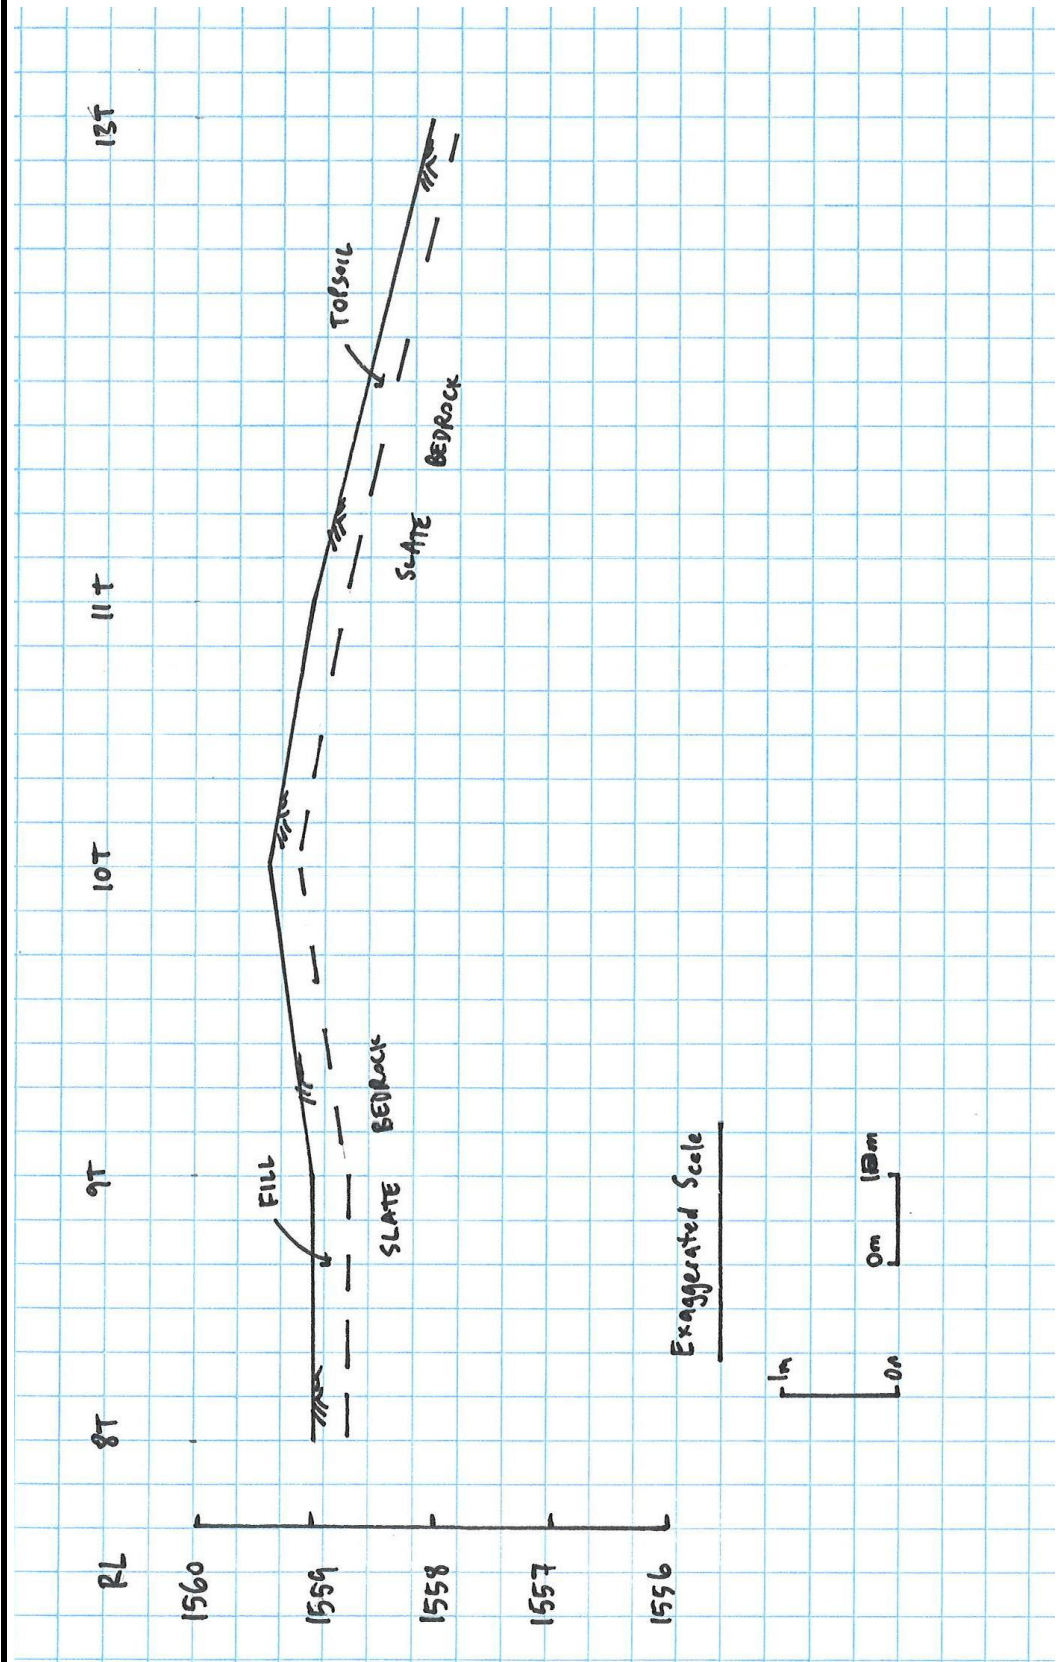
**TSA MANAGEMENT**  
**SELWYN SNOW RESORT REDEVELOPMENT**  
**GEOTECHNICAL MODEL – SUBSURFACE SECTION B-B'**

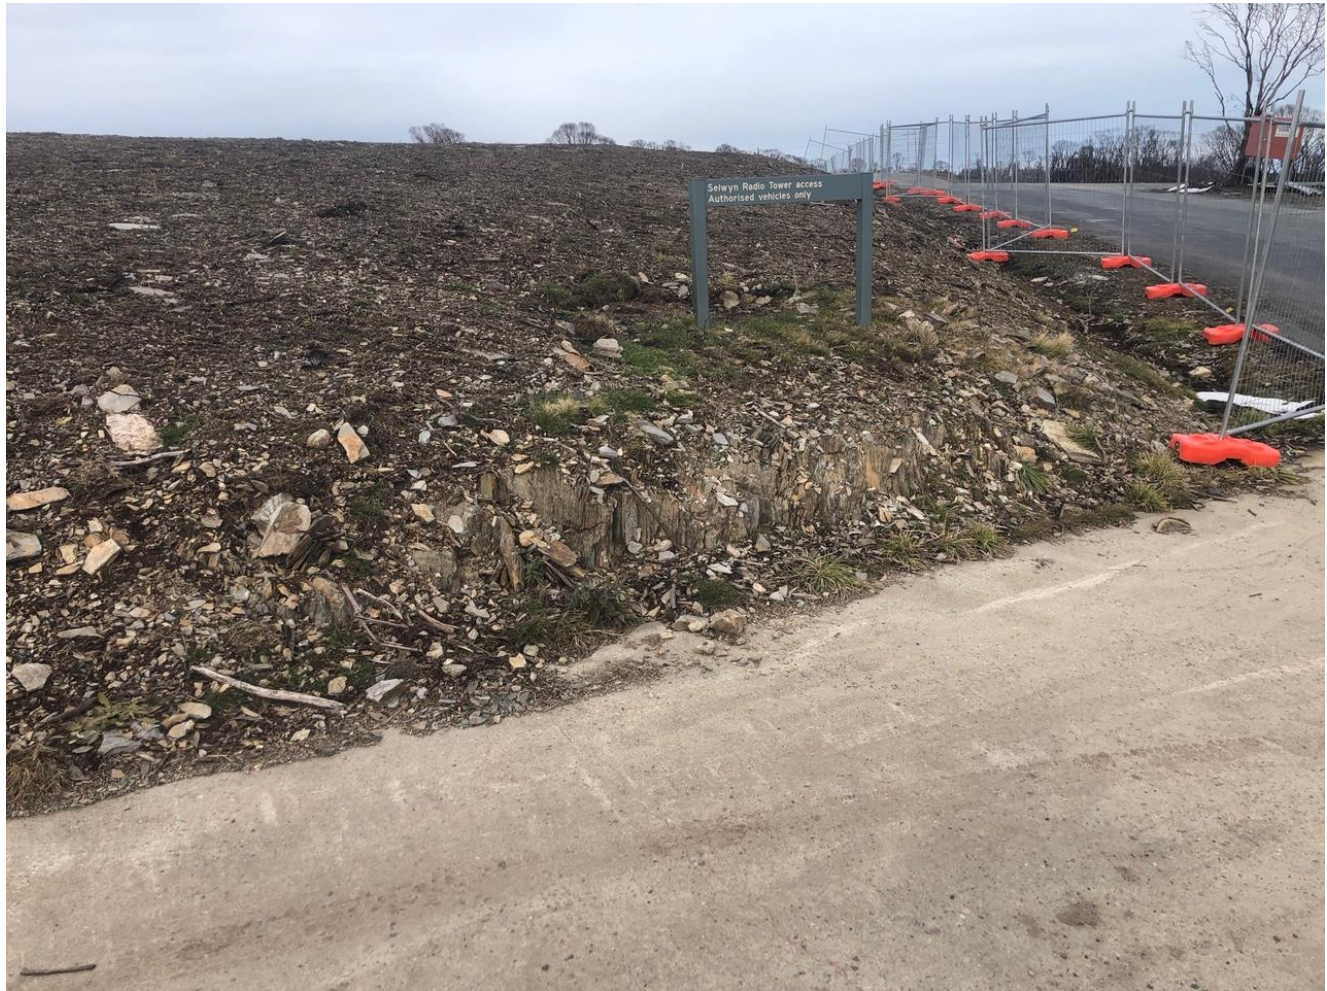
**FIGURE 13**

**Photo 6 – 10/7/2020** – View of an existing cutting on the corner of Kings Cross Road and Selwyn Trail (near NW corner of the proposed Guest Facilities building), showing slate bedrock at shallow depth.

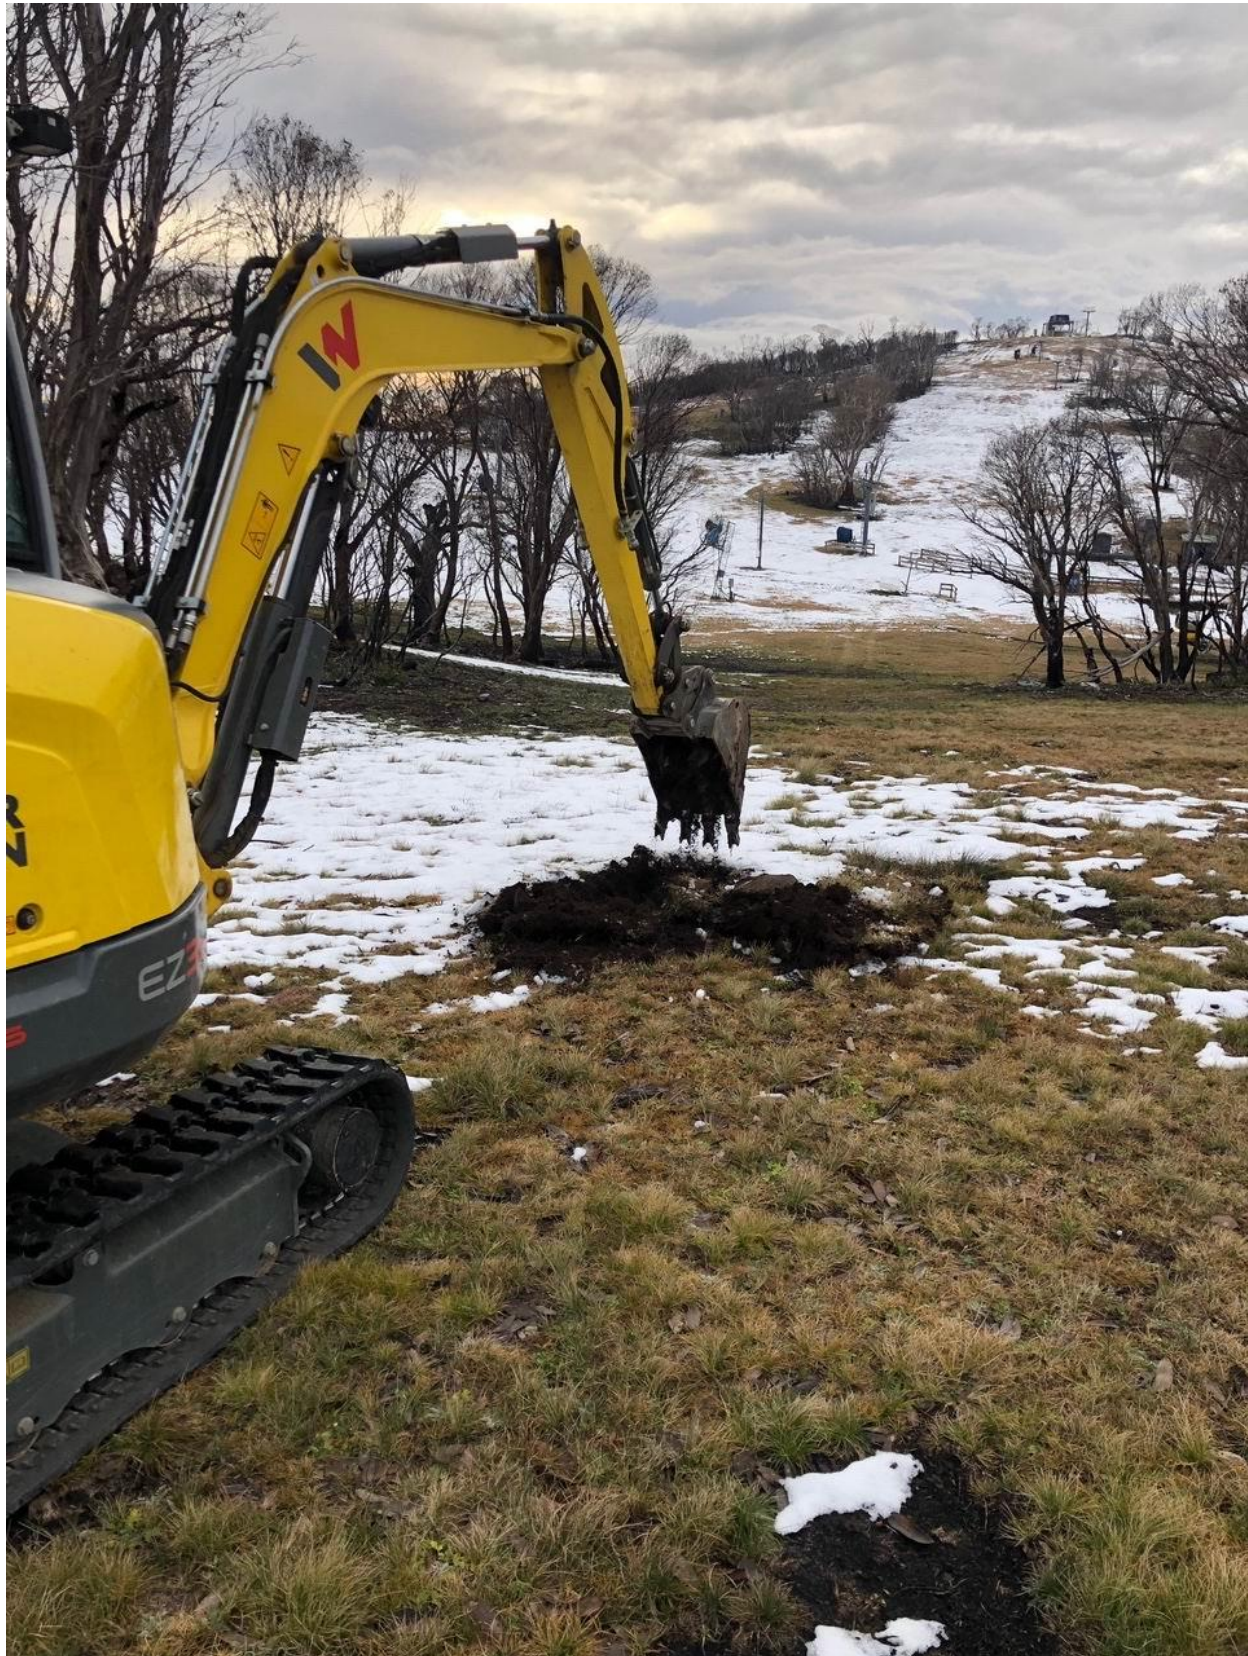
Photo 7 – 10/7/2020 – View of test pit 3T being excavated.

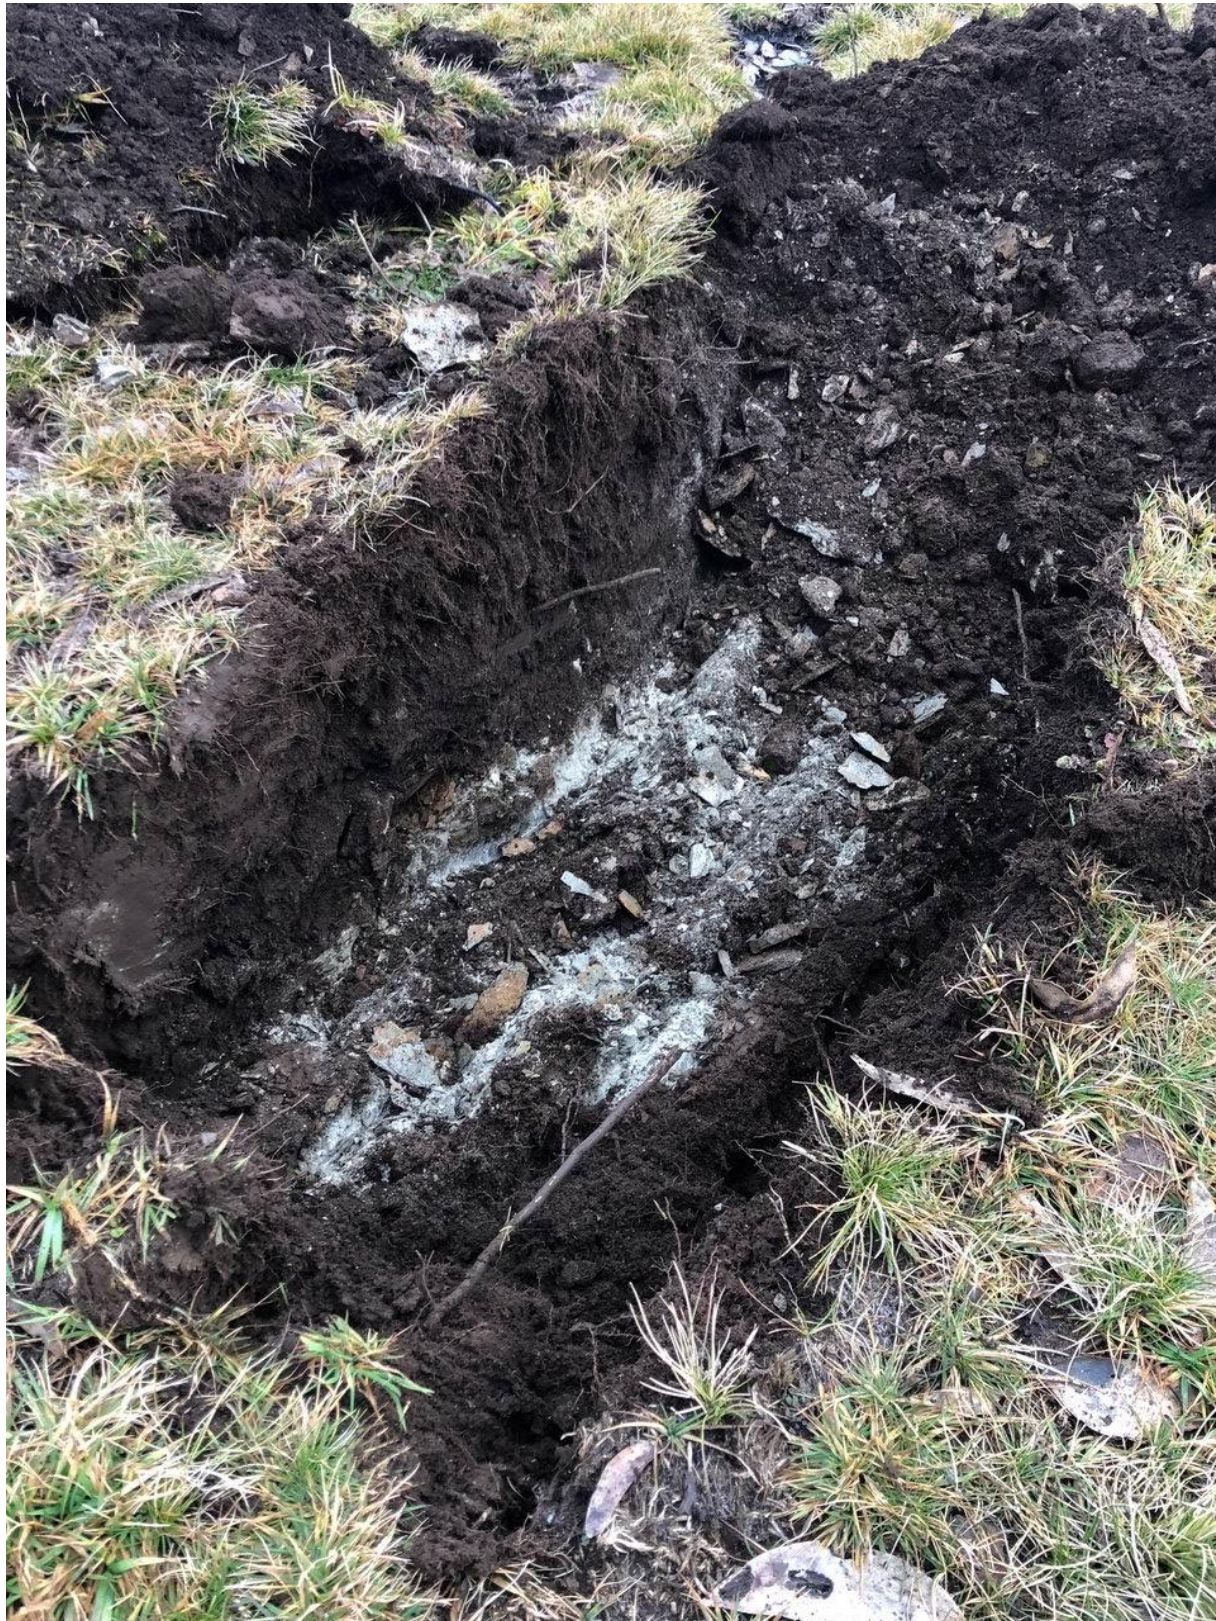
**Photo 8 – 10/7/2020** – View of the subsurface profile of test pit 1T, showing topsoil, directly underlain by medium strong slate bedrock.

Test Pits 1T to 5T found the following subsurface profile:

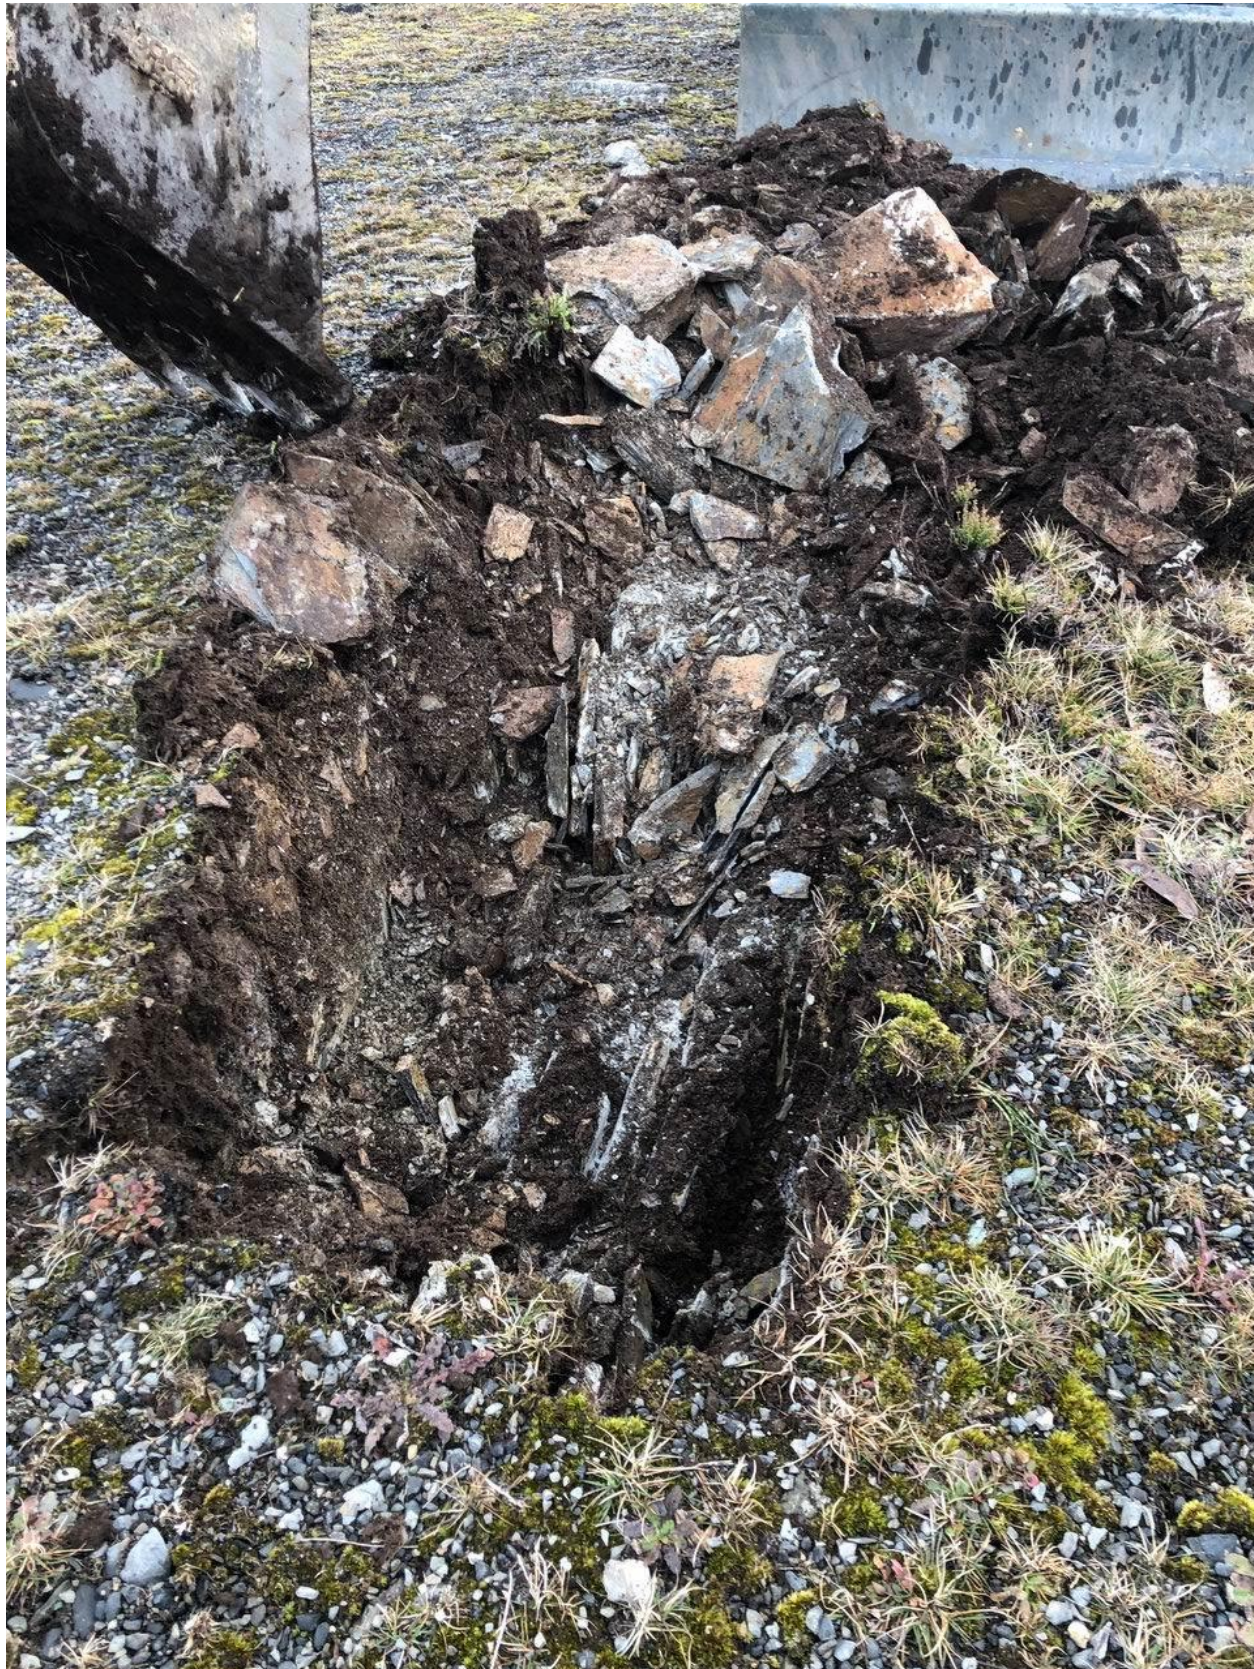
**Photo 9 – 10/7/2020** – View of the subsurface profile of test pit 2T, showing shallow topsoil, directly underlain by medium strong slate bedrock.

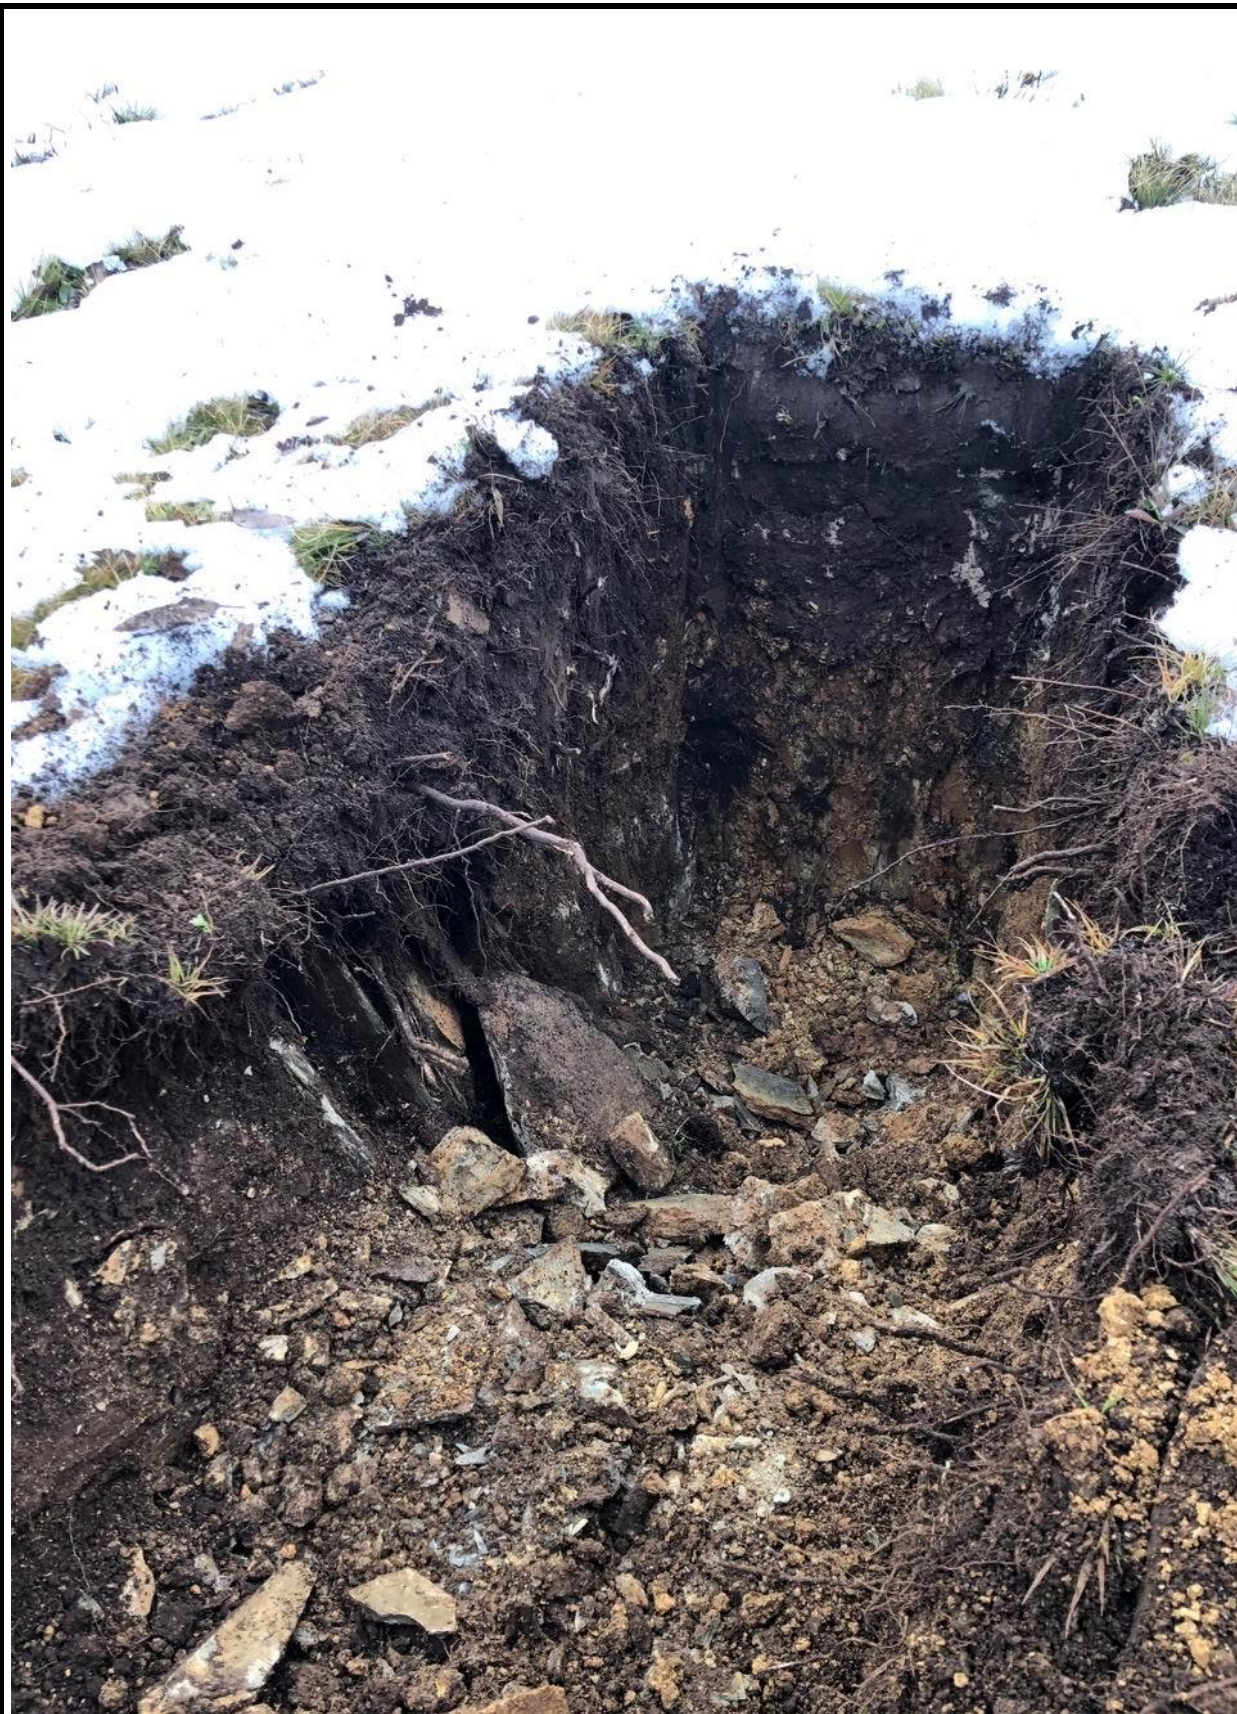
**Photo 10 – 10/7/2020** – View of the subsurface profile of test pit 3T, showing topsoil, directly underlain by medium strong slate bedrock.
