Approved Application No DA 22/5248

## Project: Visitor Centre, Quarry Enlargement & Other Infrastructure 213A Kings Cross Road, Kiandra NSW Lot 36 DP 46316

## 1.0 Project Details

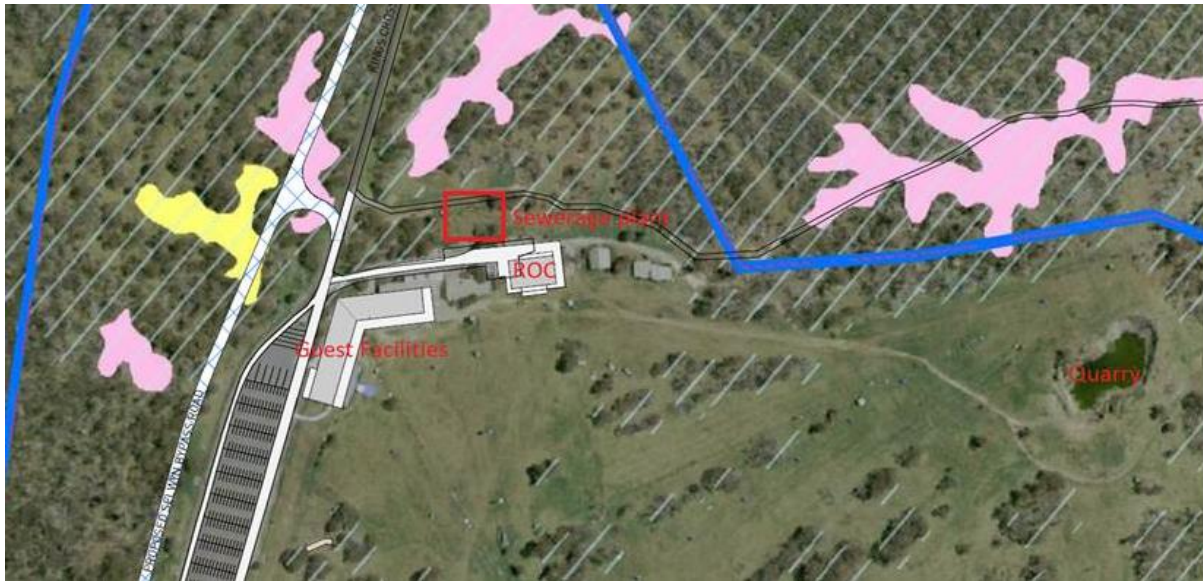
Figure 1: Location of the Guest Facilities, Resort Operation Centre and Quarry Dam. The Guest Facilities and ROC overlap with the footprint of the previous resort buildings that can be seen from the superimposed image taken before the January 2020 bushfire. Management and staff accommodation have been relocated to a proposed site further to the south adjacent to Kings Cross Road. Coloured polygons relate to significant environmental attributes (source: map provided by TSA Management).

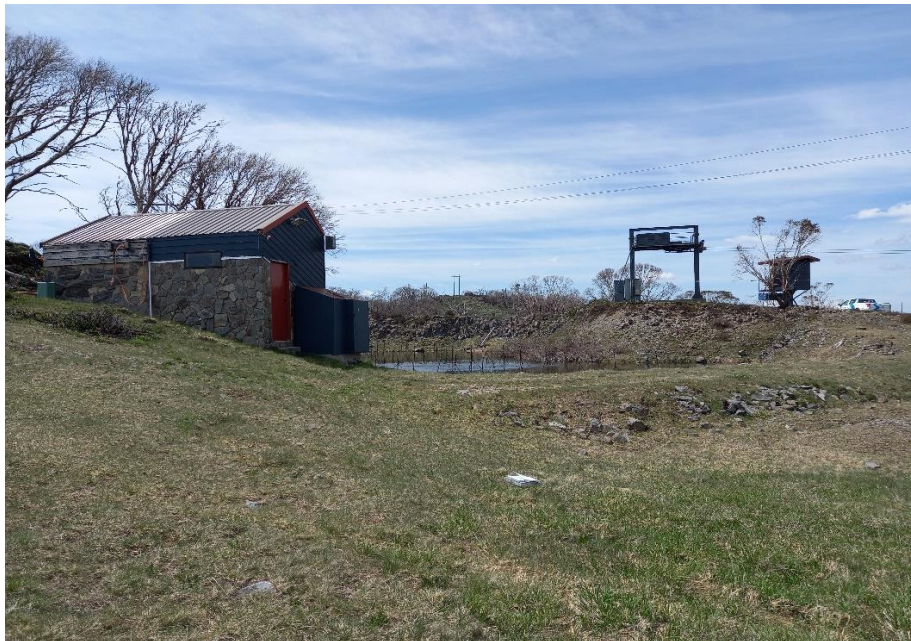
*Image 6: The quarry dam showing little habitat complexity associated with the embankment that is proposed to increase in height by 1.5 m. However, the inner environment, some of which will be flooded when the dam increases to its new full potential, is more complex than surrounding areas. A separate species list for the area on and adjacent to the current embankment is presented in Appendix 2.*

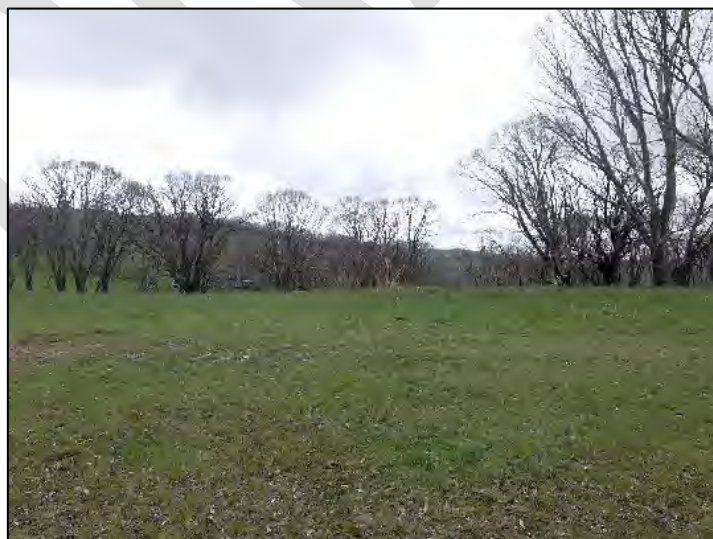
Plate 6. Looking east – Ranging pole marks site exposure – intervening surface heavily disturbed

The location of the artefacts and any comparatively undisturbed associated deposits lies approximately 40 metres from the edge of the sealed road surface or 30 metres from the edge of the road bund and is separated from this zone by approximately 20 metres of levelled surface and mixed, redeposited sediments and rock. This intervening area of disturbed soils is shown in Plate 6.

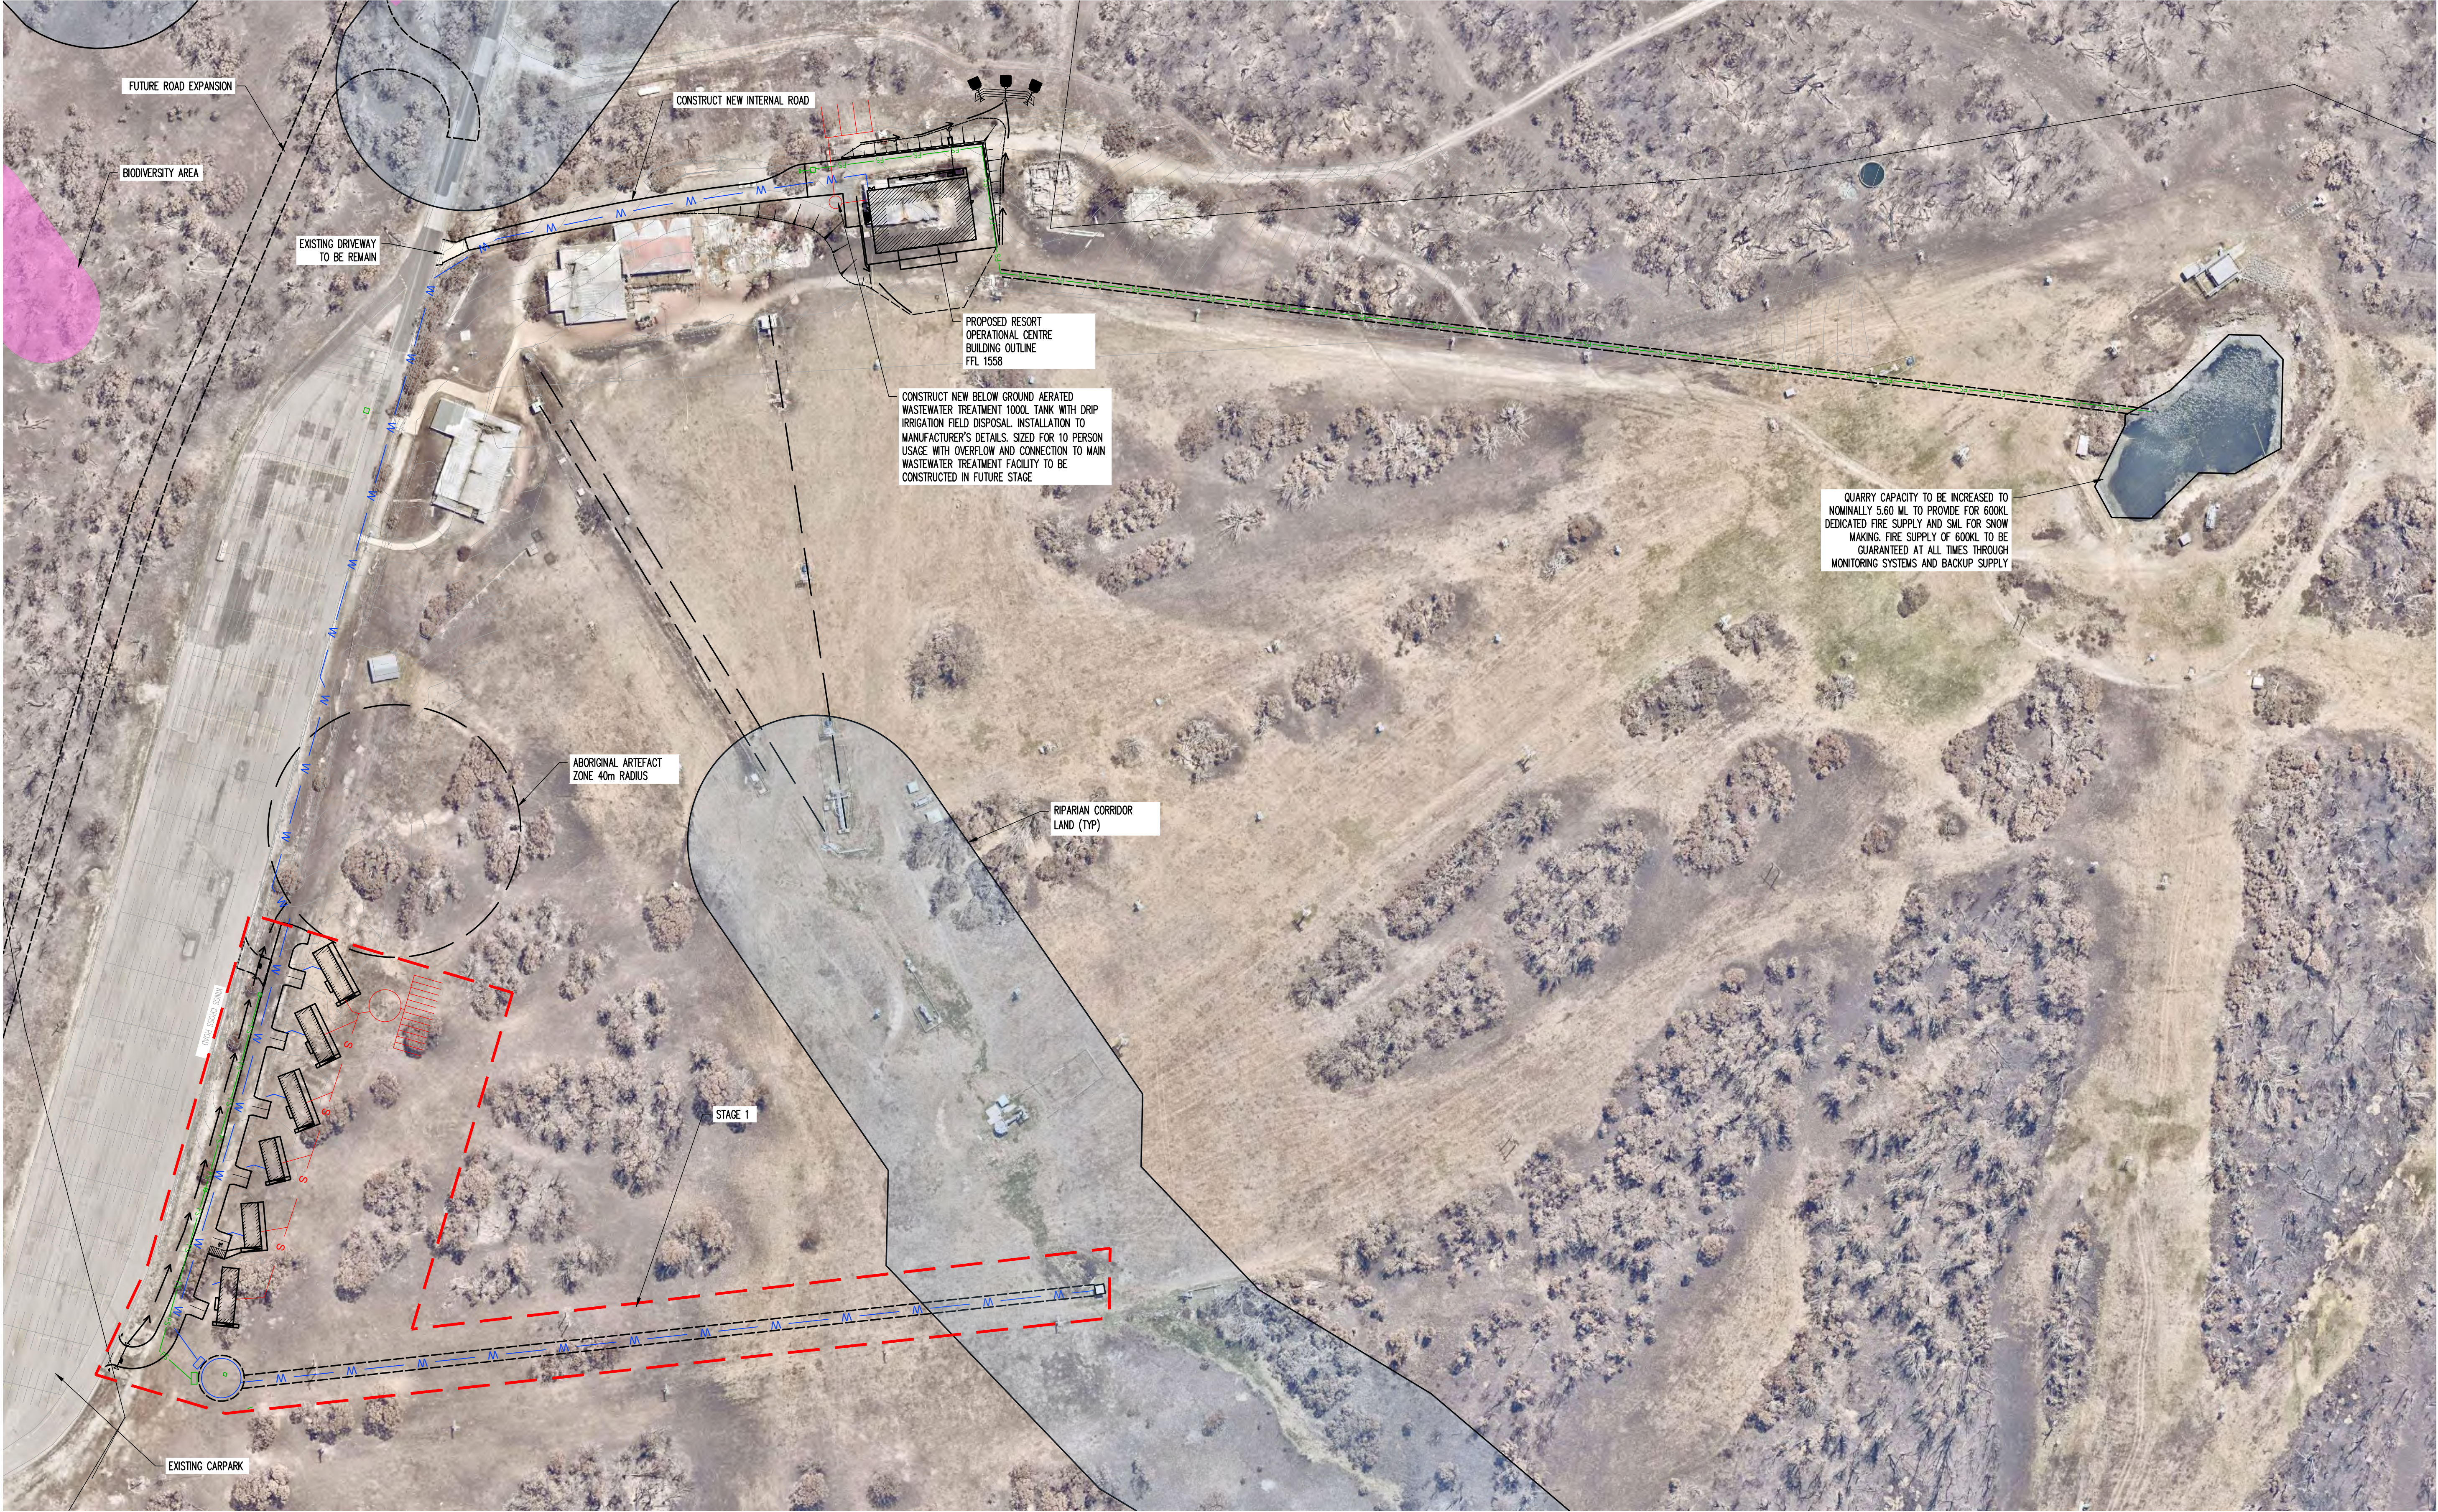
Figure 1. Proposed Works

Sheet Subject  
GENERAL ARRANGEMENT PLAN
