## SELWYN SNOW RESORT REDEVELOPMENT

KINGS CROSS ROAD, CABRAMURRA, NSW

GEOTECHNICAL INVESTIGATION & SLOPE STABILITY RISK ASSESSMENT  
SUPPLEMENTARY REPORT

SEPTEMBER 2020

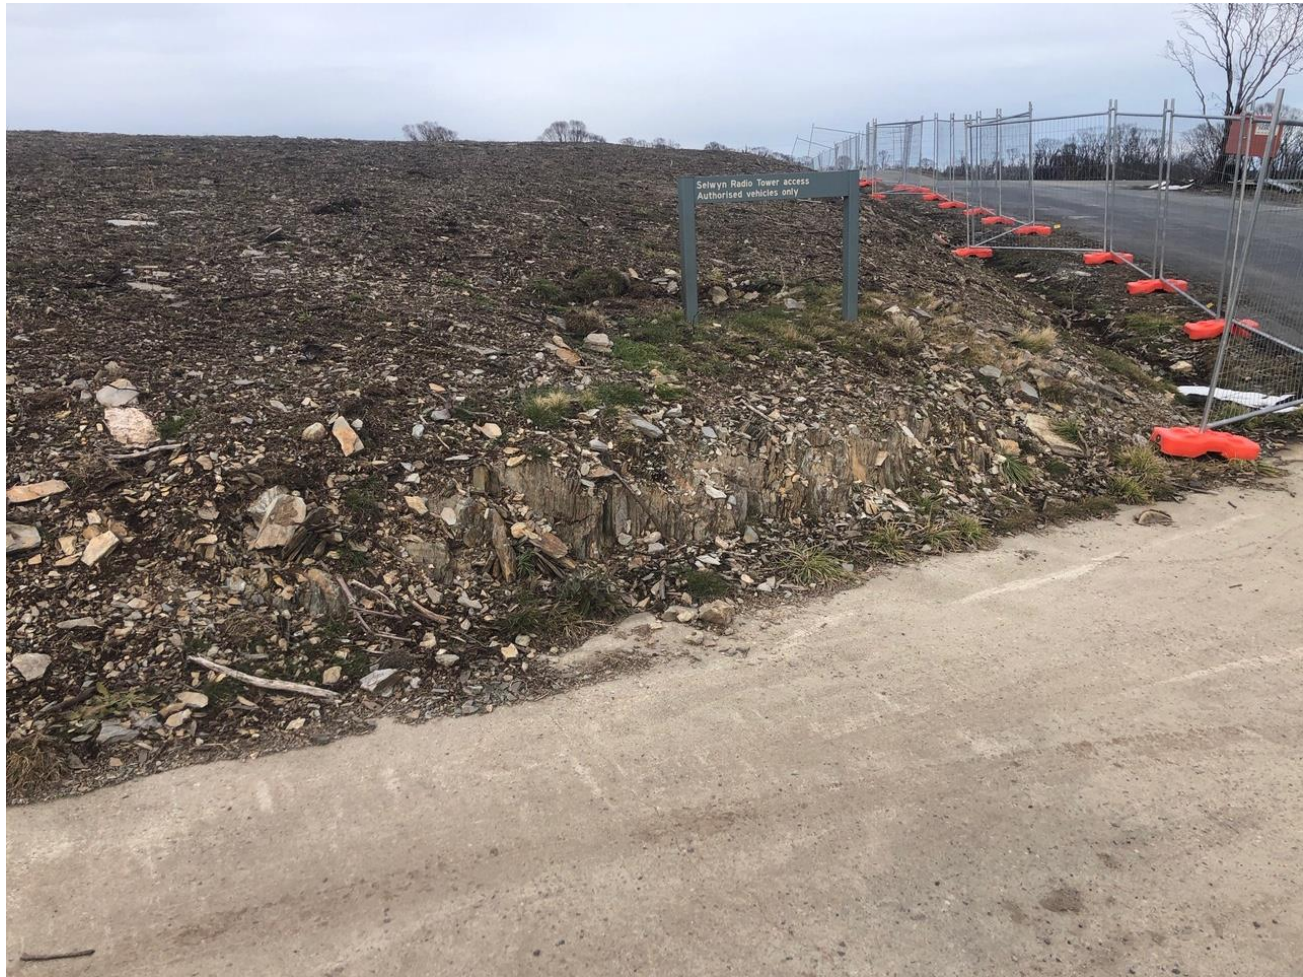
**FIGURE 13**

**Photo 6 – 10/7/2020** – View of an existing cutting on the corner of Kings Cross Road and Selwyn Trail (near NW corner of the proposed Guest Facilities building), showing slate bedrock at shallow depth.
