Geotechnical Site Investigation

S8597 Mount Selwyn

Selwyn Trail, Mount Selwyn, NSW

Intrax Consulting Engineers has completed a geotechnical investigation for the proposed Optus tower development at Selwyn Trail Mount Selwyn NSW.

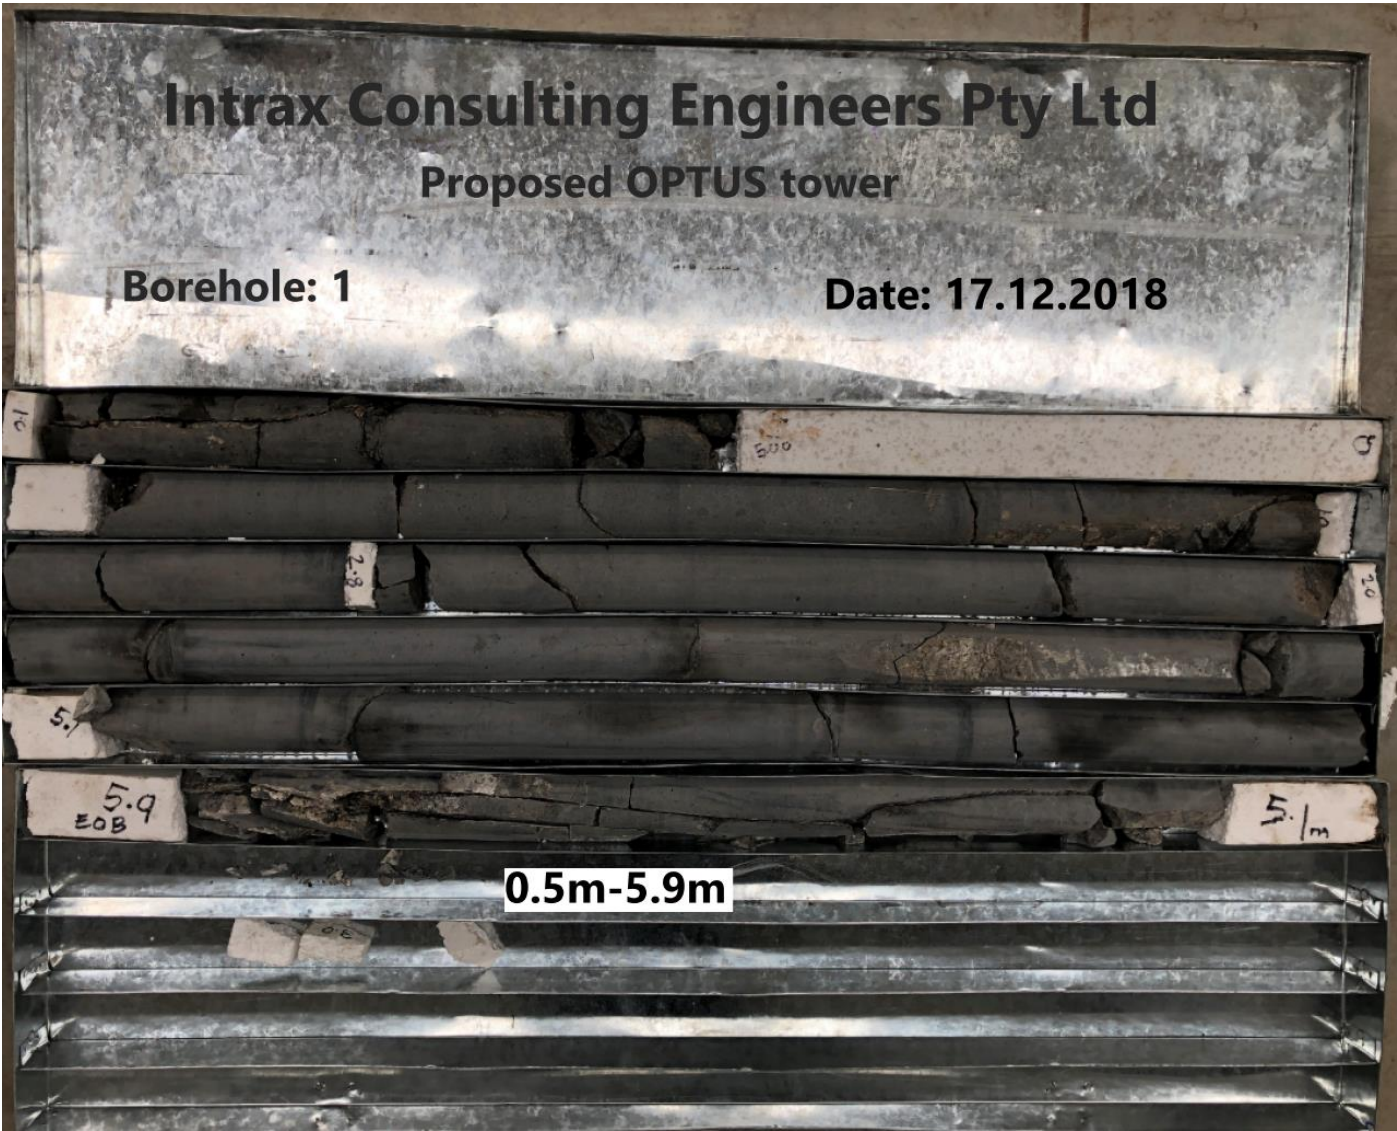
CORE BOX PHOTOGRAPH

Borehole Log:						Sheet: 2 of 3		<div>Intrax Engineering Confidence</div>							Civil Forensic Hydraulic Structural Surveying Geotechnical Building Services										
Client:		CommPlan Pty Ltd		Location:		Selwyn Trail, Mount Selwyn, NSW																			
Project:		Optus Tower		Coordinates:		-																			
Job Number:		119033		Surface RL:		-																			
Contractor:		-		Datum:		-				Logged:		JH	Date:		17.12.2018										
Drill Rig:		-		Inclination:		-				Checked:		PE	Date:		20.12.2018										
Method	Water	TCR (%)	RQD (%)	Depth (m)	RL	Graphic Log	Material Description	Weathering	Inferred Rock Strength						Defects & Additional Observations				Defect Spacing (mm)						
									<VL	VL	L	M	H	VH	EH					10	30	100	300	1000	3000
NLMC Coring		100	64	0.0			BASALT: fine grained dark grey mottled red-brown moderately weathered, high strength	MW								0.5-0.65m; Fractures Zone

1.0												0.8m; J10°, IR, VN, Fe ST 0.87m; J10°, IR, VN, Fe ST 0.9m-1.1m; J70°, UN, VN, Fe ST 1.2m; J40°, UN, RO, VN 1.27m; J40°, UN, RO, CL

2.0			dark-grey	SW								1.55m; J40°, PL, VR, CL 1.7m, J10°, UN, VR, VN									
				3.0												2.0m; J50°, UN, RO, VN 2.25m, J20°, IR, VR, VN 2.65m; J40°, CR, RO, VN 2.75-2.8m; SZ

4.0												3.1m; J45°, UN, RO, VN 3.4m; J50°, UN, RO, VN 3.55m; J60°, IR, VR, VN									
				5.0												3.95m; 2xJ20°, UN, RO, VN 4.4m; J30°, UN, VR, CL 4.8m; J40°, UN, VR, CL

6.0			End of borehole at 5.9m									5.1m; J20°, UN, VR, VN 5.2m; J40°, UN, VR, VN 5.2-5.4m; J80°, UN, RO, VN 5.4-5.8m; 3xJ85°, UN, RO, VN

7.0												5.8-5.9m; Fractured Zone									
				8.0																					
				9.0																					
				10.0																					
This borehole log is to be read in conjunction with the explanatory notes appended to the set of logs. This borehole log is not be reproduced without the full inclusion of all explanatory notes.

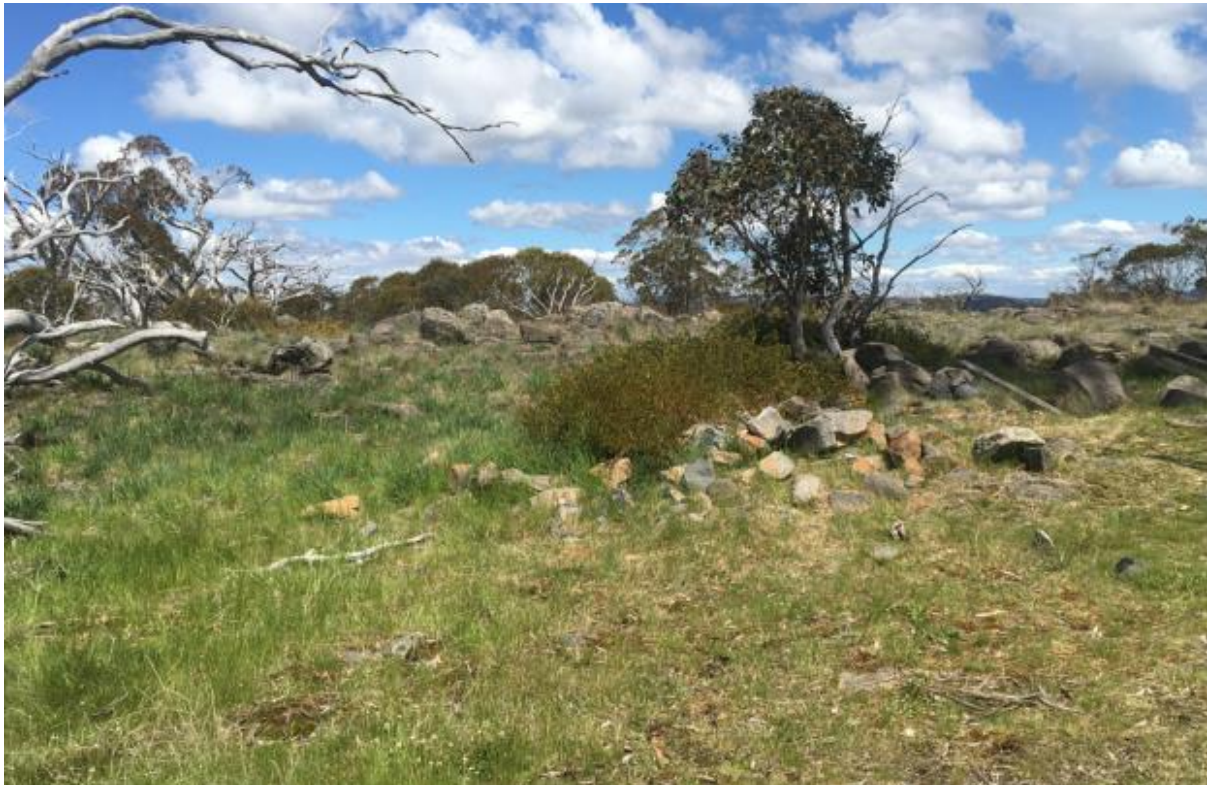
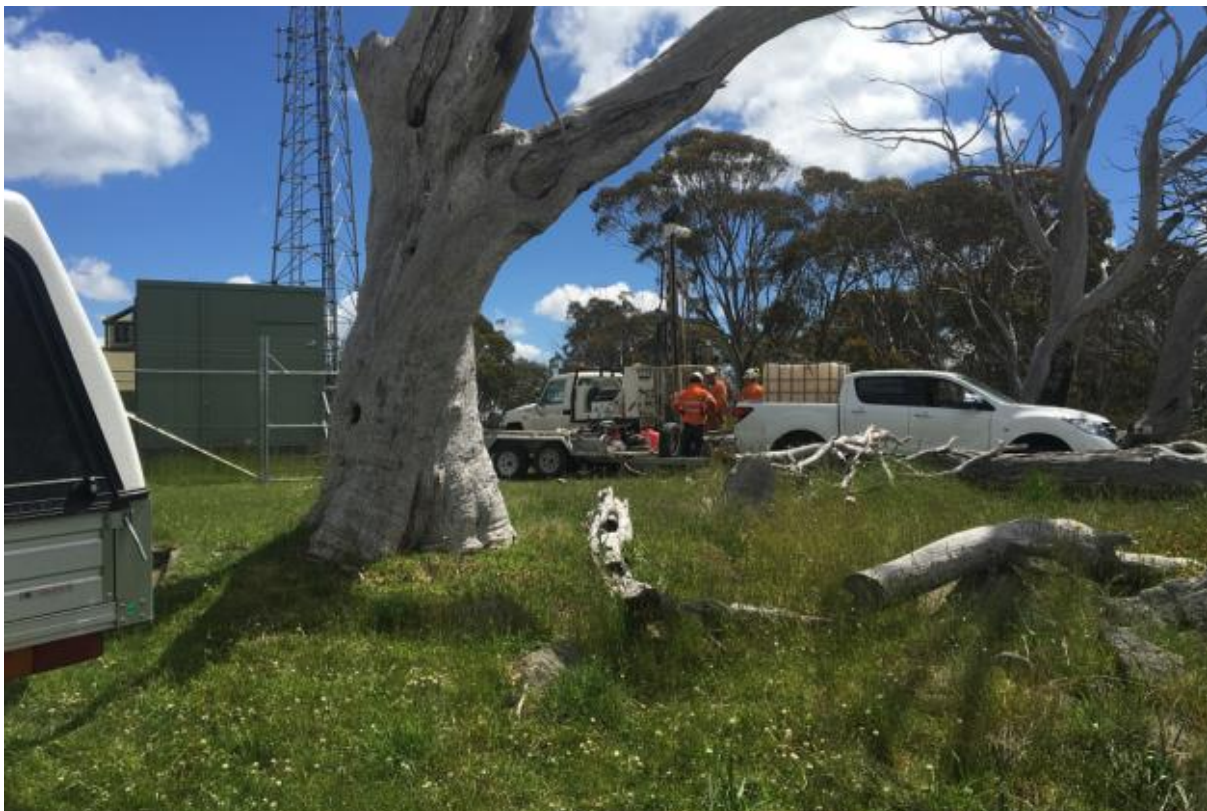
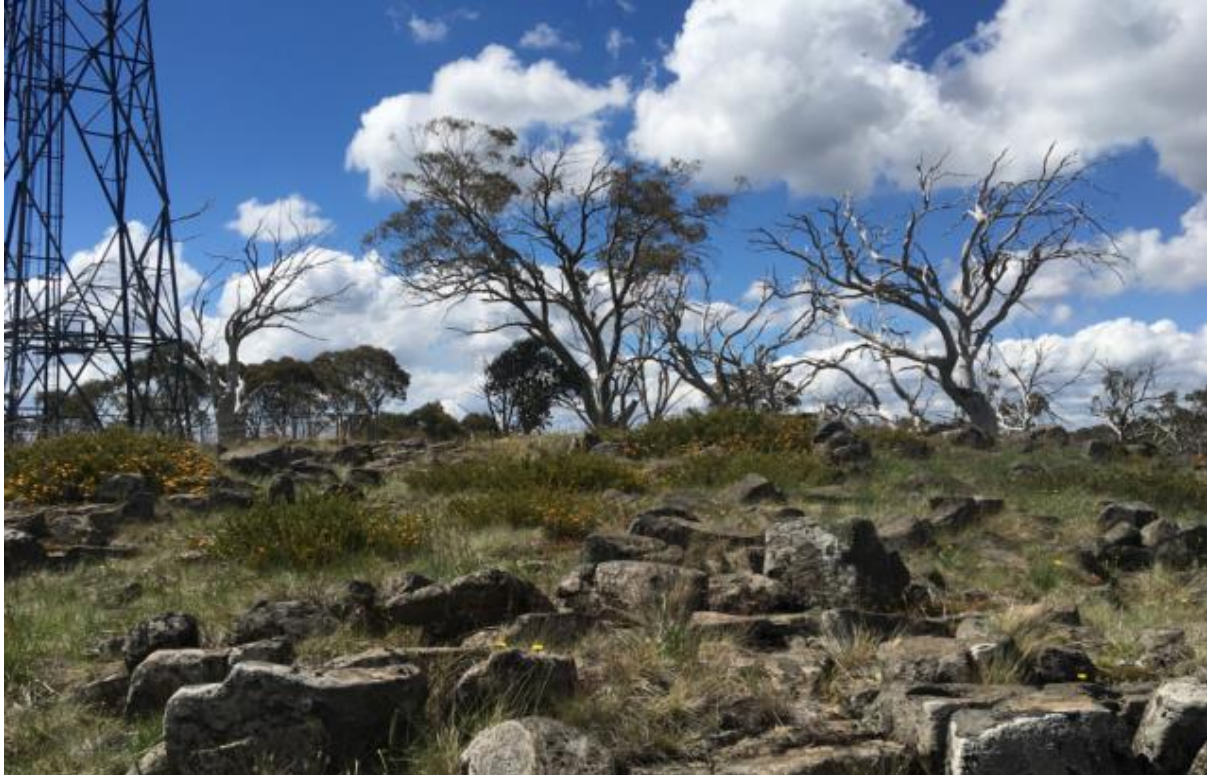
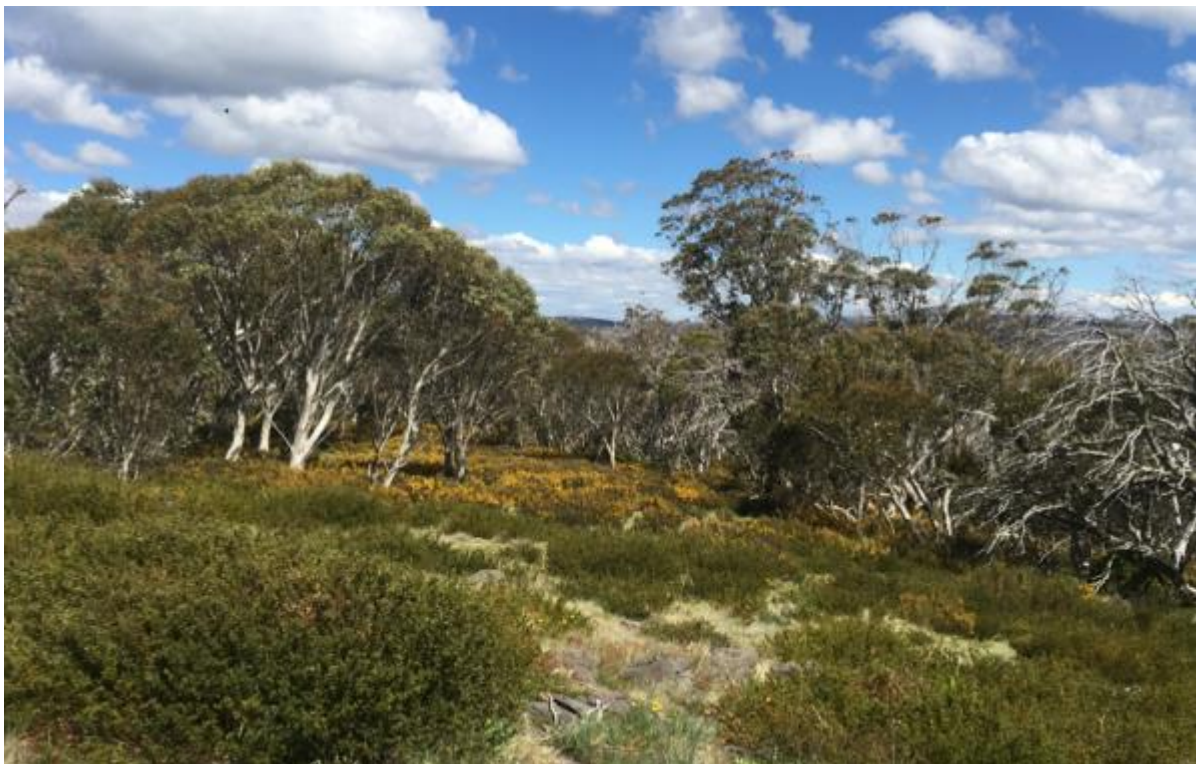
Site Photography

The investigated site is located to south of Selwyn Trail, Mount Selwyn, located in a ridge of hilly formation. The proposed building envelope is bounded to the north by Selwyn Trail, to the east, south and west by existing forest. Large basalt rock out-crops were scattered throughout the. The ground cover mainly consisted of rock outcrops, grass and shrubs.

Site conditions on the date of inspection are visible in the attached photography in Appendix B with the site features indicated in the site plan, refer Appendix A.
