Cultural Heritage Due Diligence Assessment

To accompany a development application for Environmental
Protection Works on the Murray River near Barmah, NSW

March 2022

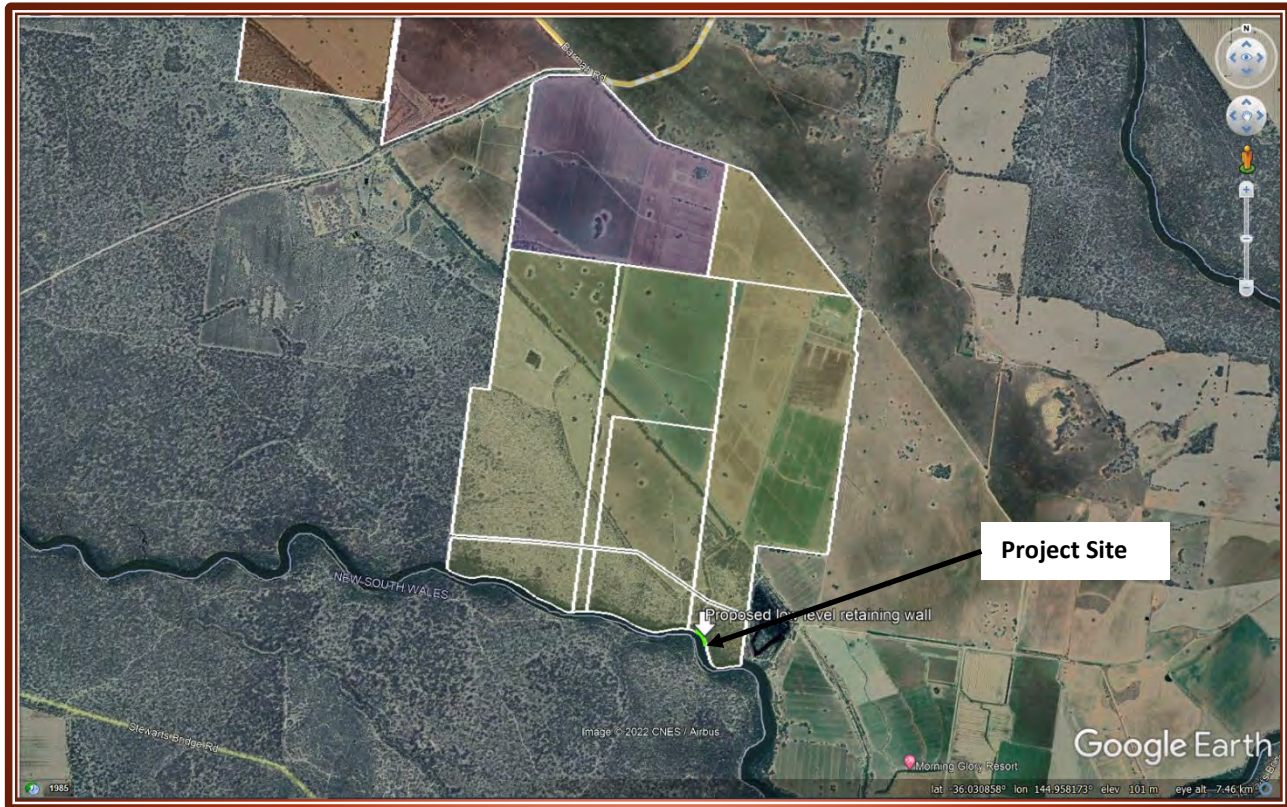
Figure 1-2 Image showing overview of the location proposed works and properties

The project area stretches almost 150m along the river bank where ongoing erosion of the lower banks has led to degradation of the bank. The existing earthen boat ramp will be retained and as such the proposed wall with be spilt into two spans either side of the boat ramp.

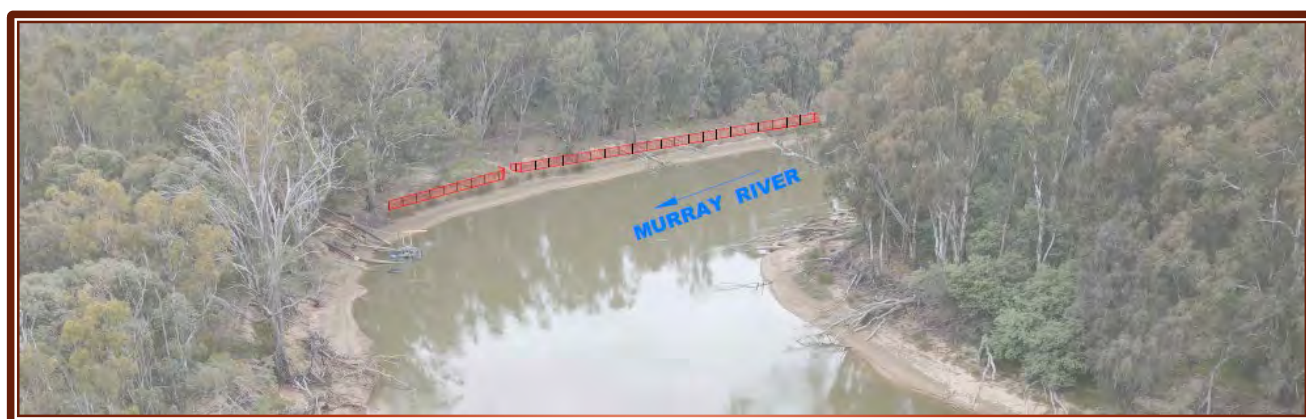
Figure 2-3 - Image showing proposed retaining wall.

The image below shows the existing site with an impression of the proposed wall shown in red.

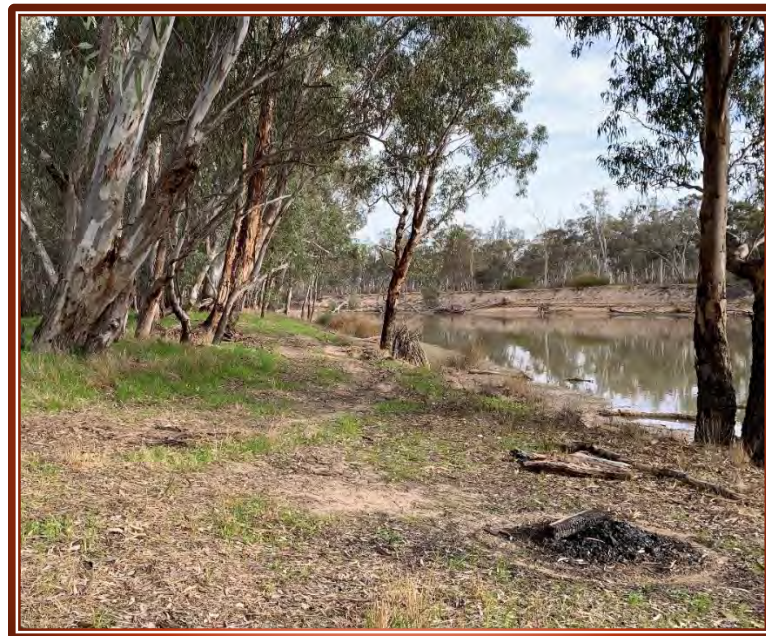
Figure 2-4 - Image showing upstream of project site

The area upstream of the project site, has banks that are in varying stages of stability and contain native riparian vegetation, fallen timber, leaf litter and very little ground cover. This site is subject to inundation during high river flows and is utilised by livestock for grazing and water access. Morning Glory River Resort is located 2.5kms (by River) upstream and clientele from the resort regularly use this section of the River for riverboat activities.

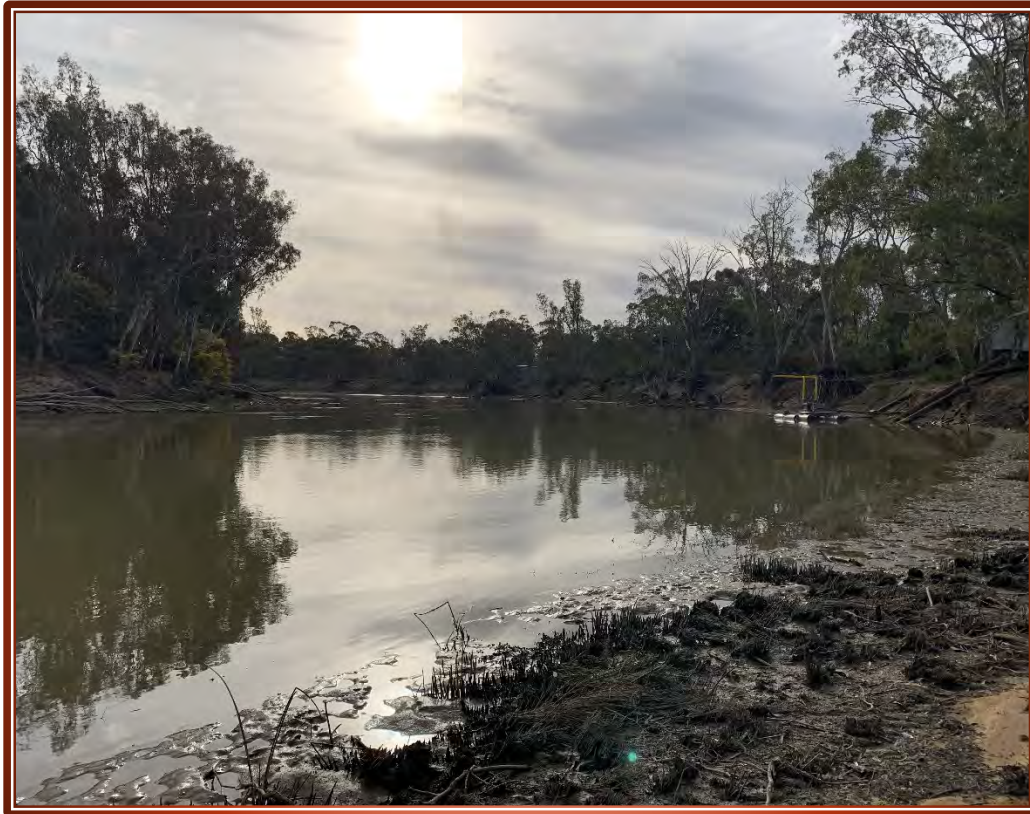
Figure 2-5 - Image showing downstream of project site

The area downstream of the project site is the continuation of an outside bend. The Bama Irrigation Trust and other community pumping systems maintain pump infrastructure within this area. The area also contains irrigation channels, levee banks, overhead and buried electricity supply infrastructure, access tracks, fencing and pipelines. The banks in this section are subject to erosion however are nearly vertical in nature. This area is predominantly natural, and portions receive periodic flooding. The vegetation in this area has also been disturbed with little very old remnant vegetation in the immediate landscape.

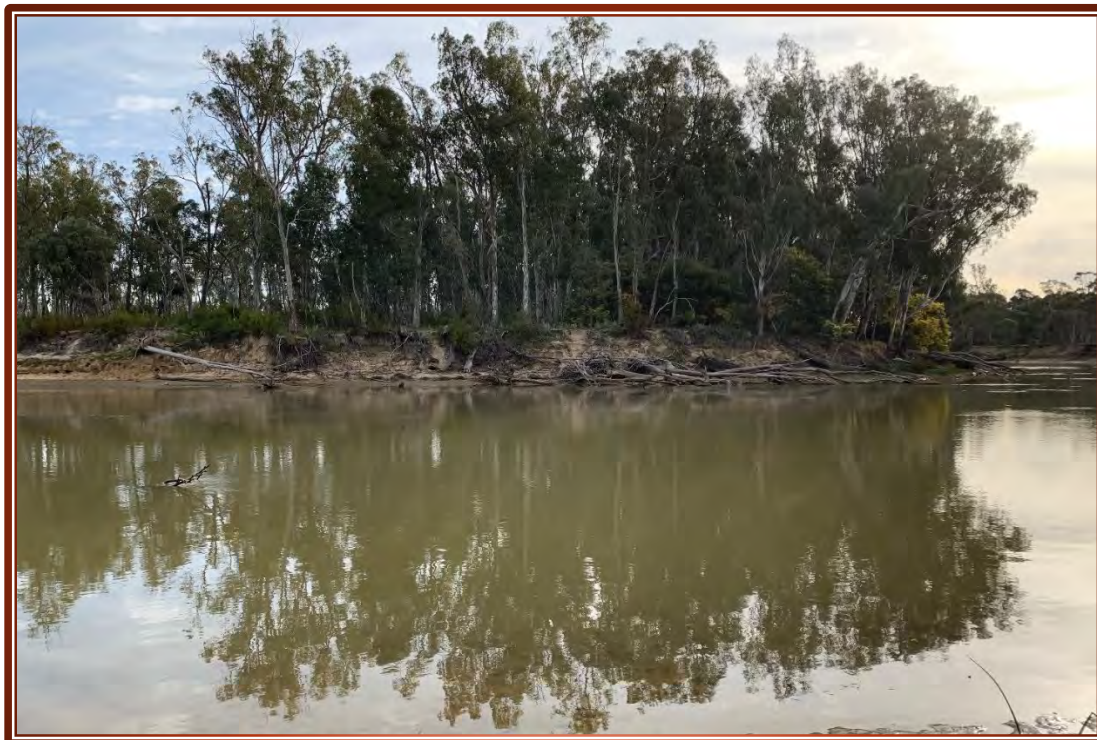
Figure 2-6 - Image showing opposite bank

The area on the opposite bank of the river is the Lower Goulburn National Park. This area contains native vegetation and the banks are eroding. Based on satellite imagery this area seems to be subject to inundation. The site is not accessible so limited information is available on this area.

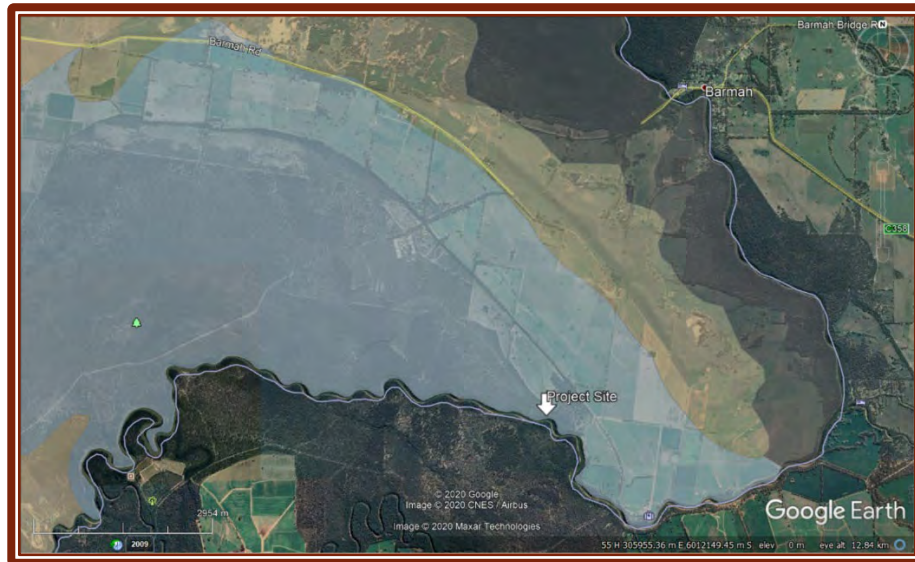
Figure 2-10 - Image showing soils and project site Source: Google earth and eSPADE)

The “soil and land resources” layer from espade.environment.nsw.gov.au, State of NSW and Office of Environment and Heritage, 2020 has been utilised to review both the soils at the site and the surrounding area. This mapping identifies the soils at the site as Lake Urana (shown below shaded in blue) being described as *typically high in clay content, and commonly form grey and black cracking clays. Gilgai micro-relief is common. These grade to silty grey and brown silty clays where lacustrine silt contents are high. On outer margins with plains or lunettes, soils are typically sodic and brown/grey solodic soils occur. These are occasionally overlain by sandy beach materials—arenic siliceous sands on the windward side of the lake shores.* (DECCW, NSW, 2010) This mapped soil type broadly matches those visually identified on site.

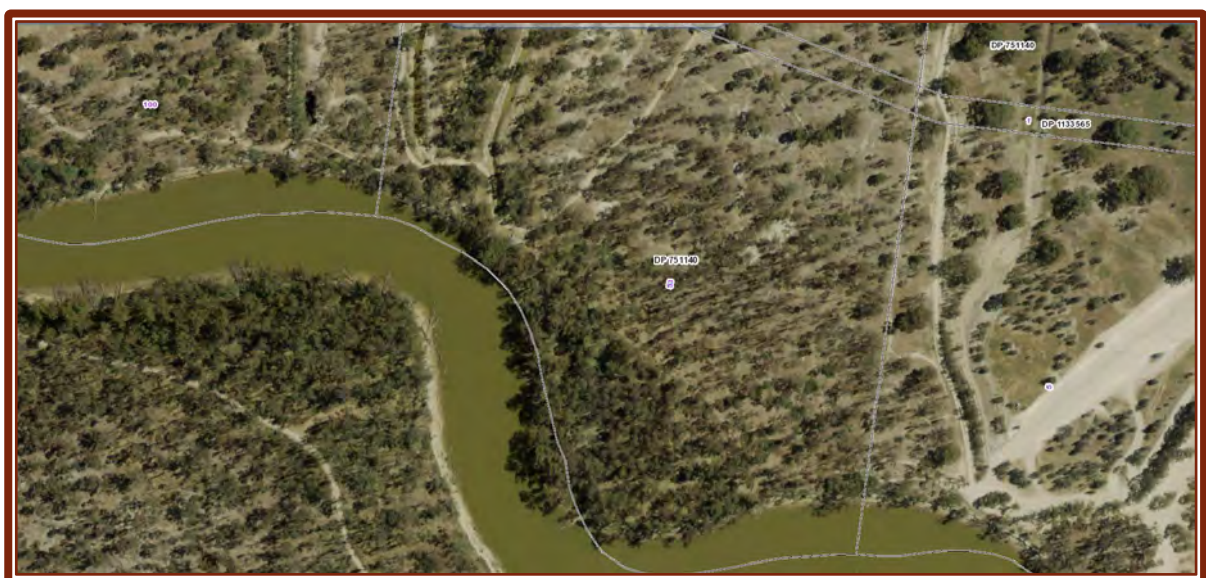
Figure 4-6 - Project site and most recent image showing current area disturbance (Source: Six viewer)

The licencing of the existing pump site relating to this application was recorded on the 17th October 2003 in the NSW Government Gazette No 165. Since this time, except for ongoing general maintenance, little has changed at the site.
