Site Environmental Management Plan (SEMP)

Merritts Mountain House Restaurant Services Upgrade

Thredbo Alpine Resort
Kosciuszko National Park, NSW

March 2022

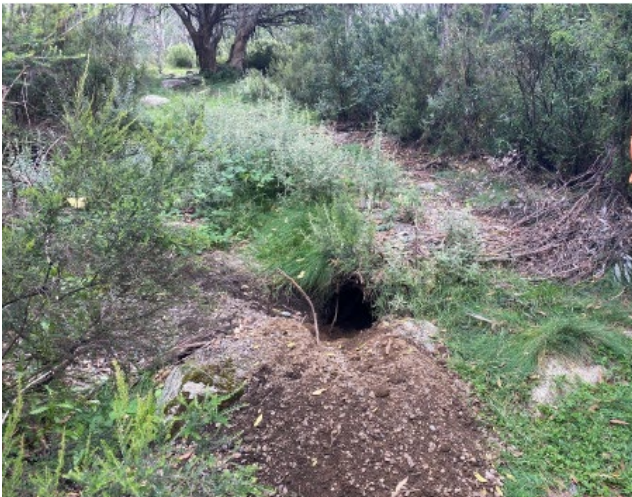
<p><i>Active wombat burrow between the existing UV building and Merritts Creek (Source: ELA 2022)</i></p> <p>Biosecurity</p> <ul style="list-style-type: none"> • prior to the commencement of construction works, all weed species identified within the construction corridor will be treated in accordance with best practice methods to ensure these weeds are not spread further within the site or throughout KNP; • project machinery and vehicles to arrive/depart from KNP and the Project site in a clean condition, free of mud and vegetative propagules and pathogens; • all vehicles and machinery entering Thredbo must adhere to the Standard Operating Procedure: Use and Maintenance of Wash Down Bay, March 2019 (KT055) which requires all vehicles and machinery to utilise the weed wash-down bay prior to entering site to ensure no new weed seeds are introduced to the site and KNP; • machinery to be regularly maintained and manoeuvred to prevent the spread of weeds and pathogens; • storage of plant and machinery is to be restricted to the designated disturbed areas within the construction corridor; and • follow up weed control to be carried out if deemed necessary.

<ul style="list-style-type: none"> • appropriate safeguards should be in place during the proposed works to limit the potential for invasive plants or pathogens, chemicals or any other pollutants to enter the environment in association with the proposed development (ELA 2022); • the construction works will be confined to the approved construction corridor; • ensure equipment and construction materials are stored on previously disturbed areas to avoid impacts to native vegetation; • maintain a clean and tidy work area to ensure animals are not attracted to the site, including provision of covered bins during proposed works; • all disturbed areas to be progressively stabilised and/or revegetated in accordance with the Rehabilitation Plan so that no areas remain exposed if works are completed in that area; and • disturbance areas are to be rehabilitated immediately following the completion of works. <p>Fauna</p> <ul style="list-style-type: none"> • reasonable and practicable native fauna management measures will be implemented during construction to avoid environmental harm and nuisance to native fauna, known habitats and breeding places; and • prior to the commencement of the proposed works, a wombat management plan should be prepared to manage impacts on the active wombat burrow that was detected between the UV building and Merritts Creek (within the existing access track) (ELA 2022).

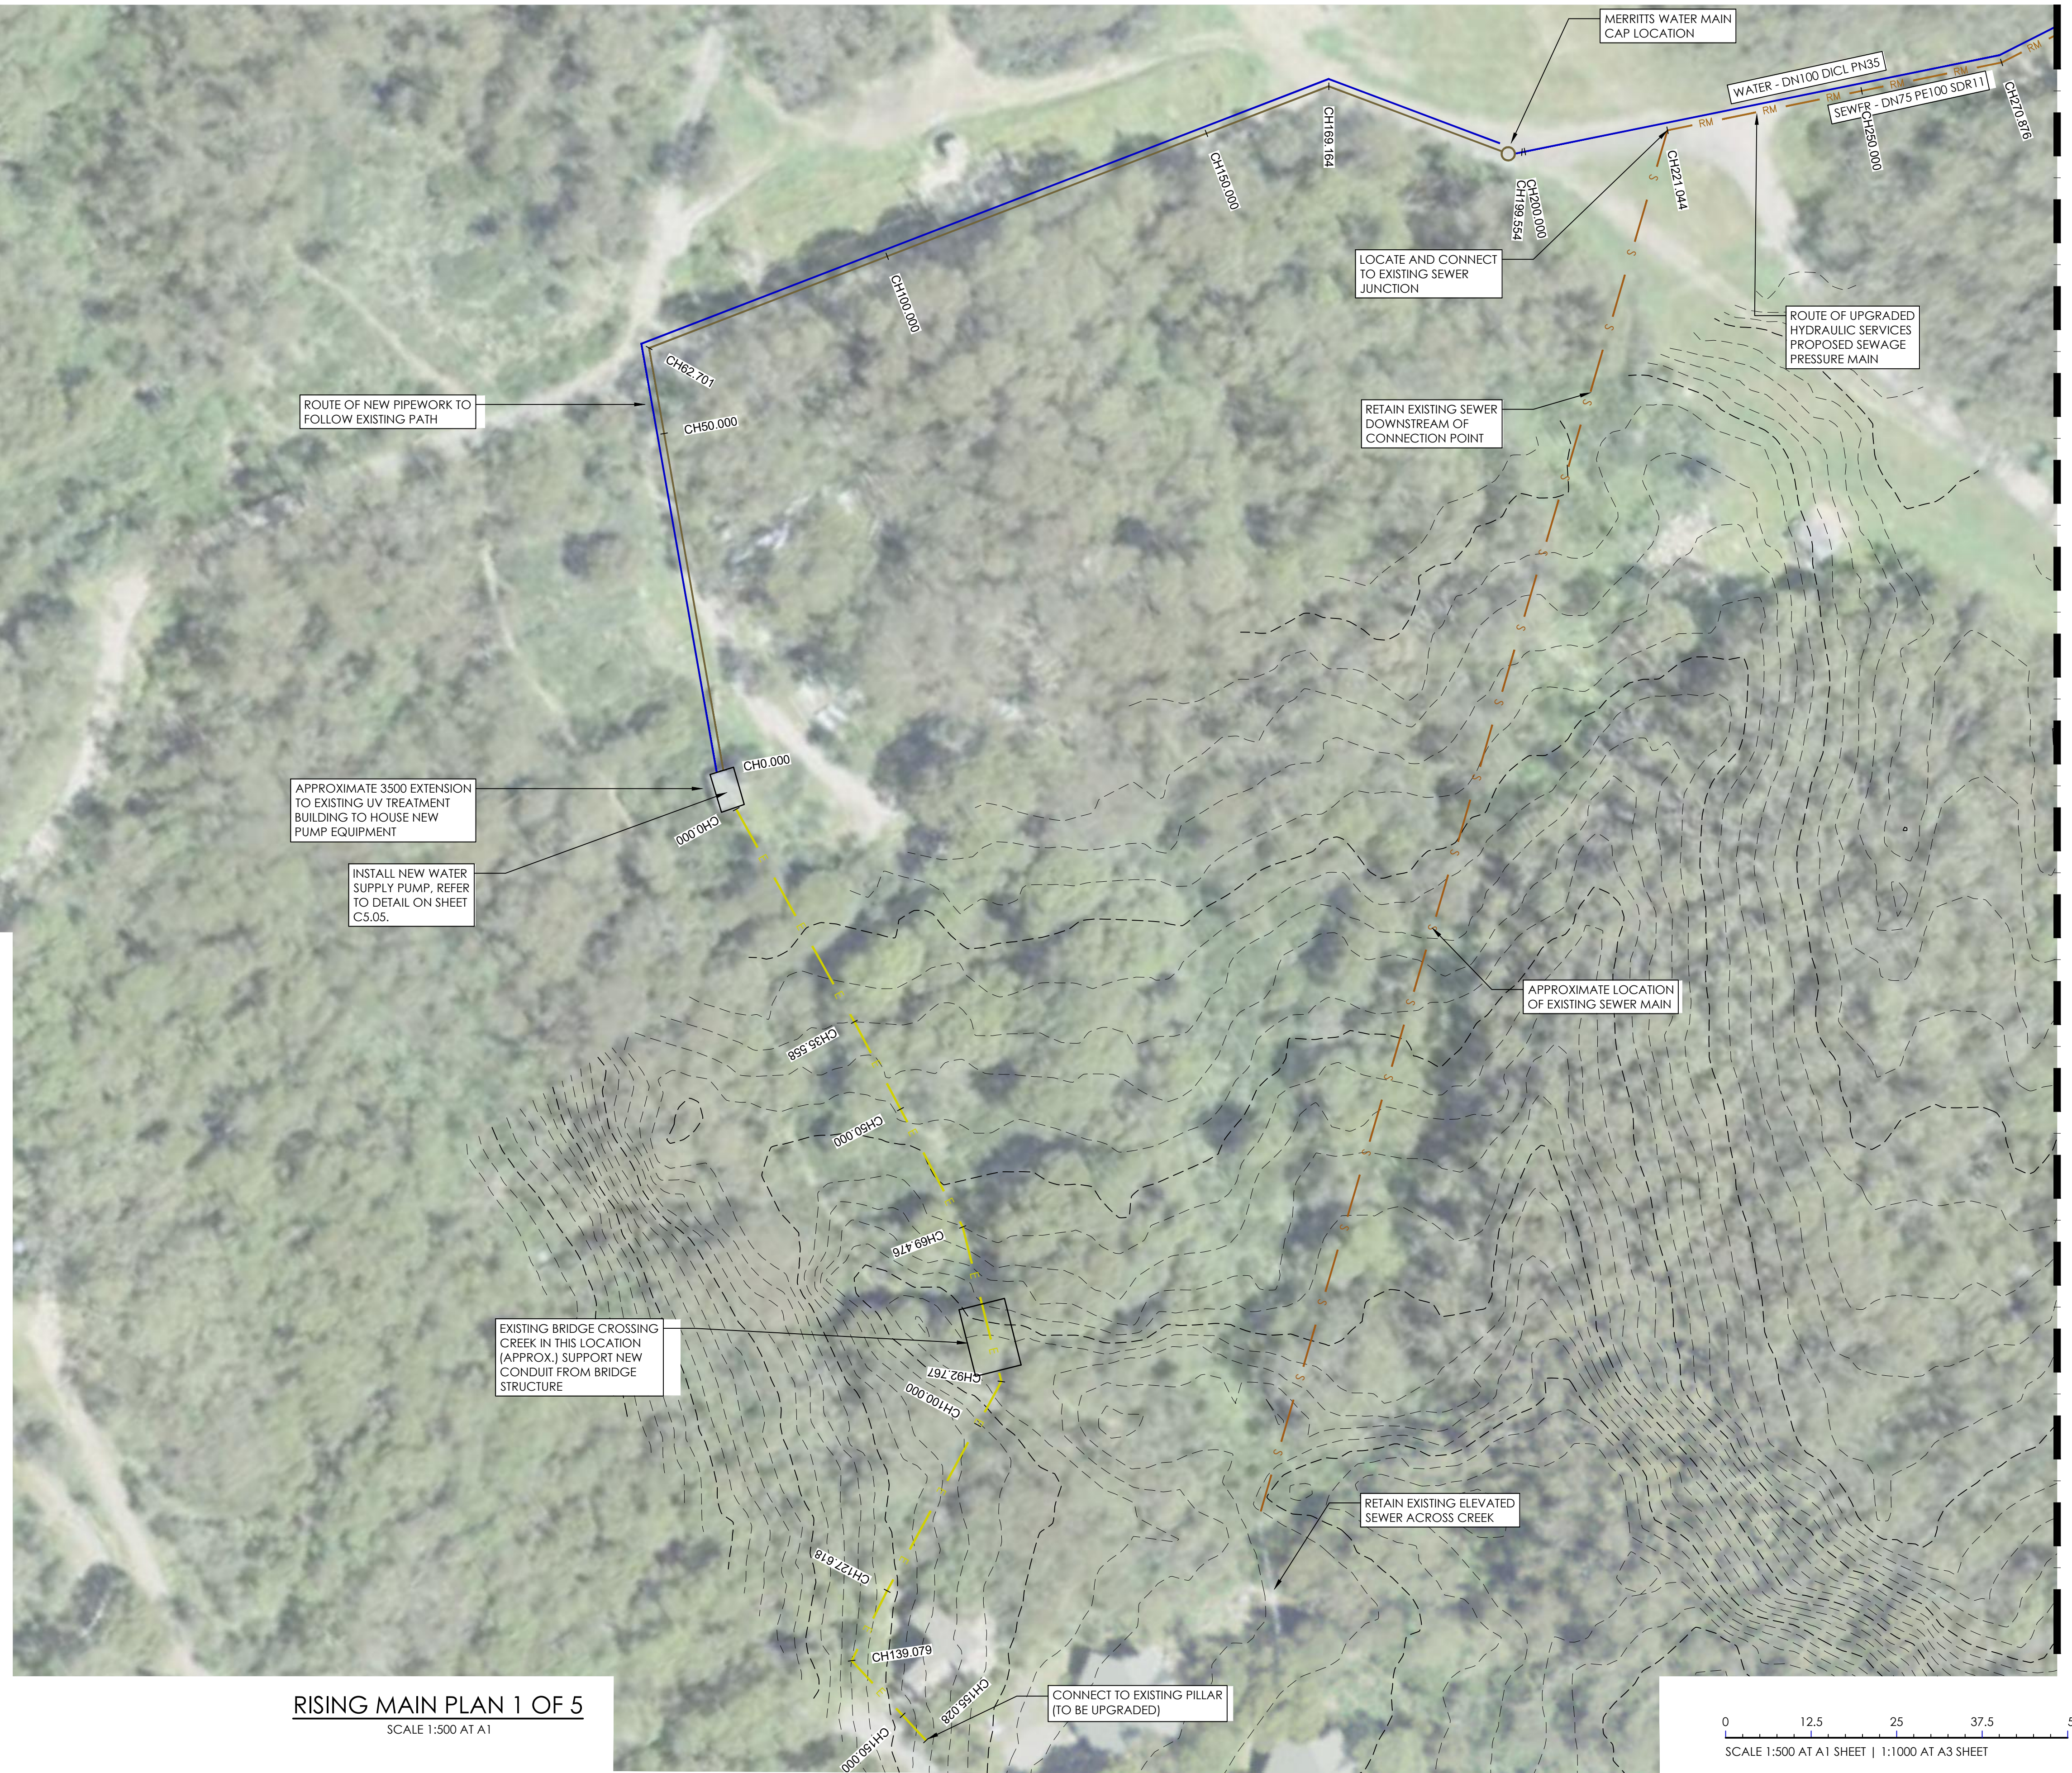
DRAWING TITLE
RISING MAIN PLAN SHEET 1 OF 5

SYMBOL	DESCRIPTION
	CONTOUR MAJOR (5m)
	CONTOUR MINOR (1m)
	PROPOSED ELECTRICAL CONDUIT 150mm NOM
	EXISTING SEWER (APPROX. LOCATION)
	SEWER PRESSURE - DN75 PE100 SDR11
	WATER SUPPLY - DN100 DICL PN35
	WATER LINE - RING MAIN

NOTE:
SUBJECT TO CONFIRMATION OF DETAILED HYDRAULIC ANALYSIS THE DN100 DICL PN35 WATER SUPPLY PIPELINE MAY TRANSITION TO HDPE TOWARDS THE UPPER ELEVATION OF THE PIPELINE

RISING MAIN PLAN 1 OF 5
SCALE 1:500 AT A1

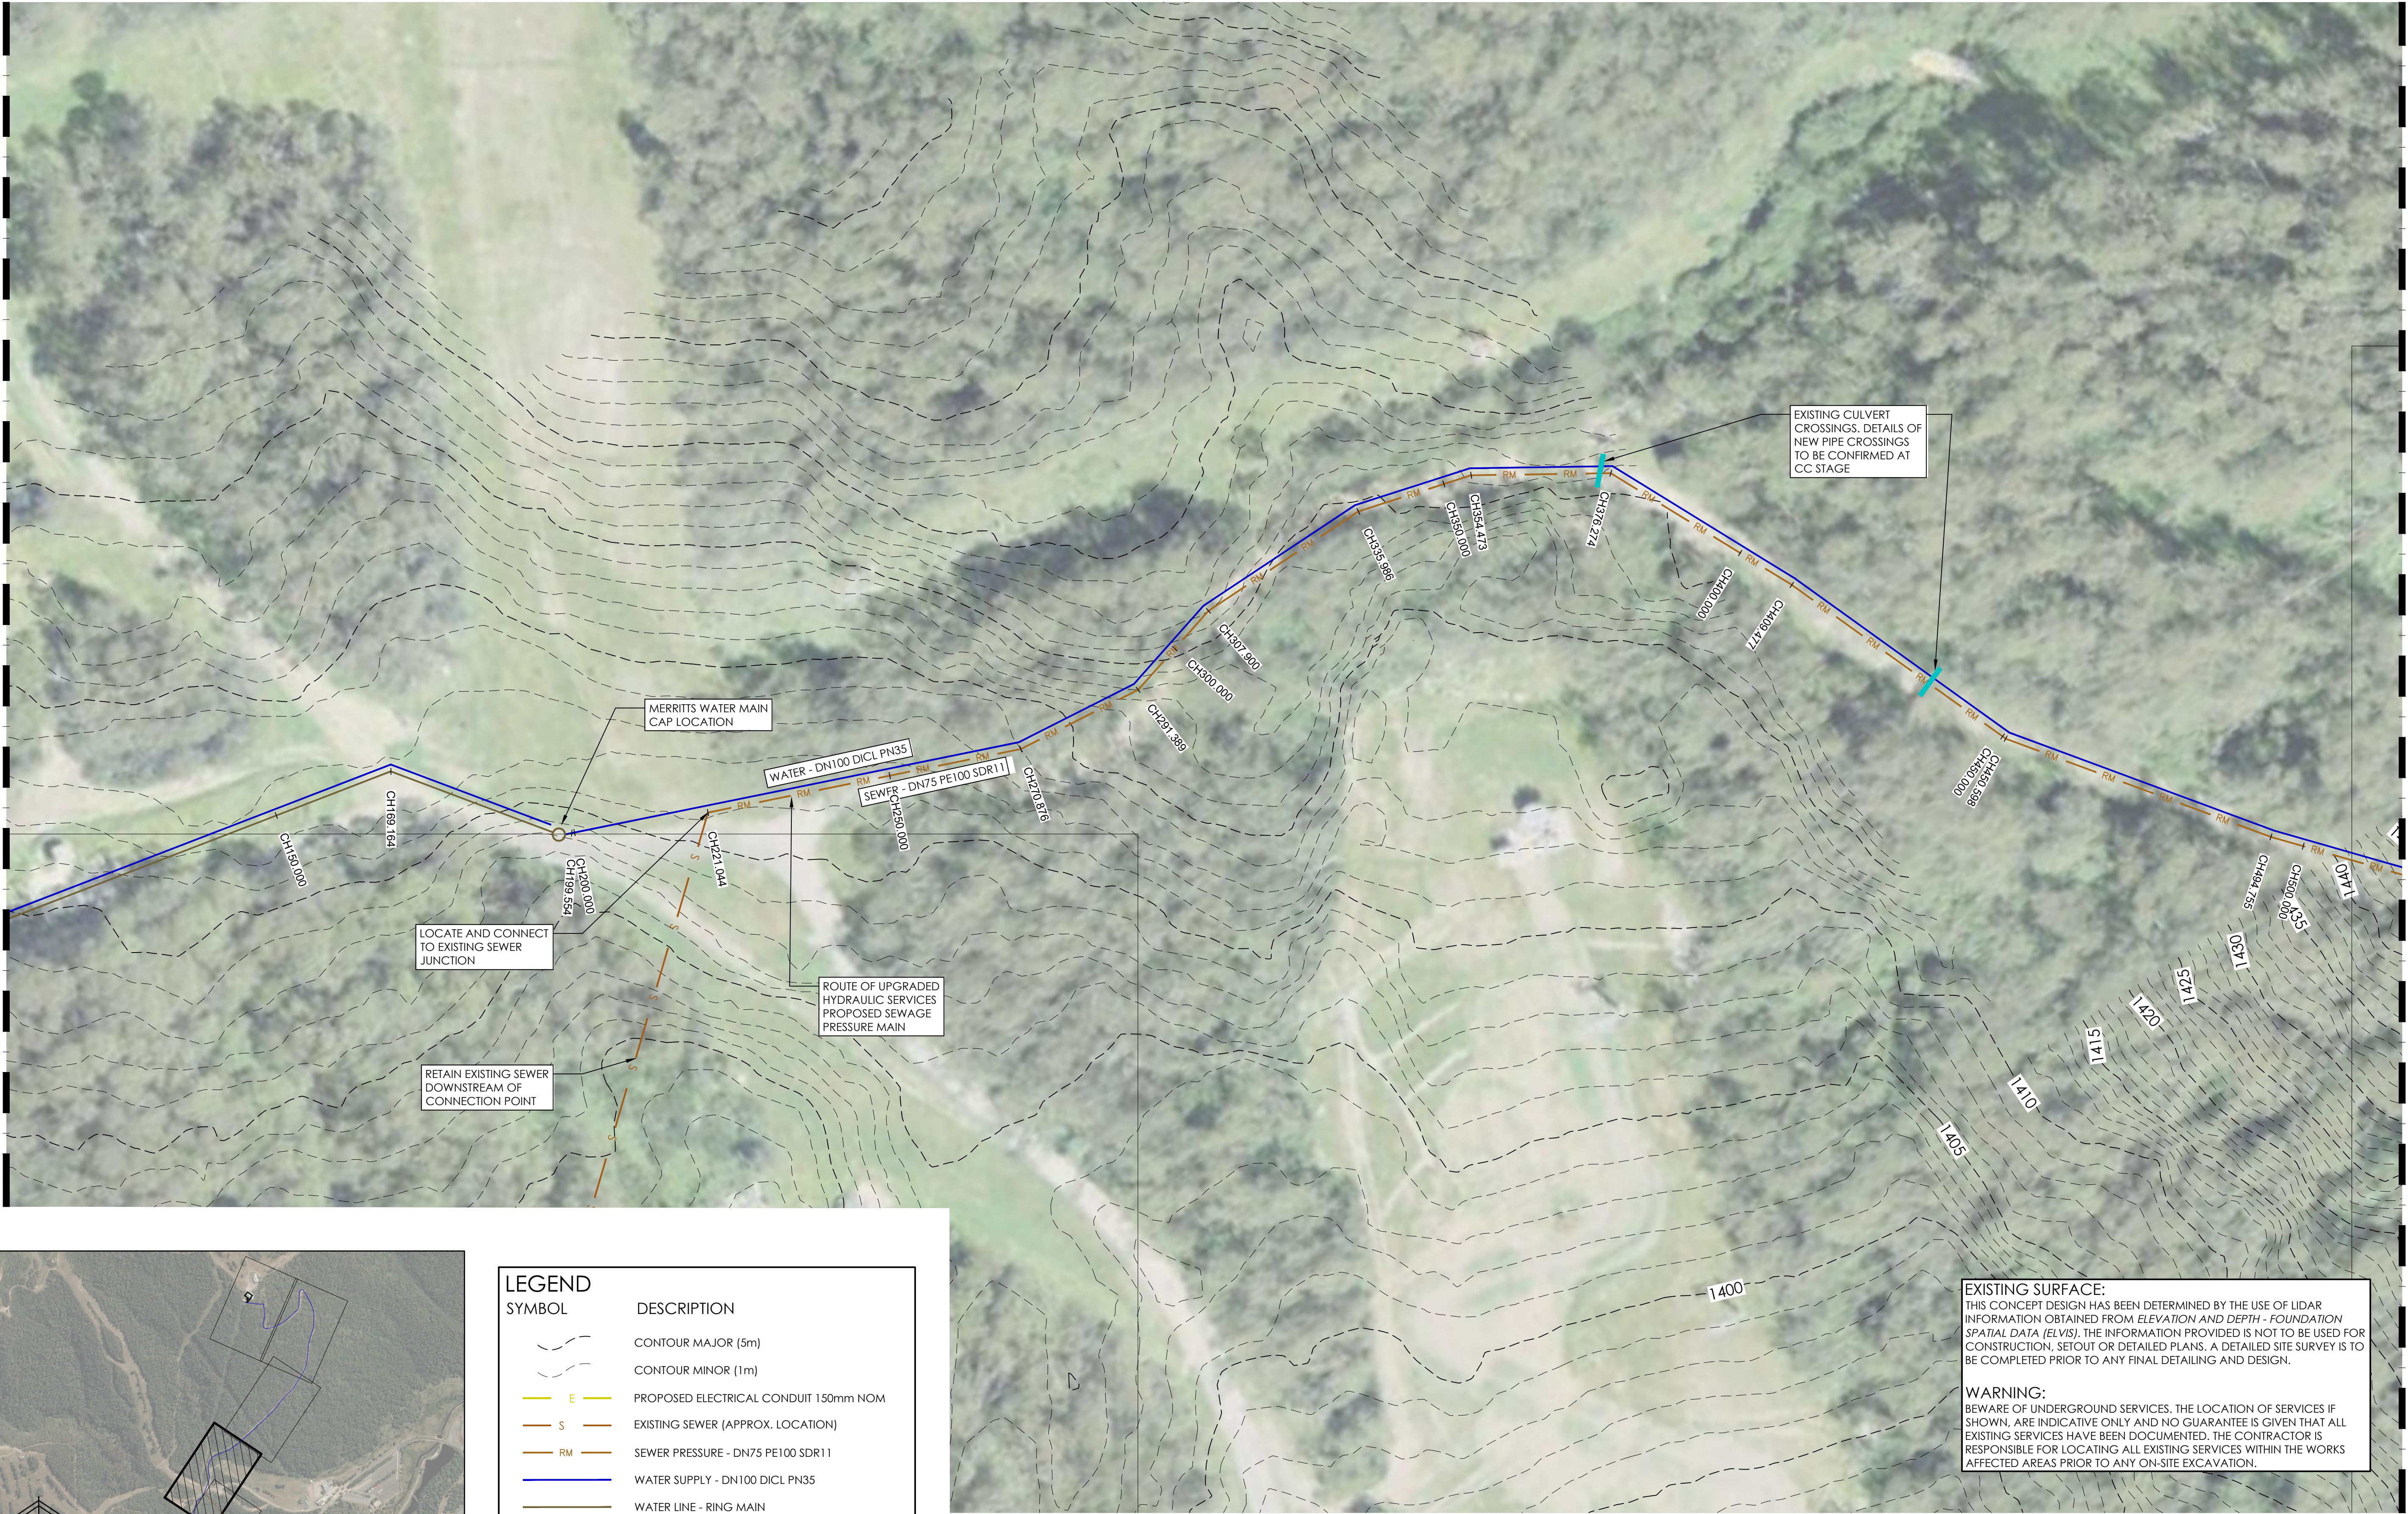
DRAWING TITLE
RIISING MAIN PLAN SHEET 2 OF 5

SYMBOL	DESCRIPTION
	CONTOUR MAJOR (5m)
	CONTOUR MINOR (1m)
	PROPOSED ELECTRICAL CONDUIT 150mm NOM
	EXISTING SEWER (APPROX. LOCATION)
	SEWER PRESSURE - DN75 PE100 SDR11
	WATER SUPPLY - DN100 DI CL PN35
	WATER LINE - RING MAIN

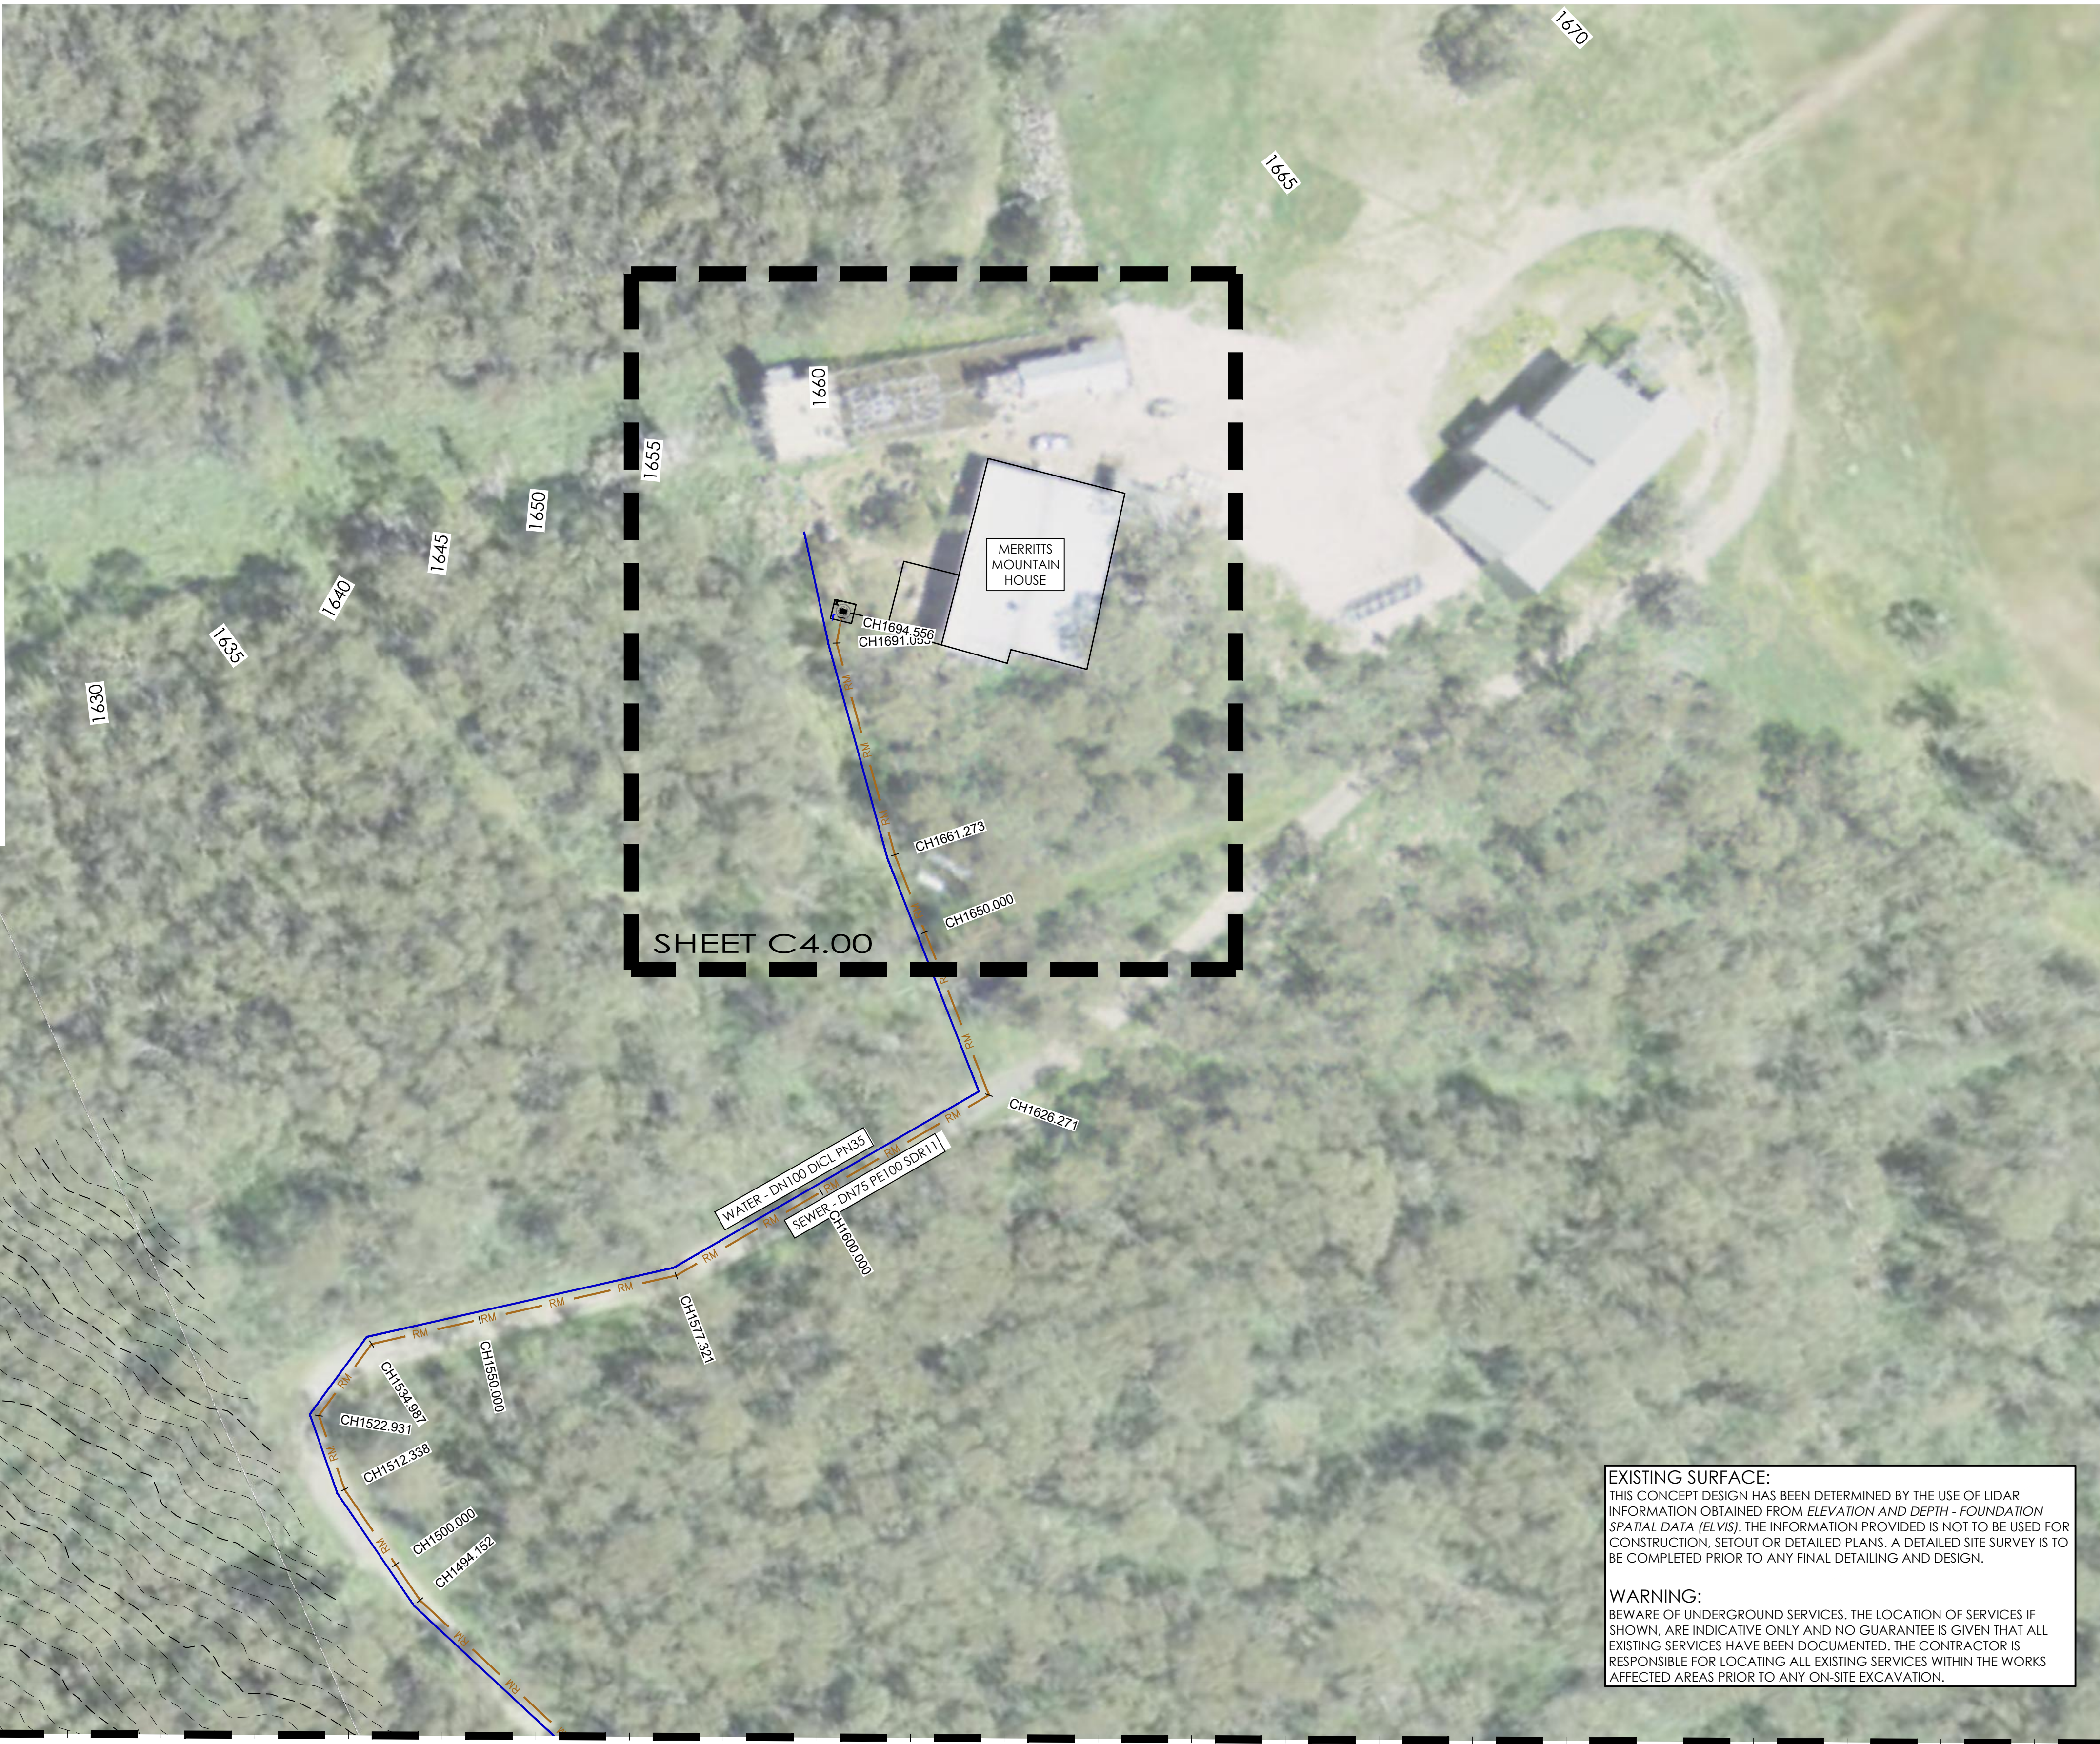
DRAWING TITLE
RIISING MAIN PLAN SHEET 5 OF 5

SYMBOL	DESCRIPTION
	CONTOUR MAJOR (5m)
	CONTOUR MINOR (1m)
	PROPOSED ELECTRICAL CONDUIT 150mm NOM
	EXISTING SEWER (APPROX. LOCATION)
	SEWER PRESSURE - DN75 PE100 SDR11
	WATER SUPPLY - DN100 DICL PN35
	WATER LINE - RING MAIN

NOTE:
SUBJECT TO CONFIRMATION OF DETAILED HYDRAULIC ANALYSIS THE DN100 DICL PN35 WATER SUPPLY PIPELINE MAY TRANSITION TO HDPE TOWARDS THE UPPER ELEVATION OF THE PIPELINE

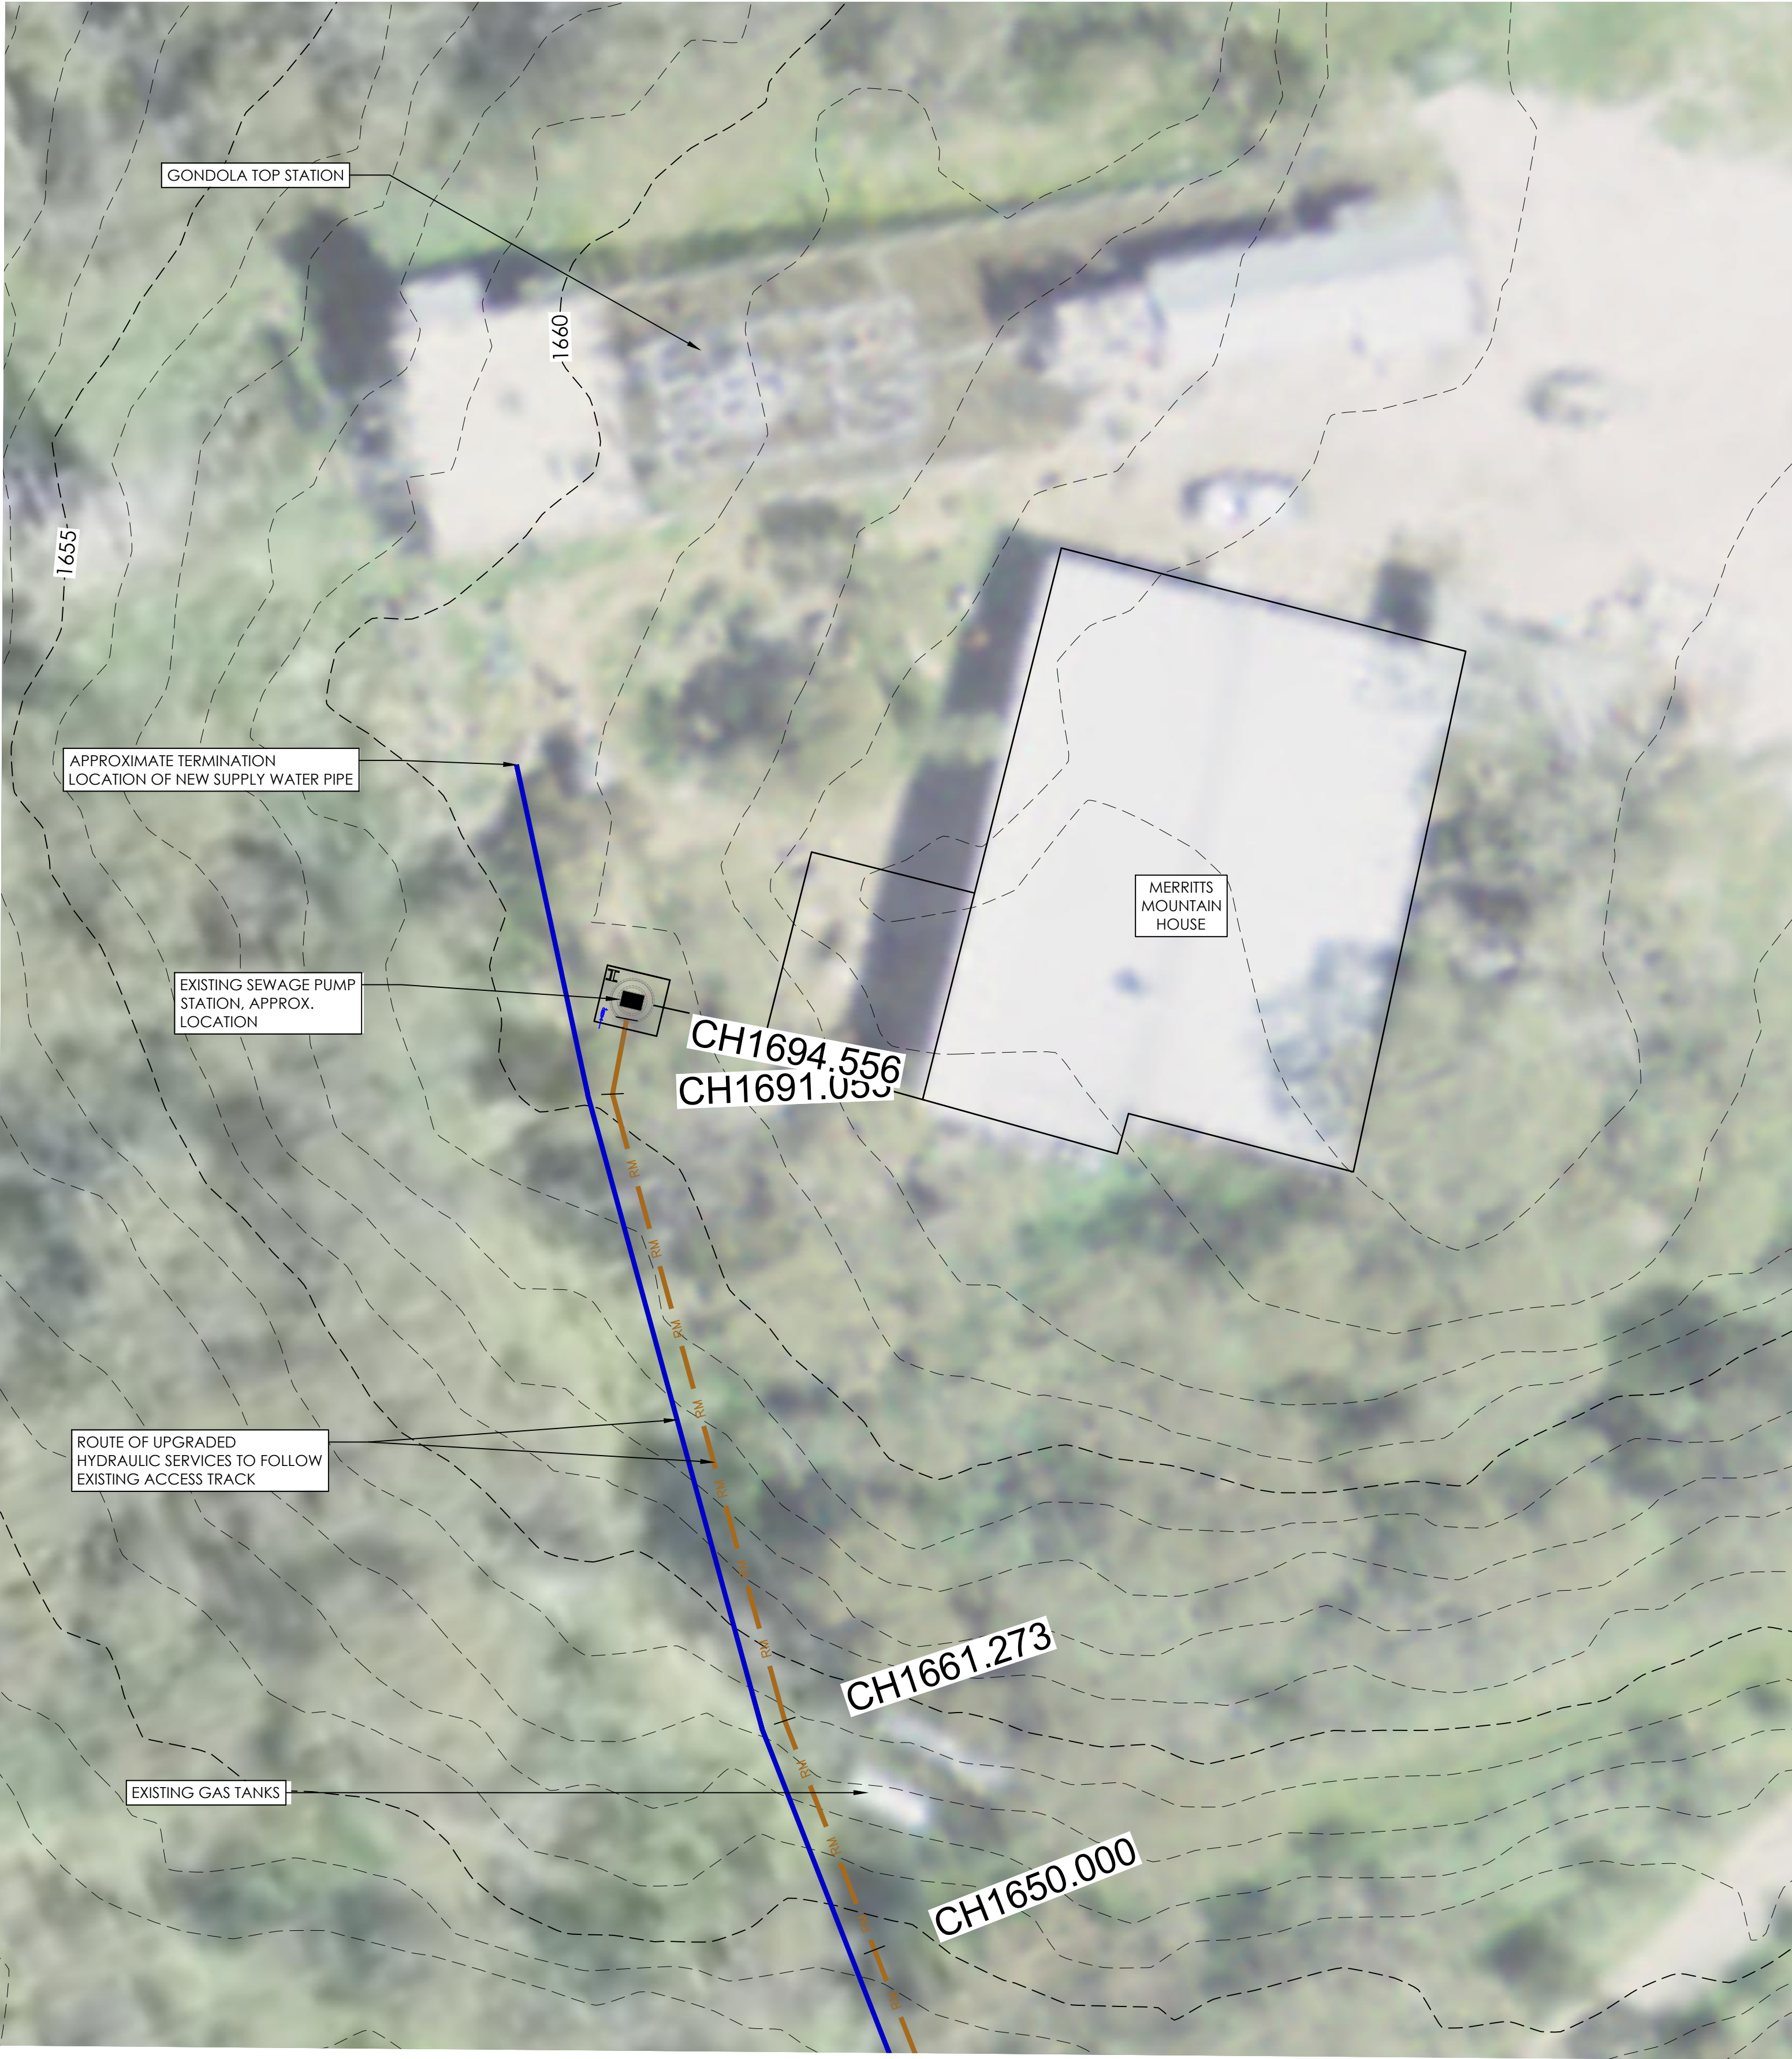
MERRITTS MOUNTAIN HOUSE SITE PLAN
SCALE 1:200 AT A1

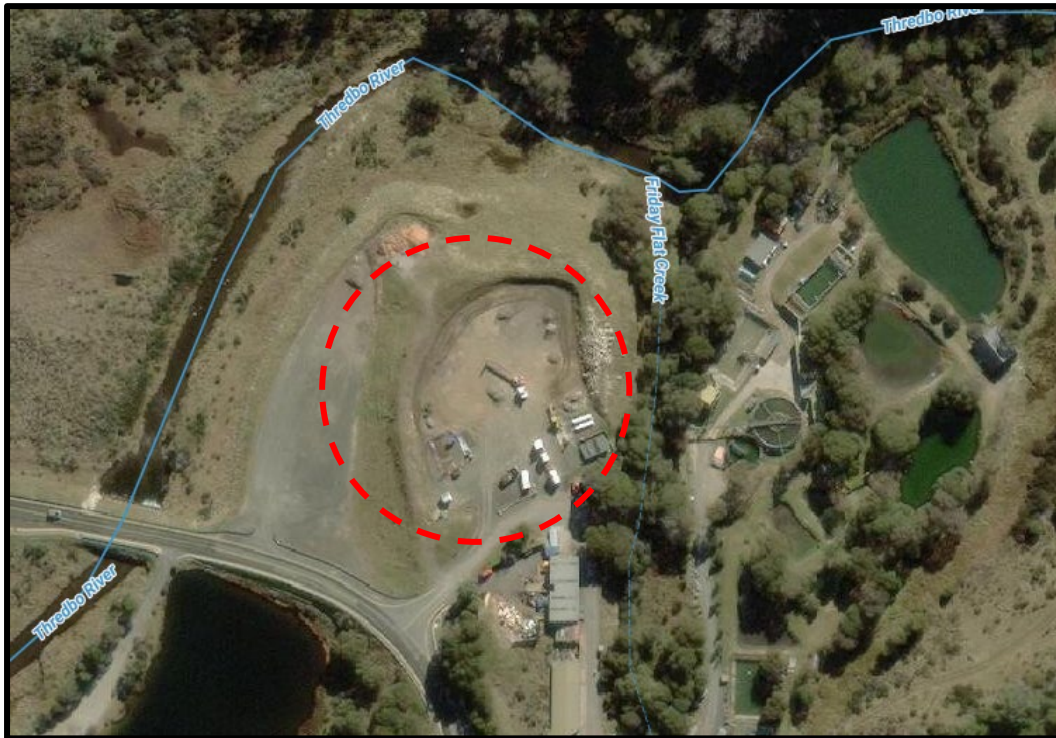
Main stockpile locations located at the carpark adjacent to the Thredbo Waste Transfer Station

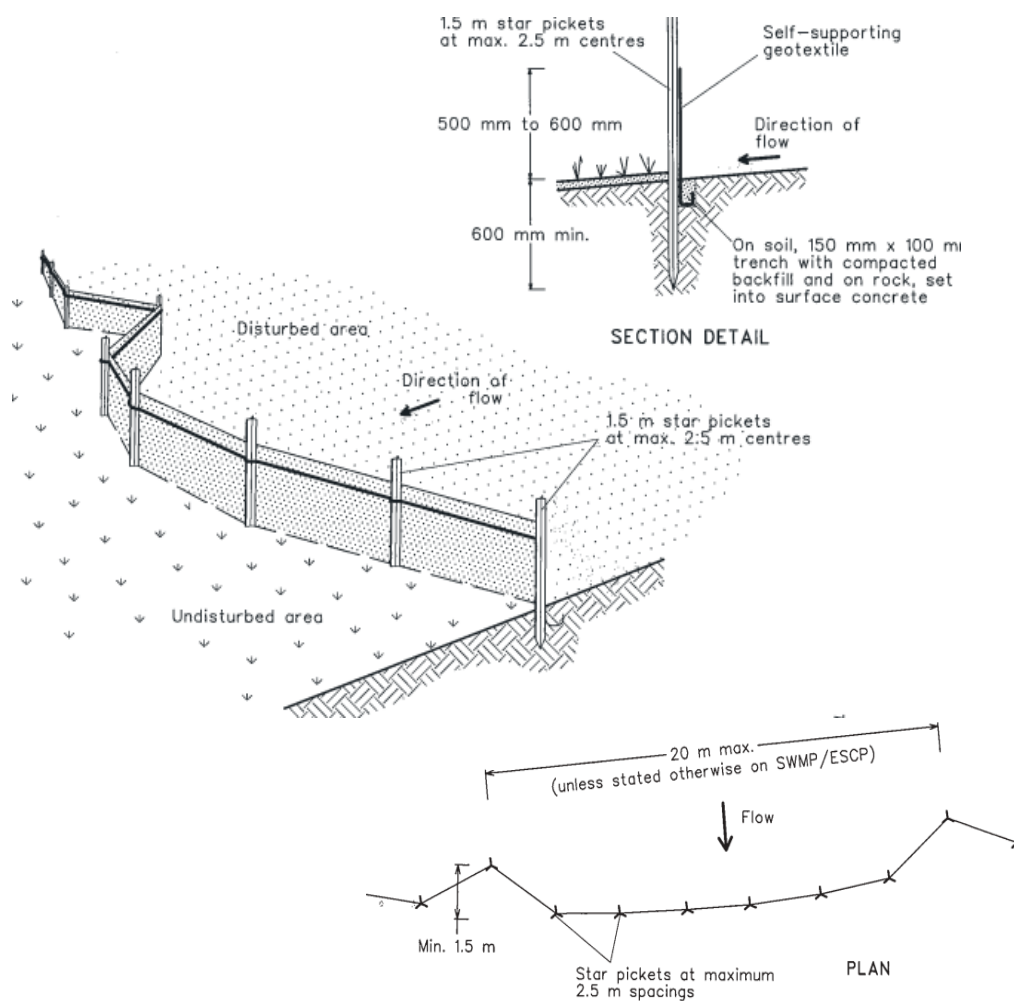
- 1) Construct sediment fences as close as possible to being parallel to the contours of the site, but with small returns to limit the catchment area of any one section. **The catchment area should be small enough to limit water flow if concentrated at one point to 50 L/s in the design storm event, usually the 10-year event.*
- 2) Dig a 150 mm deep trench along upslope line of fence for the bottom of the fabric to be entrenched.
- 3) Install 1.5 m long star pickets into ground at 2.5 m intervals (max) on the downslope edge of the trench. **Fit star pickets with safety caps.*
- 4) Fix geotextile to the upslope side of the posts ensuring it goes to the base of the trench.

Standard Sediment Fence Installation (Source: Landcom 2004)

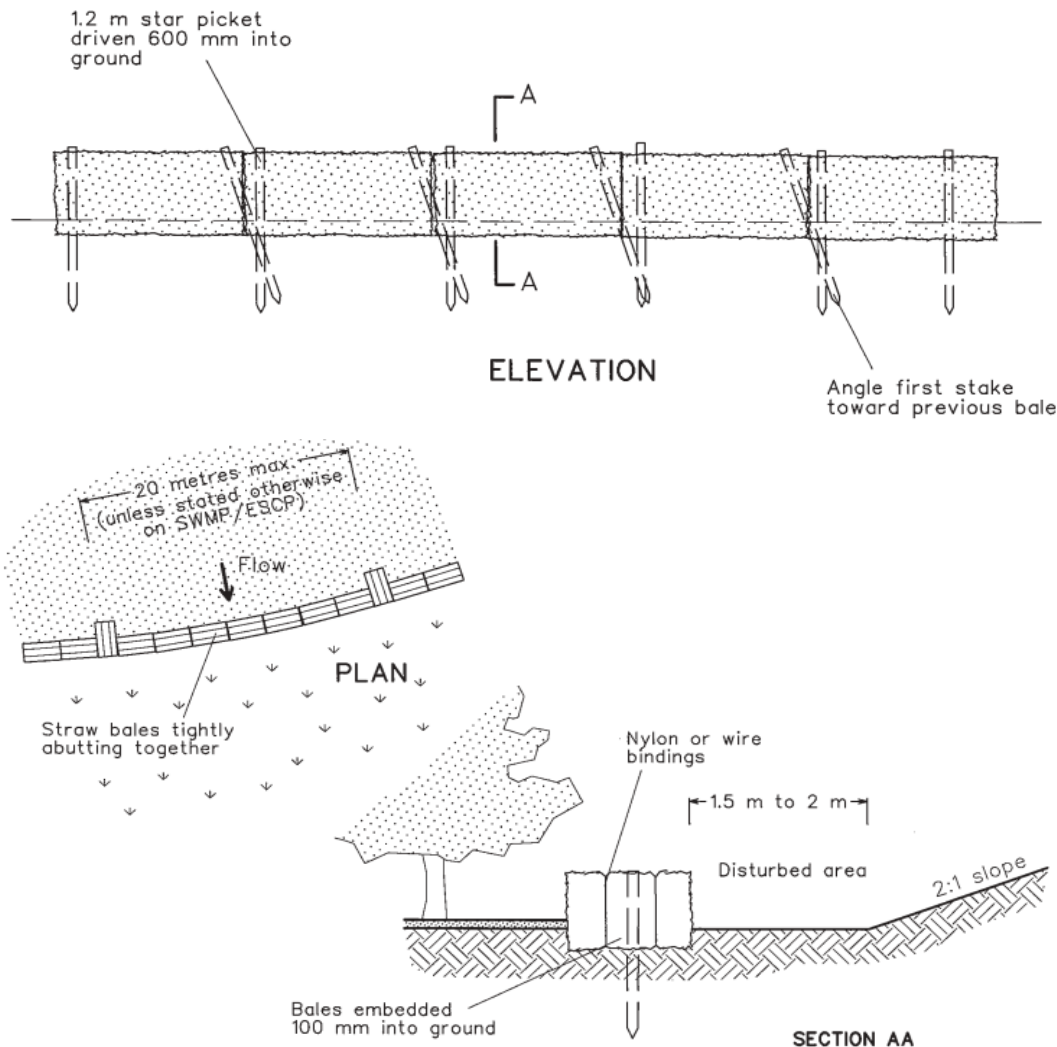
- 1) Construct the straw bale filter as close as possible to being parallel to the contours of the site.
- 2) Place bales lengthwise in a row with ends tightly abutting (1 bale = max height of filter). Fill gaps between bales with straw and wrap with geofabric where necessary.
- 3) Embed each bale in the ground 75-100 mm and anchor with two 1.2 m stakes/star picket. Angle the first stake in each bale towards the previously laid bale. Stakes should be driven 600 mm into ground, sitting flush with top of bale (if possible). **If using star pickets which protrude above bales, fit with safety caps.*
- 4) Where a straw bale filter is constructed downslope from a disturbed batter, ensure the bales are placed 1-2 m downslope from the toe.

Standard Straw Bale Filter Installation (Source: Landcom 2004)

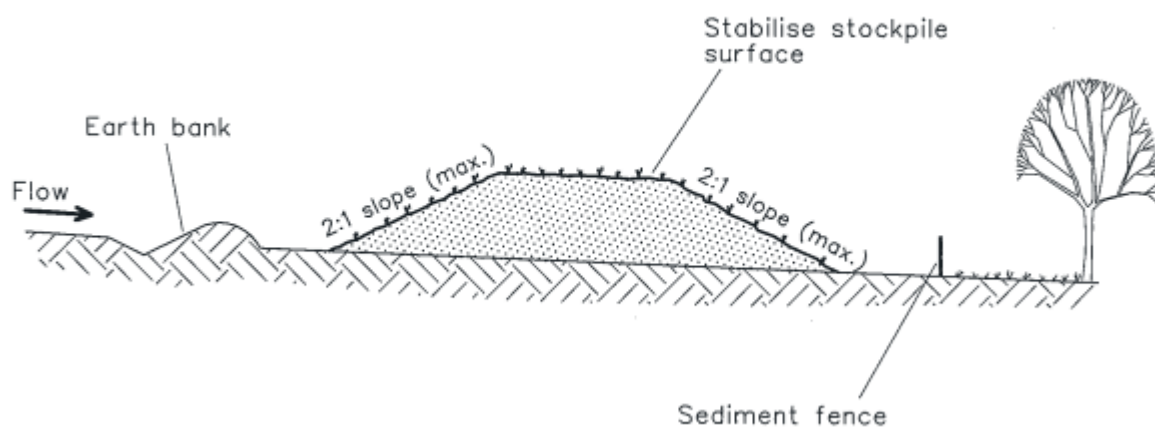
- 1) Stockpiles should be located at least 2 m (preferably 5 m) from existing vegetation and waterbodies, concentrated water flows, roads and hazard areas. Recommended location within weed free, disturbed area if possible.
- 2) Construct stockpiles as low, flat mounds (<2 m high) with a slope <50% (26°).
- 3) Install appropriate sediment controls (e.g. sediment barriers 1-2 m downslope) around stockpiles.
 - It is recommended to cover stockpiles (e.g. with anchored geofabric) during strong wind or high rainfall events.
 - Straw bales used for sediment and erosion control must be certified weed free.

Stockpile Management (Source: Landcom 2004)
