Southern Alps Ski Club Lodge Cooperative Limited
21 Dundas Street
Coogee NSW 2034

Project 205286.00
1 July 2021
R.001.Rev0
CMR

Report on Geotechnical Inspection Proposed Additions and Alterations 4 Spencers Creek Road, Charlotte Pass

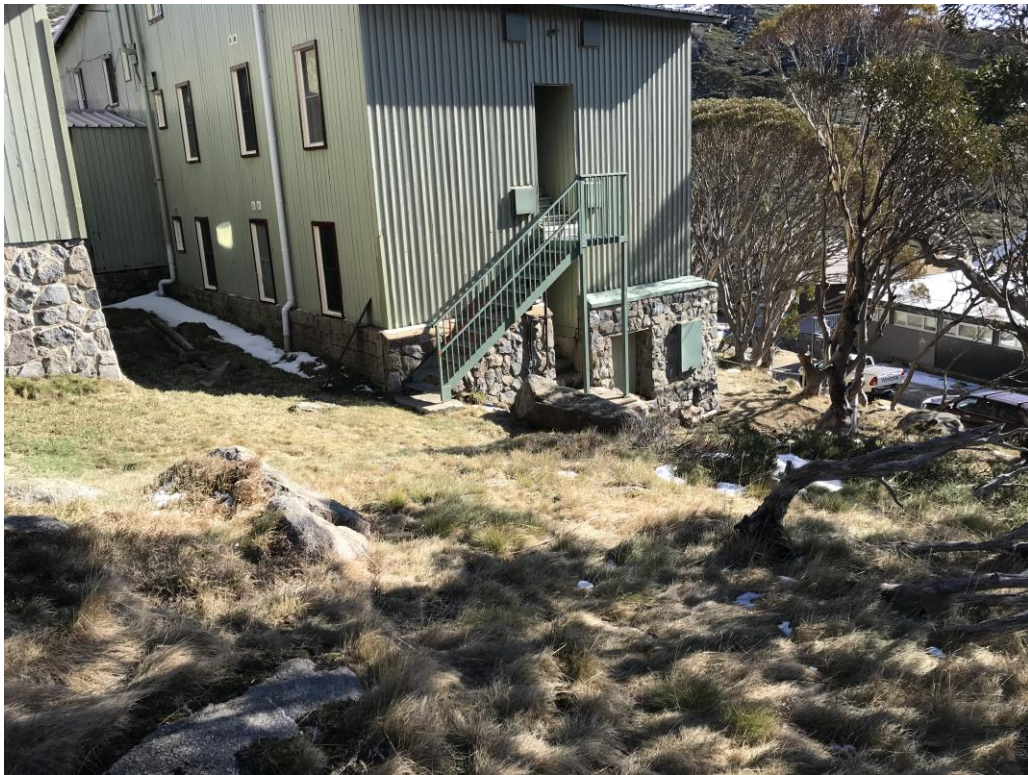
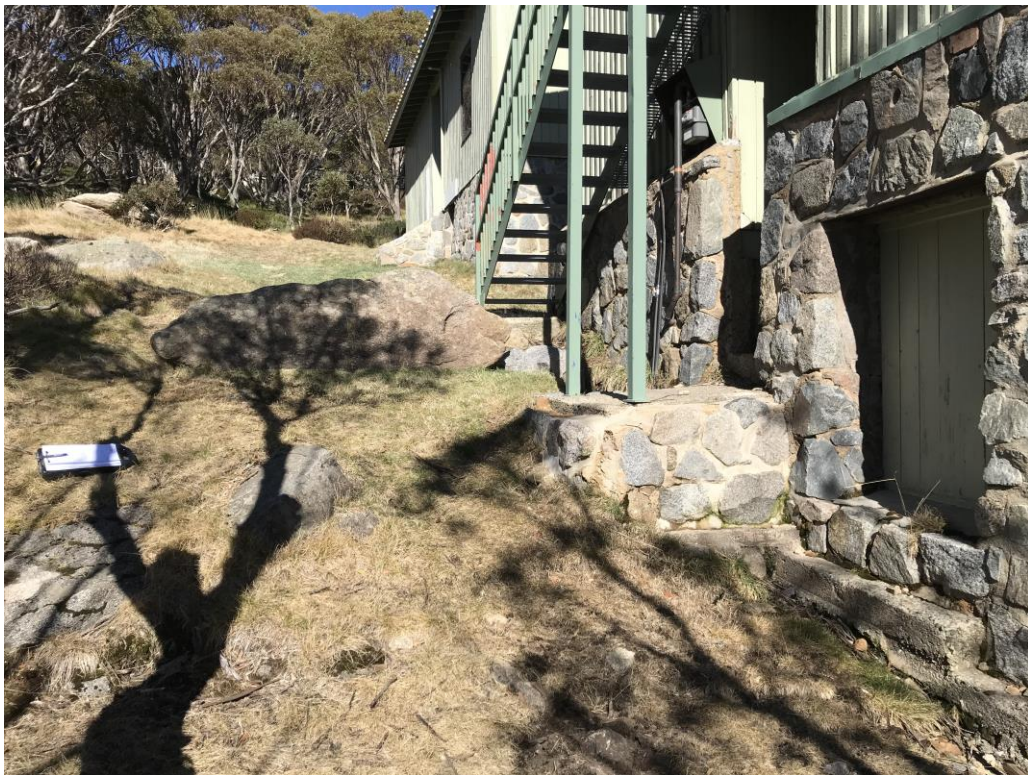
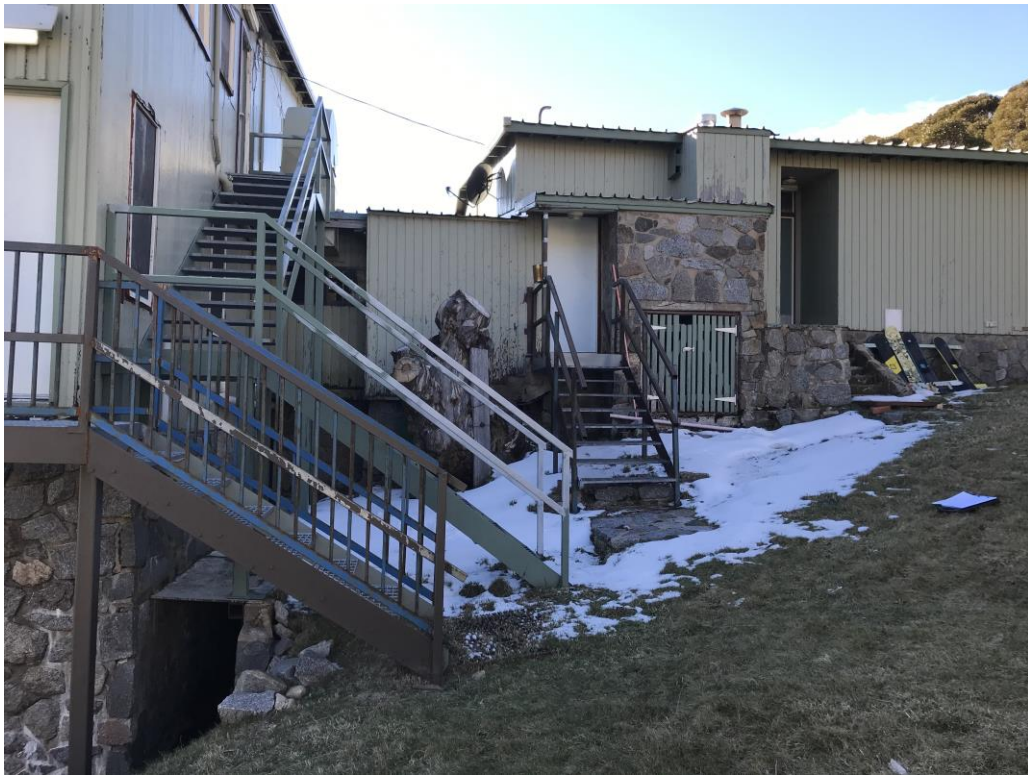
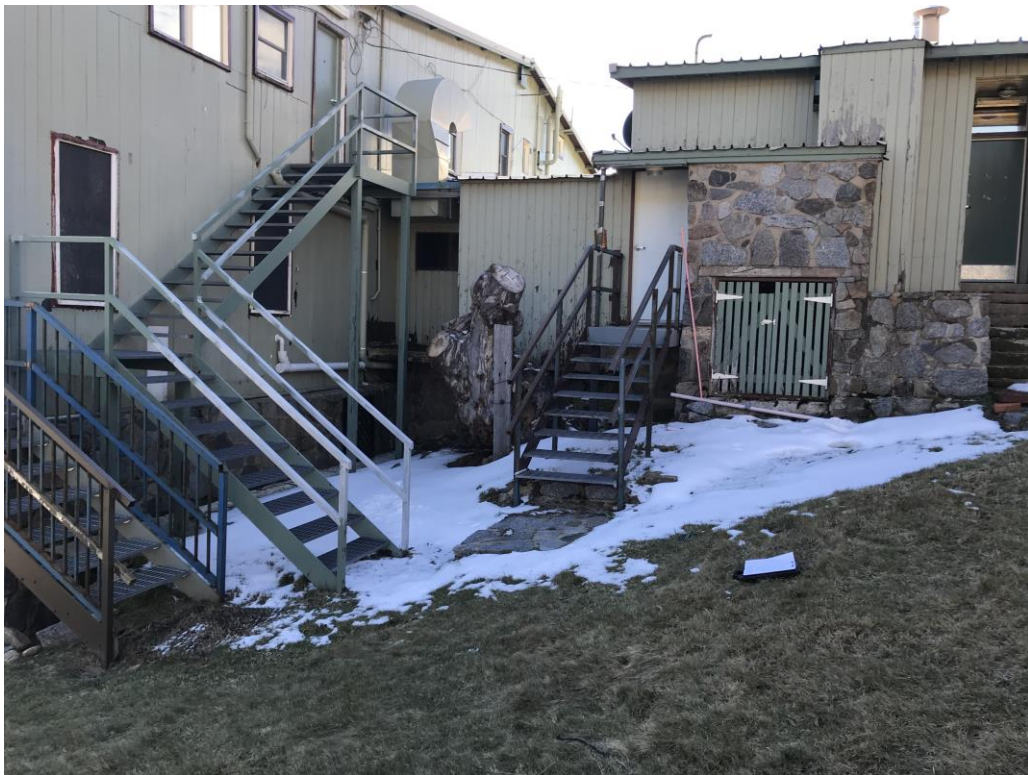
Site Photographs

At the time of DP’s site inspection and subsurface investigation, the existing stairs on both sides of the building and southern parts of the building to be altered were in good condition. Trees located in the surrounding area were generally upright and no signs of deep-seated instability were observed. A stump from a former tree was still present adjacent to (approximately 1 m) the building and planned alterations to the building’s south wall. Surface water run-off from high ground to the east of the lodge was mostly being directed to either side (north and south) of the lodge, however there was some seepage and signs of possible overland flow, particularly during high flow events, that was making its way to the eastern side of the lodge.

- It is also suggested that a more formalised subsoil drain to say 0.6 – 0.8 m depth should be constructed upslope around the eastern side of the lodge to act as a cut-off and reduce groundwater seepages and flows reaching the lodge structure and impacting the proposed works.
