Kooragang Island Billboards

Geotechnical and contamination report

Ooh!Media Pty Limited

9 March 2022

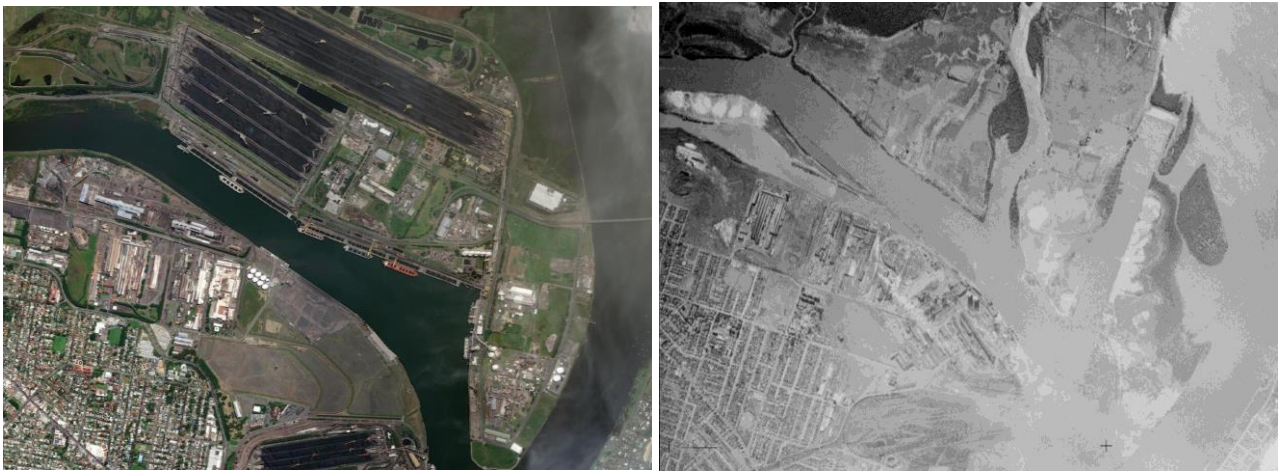
Figure 2.1 Recent (2020) and historic (1958) aerial image, NSW Government

Subsurface conditions at Kooragang typically comprise fill comprising dredged sand with gravel to cobble size waste material (e.g. slag, timber, ballast) overlying natural soils underlying the fill and dredged sand, or at the surface where filling has not occurred, comprise soils of estuarine and marine depositional origin, including soft clays and loose sand, with sand density increasing with depth. Sedimentary bedrock levels vary between 10 m and greater than 50 m.

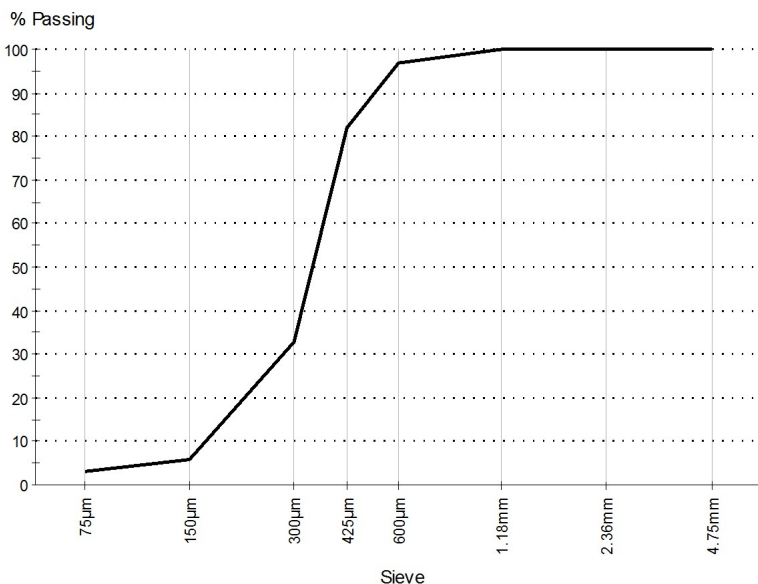
Sieve Size	% Passing	Limits
4.75mm	100	
2.36mm	100	
1.18mm	100	
600µm	97	
425µm	82	
300µm	33	
150µm	6	
75µm	3

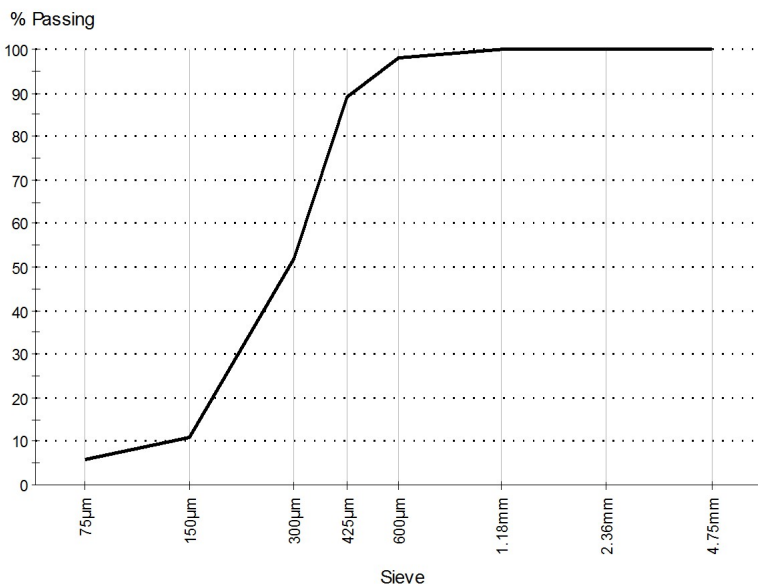
Sieve Size	% Passing	Limits
4.75mm	100	
2.36mm	100	
1.18mm	100	
600µm	98	
425µm	89	
300µm	52	
150µm	11	
75µm	6

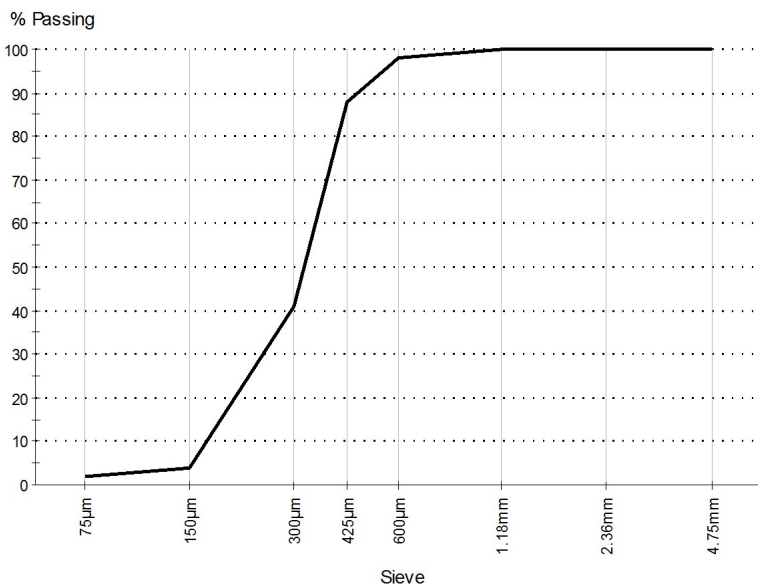
Sieve Size	% Passing	Limits
4.75mm	100	
2.36mm	100	
1.18mm	100	
600µm	98	
425µm	88	
300µm	41	
150µm	4	
75µm	2
