Statement of Environmental Effects

Riverside to Athol Services Connection

Thredbo Alpine Resort
Kosciuszko National Park, NSW

April 2022

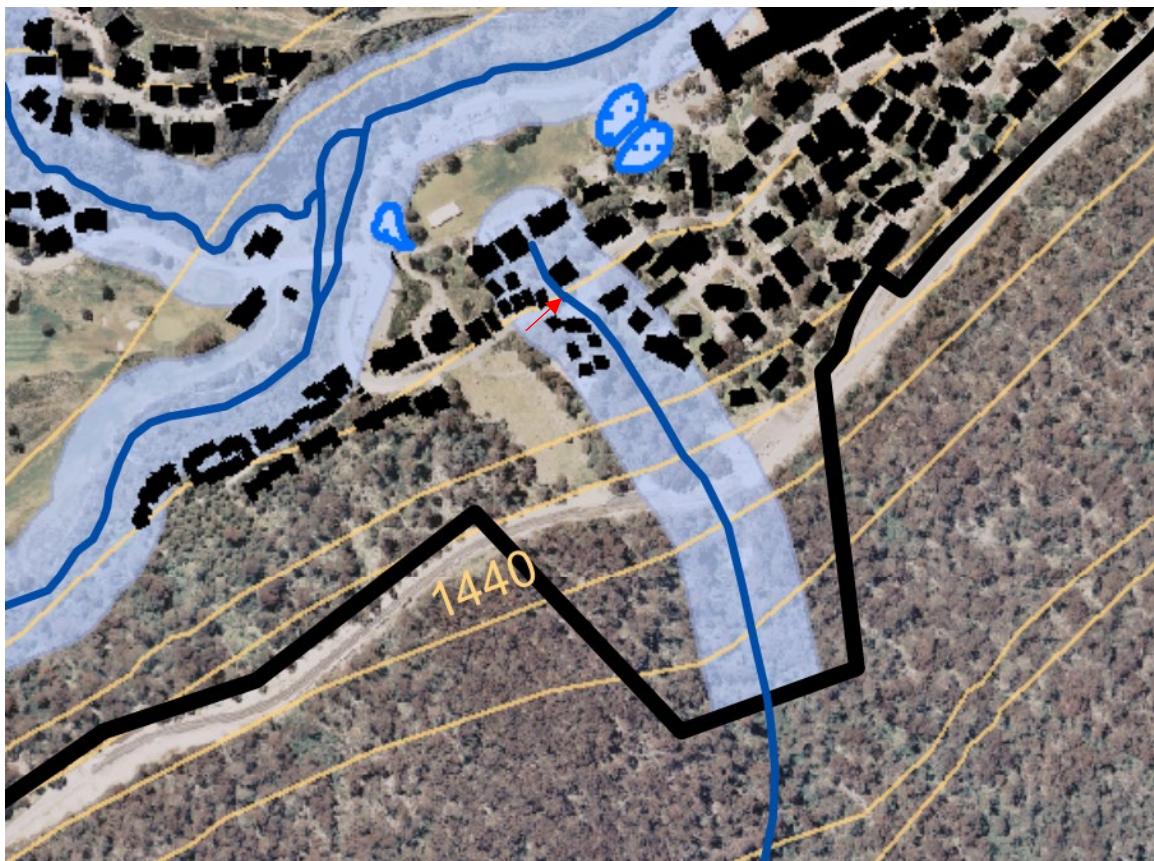
Figure 7: Extract of the Alpine SEPP Thredbo Alpine Resort map (DoP 2006)

Ground-truthing identified the watercourse traverses the site further east which is identified on the Alpine SEPP Thredbo Alpine Resort map (DoP 2006) (**Figure 7**).

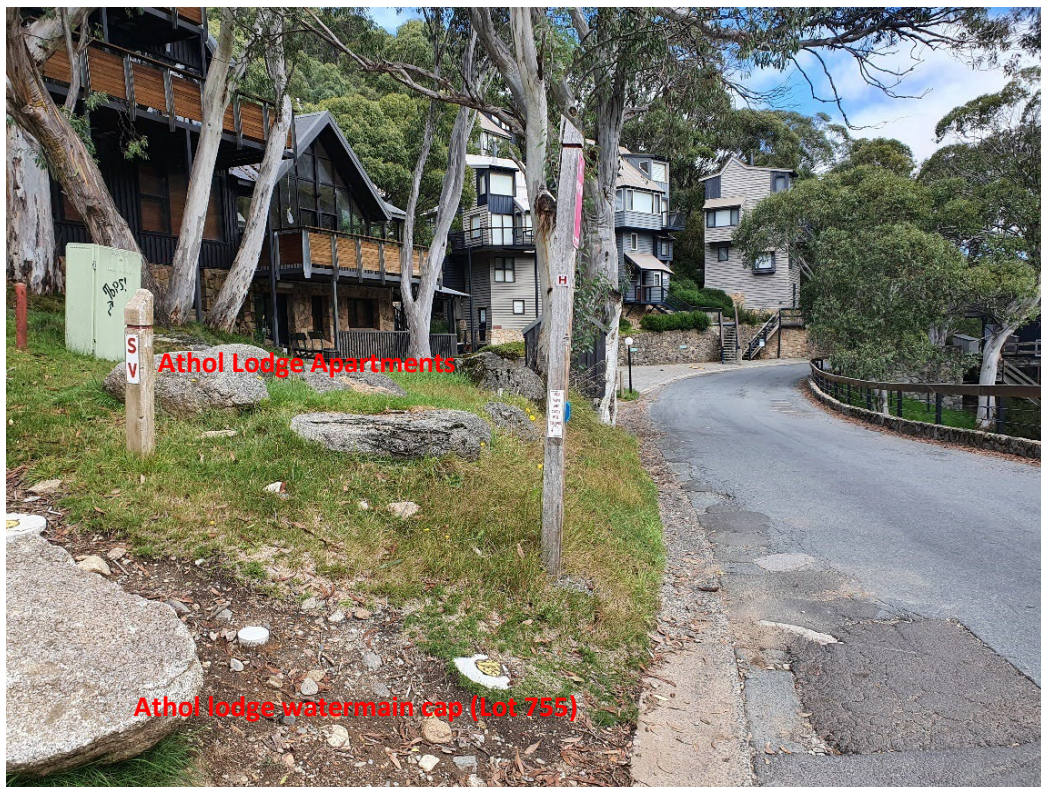
Limit of works – main cap located on Lot 755 (Ramshead Hut)

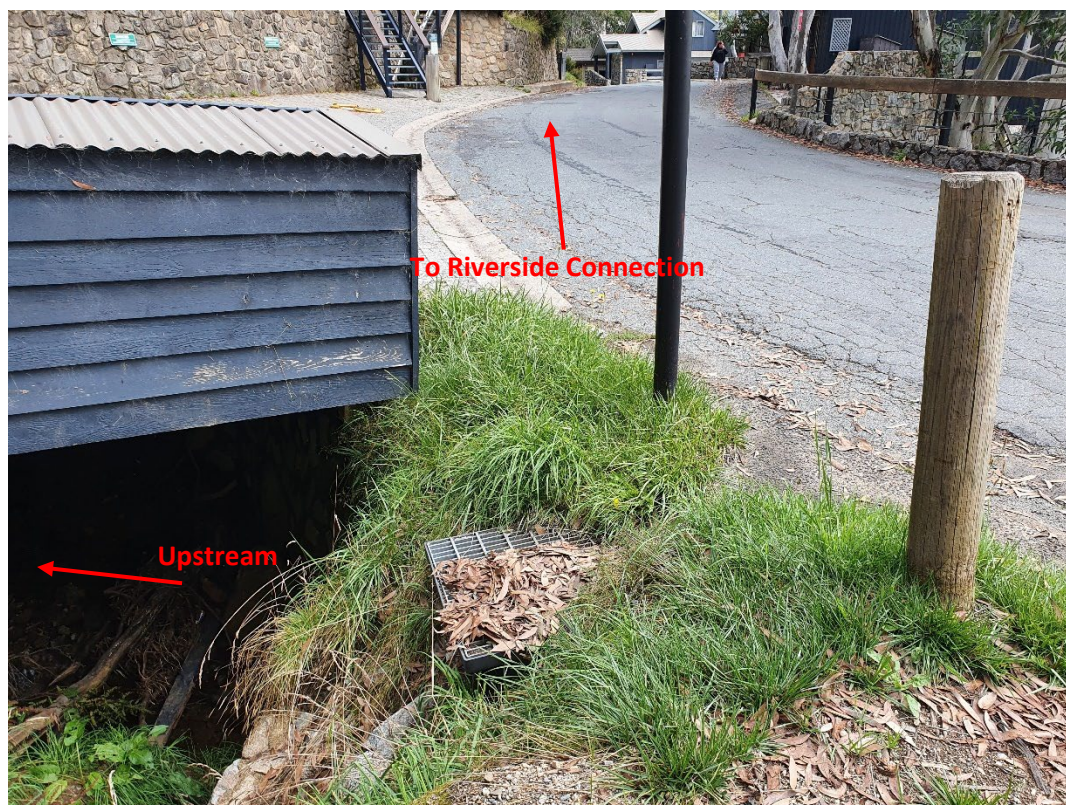
Drop inlet into minor watercourse (runs below Diggings Terrace)

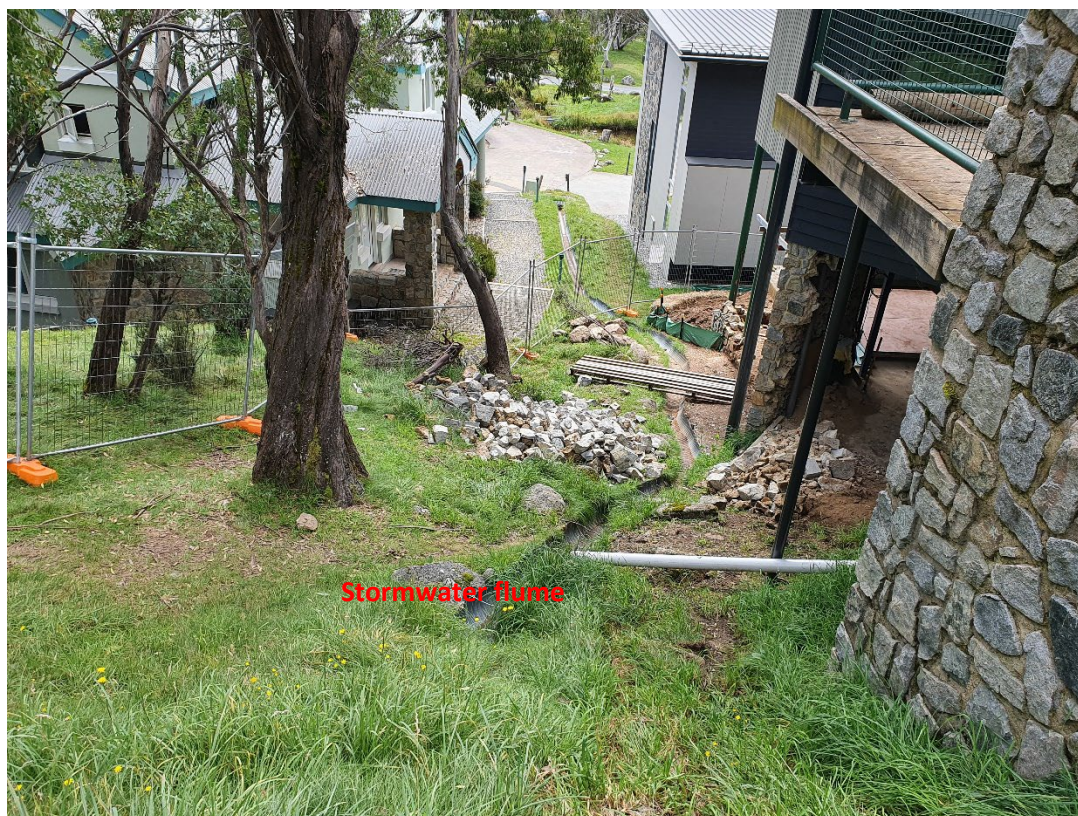
Stormwater outlet/flume below Diggings Terrace (opposite Lot 768/DP1119757)

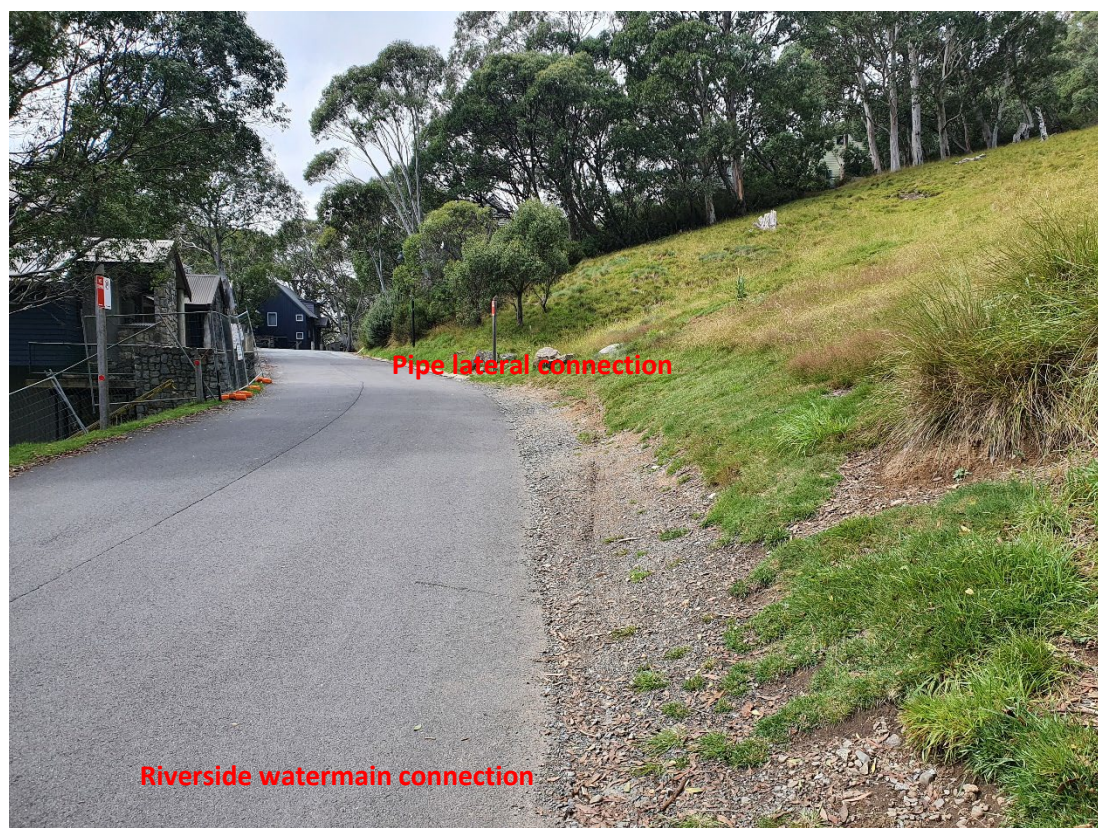
Limit of works – Riverside watermain connection, looking east towards proposed pipe lateral within 768/DP1119757

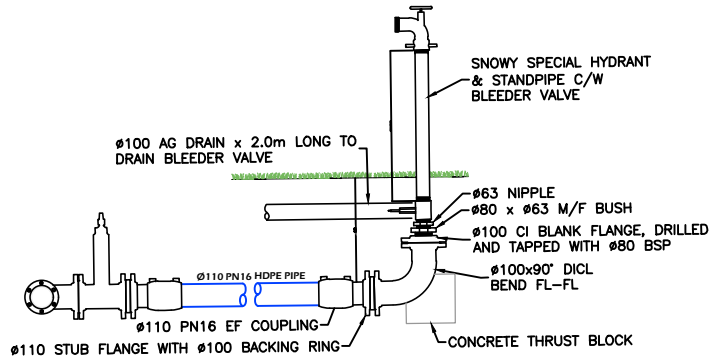
TYPICAL SNOWY SPECIAL HYDRANT DETAIL

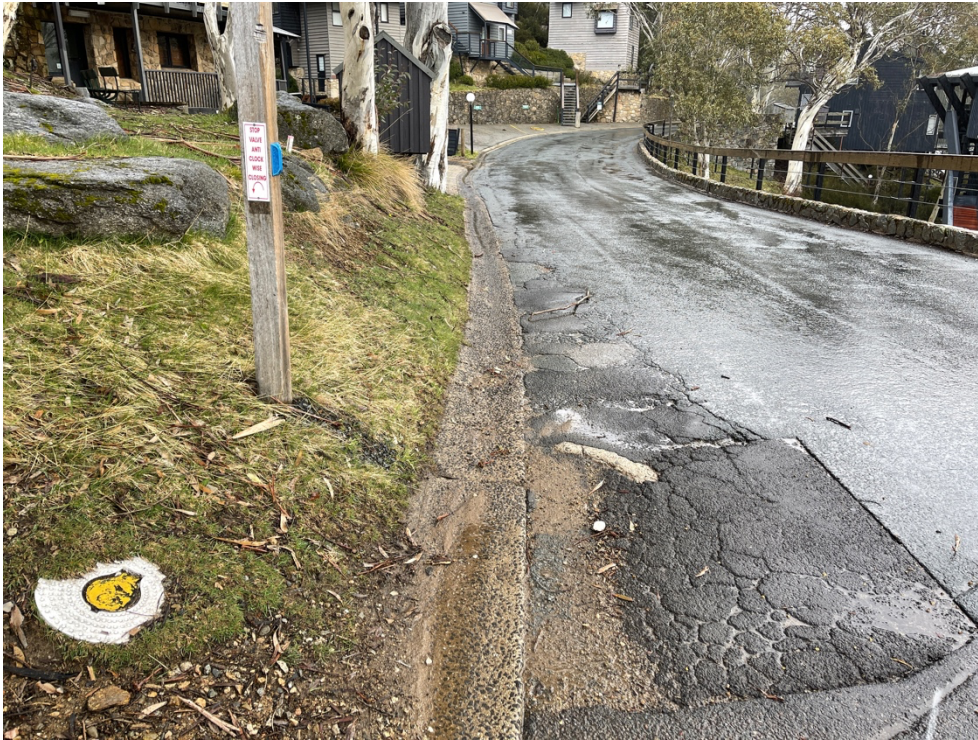
Photo 1 – view of Diggins Terrace along new water main alignment (north-eastern end, looking south-west).

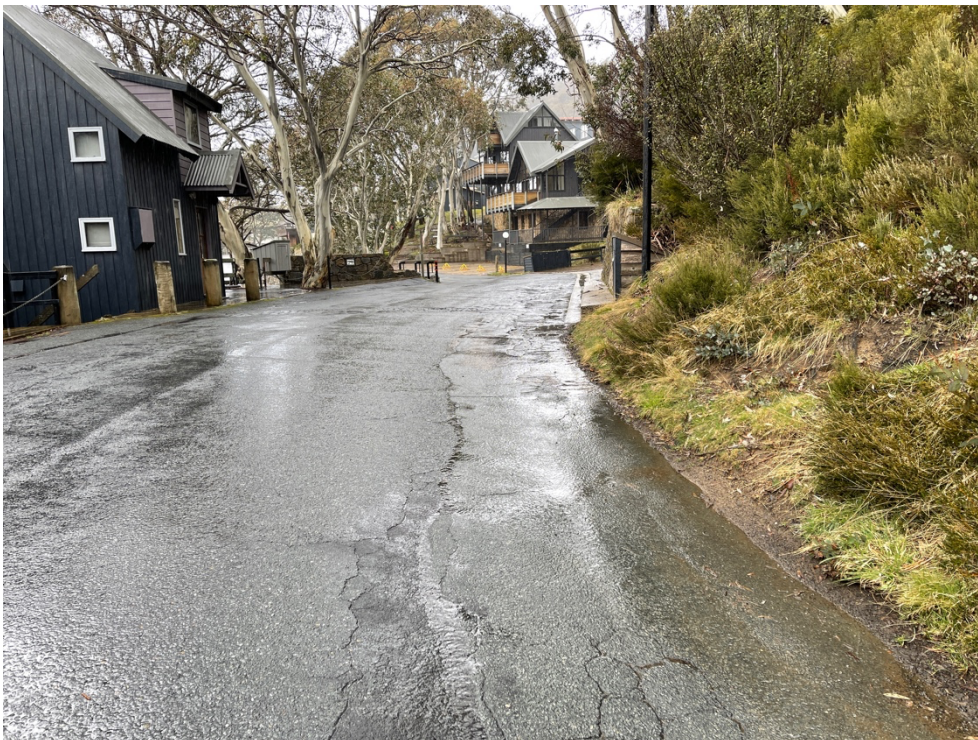
Photo 2 – view of Diggins Terrace along new water main alignment (approx. mid-way, looking north-east).

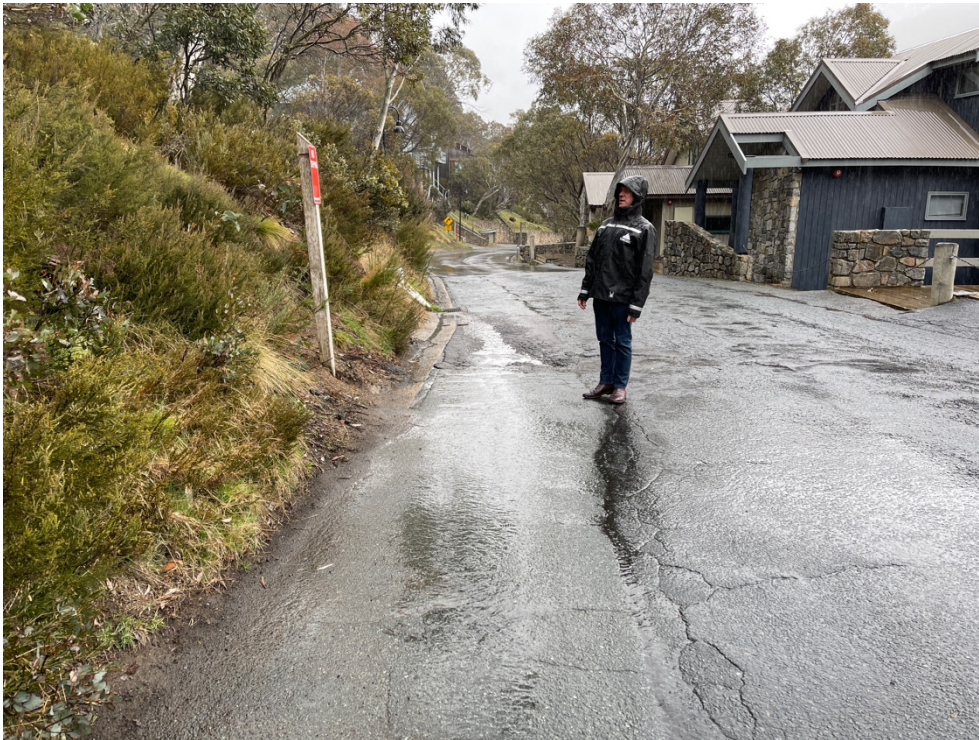
Photo 3 – view of Diggins Terrace along new water main alignment (approx. mid-way, looking south-west).

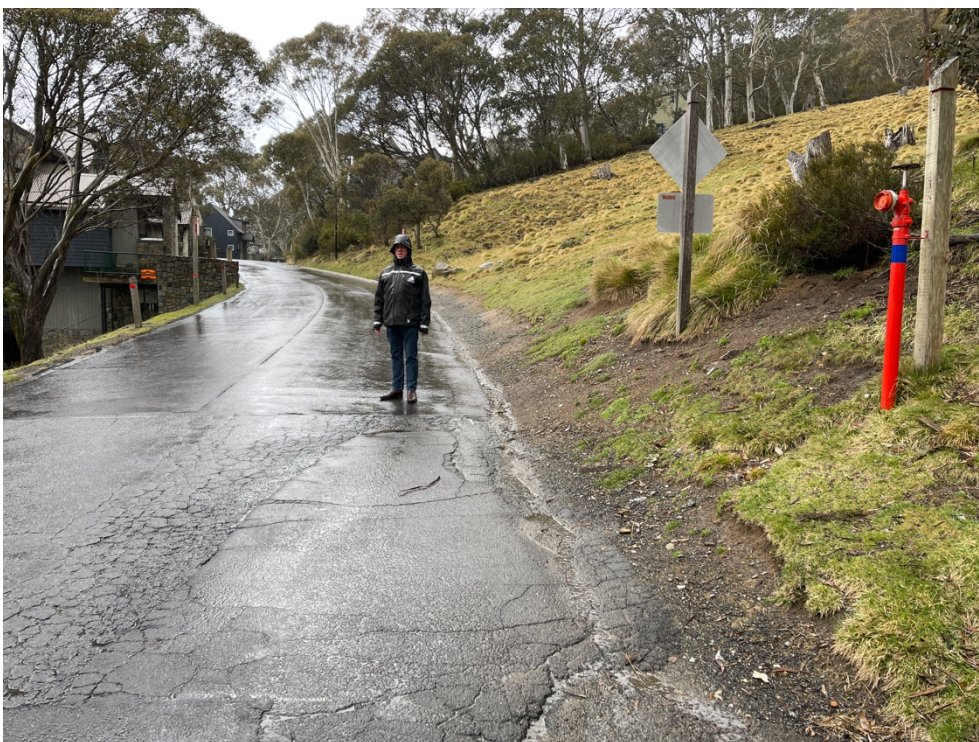
Photo 4 – view of Diggins Terrace along new water main alignment (at south-west end looking north-east).
