# Statement of Environmental Effects

## Riverside to Athol Services Connection

Thredbo Alpine Resort  
Kosciuszko National Park, NSW

**Kosciuszko Thredbo Pty Ltd**

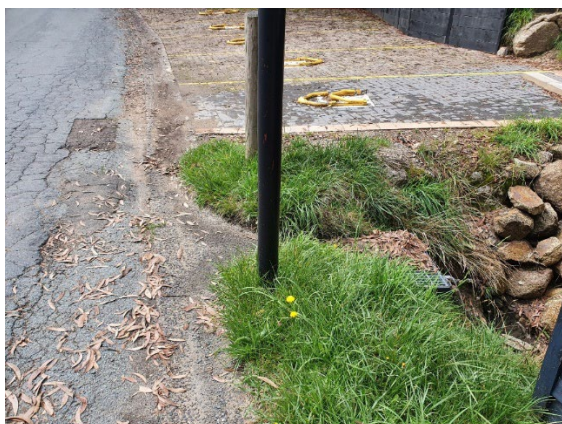
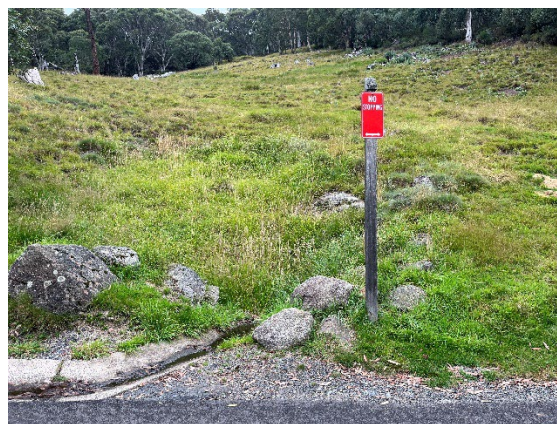
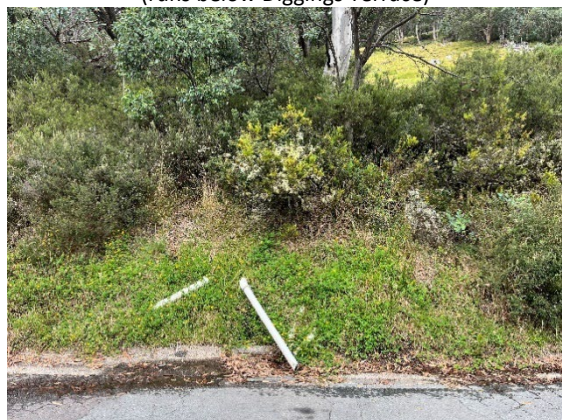
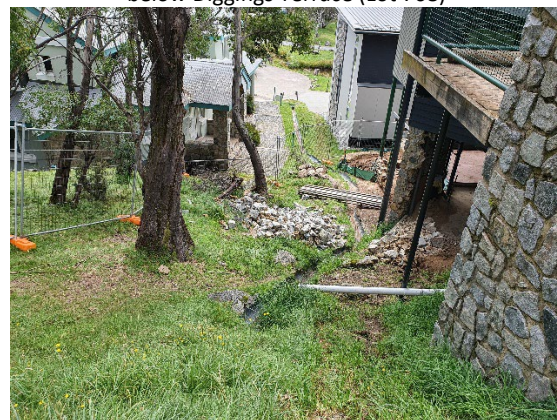
**Figure 4: Existing Drainage within/adjacent to site**

- concrete v-drain running parallel to Diggings Terrace;
- two (2) drop inlets; and
- stormwater flume (predominately open corrugated pipe).

Photo A: V-drain alongside road leading into drop inlet (runs below Diggings Terrace)

Photo B: V-drain leading into stormwater inlet/pipe runs below Diggings Terrace (Lot 768)

Photo C: Drop inlet drain (Lot 768)

Photo D: Stormwater outlet/flume (opposite Lot 768)

No adverse impacts to existing drainage are anticipated from the Project. Appropriate environmental controls will be implemented during construction in accordance with the SEMP (**Appendix C**).

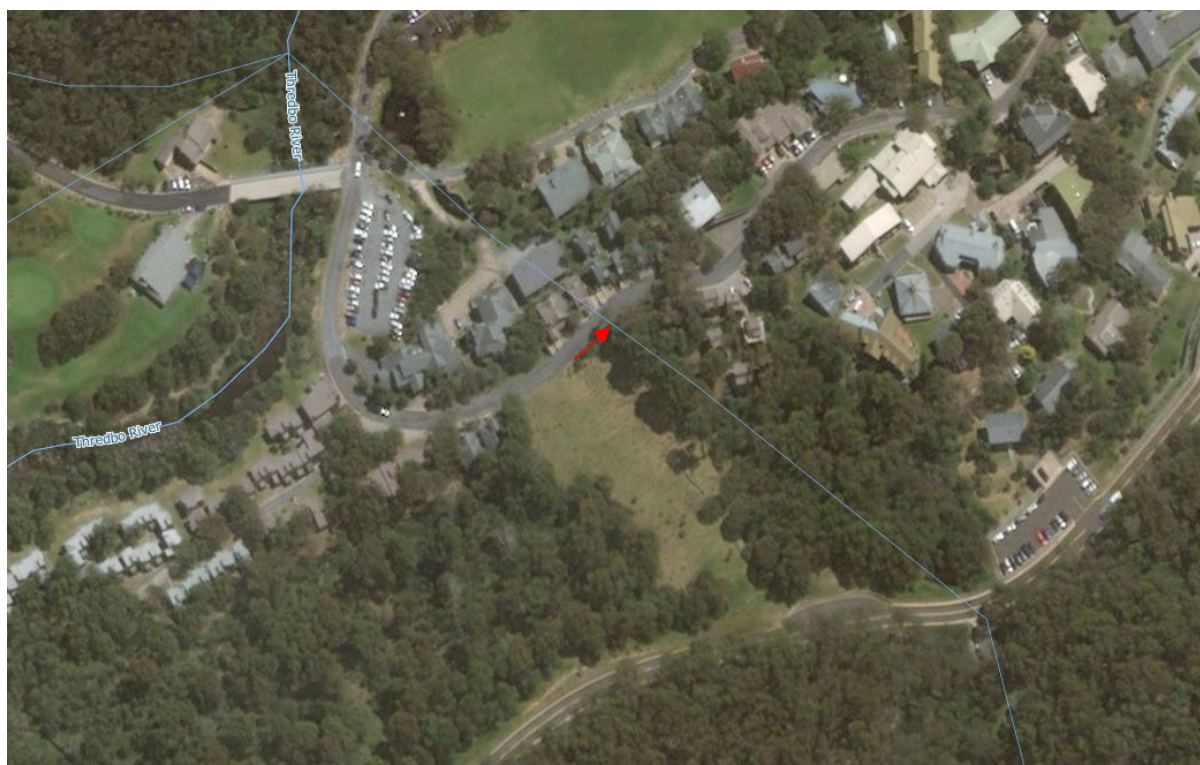
**Figure 5: WM (General) Regulation hydroline spatial data 1.0 (Source: NSW Government 2022a)**

A watercourse line is mapped within the Project site (traversing Lot 768/Diggings Terrace) on the *WM (General) Regulation hydroline spatial data 1.0* map (refer **Figure 5**). Ground-truthing of this mapped watercourse identified the section of the watercourse which traverses Diggings Terrace outside Lot 768 does not exhibit the features of a defined channel with bed and banks, as shown on **Figure 6**. Two (2) stormwater inlets/drainage are located in close proximity of the mapped watercourse line at this location.

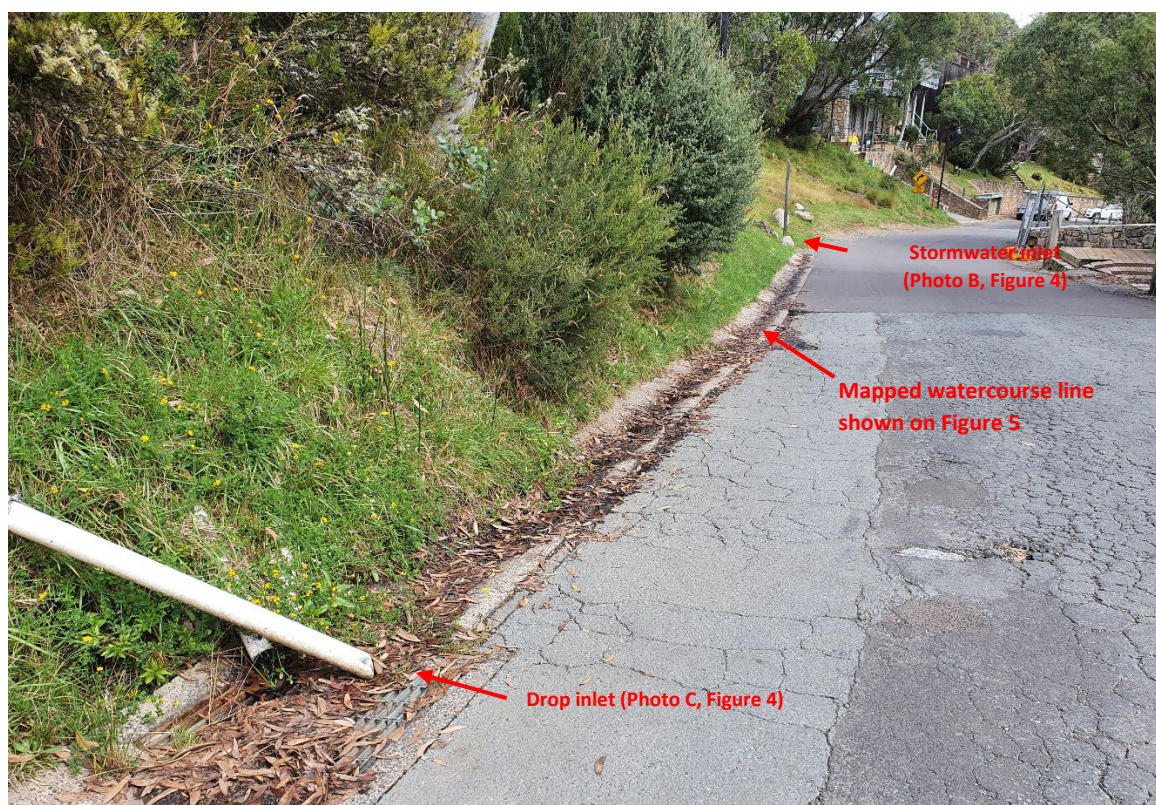
**Figure 6: Field Verification of Mapped Watercourse**

Ground-truthing identified the watercourse traverses the site further east which is identified on the Alpine SEPP Thredbo Alpine Resort map (DoP 2006) (**Figure 7**).

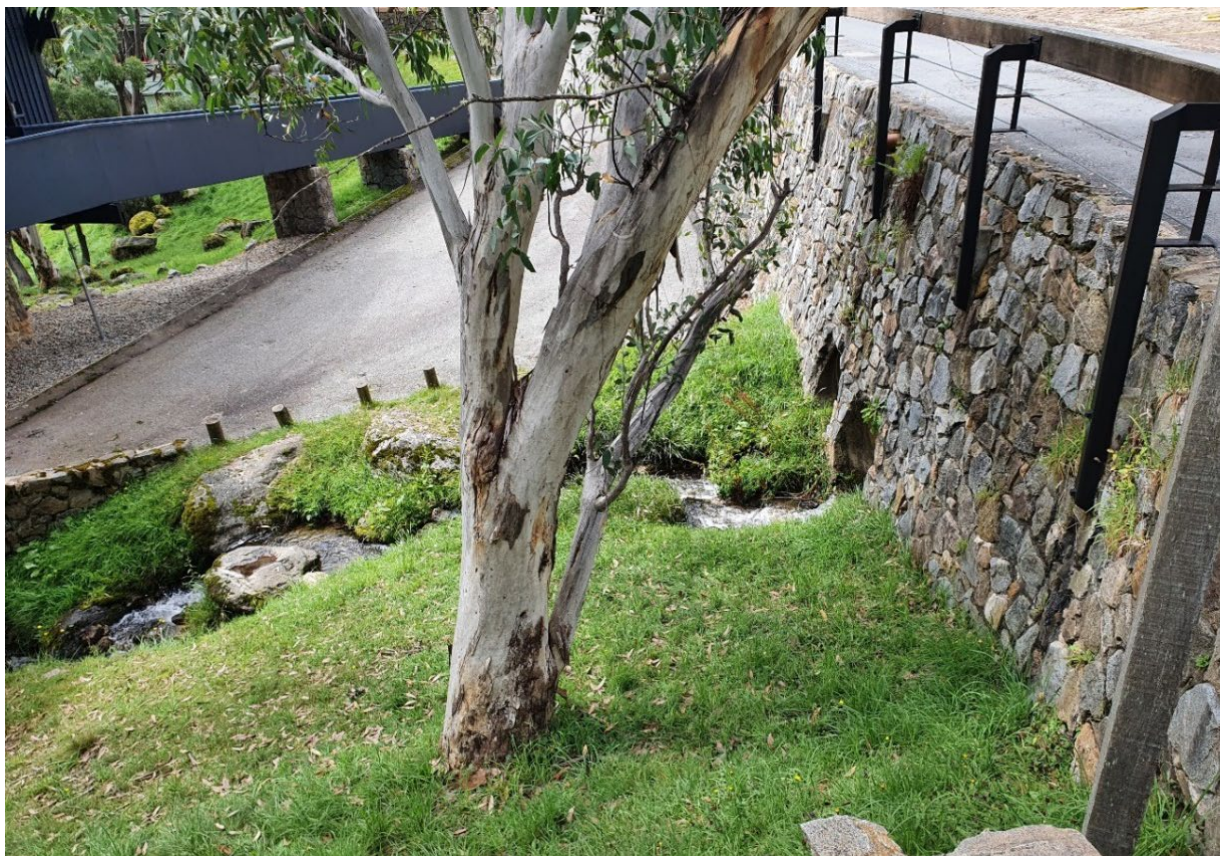
**Figure 8: Downstream of minor watercourse (first order stream)**

This watercourse is a first order stream as defined under the Strahler System (Schedule 2 of the WM (General) Regulation). The minor watercourse runs below Diggings Terrace, via two concrete lined culverts (refer **Figure 8** and **Figure 9**). No impacts to the minor watercourse are anticipated given the following:

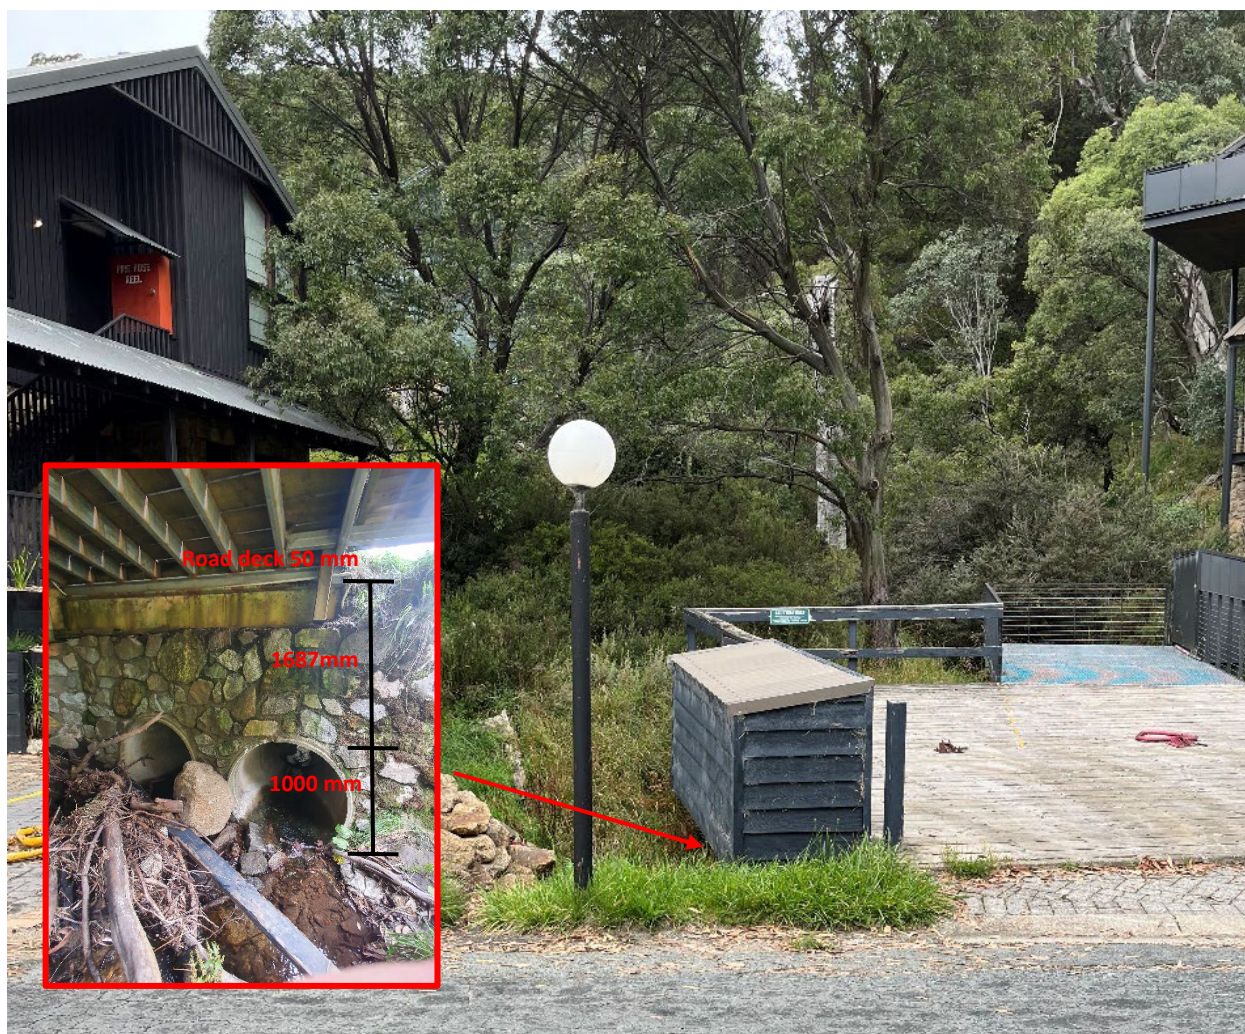
Figure 9: Upstream of minor watercourse (first order stream)

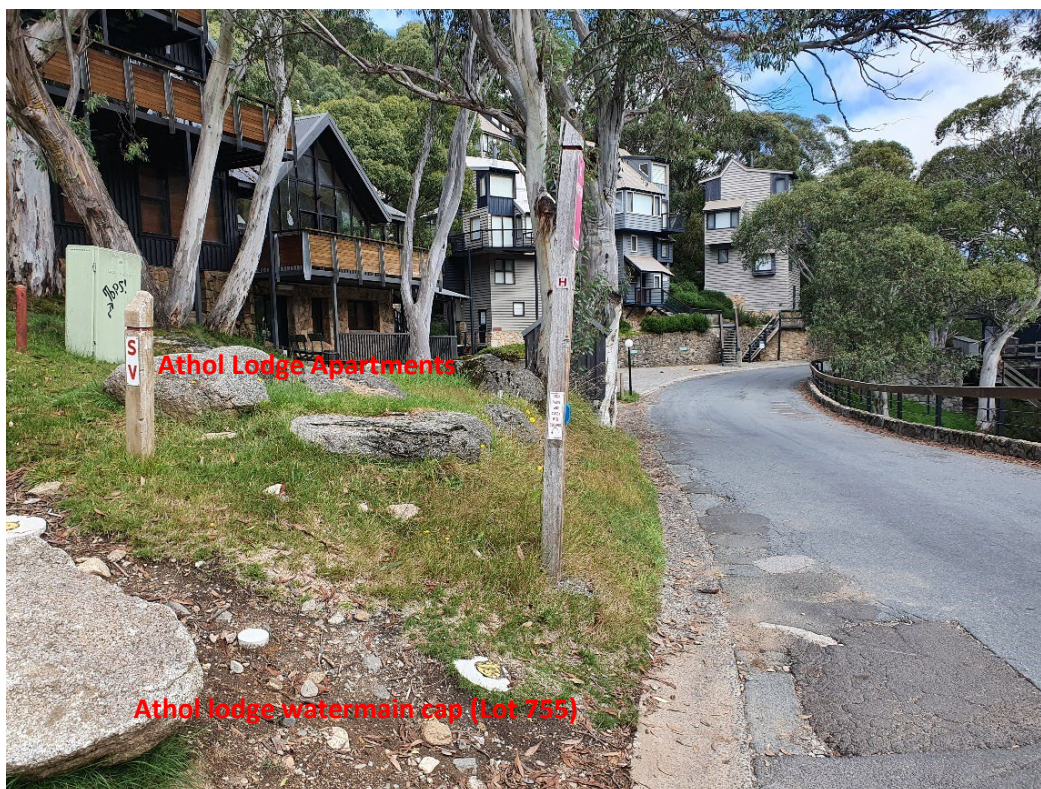
Limit of works – main cap located on Lot 755 (Ramshead Hut)

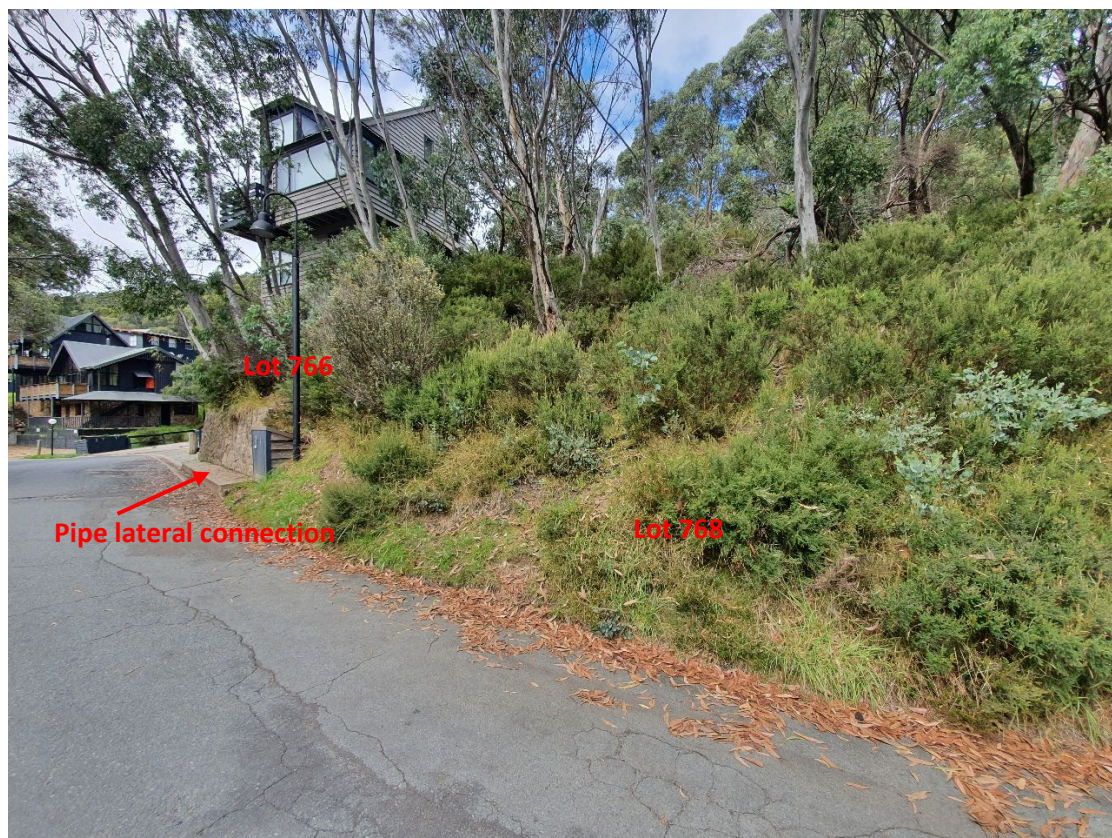
**Proposed pipe lateral connection outside Lot 766/DP1119757**

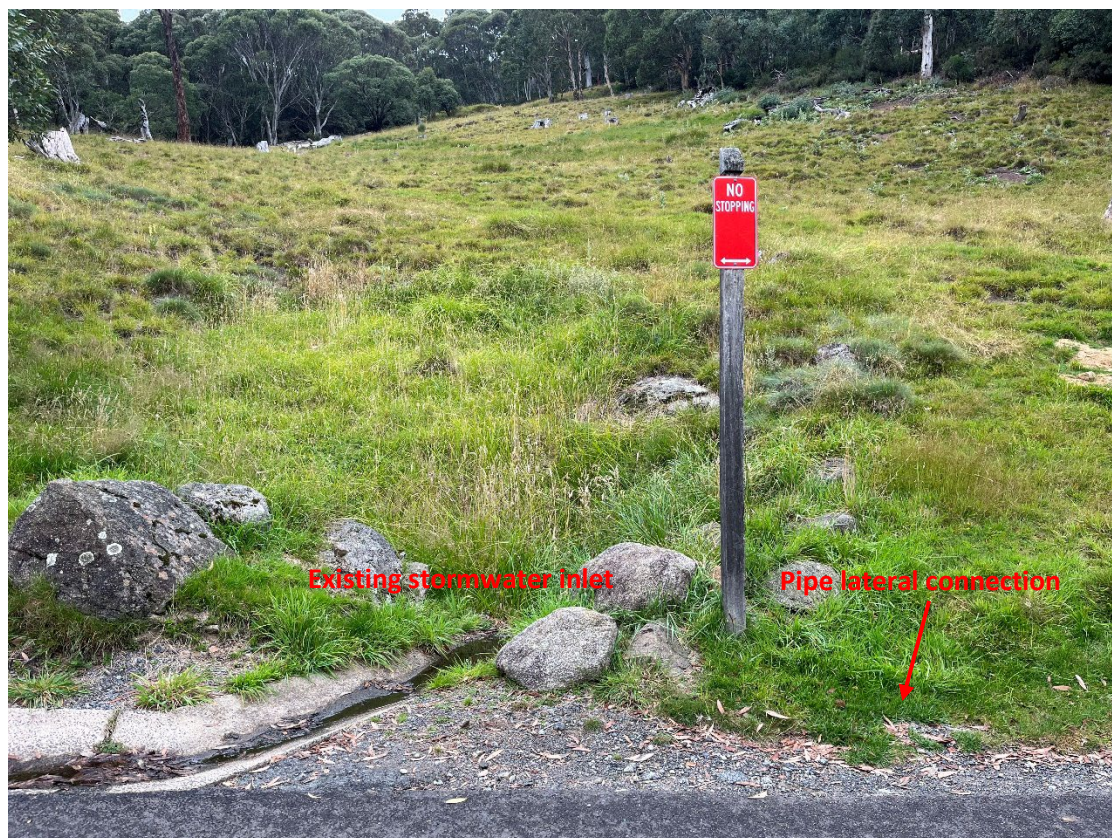
**Existing stormwater inlet and proposed pipe lateral connection within Lot 768/DP1119757**

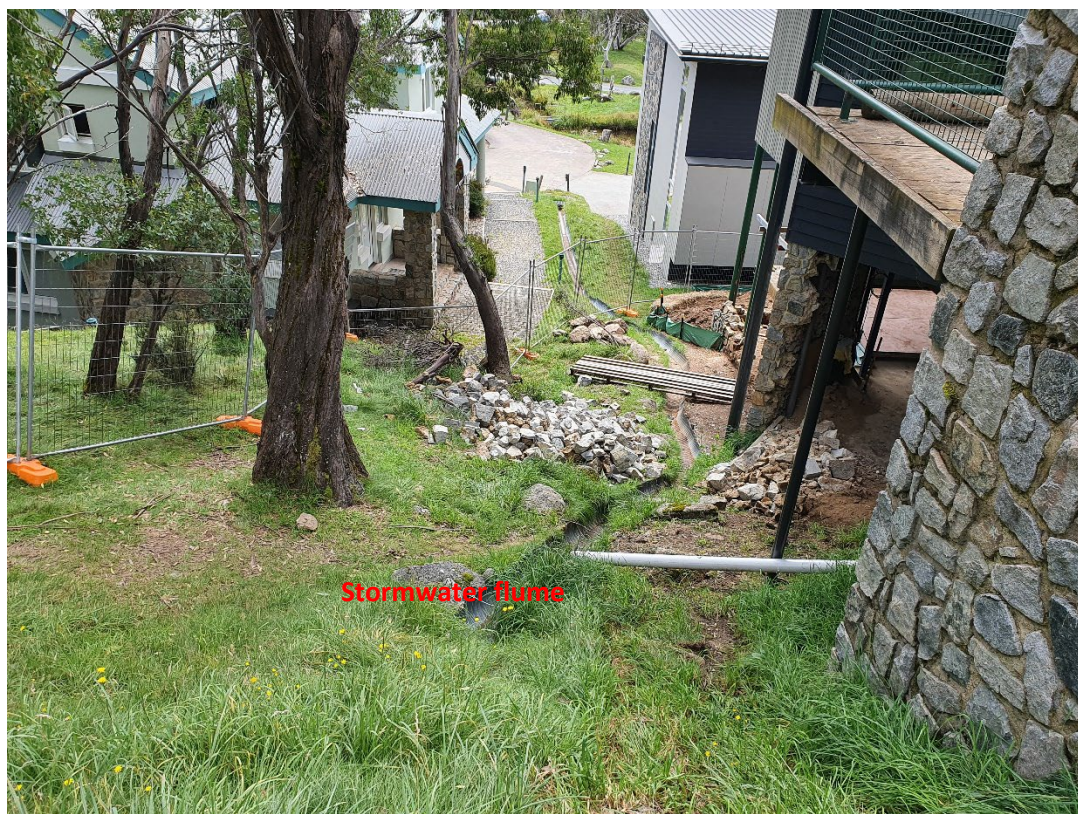
**Stormwater outlet/flume below Diggings Terrace (opposite Lot 768/DP1119757)**

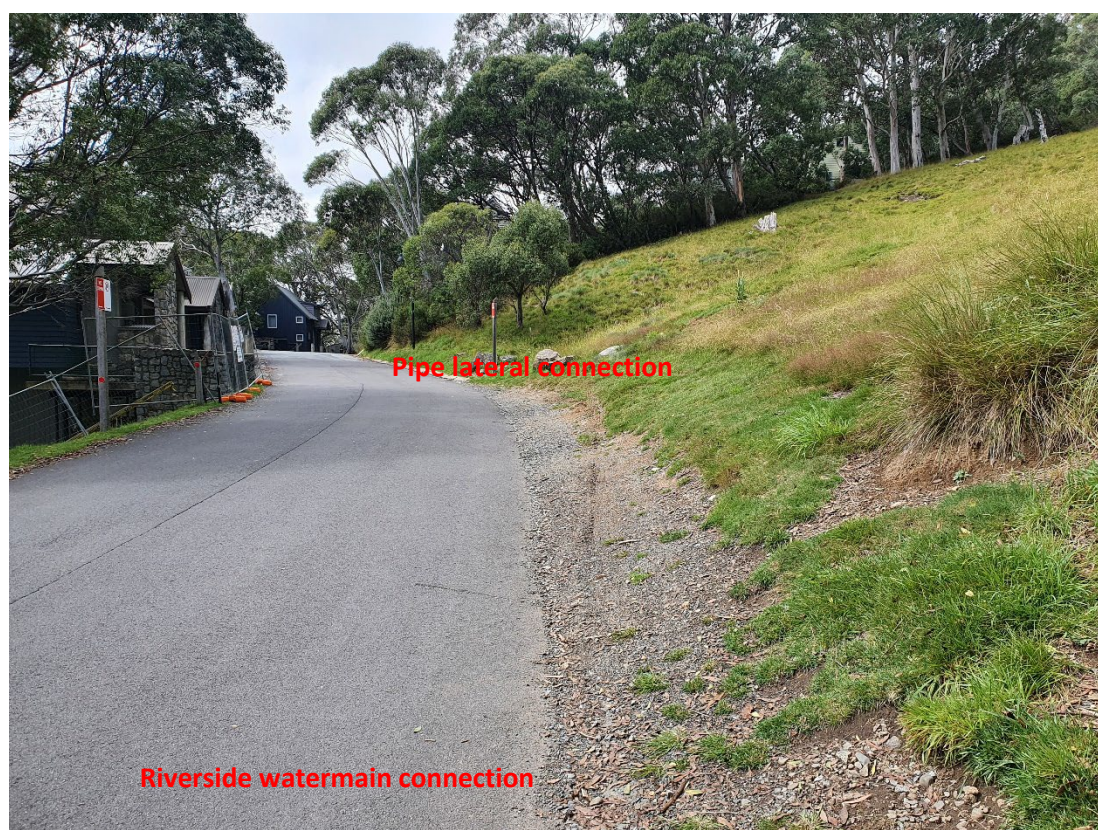
**Limit of works – Riverside watermain connection, looking east towards proposed pipe lateral within 768/DP1119757**
