### GEOTECHNICAL ASSESSMENT (RCA AUSTRALIA)

RCA ref 16035-201/0  
Client ref WO13822

**GEOTECHNICAL INVESTIGATION  
CARRINGTON HYDRAULIC ENGINE HOUSE  
106 BOURKE STREET, CARRINGTON**

**TEST LOCATION PLAN**  
**106 BOURKE STREET**  
**CARRINGTON**

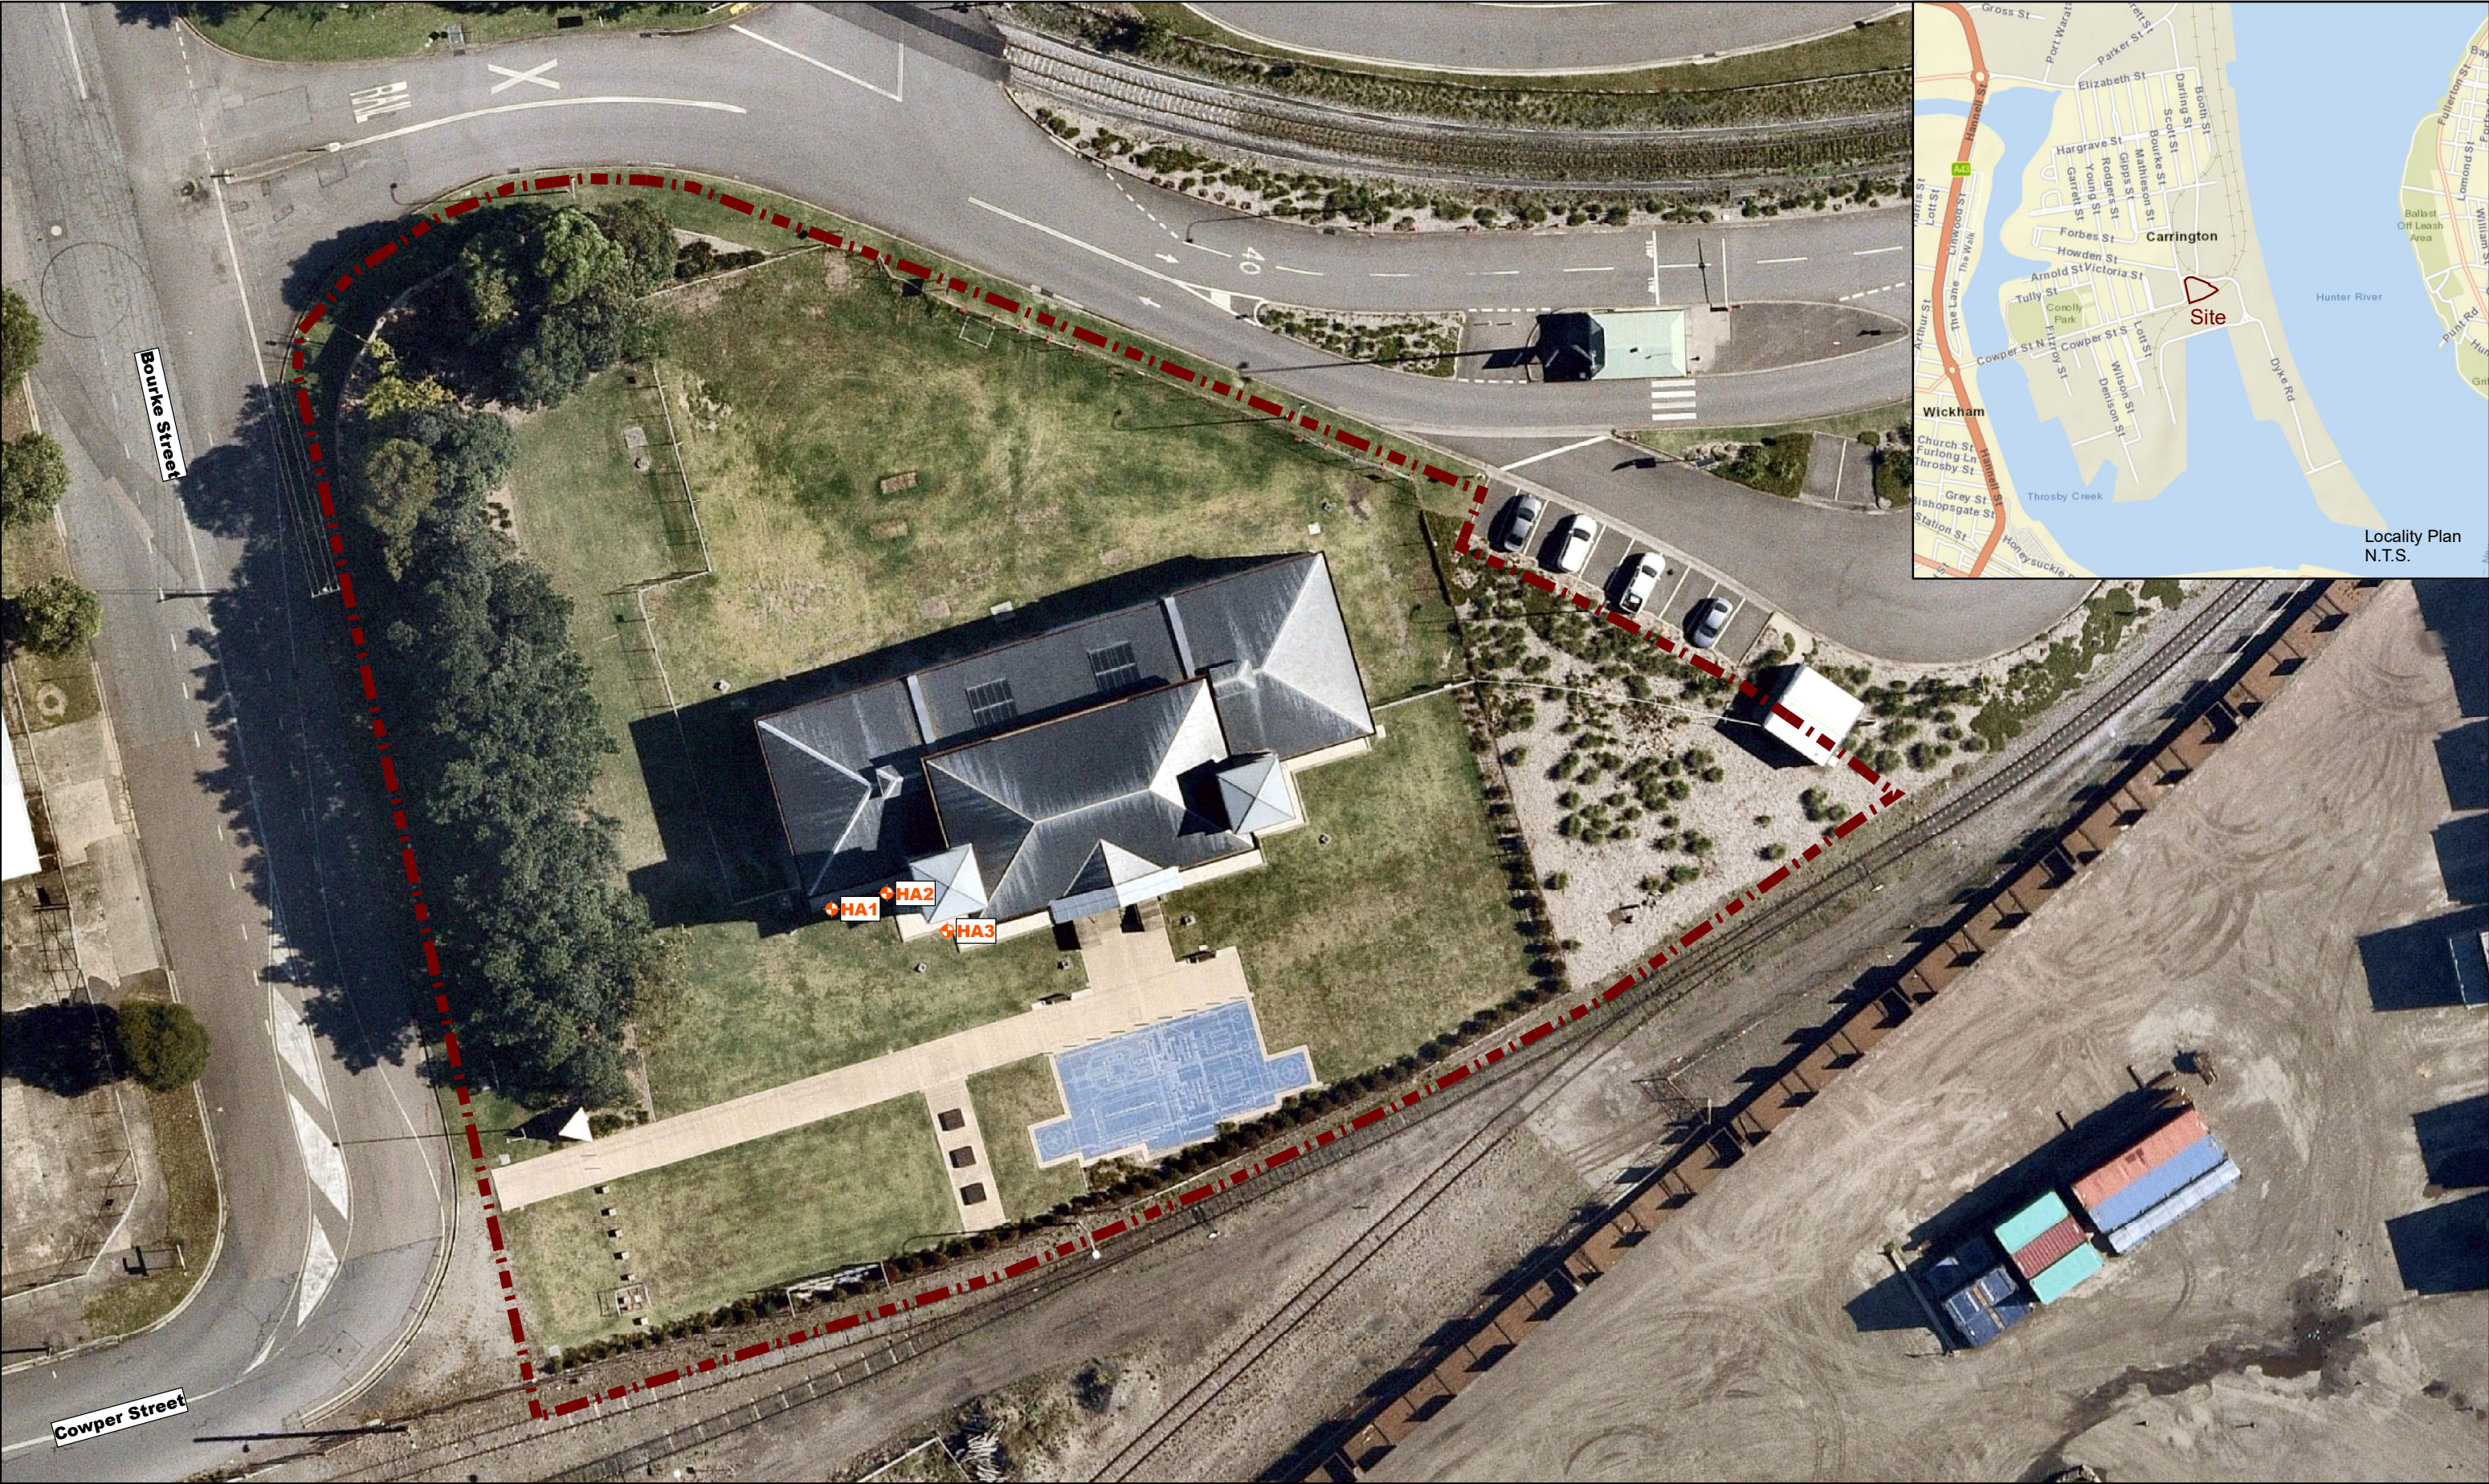
Drawing 1 - Test Location Plan

- Hand auger boreholes at three locations shown on the attached **Drawing 1** to depths of up to 0.8m.
- Dynamic cone penetrometer (DCP) tests at the hand auger borehole locations to depths of up to 1.3m.

Approximate borehole location
