Samantha Walsh  
Shoalhaven City Council  
Shoalhaven Heads, NSW 2535

18<sup>th</sup> July 2019  
Project No: ENRS0627

**SUBJECT: POTENTIAL ACID SULFATE SOIL ASSESSMENT (PASSA)  
RIVER ROAD FORESHORE, SHOALHAVEN HEADS, NSW 2535**

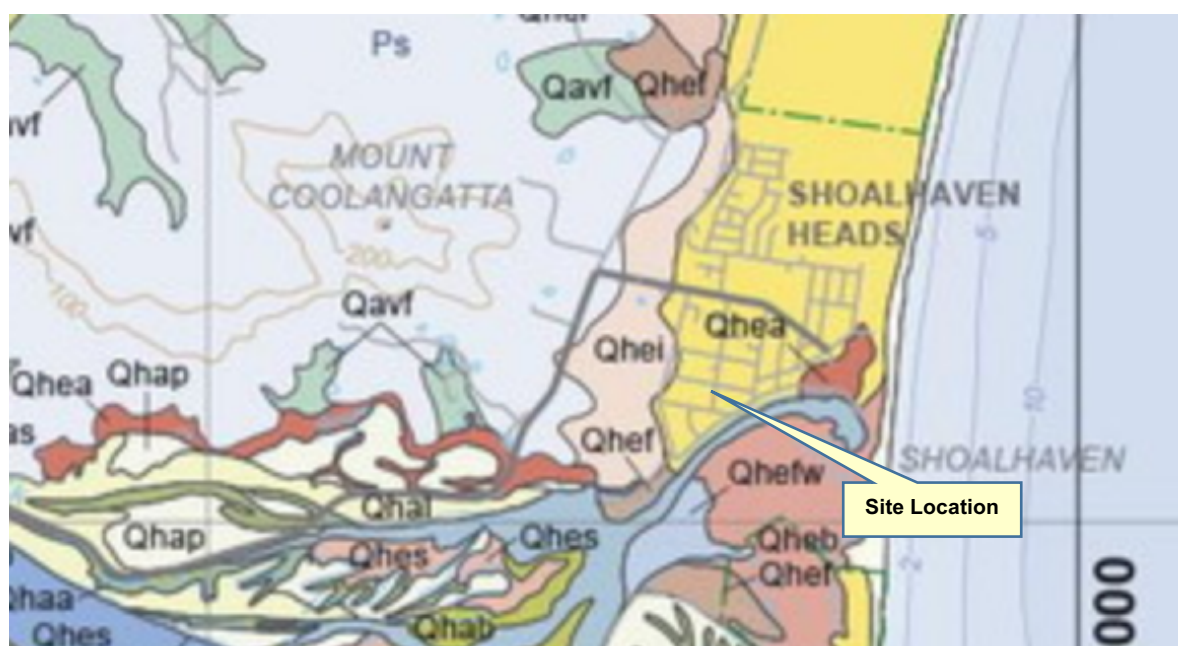
### Figure 1 Site Geology and Soil Landscape

A review of the geological setting was conducted with reference to the Nowra 1:25,000 Coastal Quaternary Geology Sheet as shown in **Figure 1**. The Site area is situated in an area mapped as Holocene beach ridge and associated strandplain (Qhbr - yellow) described as marine sand, shell and gravel.

ENRS note that although *Shoalhaven City Council* identified a maximum excavation depth of 2.5m below ground level, boreholes were terminated at 1.5m due to the homogenous ground conditions observed which corresponded with the Site geology identified in **Figure 1**. ENRS recommend that the findings of this PASSA be considered representative of ground conditions likely to be encountered during the proposed works within the Site.

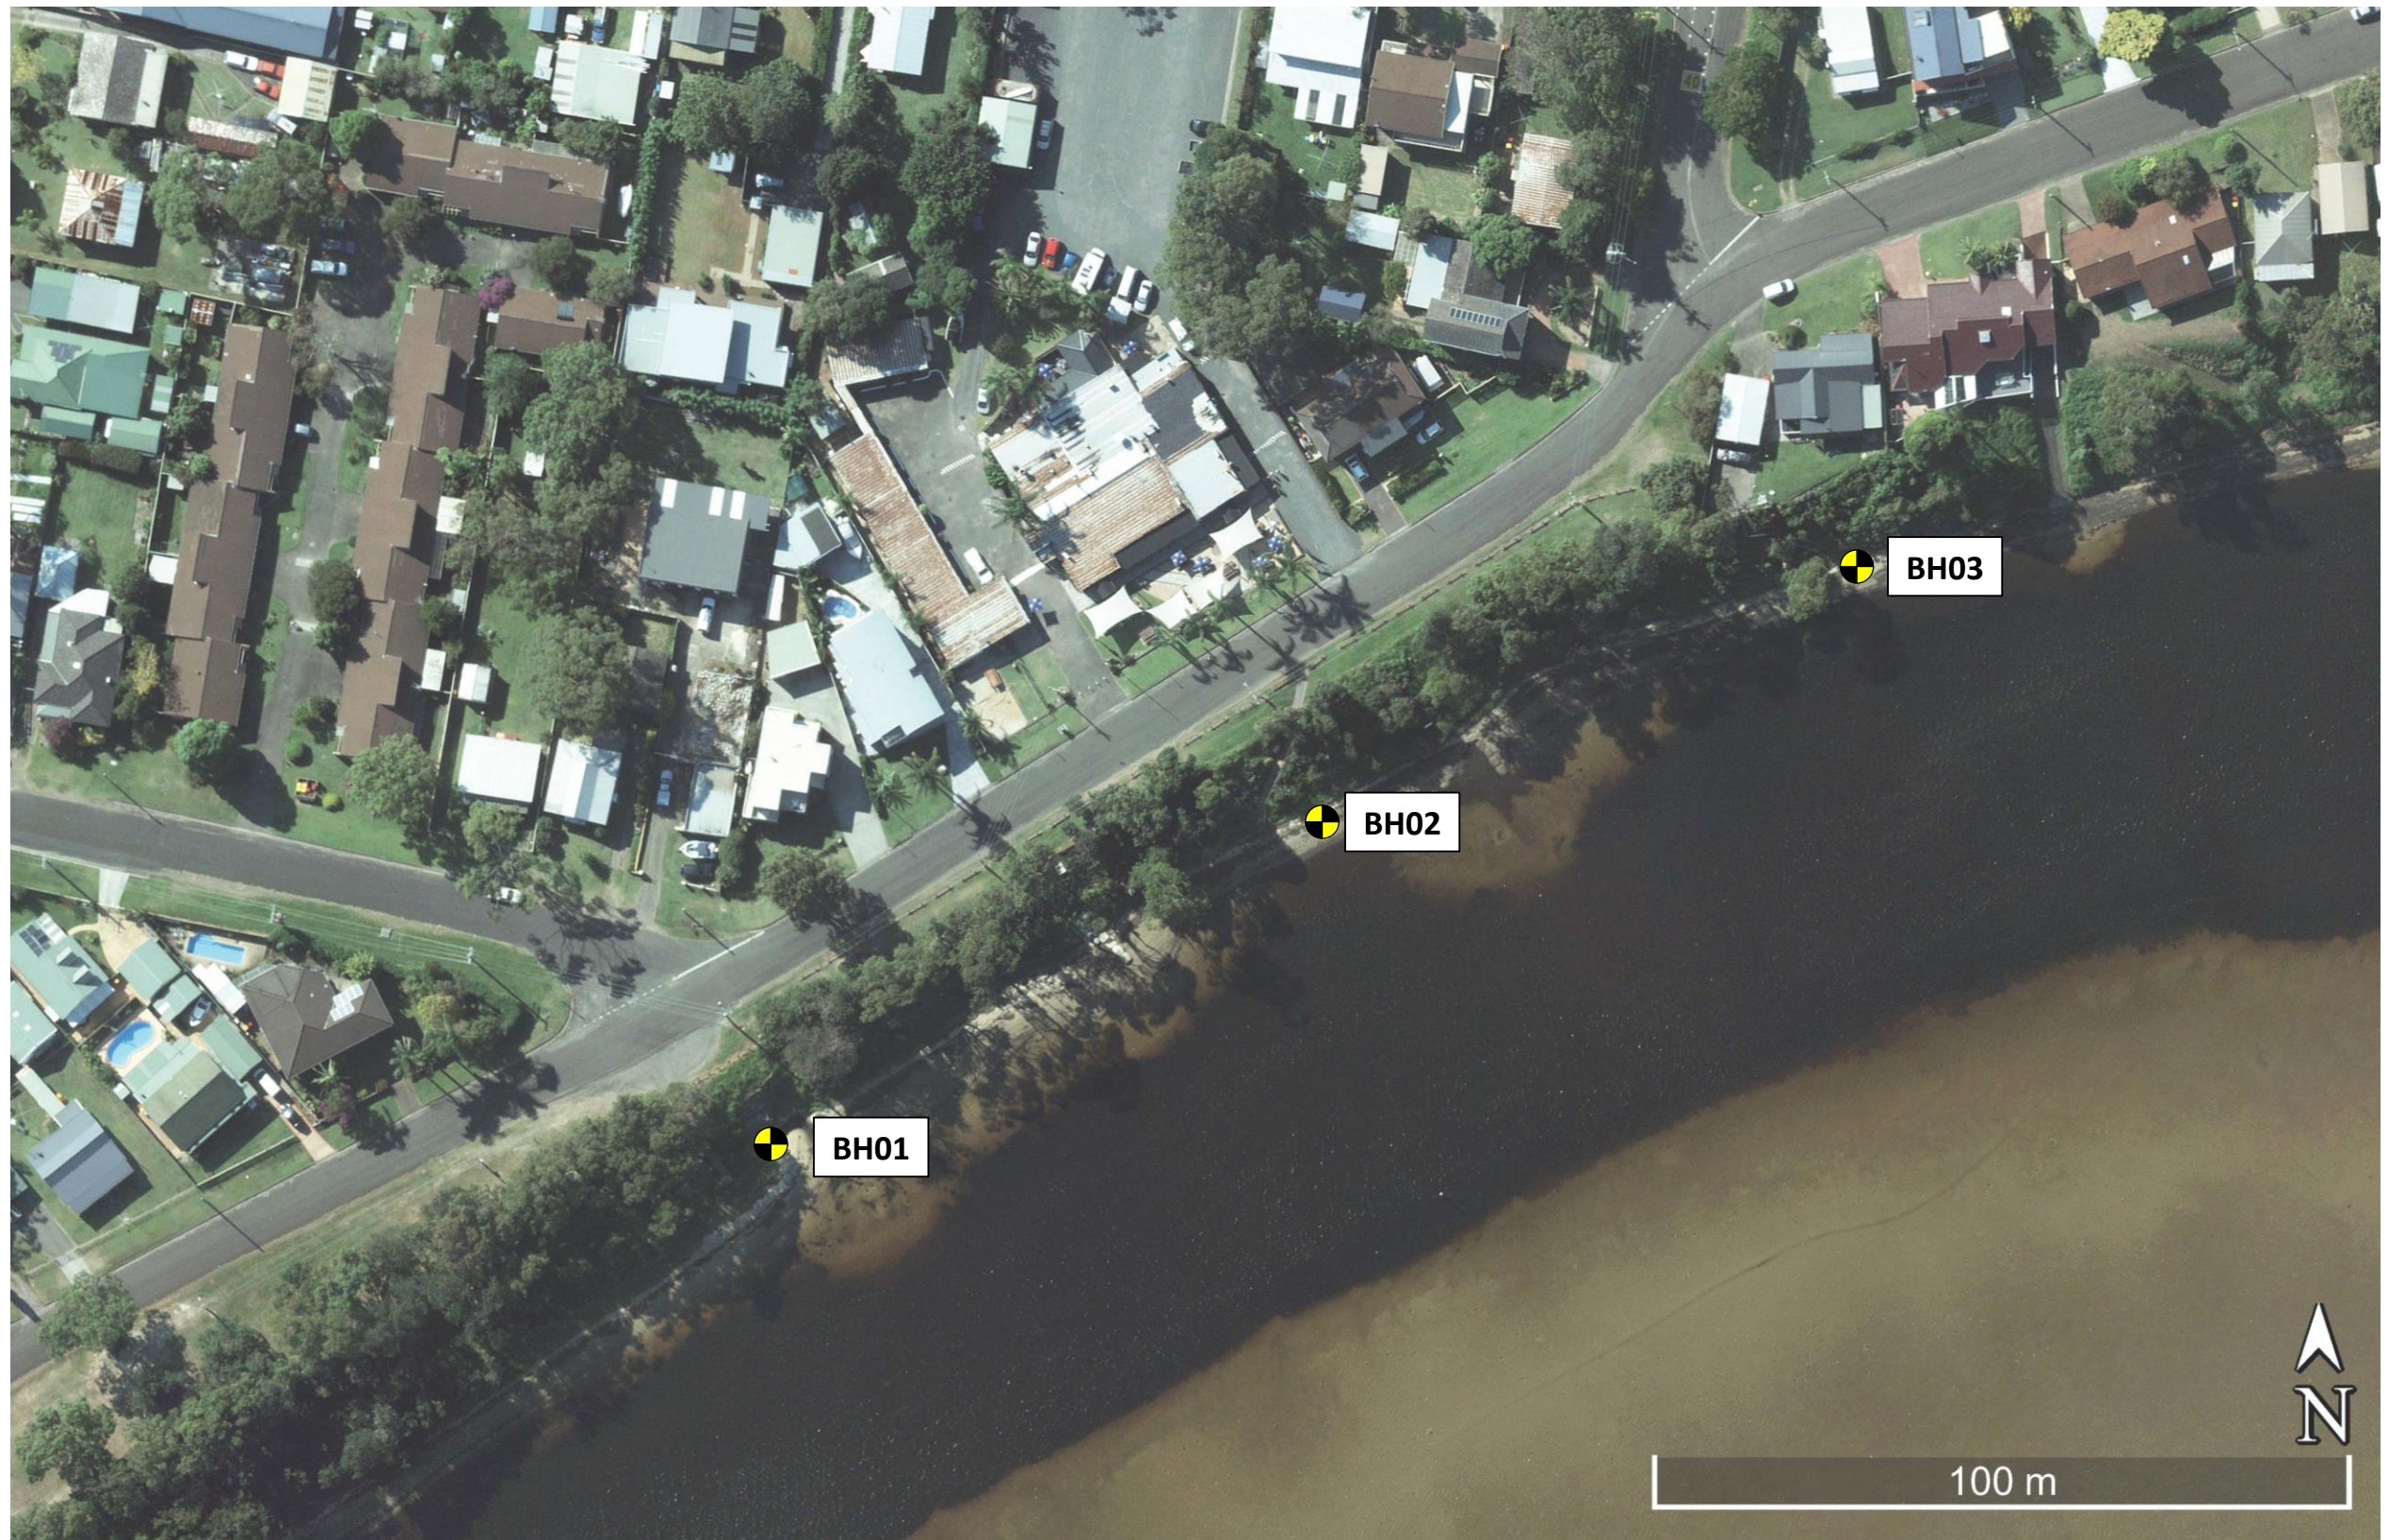
## **Figure 3 - Site Plan**

ENRS conducted soil investigations in test pits on the 28<sup>th</sup> of June and 1<sup>st</sup> of July 2019 within the proposed excavation footprint (**Figure 3**) in accordance with industry standards. Soil logging identified coarse marine sands to the maximum investigation depth of 1.5 metres below ground level (mbgl). No silty jarosite or oxide staining was observed in the loose sediments. No visual or olfactory evidence of ASS conditions was noted. Field screening of excavated material was conducted with three (3) samples from each borehole tested at depths of 0.5m, 1.0m and 1.5m below ground level. All samples reported oxidised pH values greater than pH4. Borehole logs identifying soil conditions and field screening results are presented in **Attachment 2**. Samples were not submitted for further laboratory testing as the Site was deemed to present a very low to negligible risk for potential acid sulfate soil.

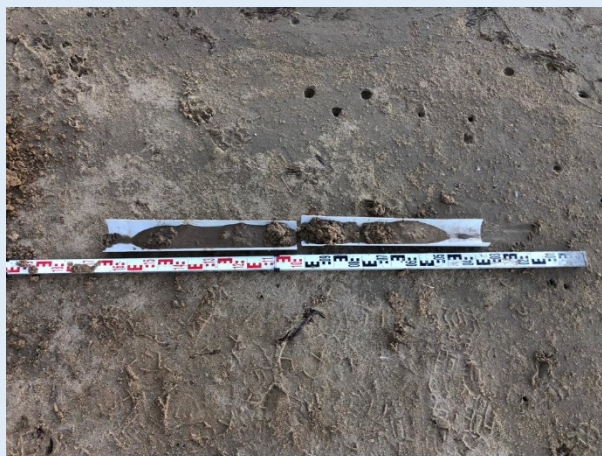
**Photograph 1: Borehole #1 Soil profile**

| Depth Metres | Description | Sample ID (ASS) | Sample ID (Chem) | PID Reading (ppm) | pH (field) | pH (FOX) |
|---|---|---|---|---|---|---|
| 0.30 | <p>0 - 1.5m: Coarse marine sand. No visual or olfactory evidence of ASS conditions were noted.</p> | BH01/1.0 | N/A | N/A | 7.84 | 6.34 |
| 0.90 | <p>BH terminated after required depth reached.</p> | BH01/1.5 | N/A | N/A | 8.08 | 6.74 |

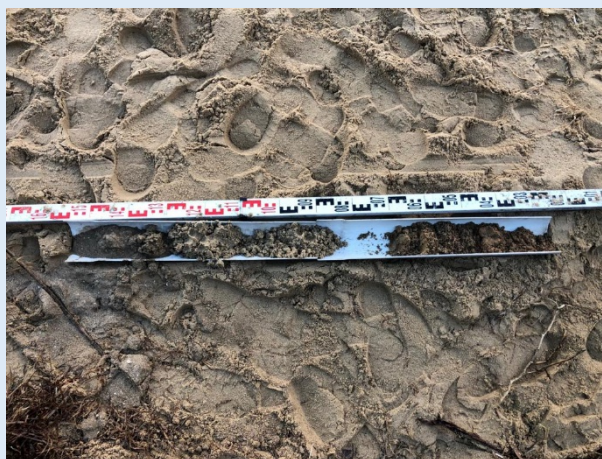
**Photograph 2: Borehole #2 Soil profile**

| Depth Metres | Description | Sample ID (ASS) | Sample ID (Chem) | PID Reading (ppm) | pH (field) | pH (FOX) |
|---|---|---|---|---|---|---|
| 0.30 | 0 - 1.5m: Coarse marine sand. No visual or olfactory evidence of ASS conditions were noted. | BH01/1.0 | N/A | N/A | 8.58 | 6.42 |
| 0.90 | BH terminated as required depth reached | BH01/1.5 | N/A | N/A | 7.92 | 6.49 |

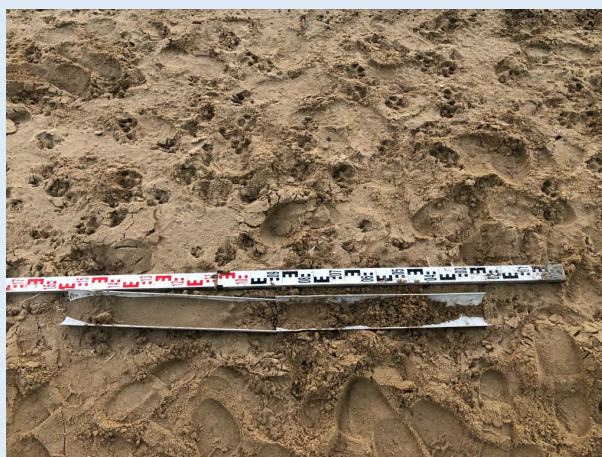
**Photograph 3: Borehole #3 Soil profile**

| Depth Metres | Description | Sample ID (ASS) | Sample ID (Chem) | PID Reading (ppm) | pH (field) | pH (FOX) |
|---|---|---|---|---|---|---|
| 0.30 | <p>0 - 1.5m: Coarse marine sand. No visual or olfactory evidence of ASS conditions were noted.</p> | BH01/1.0 | N/A | N/A | 8.07 | 6.77 |
| 0.90 | <p>BH terminated as required depth reached.</p> | BH01/1.5 | N/A | N/A | 8.39 | 6.82 |
