# BUSHFIRE ASSESSMENT REPORT

## Fjellheim Lodge -

### 91 Burramys Rd Perisher Valley

# Summary

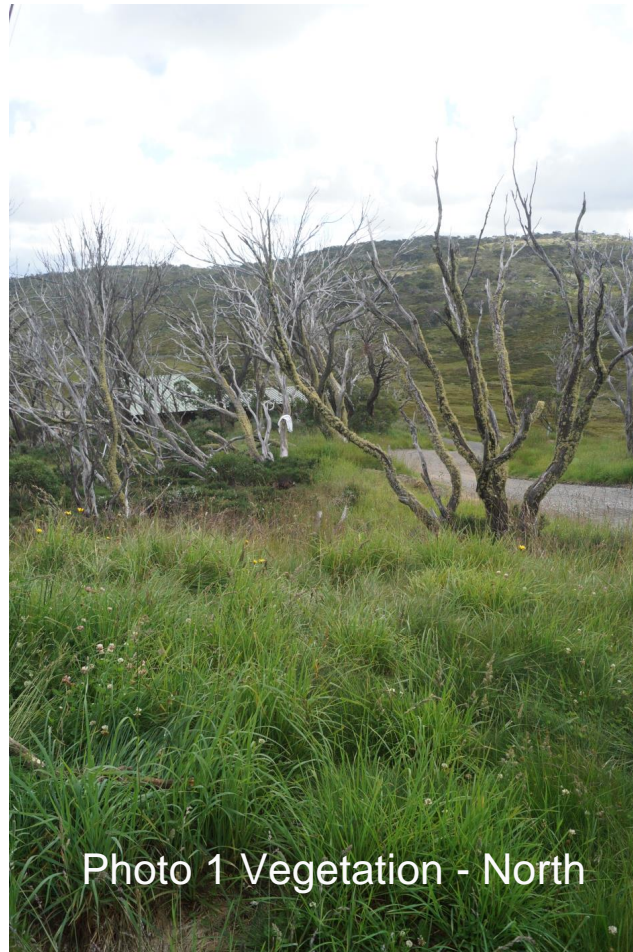
Photo 1 Vegetation - North

**North & North- West** Short mixed heath / Alpine complex with scattered dead snow gums

Short mixed heath / Alpine complex with scattered dead snow gums .

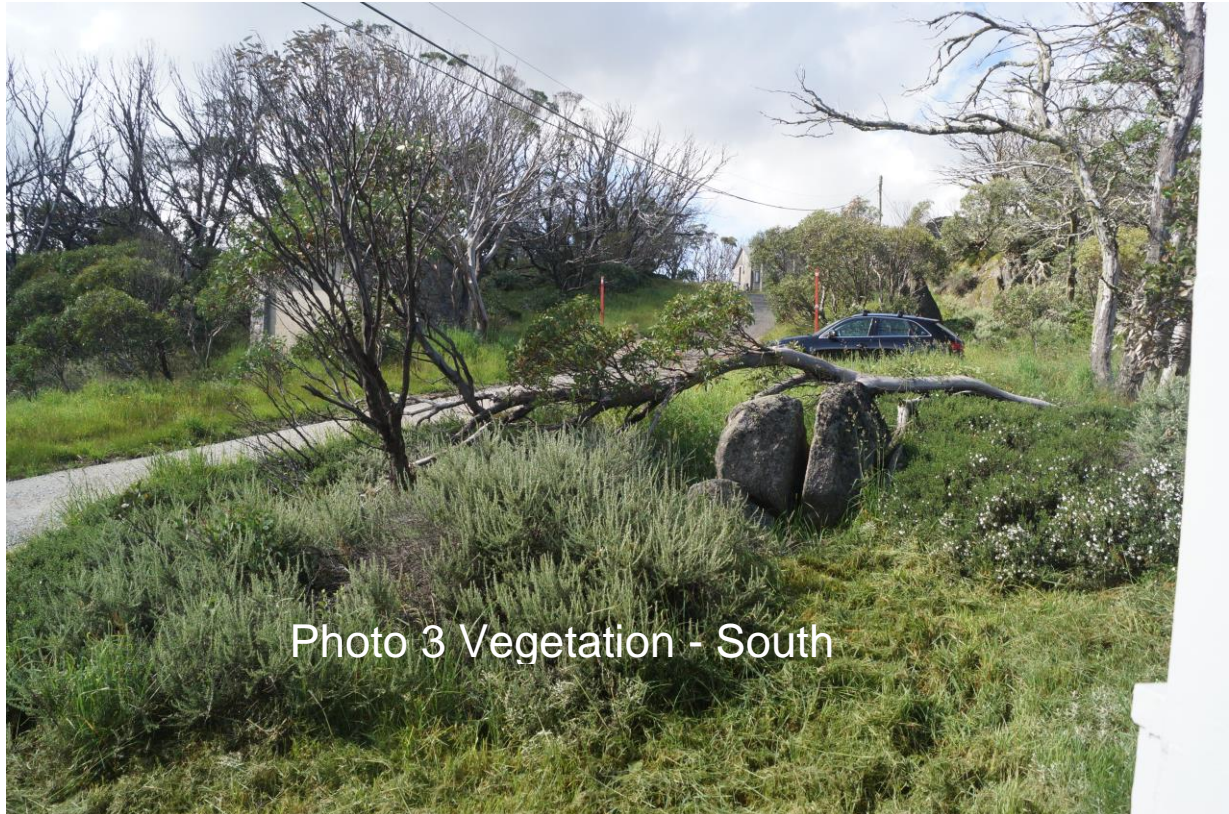
Photo 3 Vegetation - South

Short mixed heath / Alpine Complex with tall heath in the form of sparsely distributed live snow gums and some scattered dead snow gums

Short mixed heath / Alpine Complex with tall heath in the form of sparsely distributed live snow gums and some scattered dead snow gums

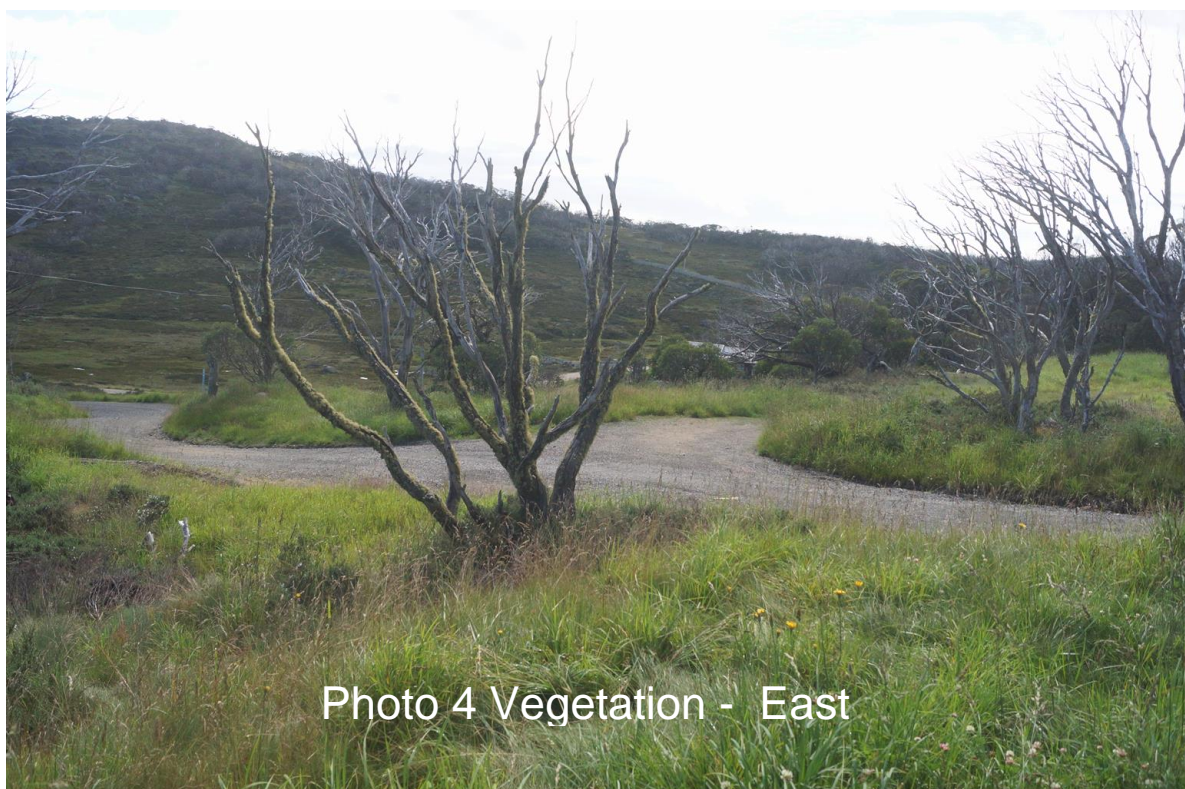
Photo 4 Vegetation - East

Short mixed heath / Alpine complex and some sparsely scattered dead snow gums

Short mixed heath / Alpine complex and some sparsely scattered dead snow gums

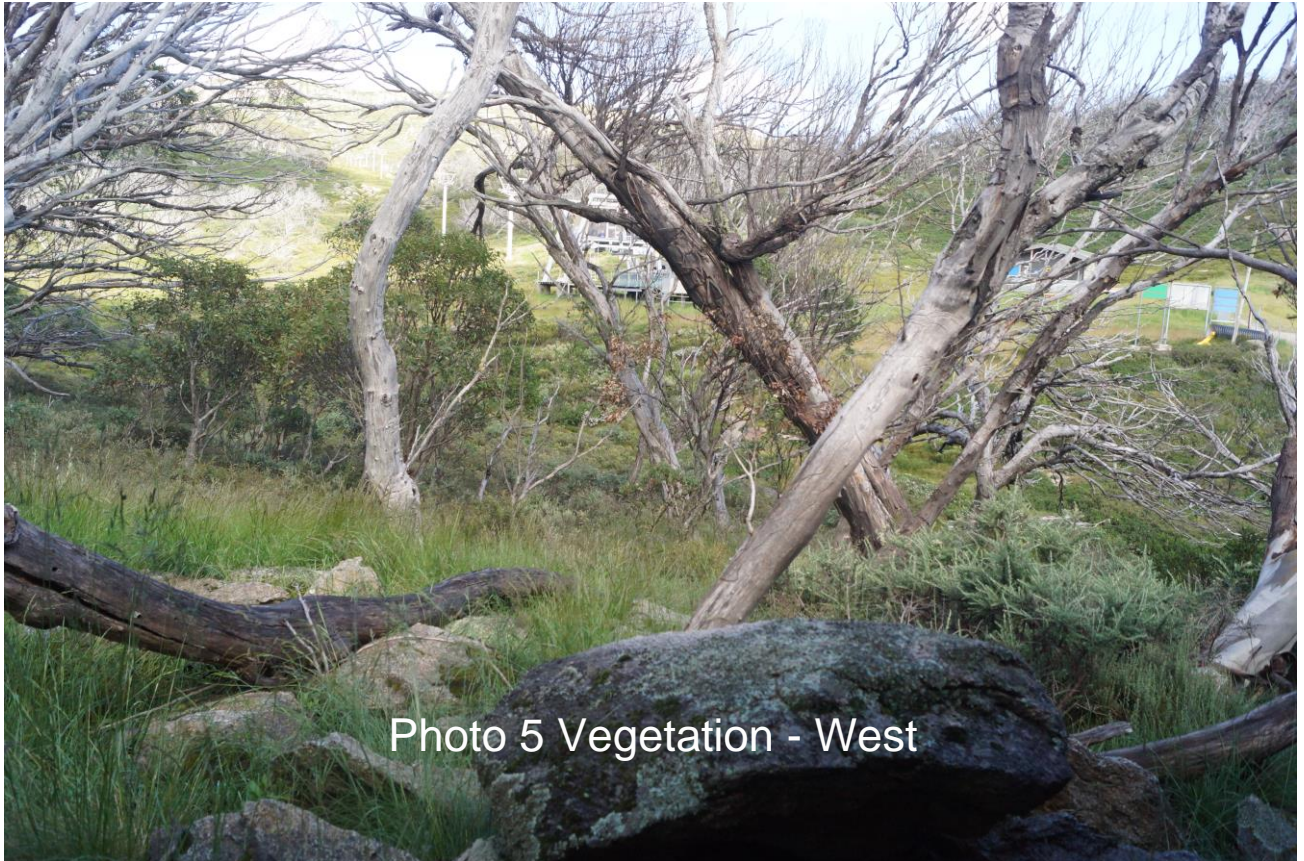
Photo 5 Vegetation - West

Short mixed heath / Alpine complex with tall heath in the form of sparsely distributed live snow gums and some scattered dead snow gums

Short mixed heath / Alpine complex with tall heath in the form of sparsely distributed live snow gums and some scattered dead snow gums

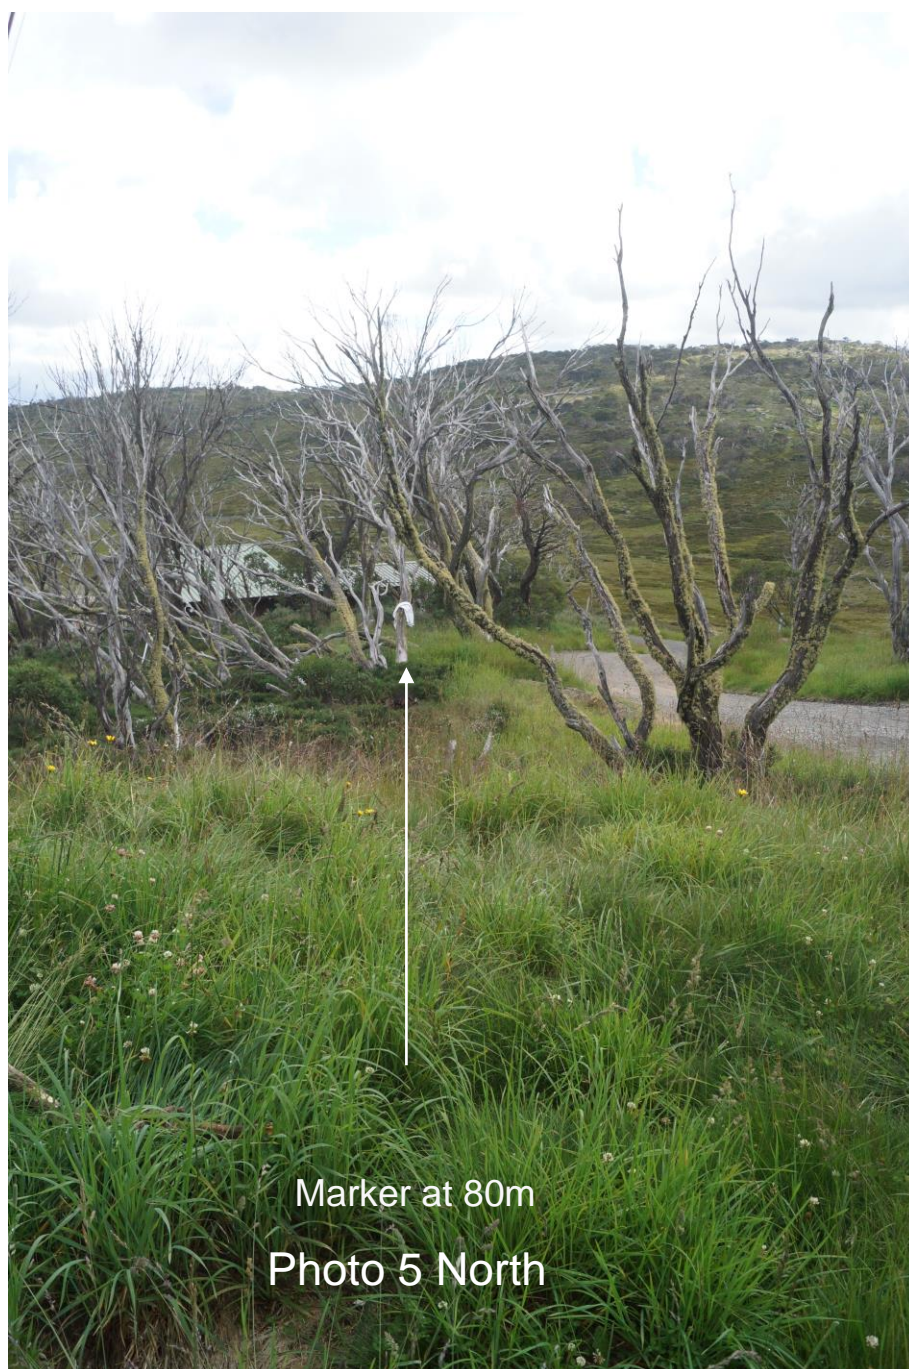
Marker at 80m  
Photo 5 North

North effective down slope 5 - 10 degrees - BAL 19

<b>North</b>	- 5 -10 degrees - Downslope	- Distance 7-<11m	- BAL 19
<b>South</b>	- 0 - 5 degrees - Upslope	- Distance 6 -<8m	- BAL 29
<b>East</b>	- 0 - 5 degrees - Flat	- Distance 12-<100m	- BAL12.5
<b>West / Sth West</b>	- 0 - 5 degrees - Flat	- Distance 6 - <8m	- BAL 29

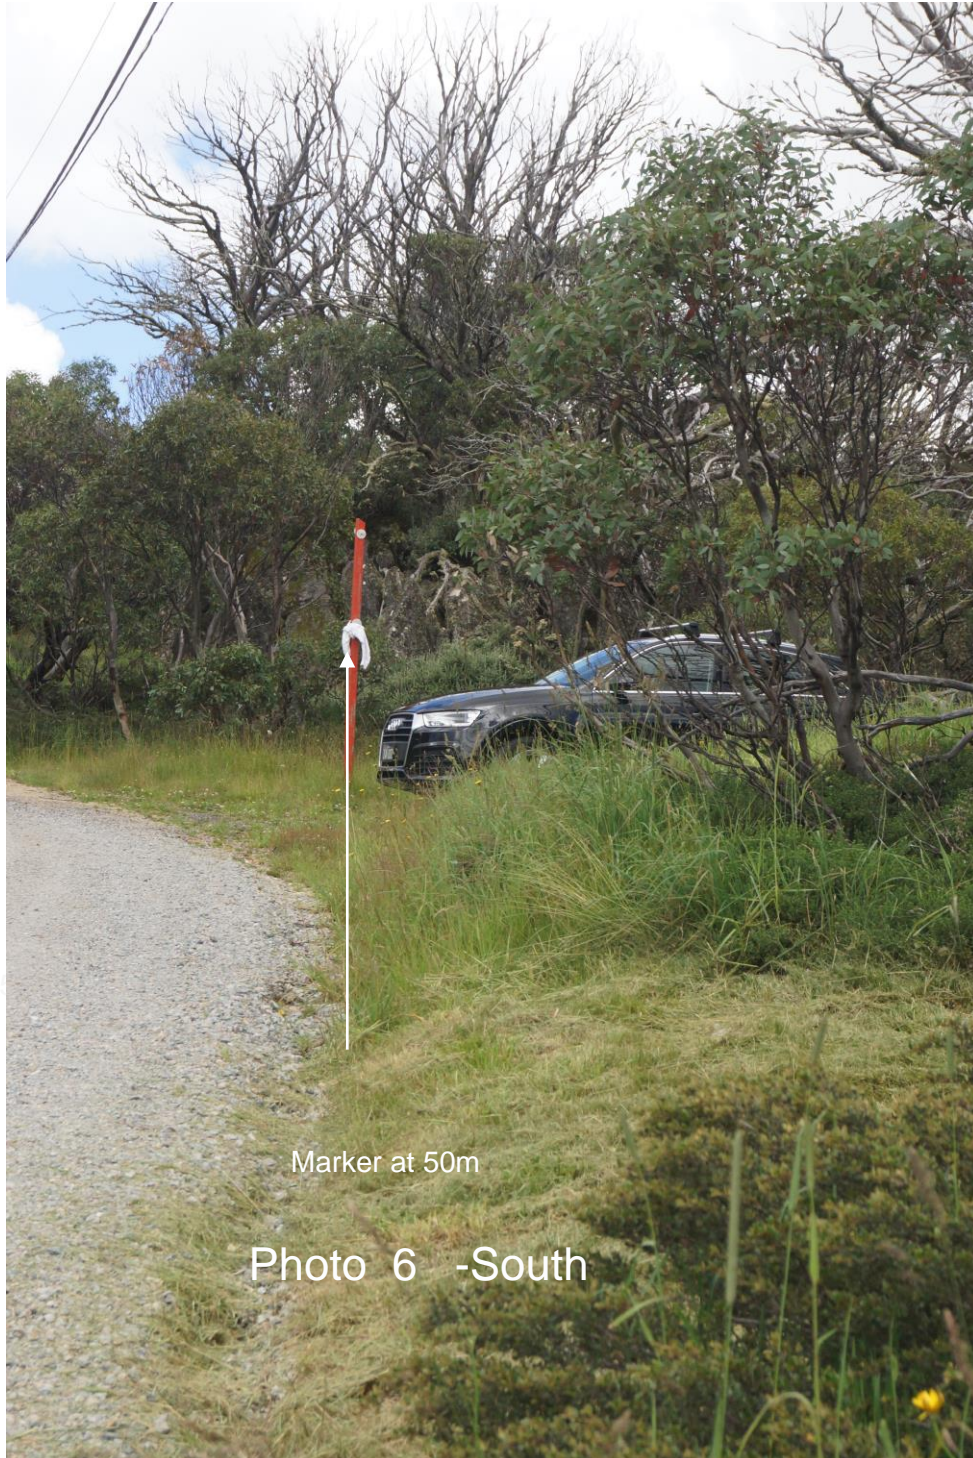
Photo 6 -South

South effective up slope 0-5 degrees - BAL 29

Marker at 50m

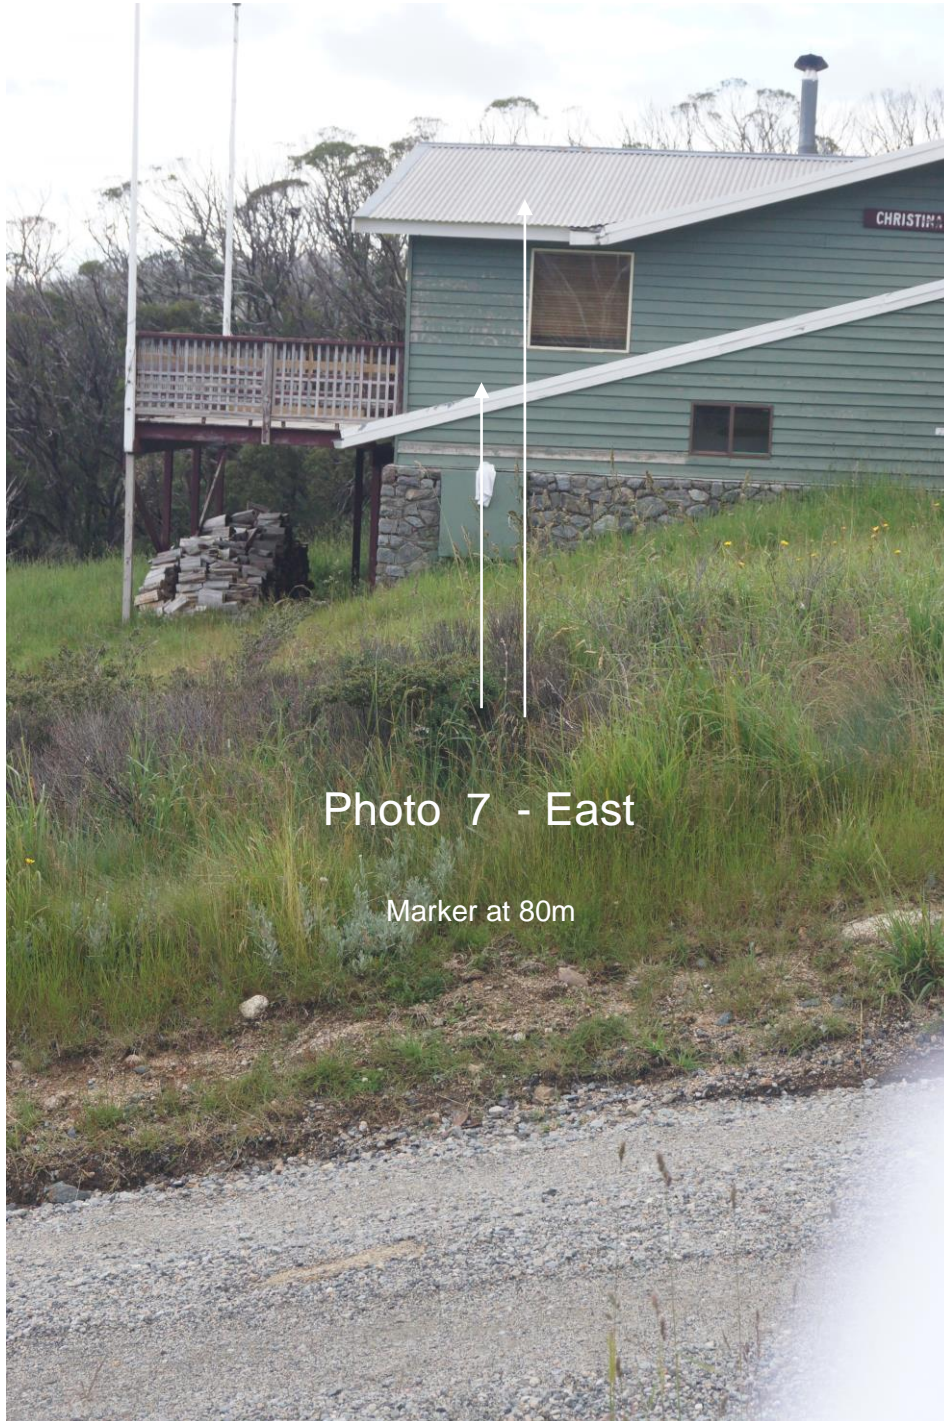
East effective slope flat 0-5 degrees - BAL 12.5

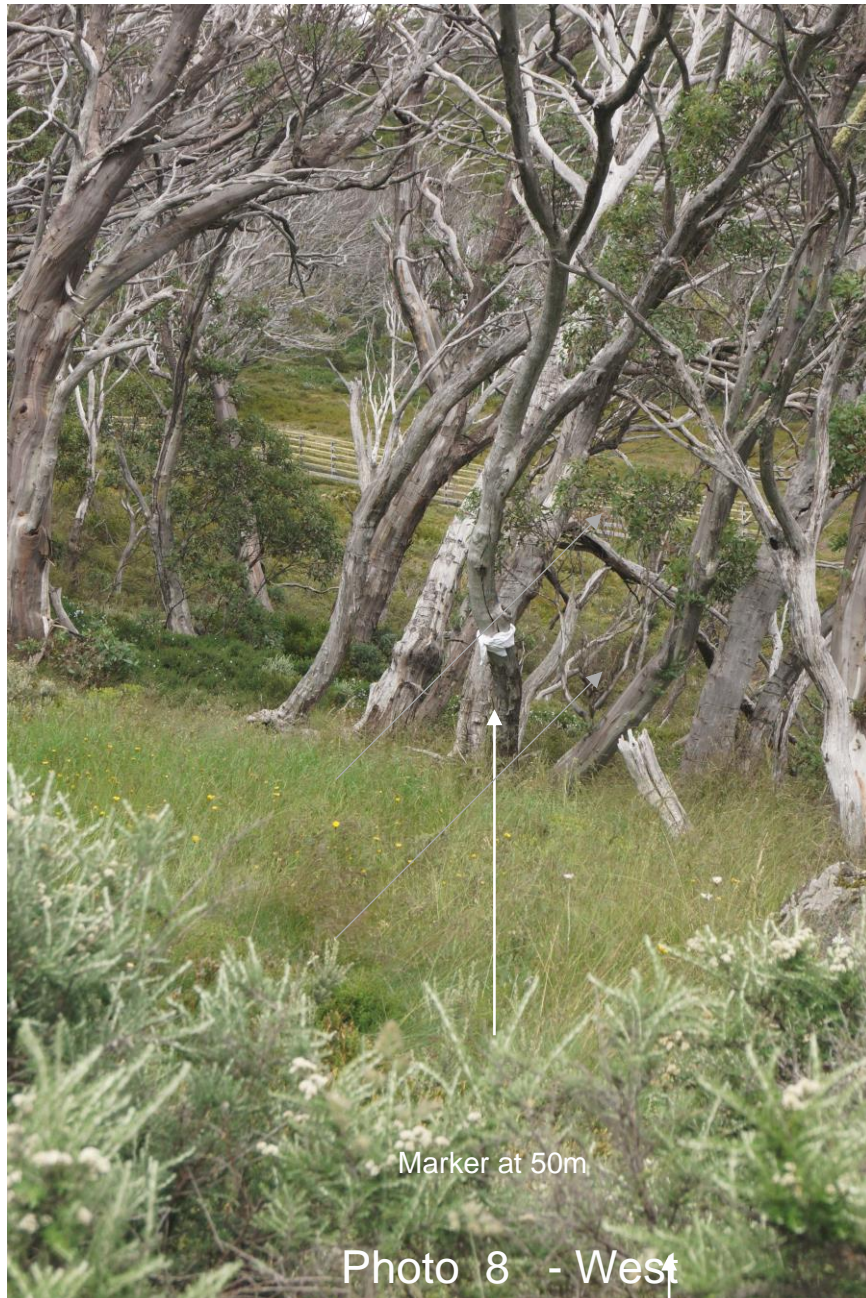
West effective slope flat 0-5 degrees - BAL 29

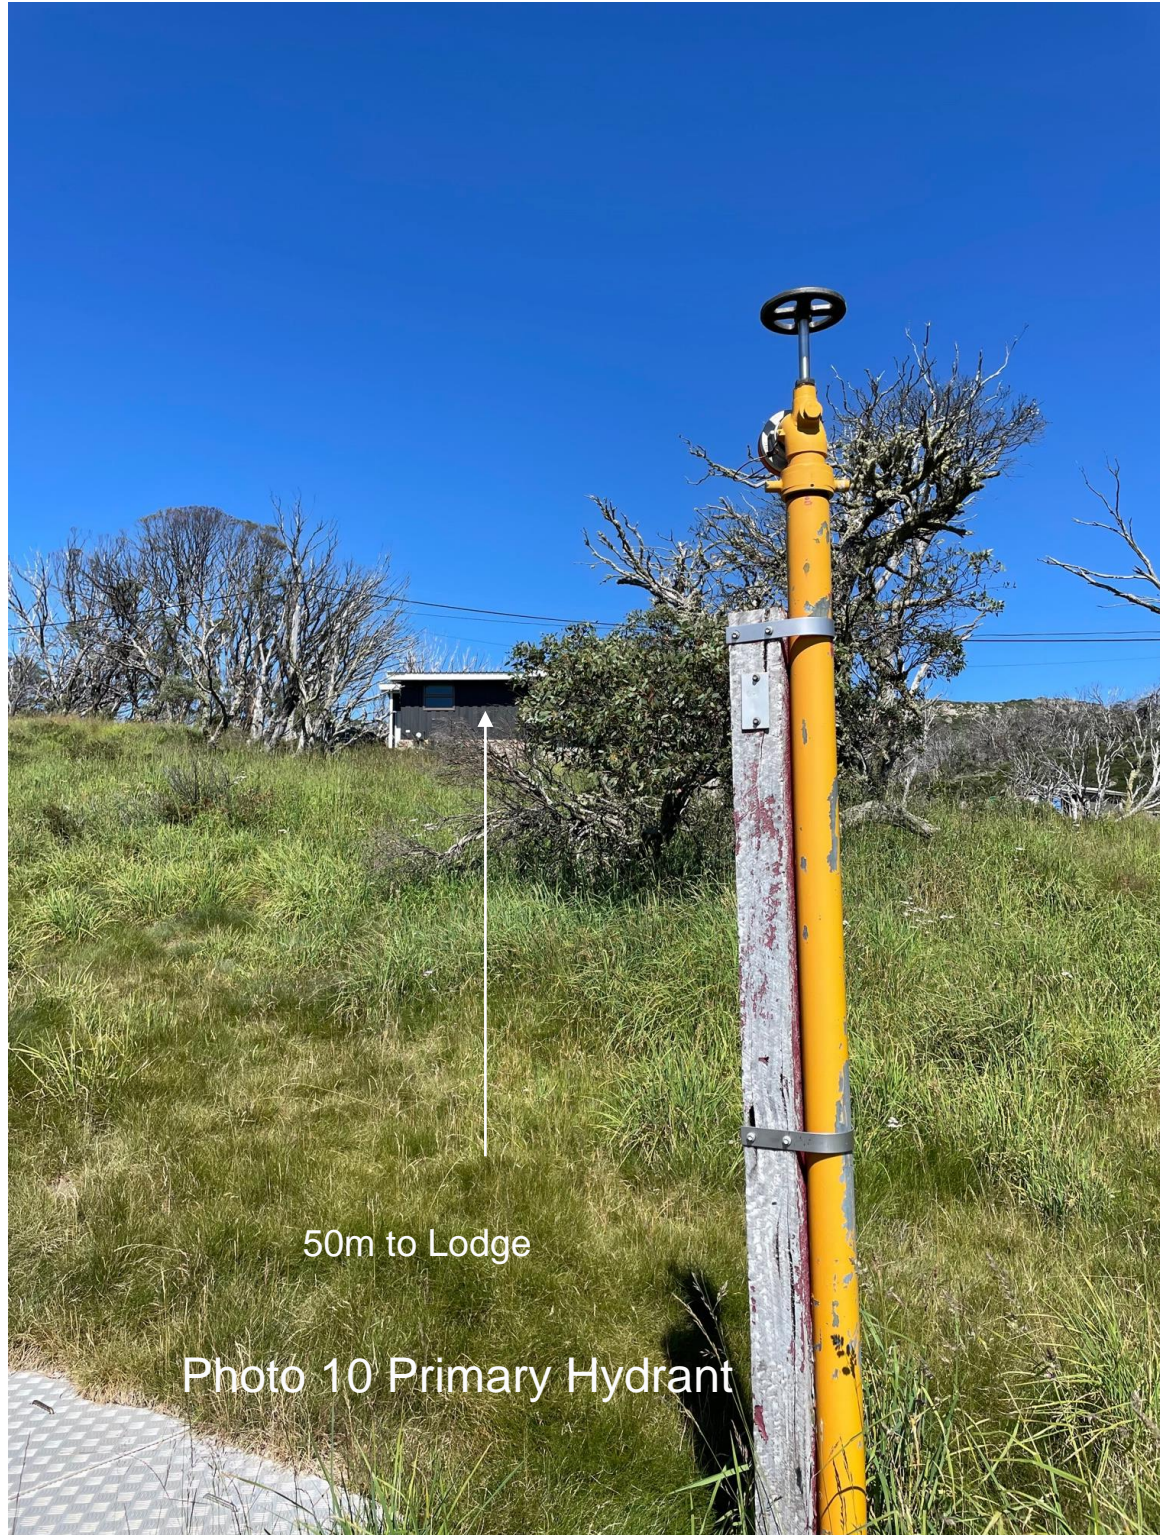
## Reticulated Water Supply

There is a hydrant to the east, adjacent to Burramys Rd approximately 50 meters from the Lodge and a further hydrant to the north also adjacent to Burramys Rd approximately 150 meters from the Lodge and below Huski Lodge

Distance 50 (m) to hydrant from house.

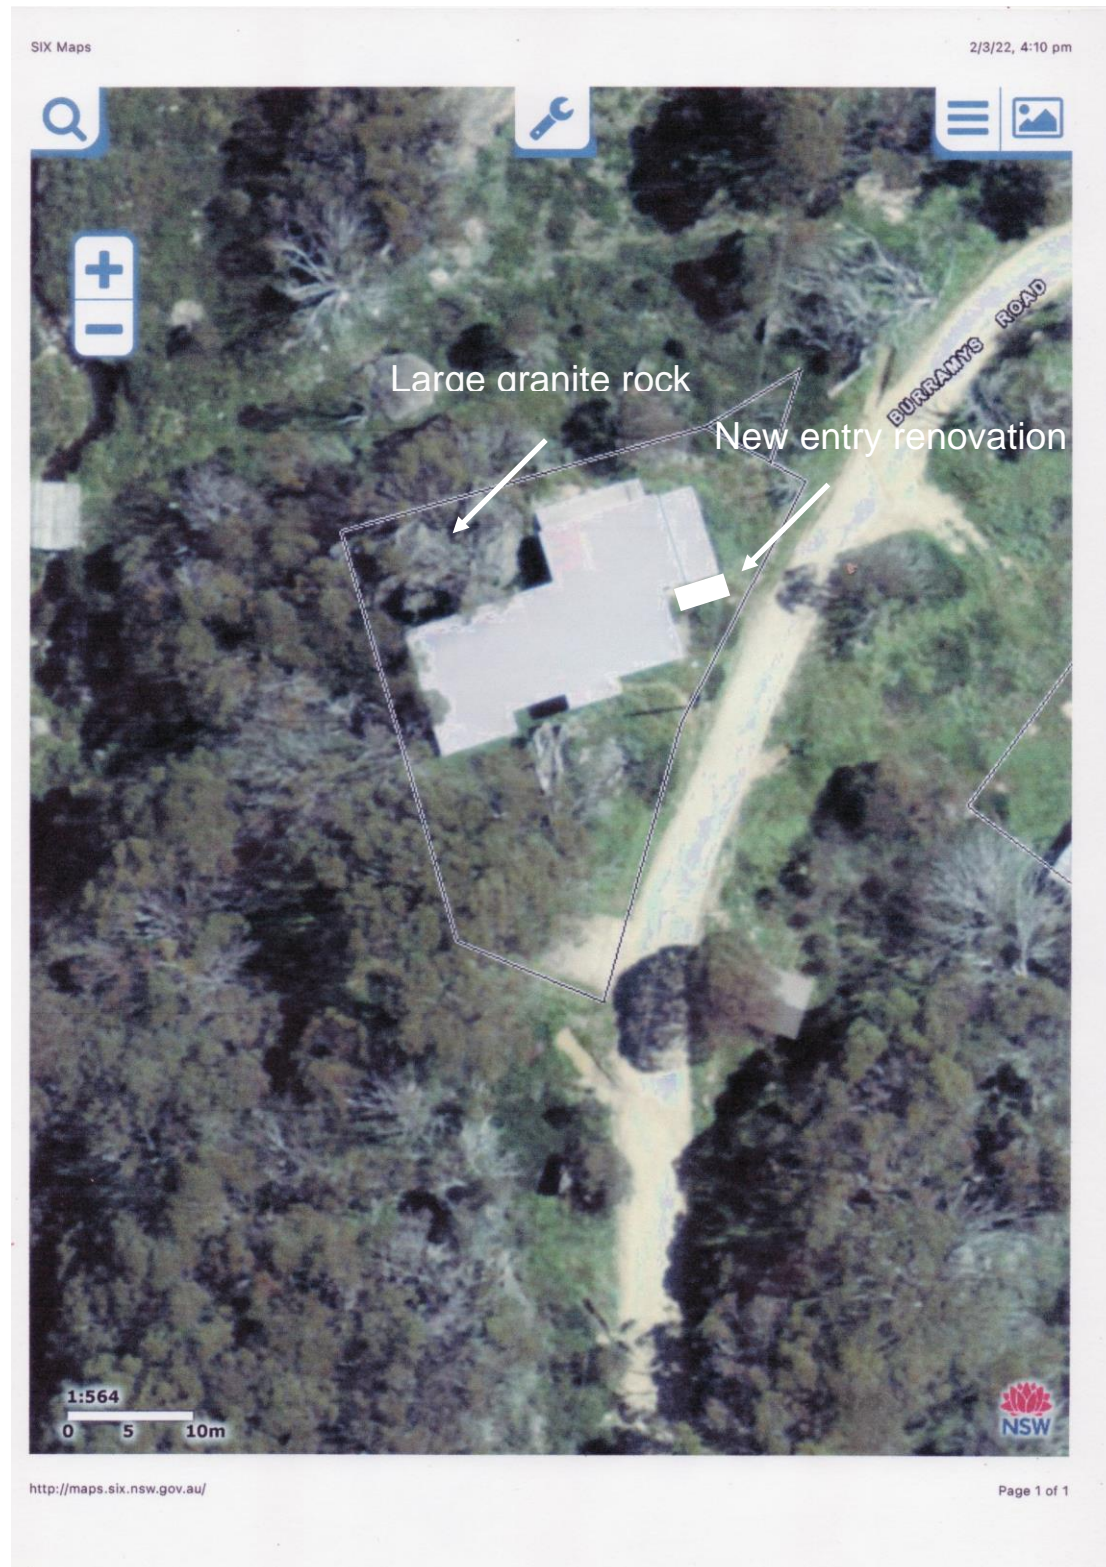
## Site plan showing new renovation

The new lower entry  
excavated entry area of

renovation is located on a previously  
8 sqm and directs egress, as required in

case of emergency, directly toward an unimpeded space, clear of vegetation and the open space of the road.
