GEOTECHNICAL INVESTIGATION REPORT

**118 Cary Street
(114-120 Cary St, 1, 2, 3, 5 Bath St and 3 Arnott Ave)
Toronto NSW 2283**

Report No. GS8030-1A Rev 3

25th February 2022

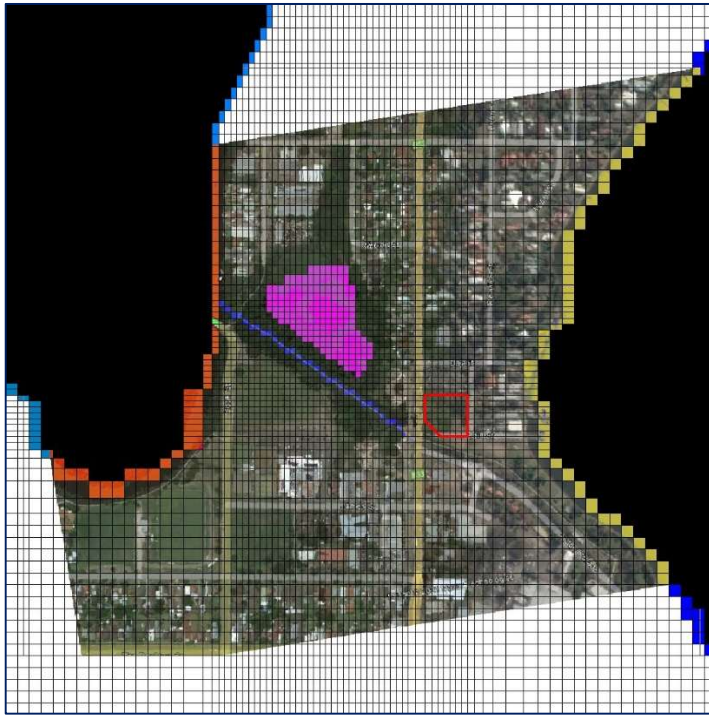
Figure 2 Model grid

- Layer 2: RL -3
- Layer 3: RL -5
- Layer 4: RL -10

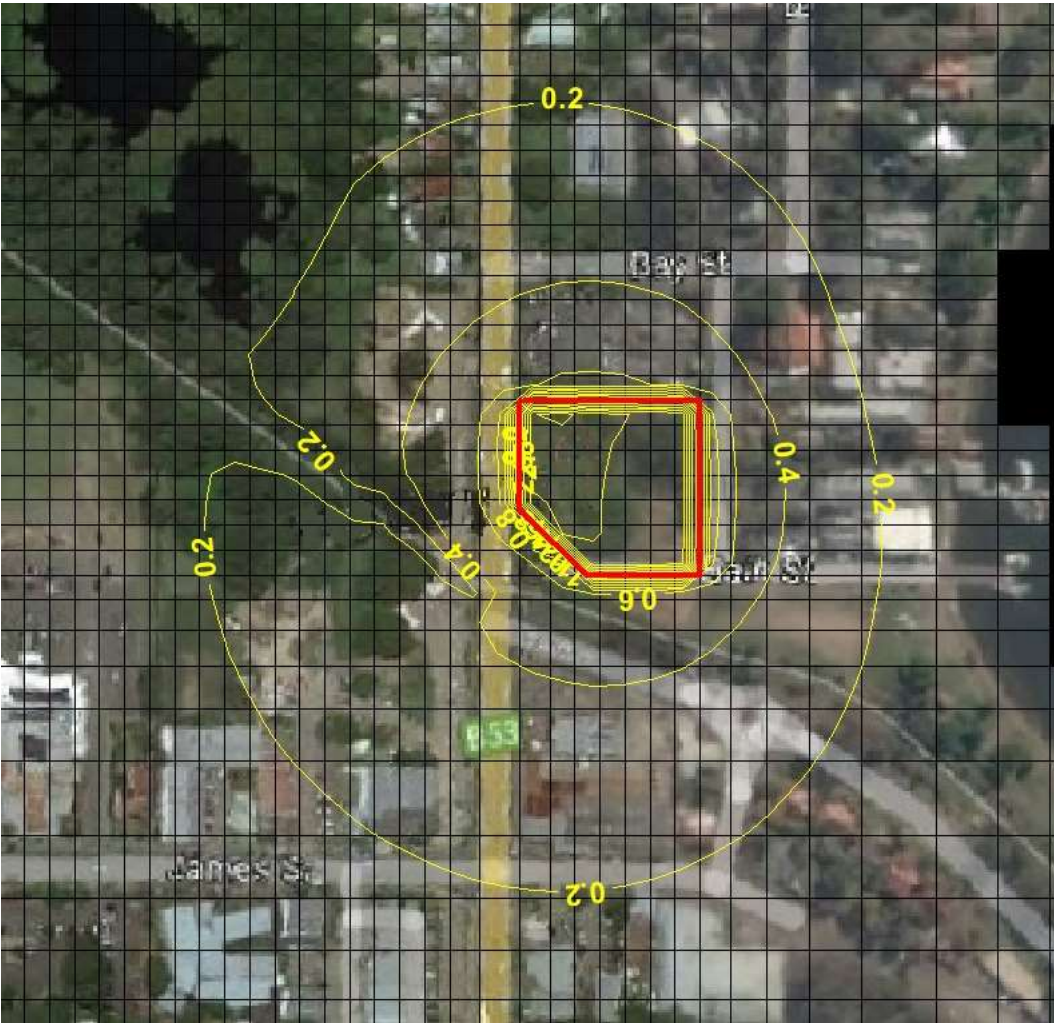
Figure 8 Groundwater drawdown – 360 days

The model indicates a maximum off-site extent of groundwater drawdown (0.2 m contour) of ~120 m to the north and south after 360 days of dewatering. The extent to the east/north-east toward the wetland is reduced due to the wetland boundary supporting the groundwater level locally. After 360 days dewatering, within approximately 30 m of the site boundary, a maximum drawdown of approximately 0.5 m is indicated.
