## 60 & 62-64 Showground Road

### Geotechnical Investigation Report

CHP Fund Pty Ltd

14 June 2021

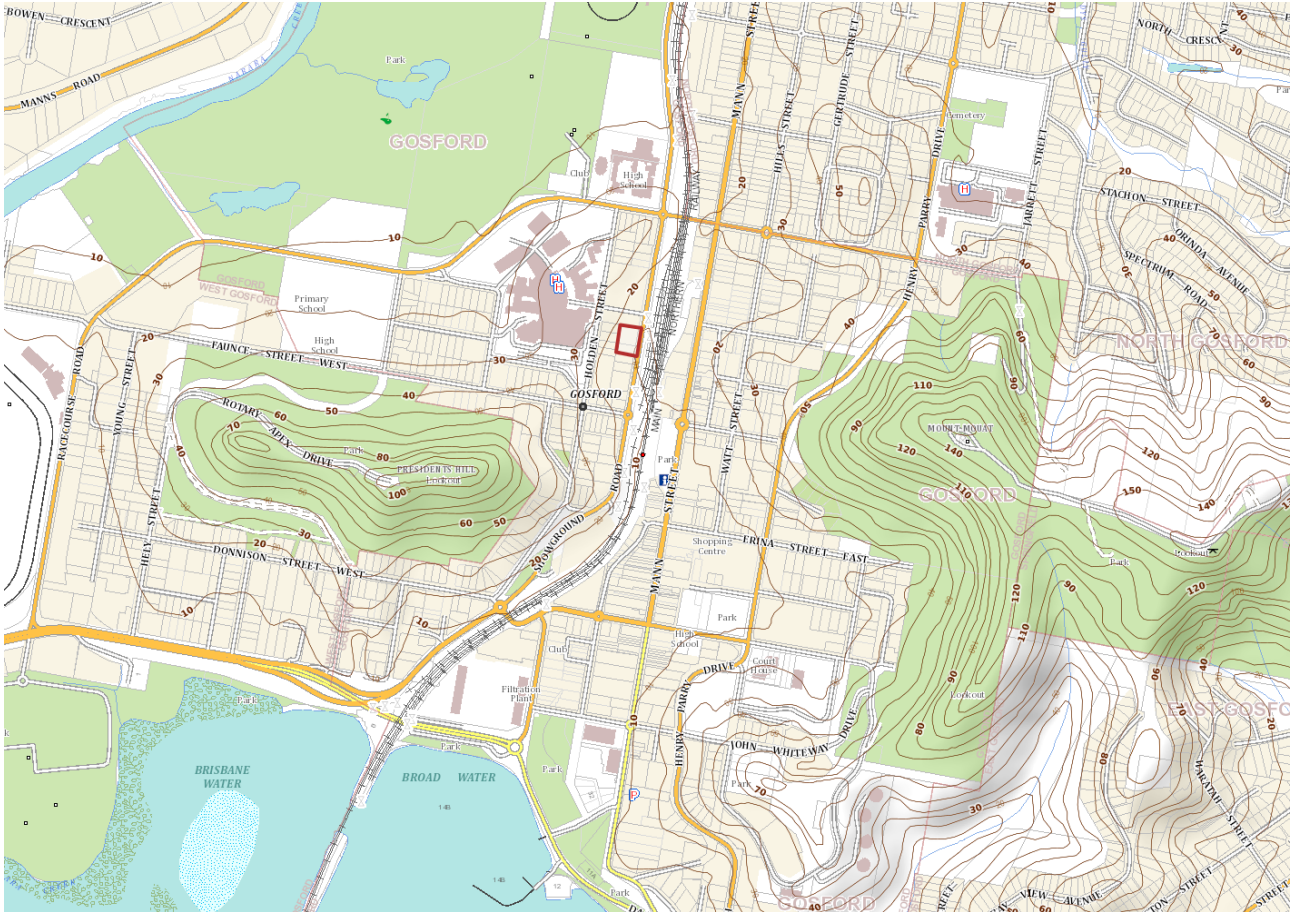
Plate 4 - Aerial Imagery Extracted from NSW Geoscience

The regional drainage line is aligned from the north to the south. 10 m contour levels are shown combined with the topographical map extract in Plate 4 below.

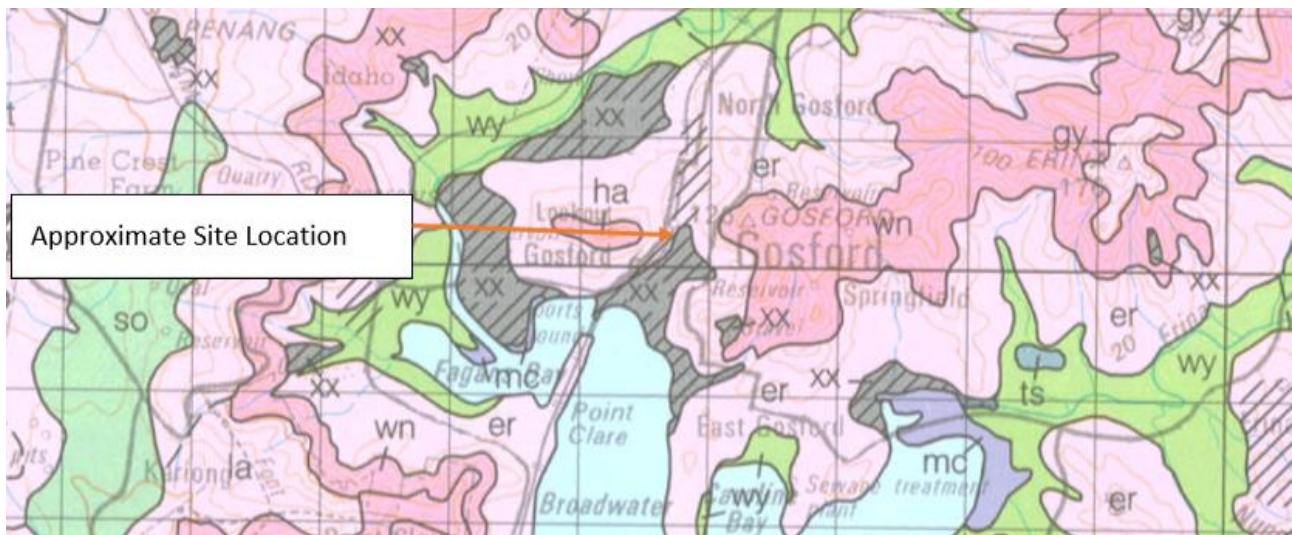
Plate 6 - Extract of the Soil Landscape

The 1:100,000 Gosford-Lake Macquarie Soil Landscape Series Sheet (9131-9231, First Edition 1993) indicates the site is underlain by anthropogenic disturbed terrain (denoted as “xx” in Plate 6 below), generally described as level plain to hummocky terrain, extensively disturbed by human activity, including complete disturbance, removal or burial of soil. Local relief and slopes are highly variable, landfill includes soil, rock, building and waste material. Original vegetation is completely cleared and is replaced with turf or grassland.

The topographic highs to the west and east are described as a colluvial (or slopewash) landscape of the Hawkesbury (“ha” in Plate 6) and Watagan (“wn” in Plate 6) Landscapes respectively. Limitations of these soil landscapes include extreme soil erosion, mass movement (rock fall) hazard, steep slopes, foundation hazard, rock outcrop, shallow, stony, and highly permeable soils.

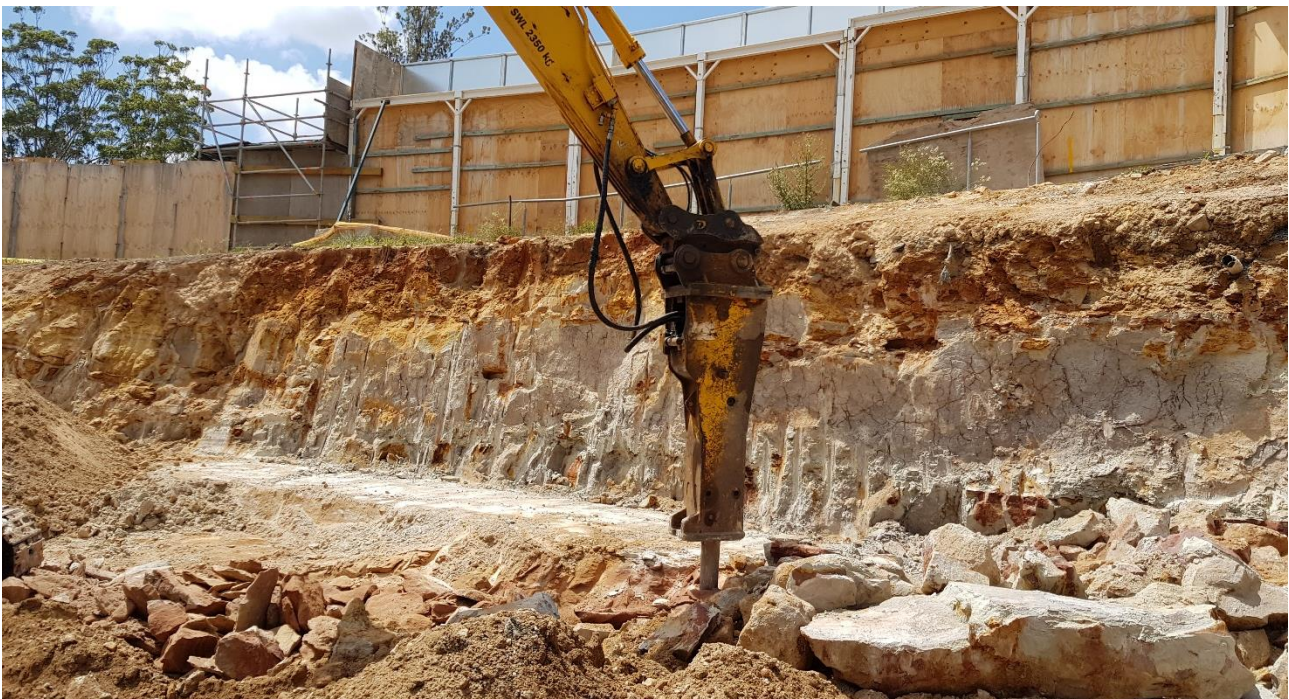
*Plate 8 - Showing Use of Hydraulic Rock Hammers for Excavation*

- The solid geology is expected to be shallower upslope with potential for outcrops towards the top of topographic highs.
- At shallower depths, excavators fitted with hydraulic rock hammers have been required for excavations.

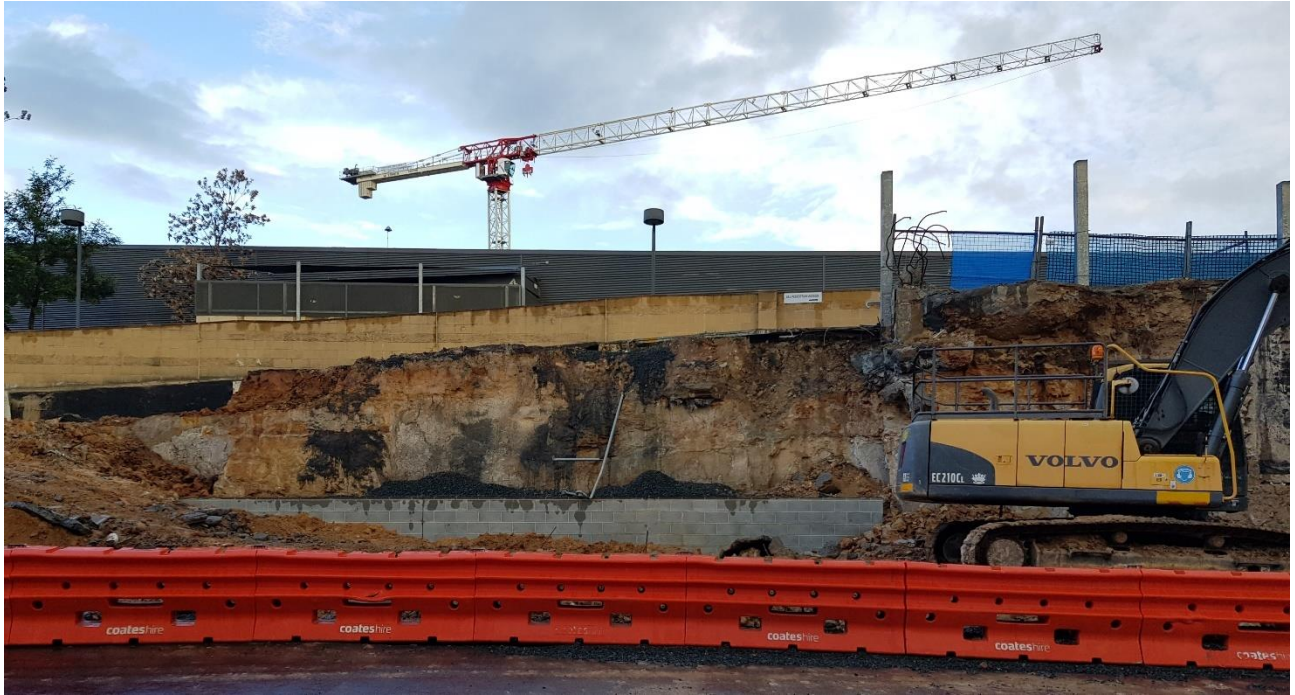
*Plate 9 - Showing Temporary Stability of Exposed Bedrock*

- Vertical walls of bedrock appear to be stable for a temporary period to allow the construction of L-shaped gravity-type retaining walls typically 3 m to 5 m retained height.

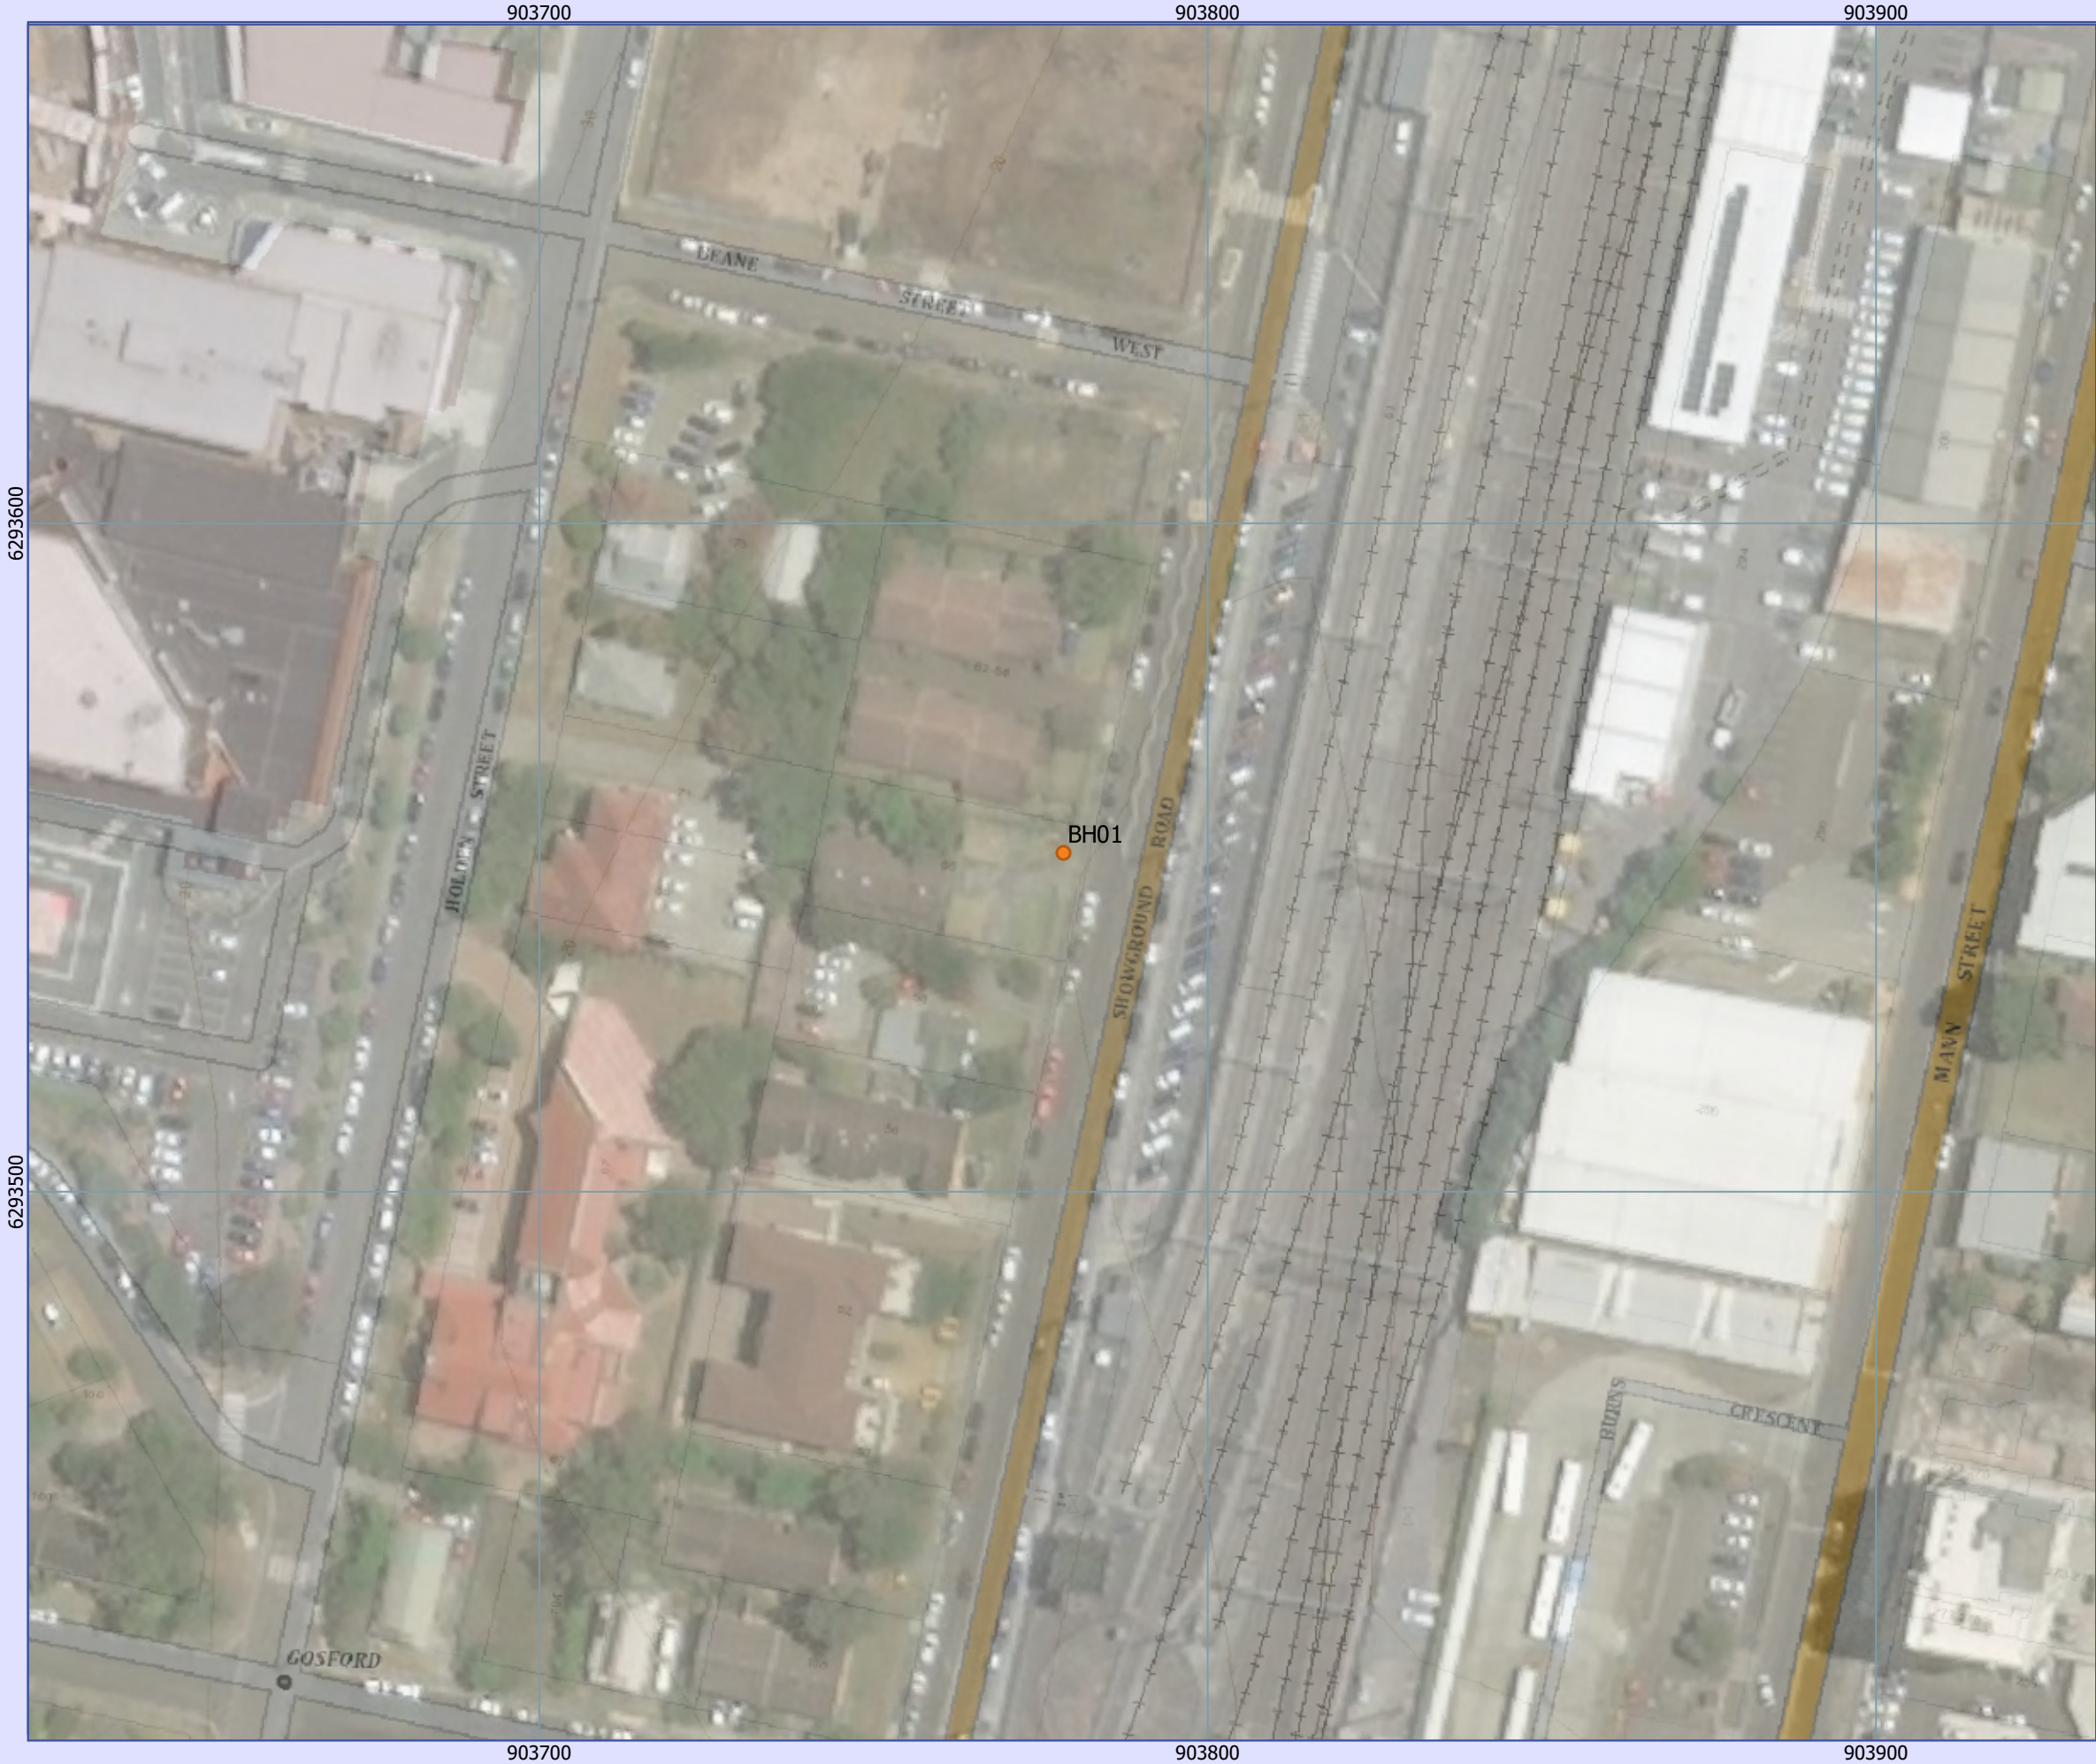
**Figure**

**Legend**  
● Borehole

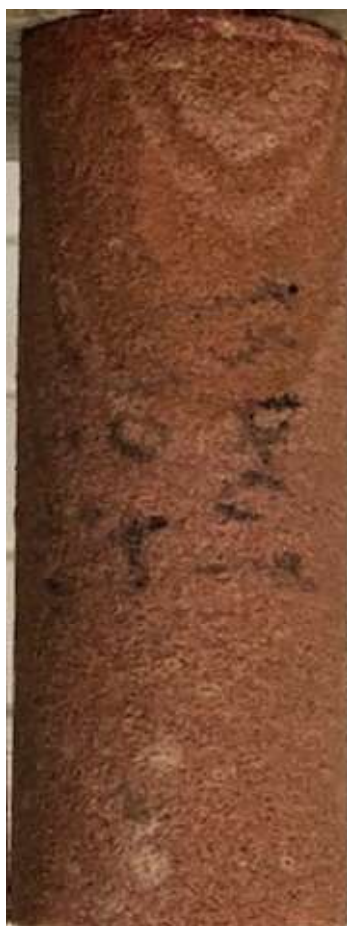
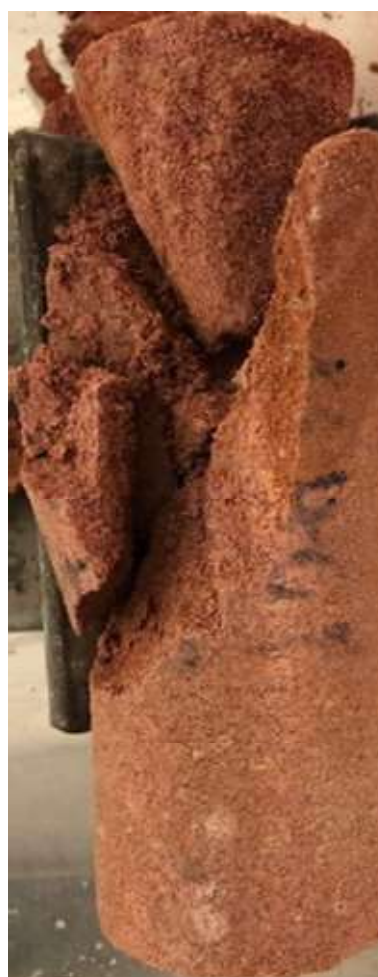
9.00 to 9.24 m

Top platen 228 mm, Bottom platen 120 mm

QESTLab work order ID	height	uniaxial compressive strength	wet density	sample description	Client's Sample ID
depth	average diameter		moisture content	bedding/foliation	
QESTLab sample ID	test duration	height/dia ratio	MPa		failure mechanism
<b>SYDS20W00107</b>		<b>149 mm</b>		<b>Ironstone</b>	
<b>9.00 to 9.24 m</b>	<b>1 Jun 21</b>	<b>51.1 mm</b>	<b>3.13</b>	<b>2.3 t/m<sup>3</sup></b>	<b>Bedding planes are at an angle of 20° to the axis of loading</b>
<b>SYDS20S00971</b>	<b>6.72 min</b>	<b>2.91:1</b>	<b>11.2 %</b>		<b>Conical</b>
