Geotechnical Investigation Report

Project
Proposed Temporary Mountain Bike Storage Unit
Kosciuszko Chairlift Base, Thredbo NSW

Date
30 June 2022

Report No
15282-GR-1-1

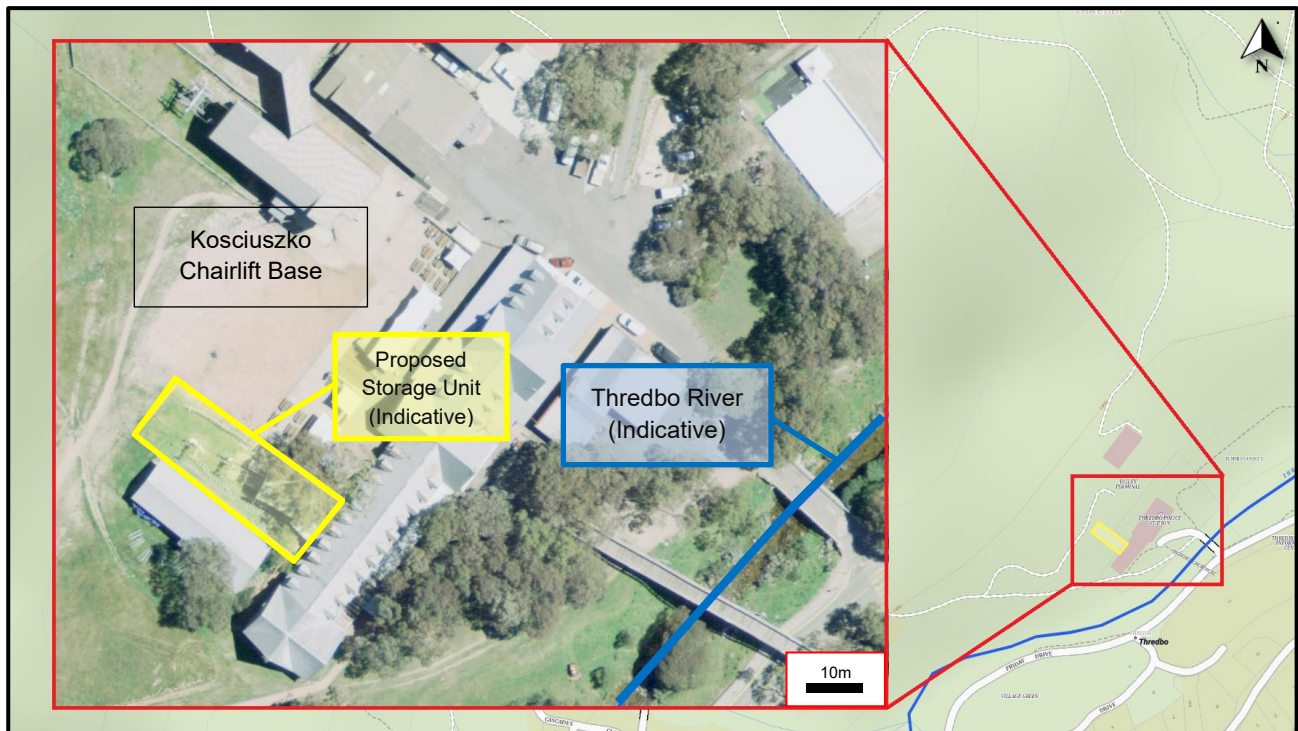
Figure 1 - The Site Location

The site is located at the Kosciuszko Chairlift ski resort in Thredbo Resort Centre within Thredbo Village, Thredbo NSW 2625. The proposed project location is bound by the Thredbo Ski Racing Club assembly building to the southwest, a commercial building to the southeast, and a barbecue area to the northeast. The site location relative to the surrounding features is shown in Figure 1 below.

During the site walkover, it was noted that a retaining wall is present on the south-eastern side, adjacent to the location of the proposed storage unit.

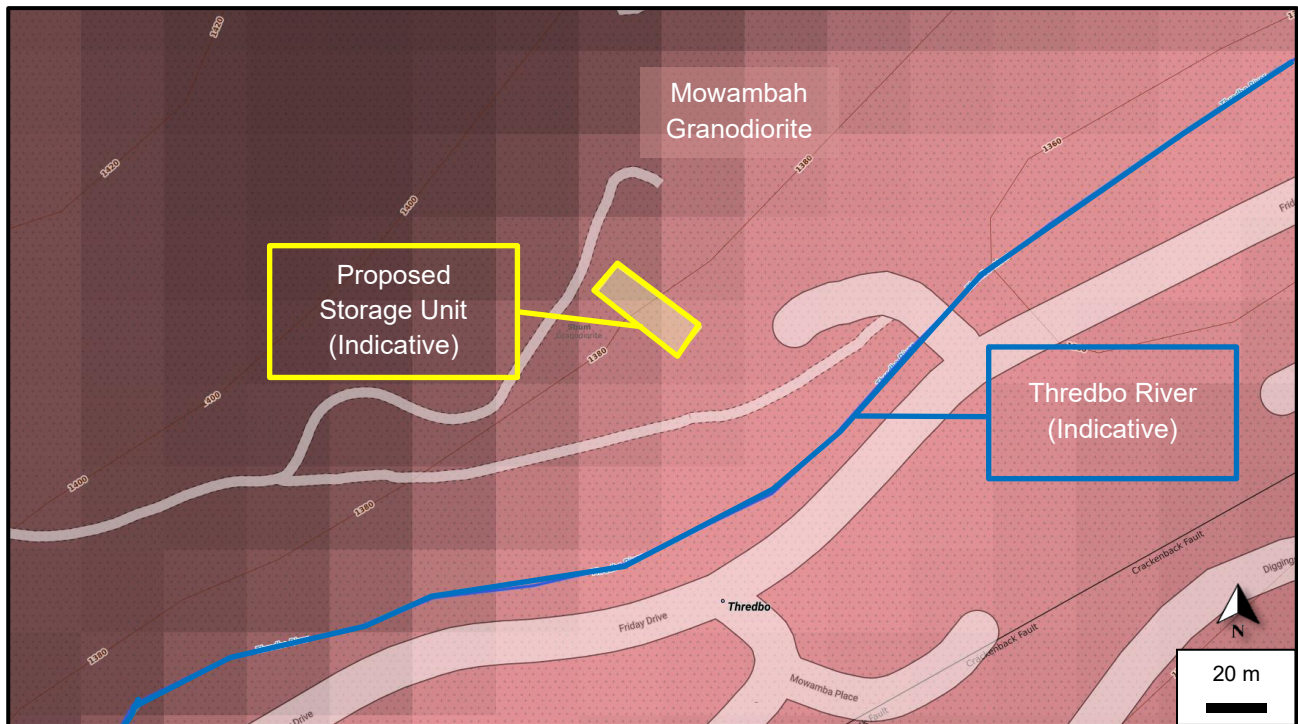
Figure 2 - The Site Location with NSW Seamless Geology and 10m Contours

The New South Wales Seamless Geology dataset, version 2.1 [Digital Dataset] published by the Geological Survey of New South Wales, indicates that the site is underlain by Silurian aged Mowambah Granodiorite which may contain *medium-grained mafic biotite-rich granodiorite, strong foliation defined by quartz and biotite crystals plus aligned xenoliths, muscovite flakes accentuate foliation, and metasedimentary xenoliths include banded cordierite gneiss*. The geology map identifies a fault trend, Crackenback Fault, along the site southeast boundary following the line of Thredbo River.

The site overlaying NSW Seamless Geology map with 10m contours are presented in Figure 2 below.

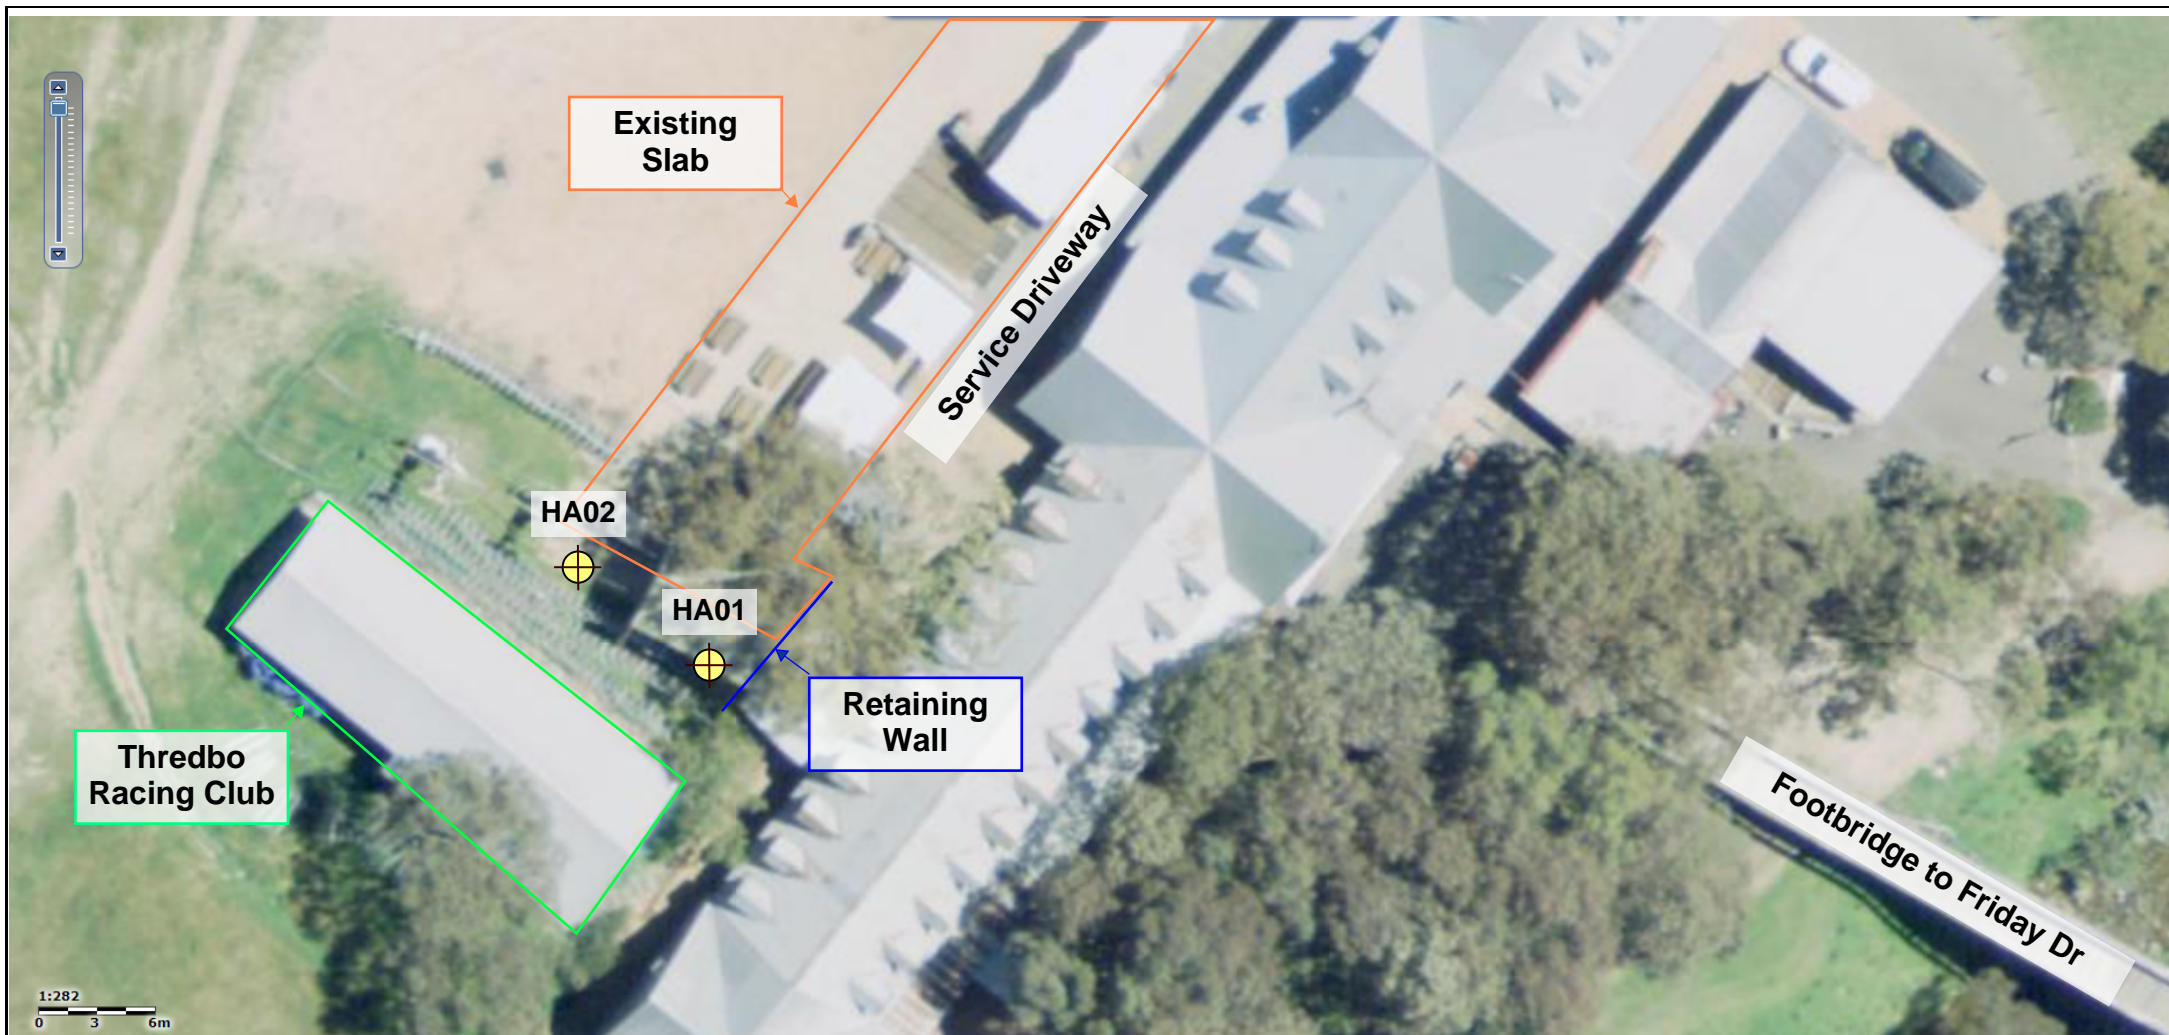
Figure / Drawing Number:	15282-GR-1-A
Figure / Drawing Date:	06 June 2022
Report Number:	15282

Selected photographs taken during the fieldwork are presented in Appendix A and the approximate borehole locations are shown on the Geotechnical Investigation Plan (Drawing 15282-GR-1-A) presented in Appendix B.

Geotechnical Investigation Plan
