# Geotechnical Investigation Report

Project  
**Proposed Temporary Mountain Bike Storage Unit  
Kosciuszko Chairlift Base, Thredbo NSW**

Prepared for  
**Kosciusko Thredbo Pty Ltd**

Report No  
**15282-GR-1-1**

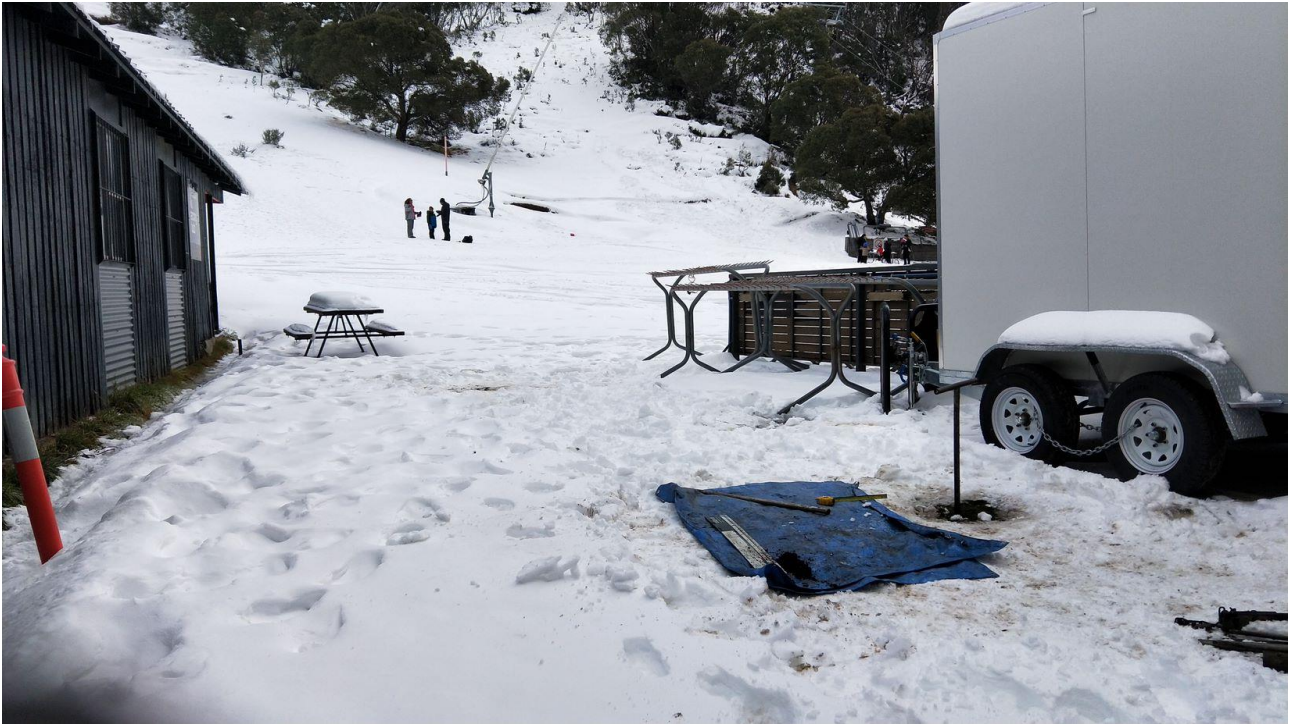
**Photo 1 – Borehole HA01 location, looking northwest**

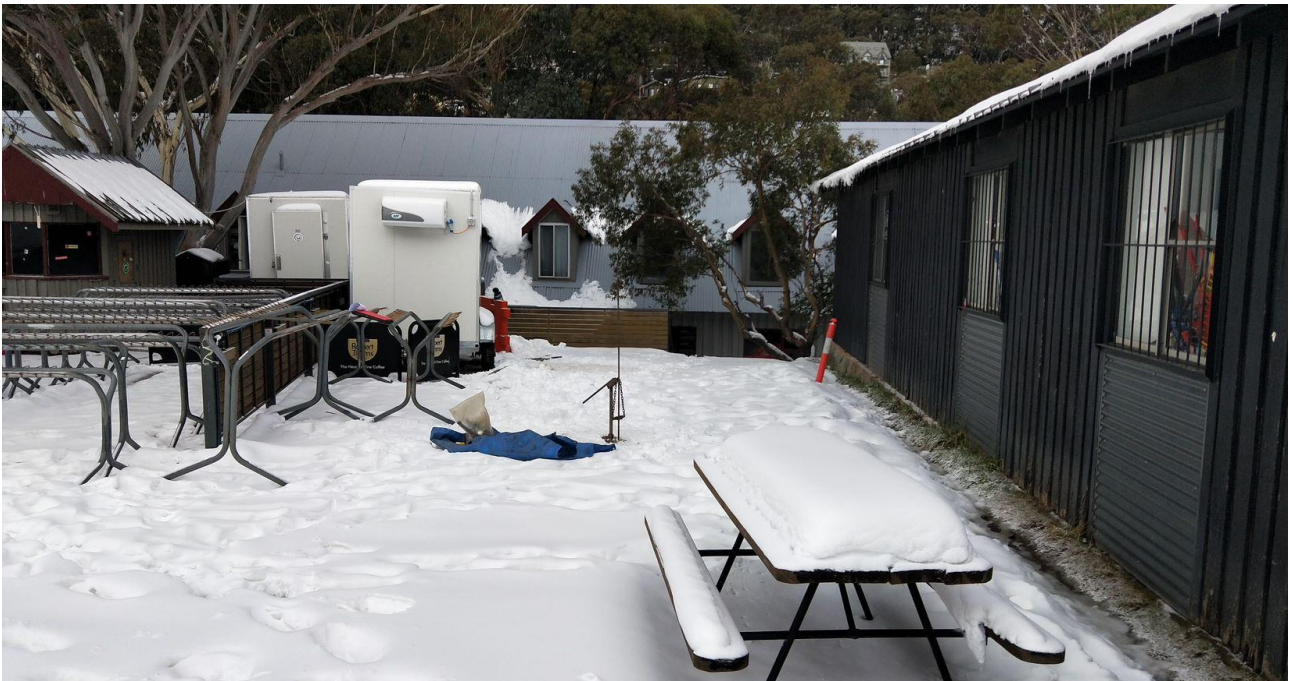
**Photo 2 – Site location shown relative to the adjacent retaining wall, looking southeast.**

- Necessary checks should be given to the adjacent structures. Loading within the zone of influence of the existing retaining wall may cause potential failure if soil pressure imposed by the load is not considered.
- Consideration must be given to the properties of the fill material, given the varying soil type across the encountered soil profile if it is to be used as the foundation layer.
- Presence of high plasticity clay layer which is sensitive to moisture changes should be noted during excavation and construction.

The effect of temporary excavation and loading on adjacent structures, in this case the assembly building on the southwest and the retaining wall on the southeast of the project location, should be noted. A dilapidation survey of any nearby structures (within the zone of influence of the proposed structure) and infrastructure is recommended to be undertaken by a structural engineer prior to the commencement of any site excavations. The report should include precise measurements of the existing defects and cracks presented with relevant photos.

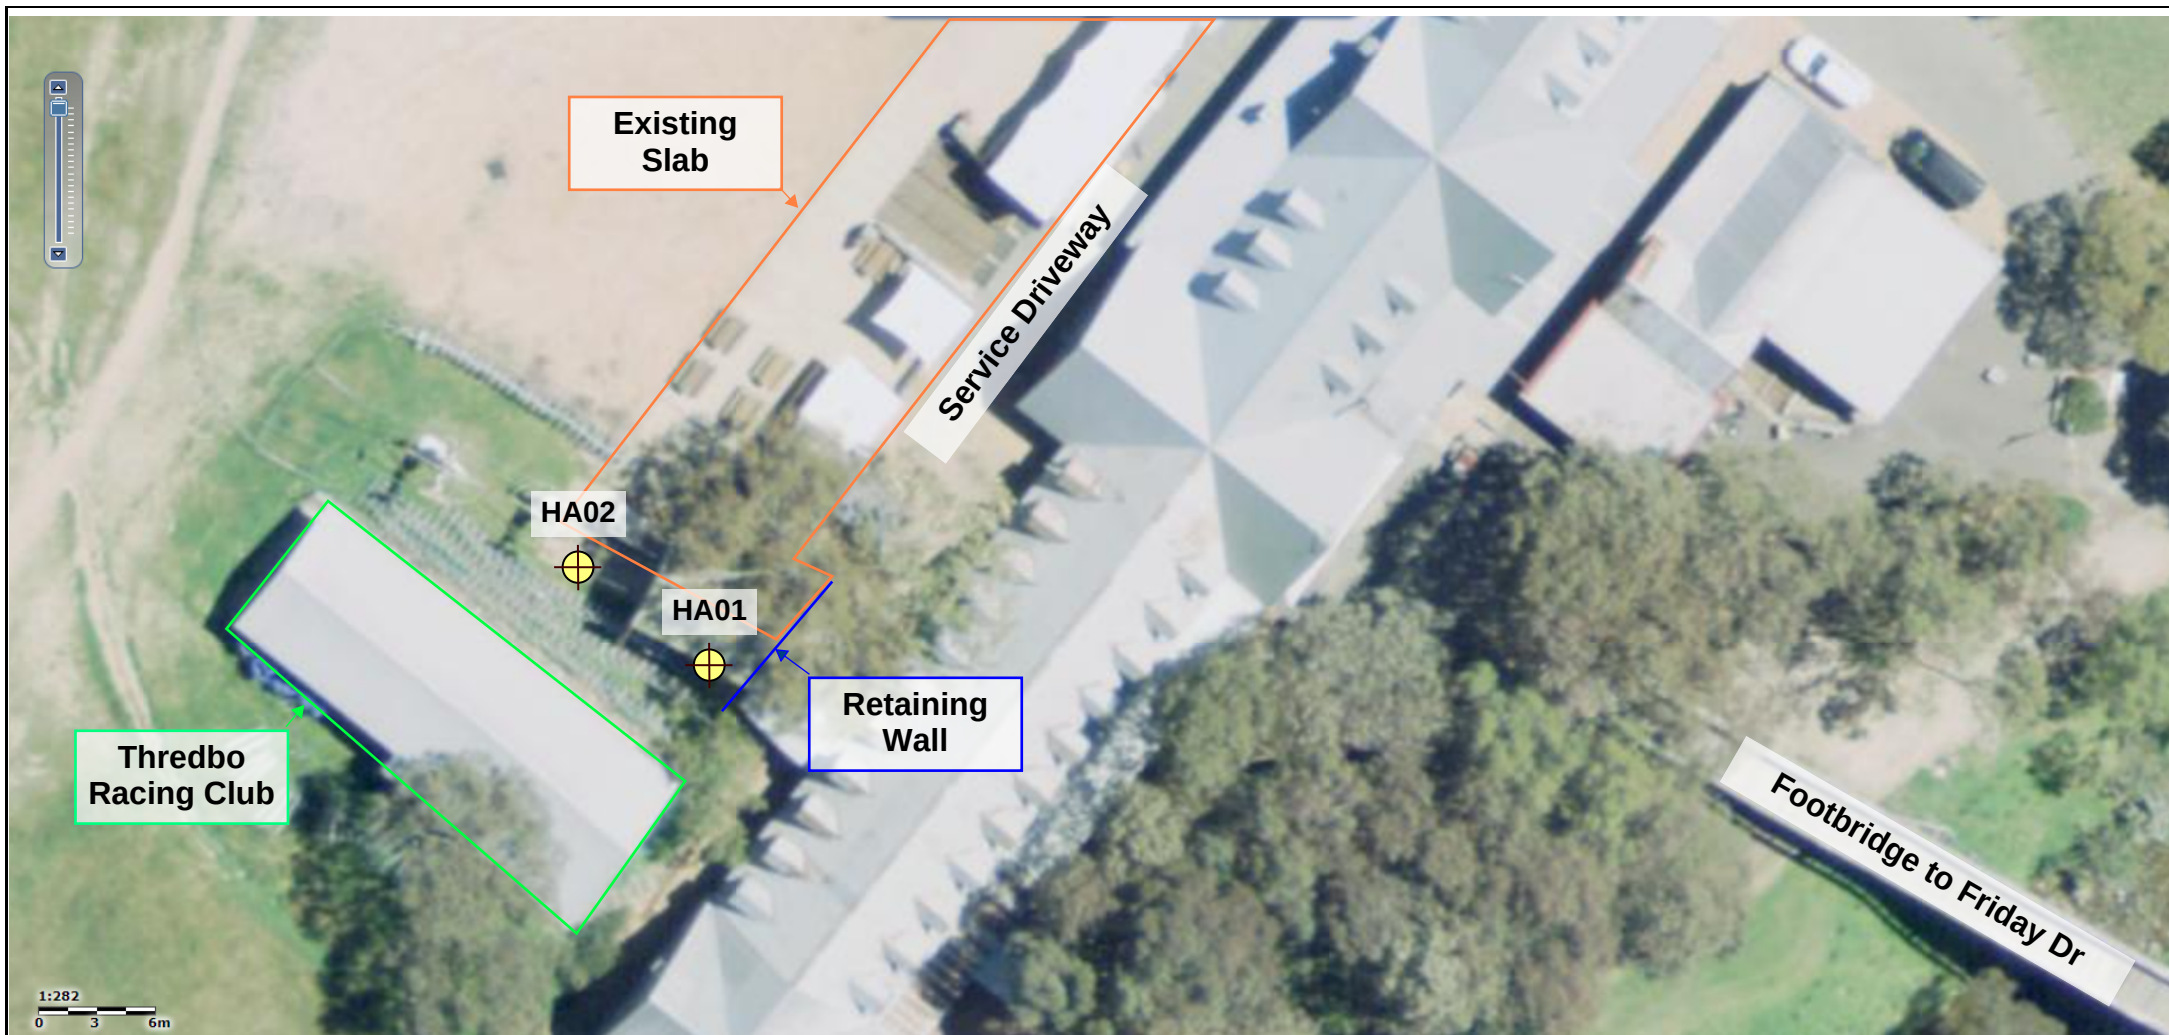
| | Client Name: | Kosciuszko Thredbo Pty Ltd | Figure / Drawing Number: | 15282-GR-1-A | |

| Legend | |
|---|---|
| | - Indicative Borehole and DCP Location |

# Geotechnical Investigation Plan

Selected photographs taken during the fieldwork are presented in Appendix A and the approximate borehole locations are shown on the Geotechnical Investigation Plan (Drawing 15282-GR-1-A) presented in Appendix B.
