Report on Geotechnical Investigation

Blueys Beach Residential Development

50522033-001.1

25 August 2022

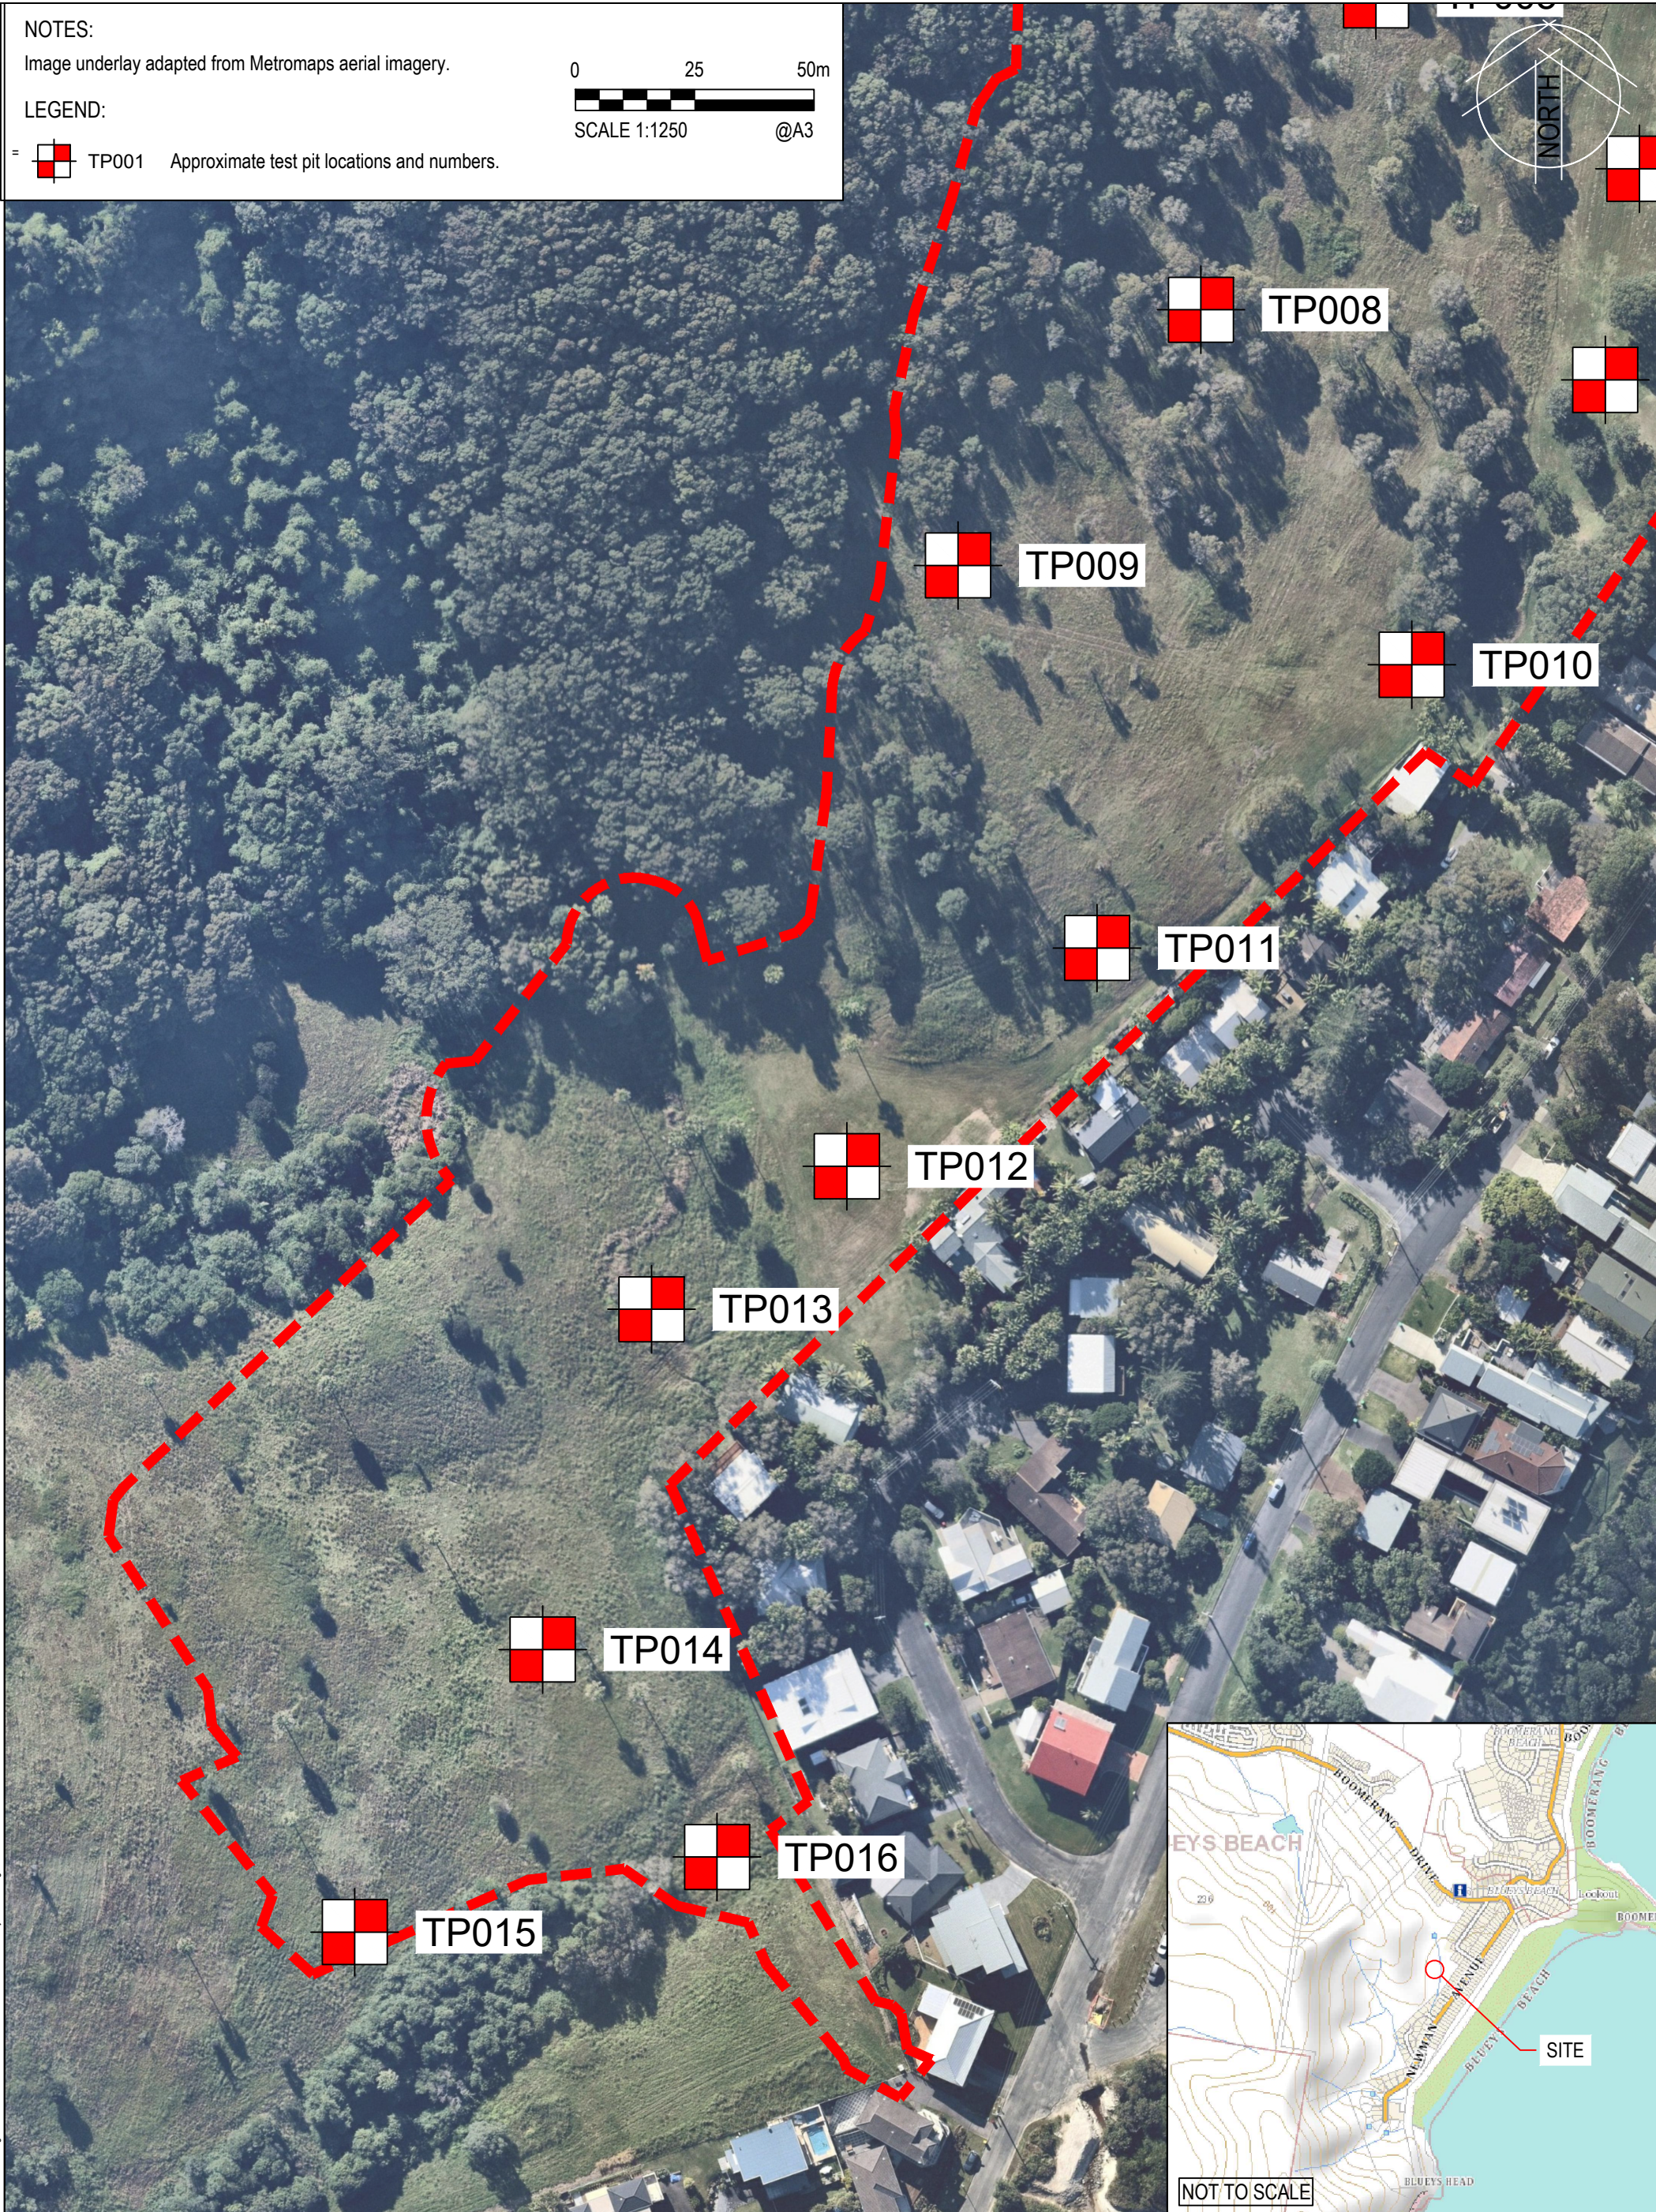
NOTES:
Image underlay adapted from Metromaps aerial imagery.

LEGEND:
TP001 Approximate test pit locations and numbers.

- > A site walkover by a geotechnical engineer from Stantec, including visual appraisal and recording of salient site conditions and features.
- > Excavation of 17 test pits and logging of subsurface conditions within the proposed allotment areas and future road alignments. Test pits were excavated utilising a 13.5-tonne excavator fitted with an 900mm toothed bucket to depths ranging from 0.95-3.5 m below existing ground level (bgl), with refusal (including slow progress termination) in the underlying weathered rock encountered in test pits TP002-TP004, TP008-TP012, TP014 and TP015. Test pit locations are shown on Figures 1-4 attached in Appendix A.
