## **GUTHRIE'S DOUBLE CHAIR LIFT CHARLOTTE PASS SNOW RESORT**

**GEOTECHNICAL INVESTIGATION REPORT**

5 May 2021

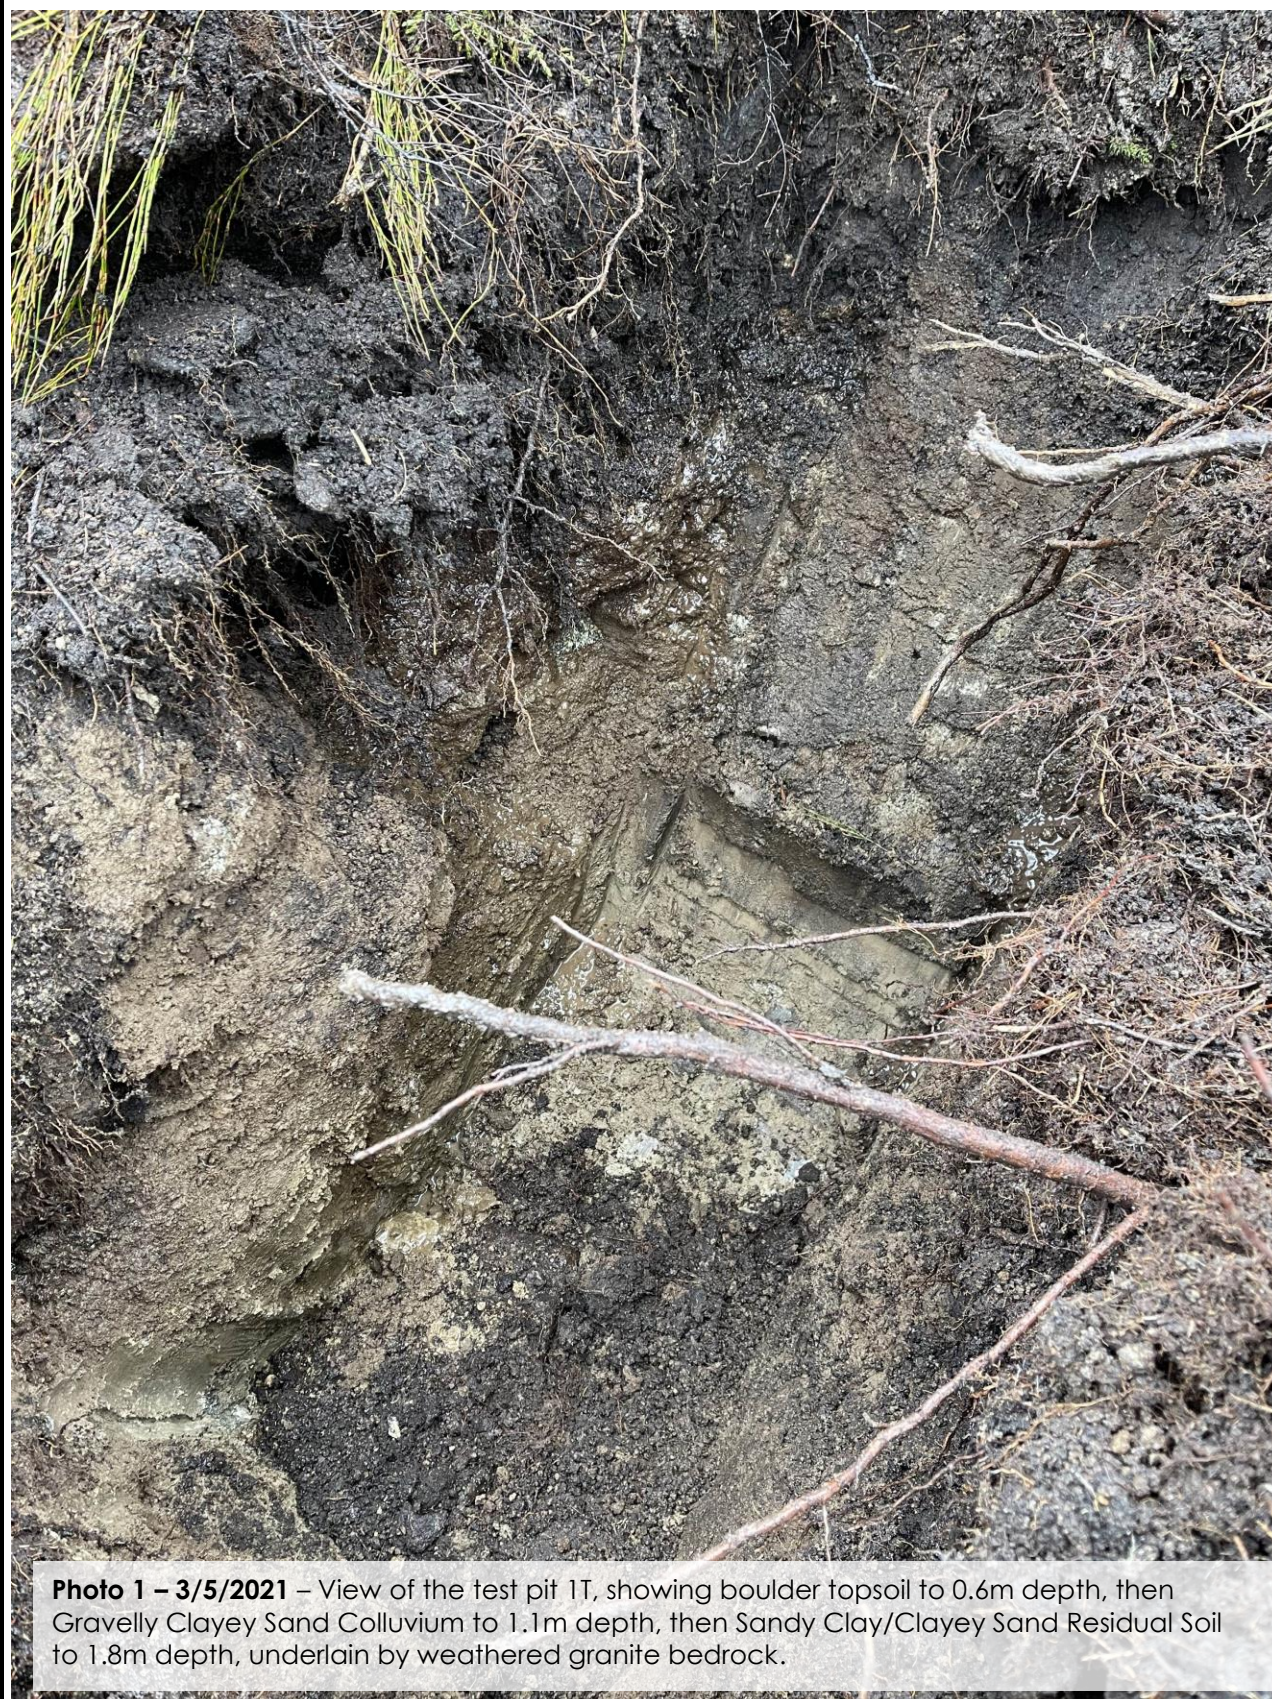
**FIGURE 5**

**Photo 1 – 3/5/2021** – View of the test pit 1T, showing boulder topsoil to 0.6m depth, then Gravelly Clayey Sand Colluvium to 1.1m depth, then Sandy Clay/Clayey Sand Residual Soil to 1.8m depth, underlain by weathered granite bedrock.

Test Pit No.	Depth to Weathered Granite Bedrock
1T	1.8m
2T	1.2m
3T	0.9m
4T	1.1m

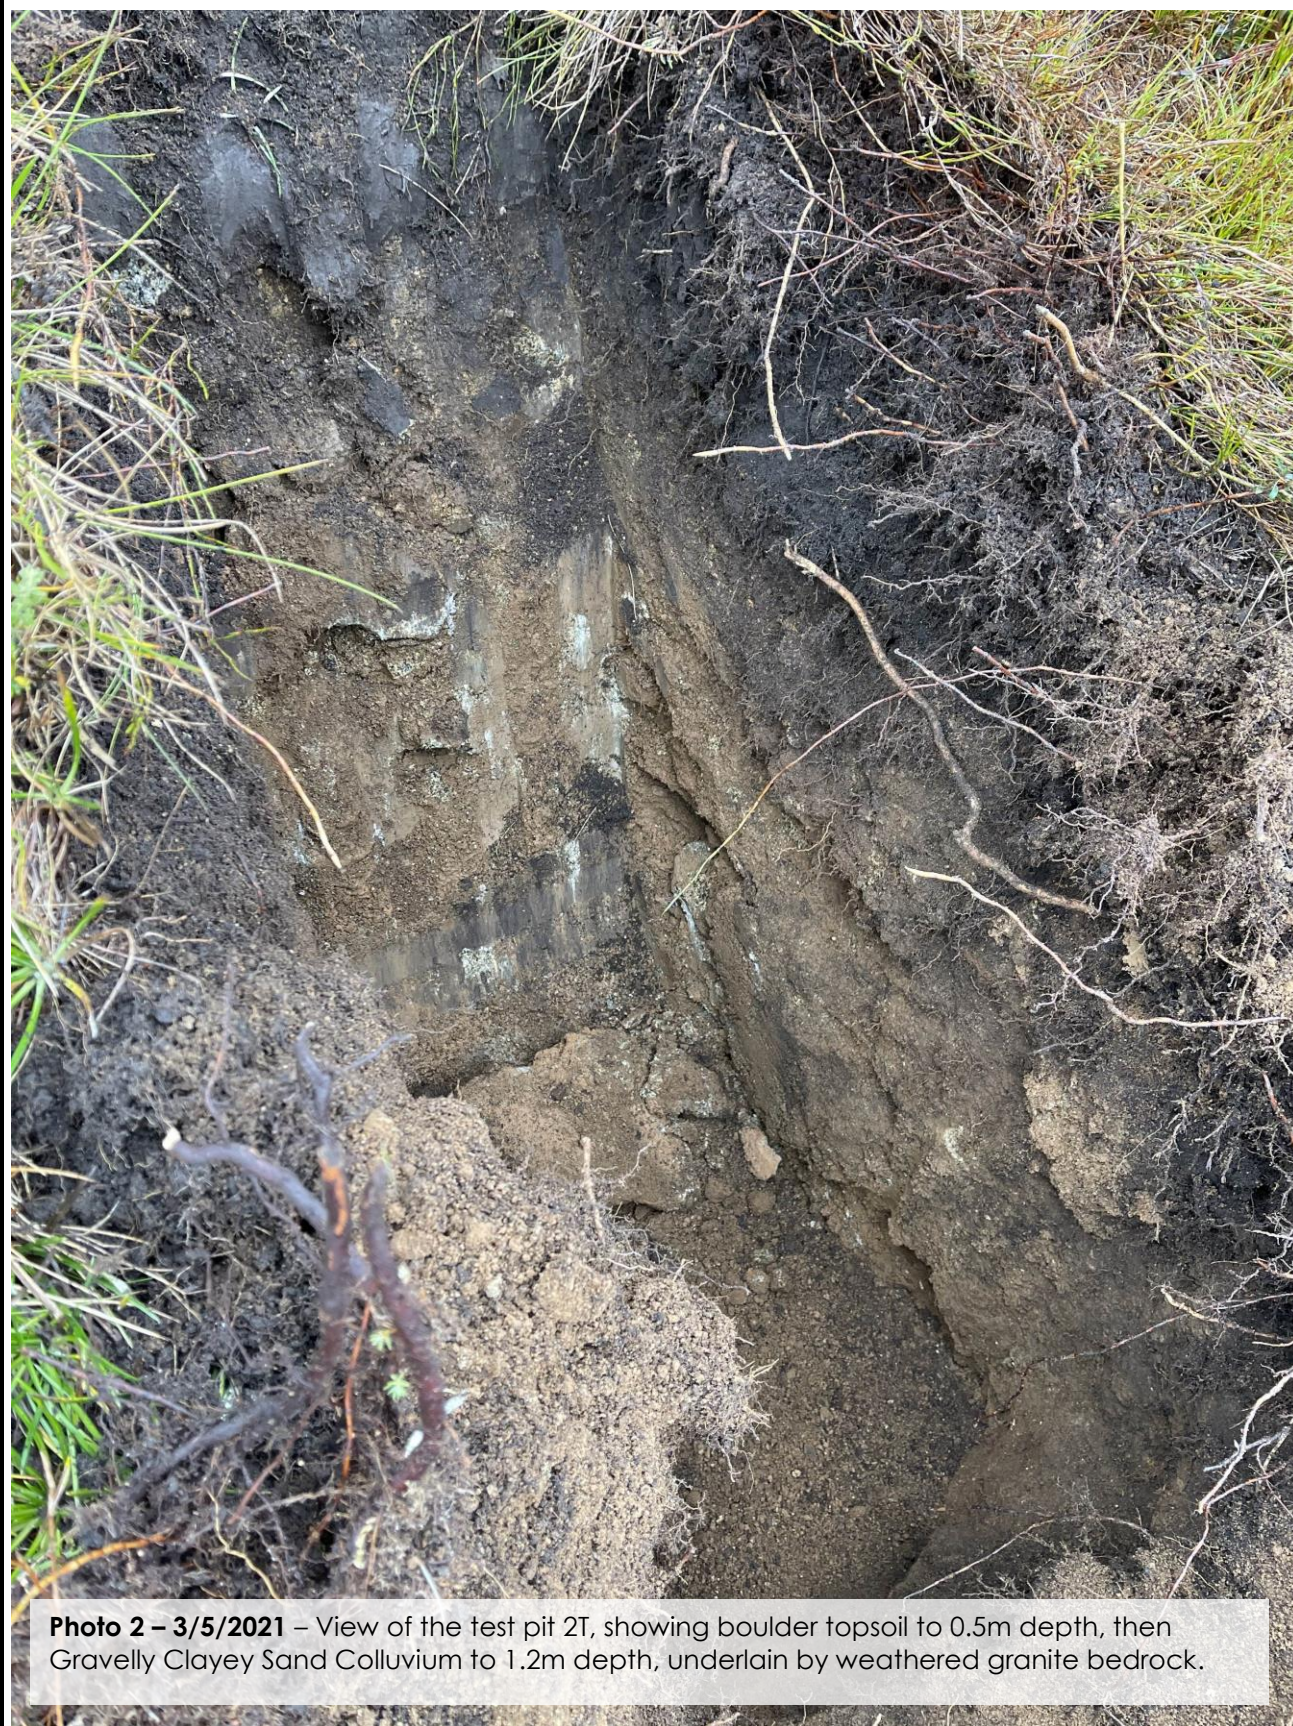
**Photo 2 – 3/5/2021** – View of the test pit 2T, showing boulder topsoil to 0.5m depth, then Gravelly Clayey Sand Colluvium to 1.2m depth, underlain by weathered granite bedrock.

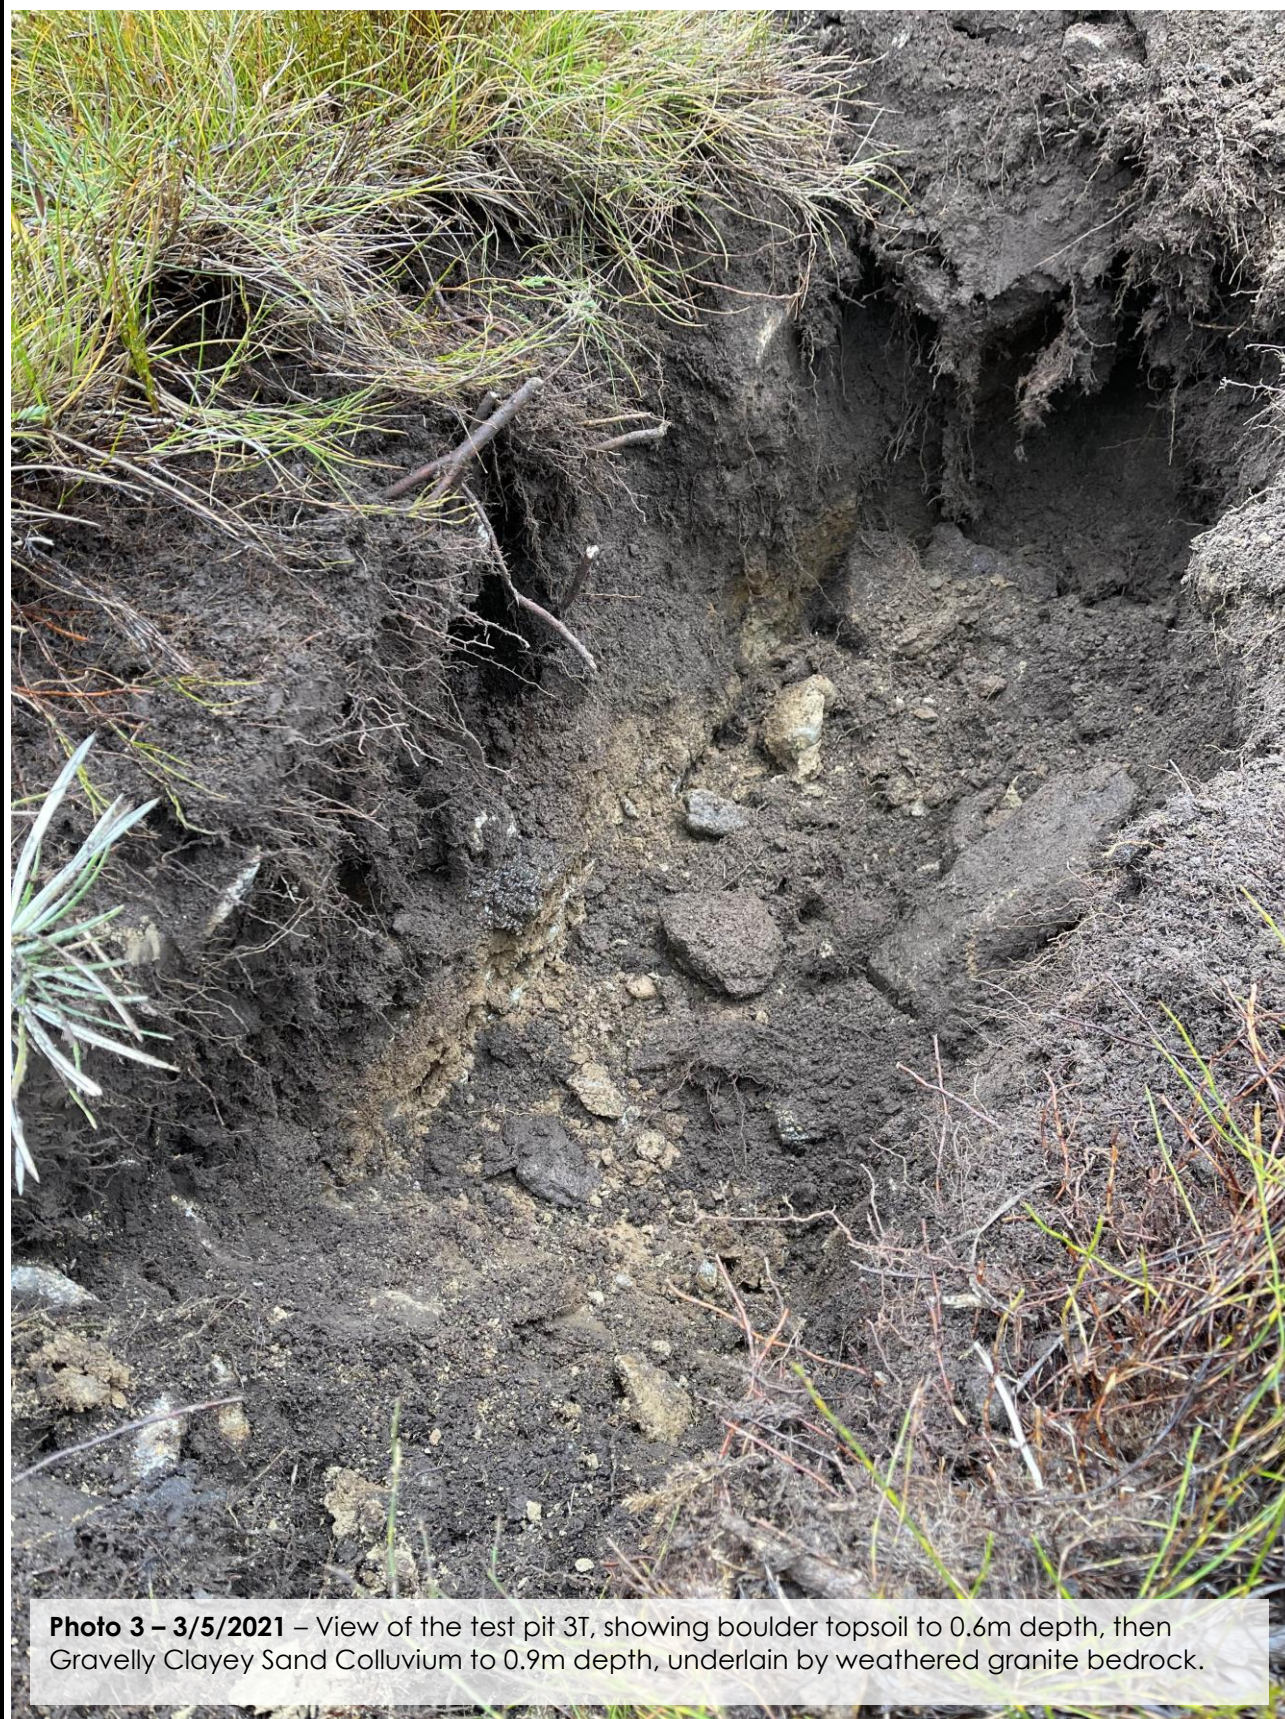
**FIGURE 7**

**Photo 3 – 3/5/2021** – View of the test pit 3T, showing boulder topsoil to 0.6m depth, then Gravelly Clayey Sand Colluvium to 0.9m depth, underlain by weathered granite bedrock.

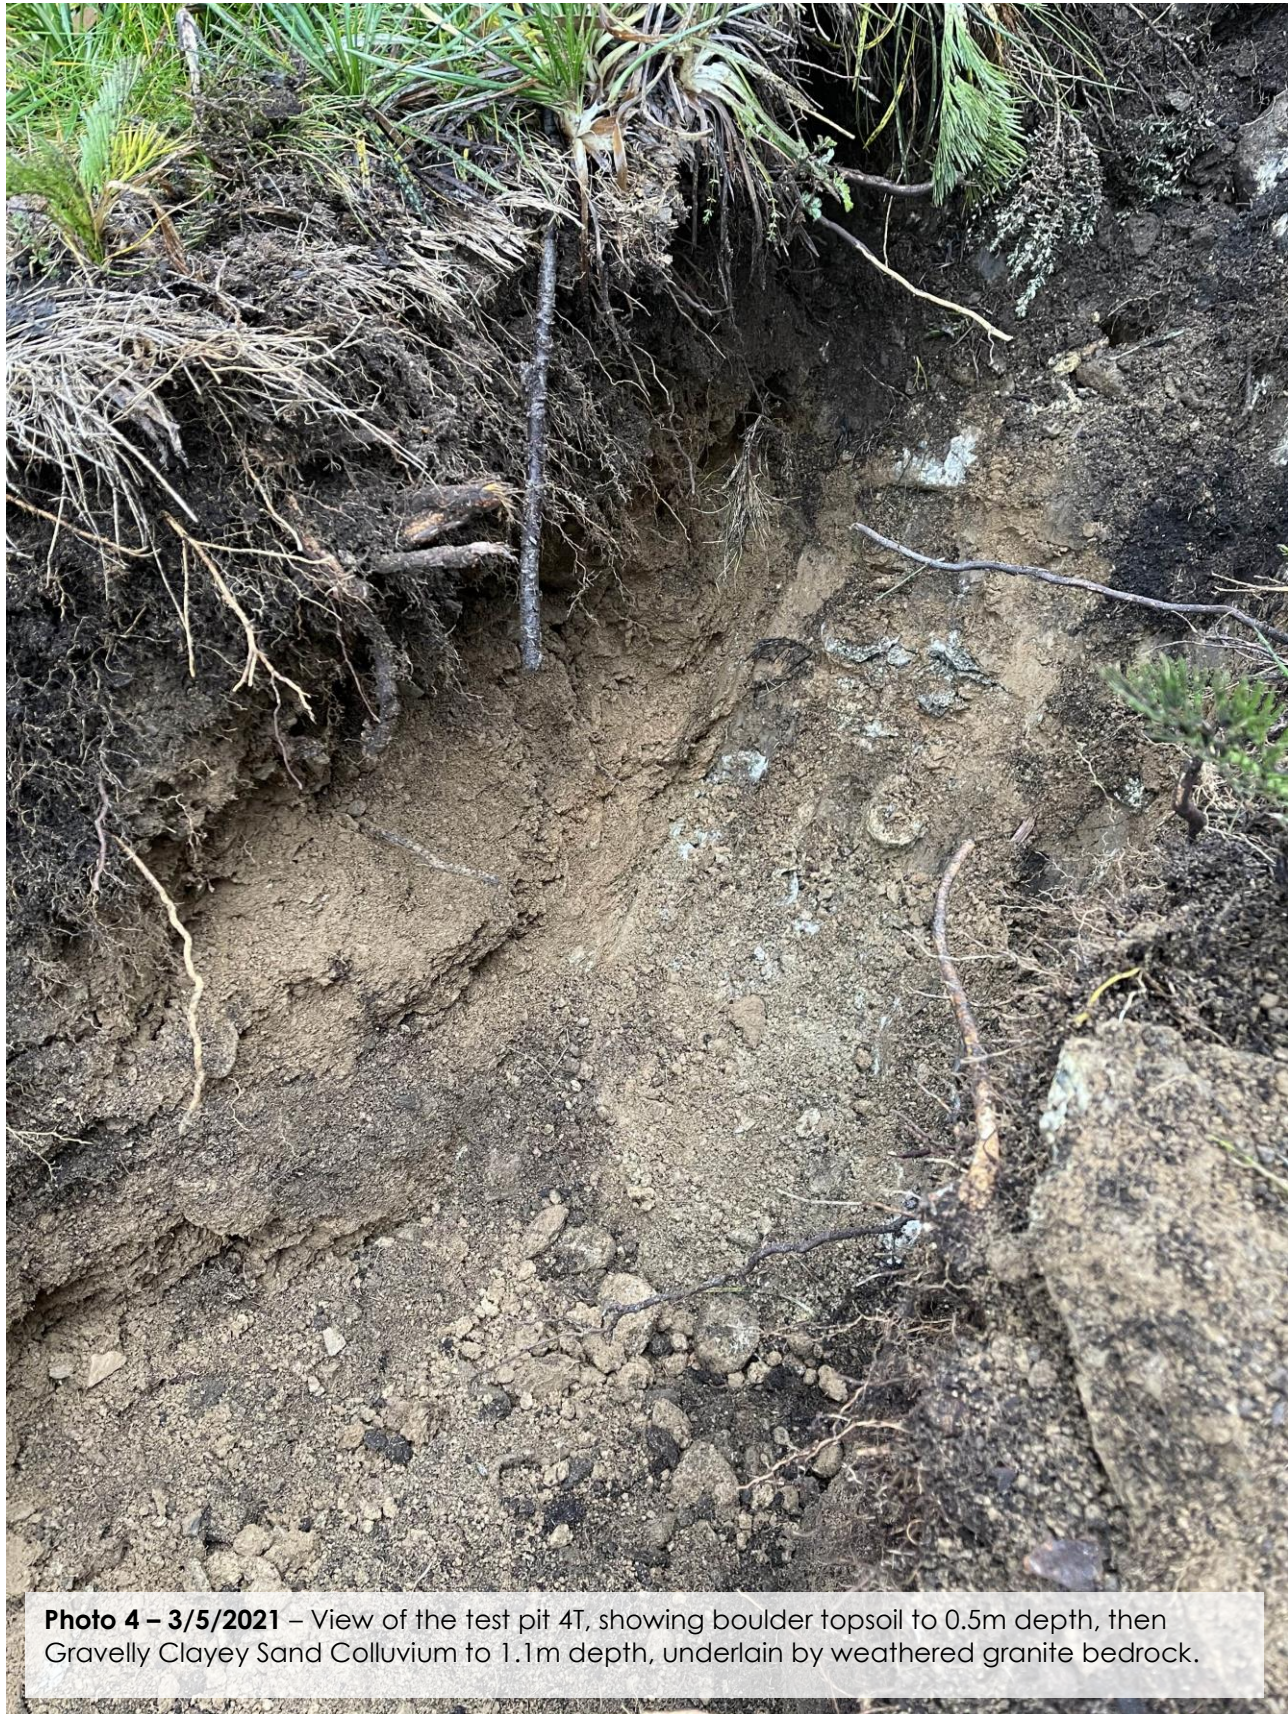
**FIGURE 8**

**Photo 4 – 3/5/2021** – View of the test pit 4T, showing boulder topsoil to 0.5m depth, then Gravelly Clayey Sand Colluvium to 1.1m depth, underlain by weathered granite bedrock.
