Inspection Report—Condition Report

78 GEORGE STREET GRENFELL 2810

INSPECTION REPORT

- *Condition of Buildings that provide facilities for Retail Premises trading as Oliver's Hardware
To support a proposed application to Demolition/develop site*

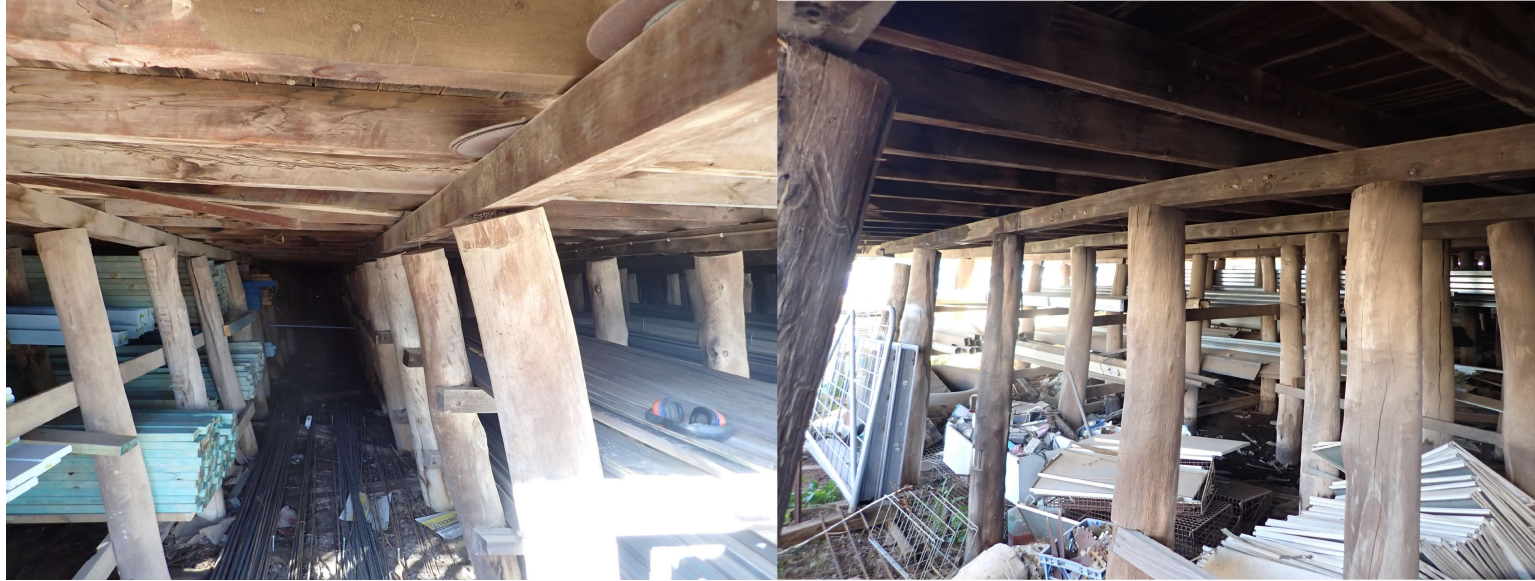
Sub Floor Frame: Main Building

Timber stump piers
Evidence of Movement off Framework

1. Failure of sub floor frame
2. Damaged/missing/failed support piers
3. Failed Guttering
4. Damaged Roof Framework

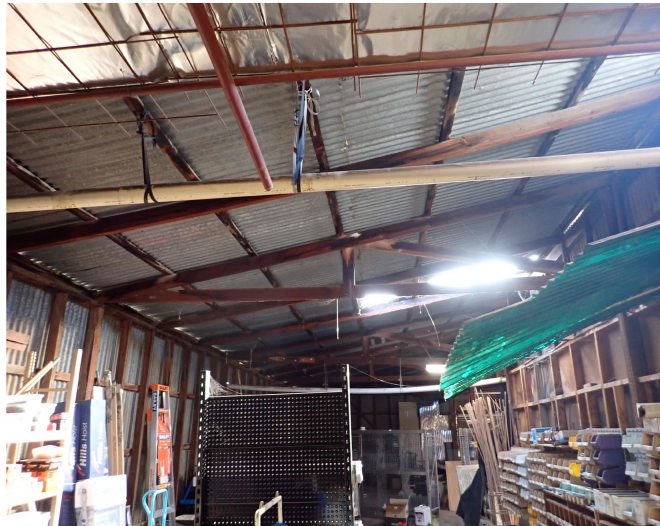
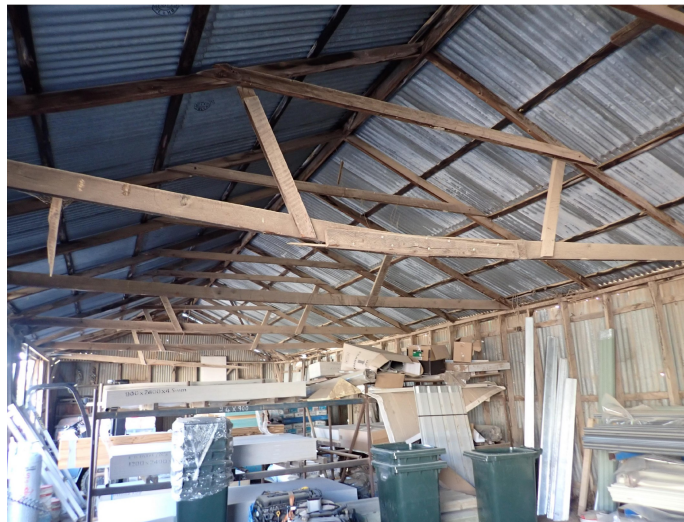
Internal Framework: (Main/secondary sheds)

Broken structural Members

Water staining
