**SELWYN SNOW RESORT REDEVELOPMENT**

**KINGS CROSS ROAD, CABRAMURRA, NSW**

**GEOTECHNICAL INVESTIGATION & SLOPE STABILITY RISK ASSESSMENT  
SUPPLEMENTARY REPORT**

**SEPTEMBER 2020**

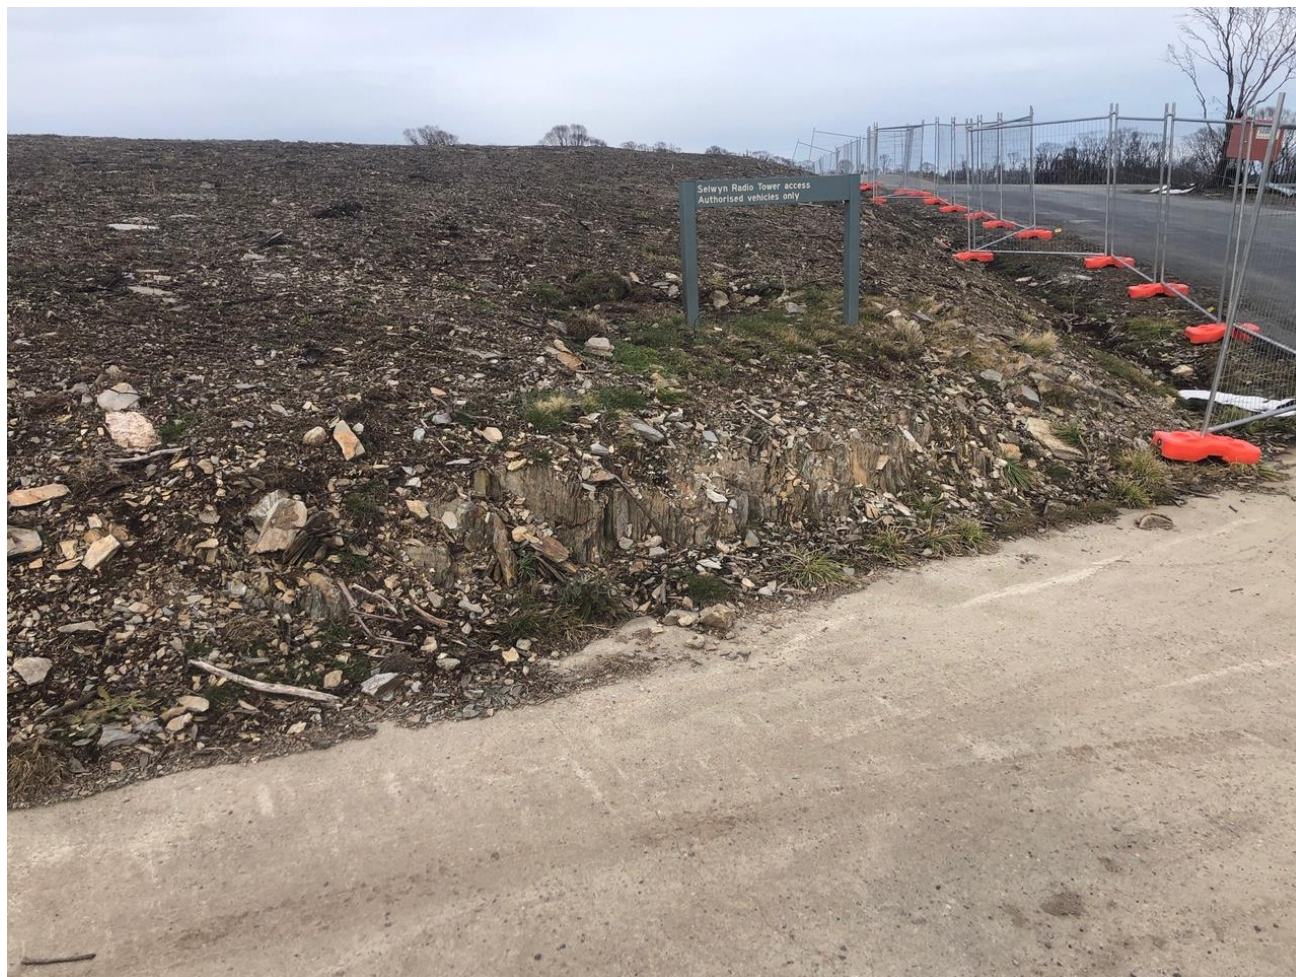
**FIGURE 13**

**Photo 6 – 10/7/2020** – View of an existing cutting on the corner of Kings Cross Road and Selwyn Trail (near NW corner of the proposed Guest Facilities building), showing slate bedrock at shallow depth.
