**Re: Supplemental Aboriginal Due Diligence Heritage Advice – Mt Selwyn Snow Resort**

This letter report provides Aboriginal heritage advice for the proposed redevelopment of the Mt Selwyn Snow Resort site located at Lot 36 DP46316, 213A Kings Cross Road Kiandra within the Kosciuszko National Park. The resort was destroyed by bushfires in 2020 and the proposed redevelopment includes a new resort operations centre providing staff facilities, ski patrol office, groomer and ski-doo storage and vehicle repair station.

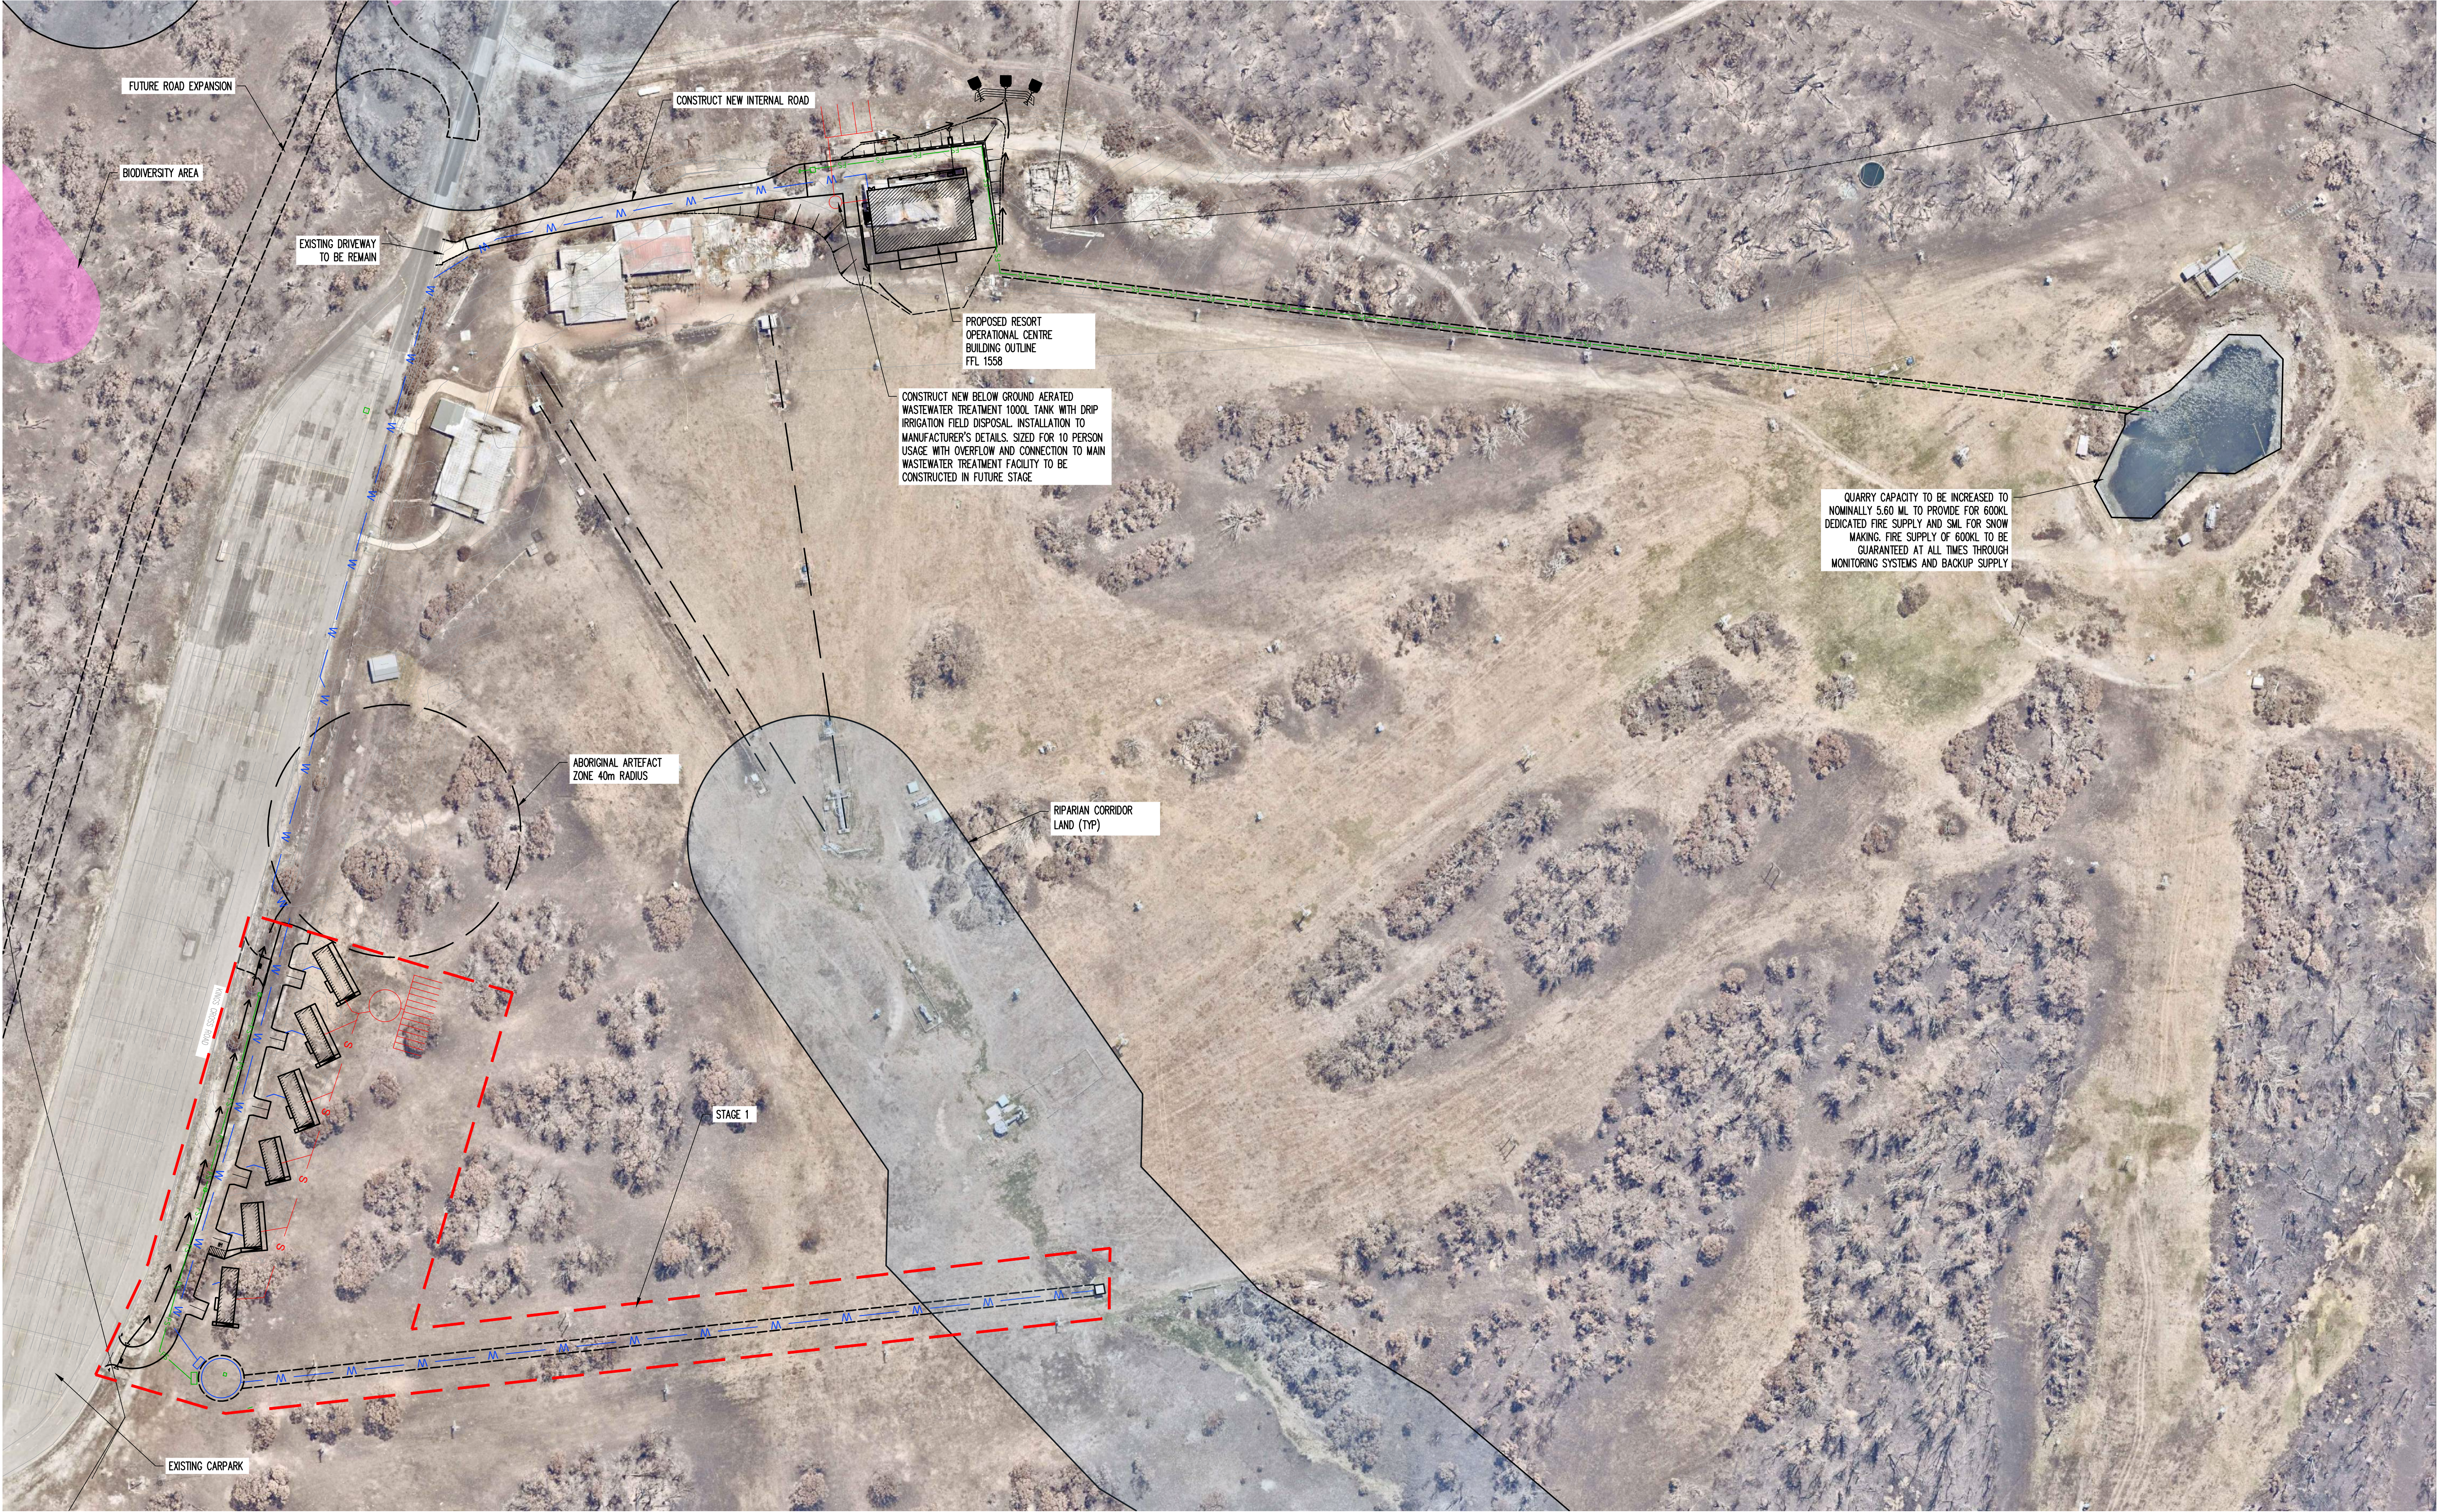
The area of trenching works and the relationship to the identified site are shown on figure 1.

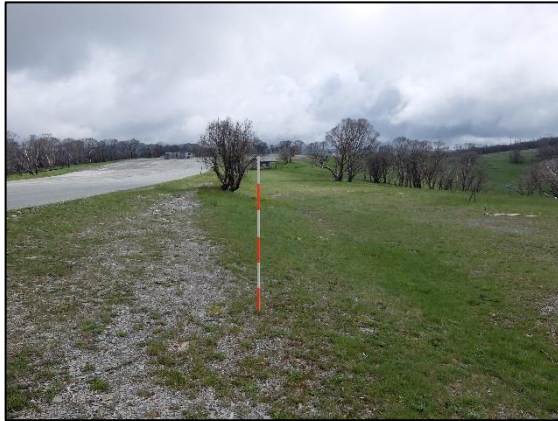
Plate 1. Looking north along road corridor

- ❖ Construction of the main sealed road feature;
- ❖ A gravel and earth bund approximately 10 metres wide directly adjacent to the eastern margin of the sealed road;

- ❖ A graded and levelled ancillary vehicle track or service corridor approximately 20 metres wide paralleling the eastern side of the road; and
- ❖ A mechanical push of mixed local soil and imported gravels several metres wide running along the eastern edge of the ancillary track.

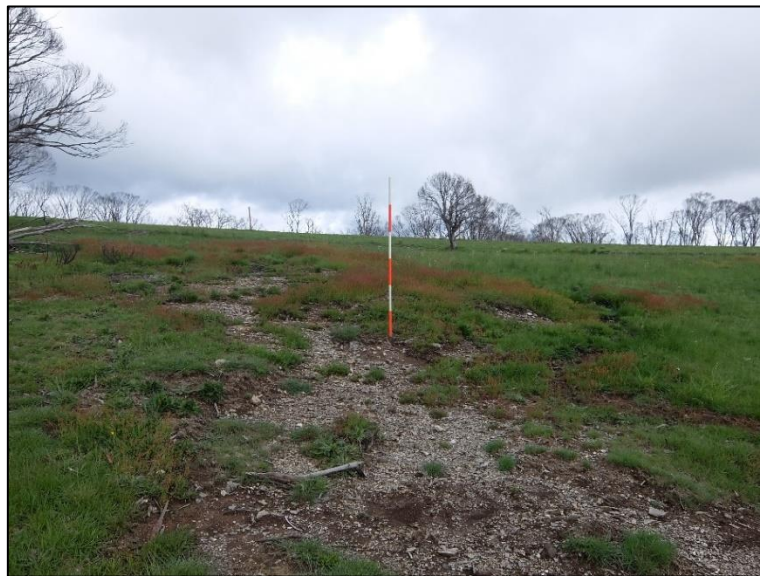
Plate 3. Site location looking south along road alignment.

The location of the artefact scatter site recorded by Feary in 2010 was revisited at GPS refs 630749. 6025330, at the eastern edge of the disturbed road corridor. The location of the recorded site at the time of the field survey is shown in Plate 3.

As noted by Feary in 2010, the location comprises an eroded surface in the upslope vicinity of a natural spring or soak. Landscape position is a low gradient upper slope or ridge side/crest interface. Following the recent bushfire events the surface exposure may be expected to have expanded in extent and during the current inspection was measured at 20m x 5m in area with very high levels of surface visibility. The deposit within the exposure area is a medium to dark brown alpine loam soil of indeterminate depth with a surface lag of locally sourced gravels. Bedrock (likely of metamorphic rock) is apparent in occasional adjacent low outcrops.

The stone artefacts noted by Feary in 2010 were not relocated and no additional archaeological items or features were found during the inspection of the exposure or surrounding landscape surfaces. Given the intervening period between the original artefact recording and the current assessment, it is not surprising that the three stone artefacts apparent at the location in 2010 are no longer visible, particularly considering surficial processes associated with ongoing solifluction, bushfire and bioturbation.
