TSA MANAGEMENT

SELWYN SNOW RESORT REDEVELOPMENT

KINGS CROSS ROAD, CABRAMURRA, NSW

GEOTECHNICAL INVESTIGATION & SLOPE STABILITY RISK ASSESSMENT SUPPLEMENTARY REPORT

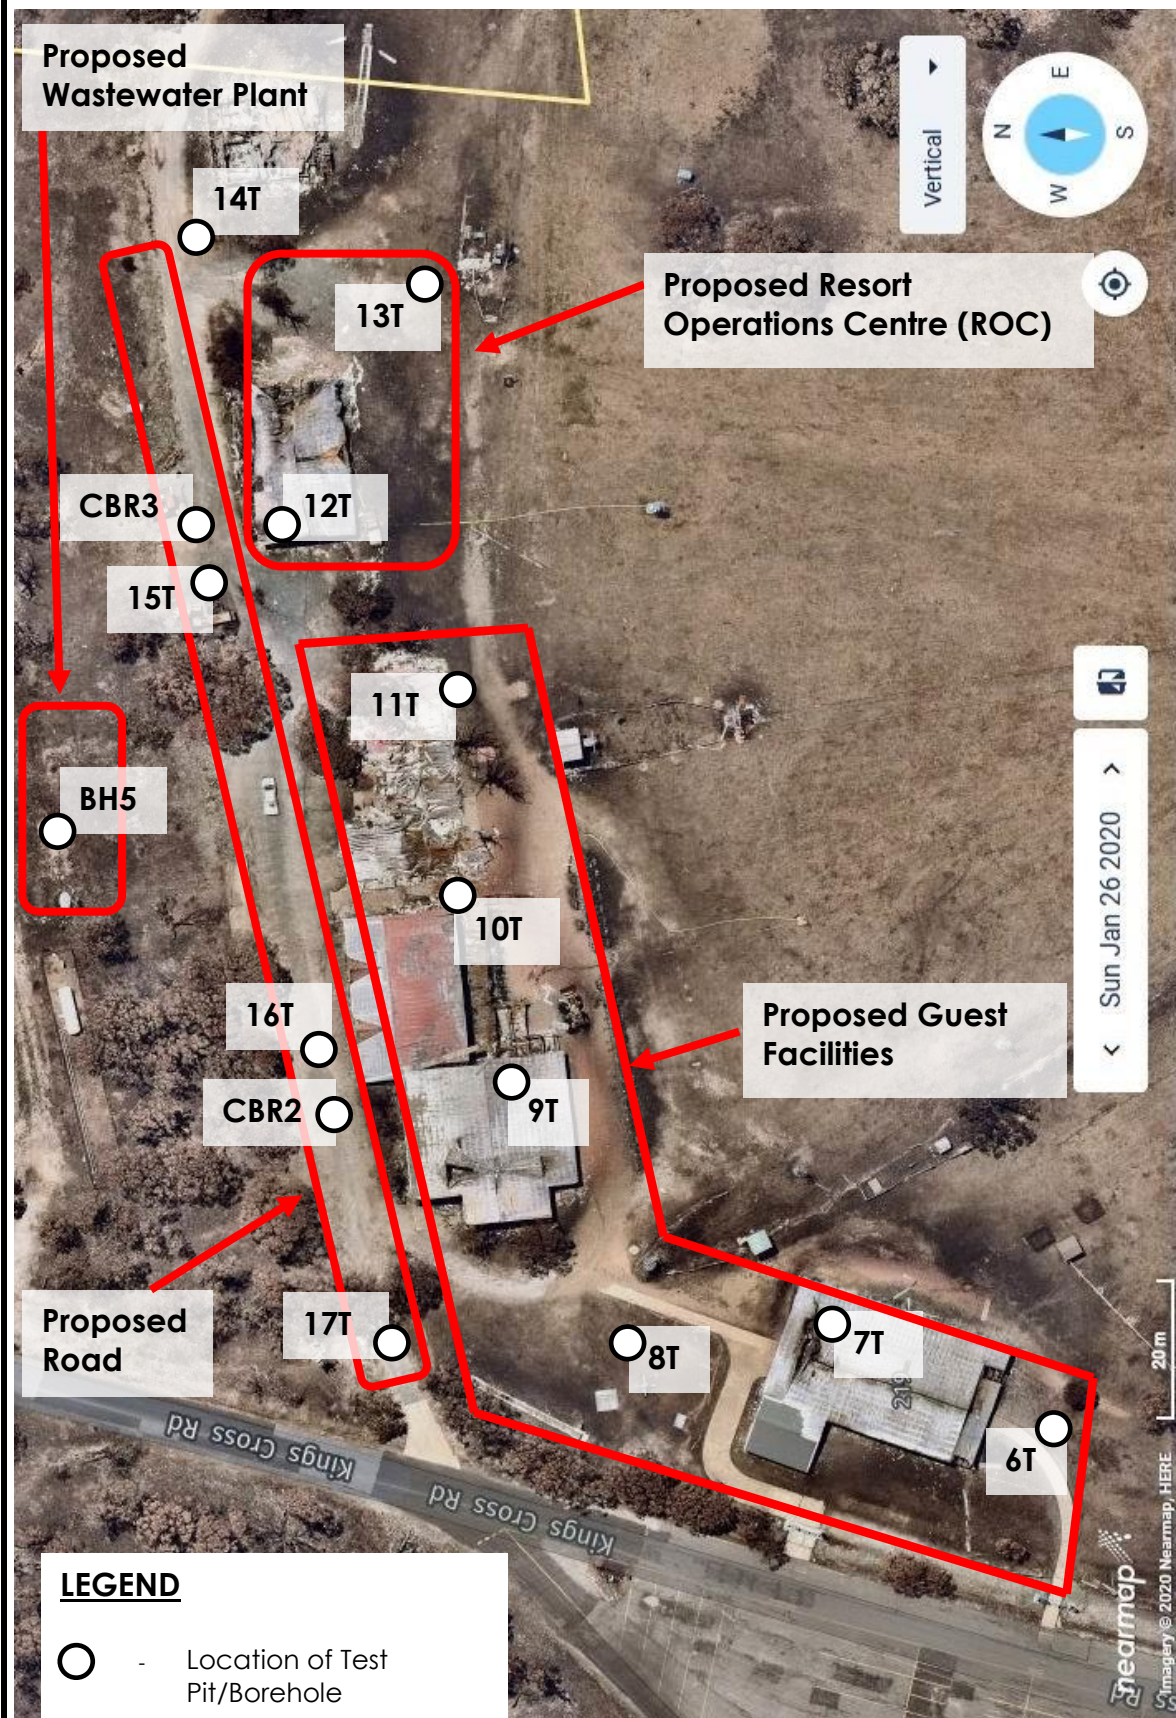
TSA MANAGEMENT
SELWYN SNOW RESORT REDEVELOPMENT
LOCATION OF BOREHOLES – ROAD, ROC & GUEST FACILITIES

Test Pits 14T to 17T and boreholes CBR2 and CBR3 found the following subsurface profile:

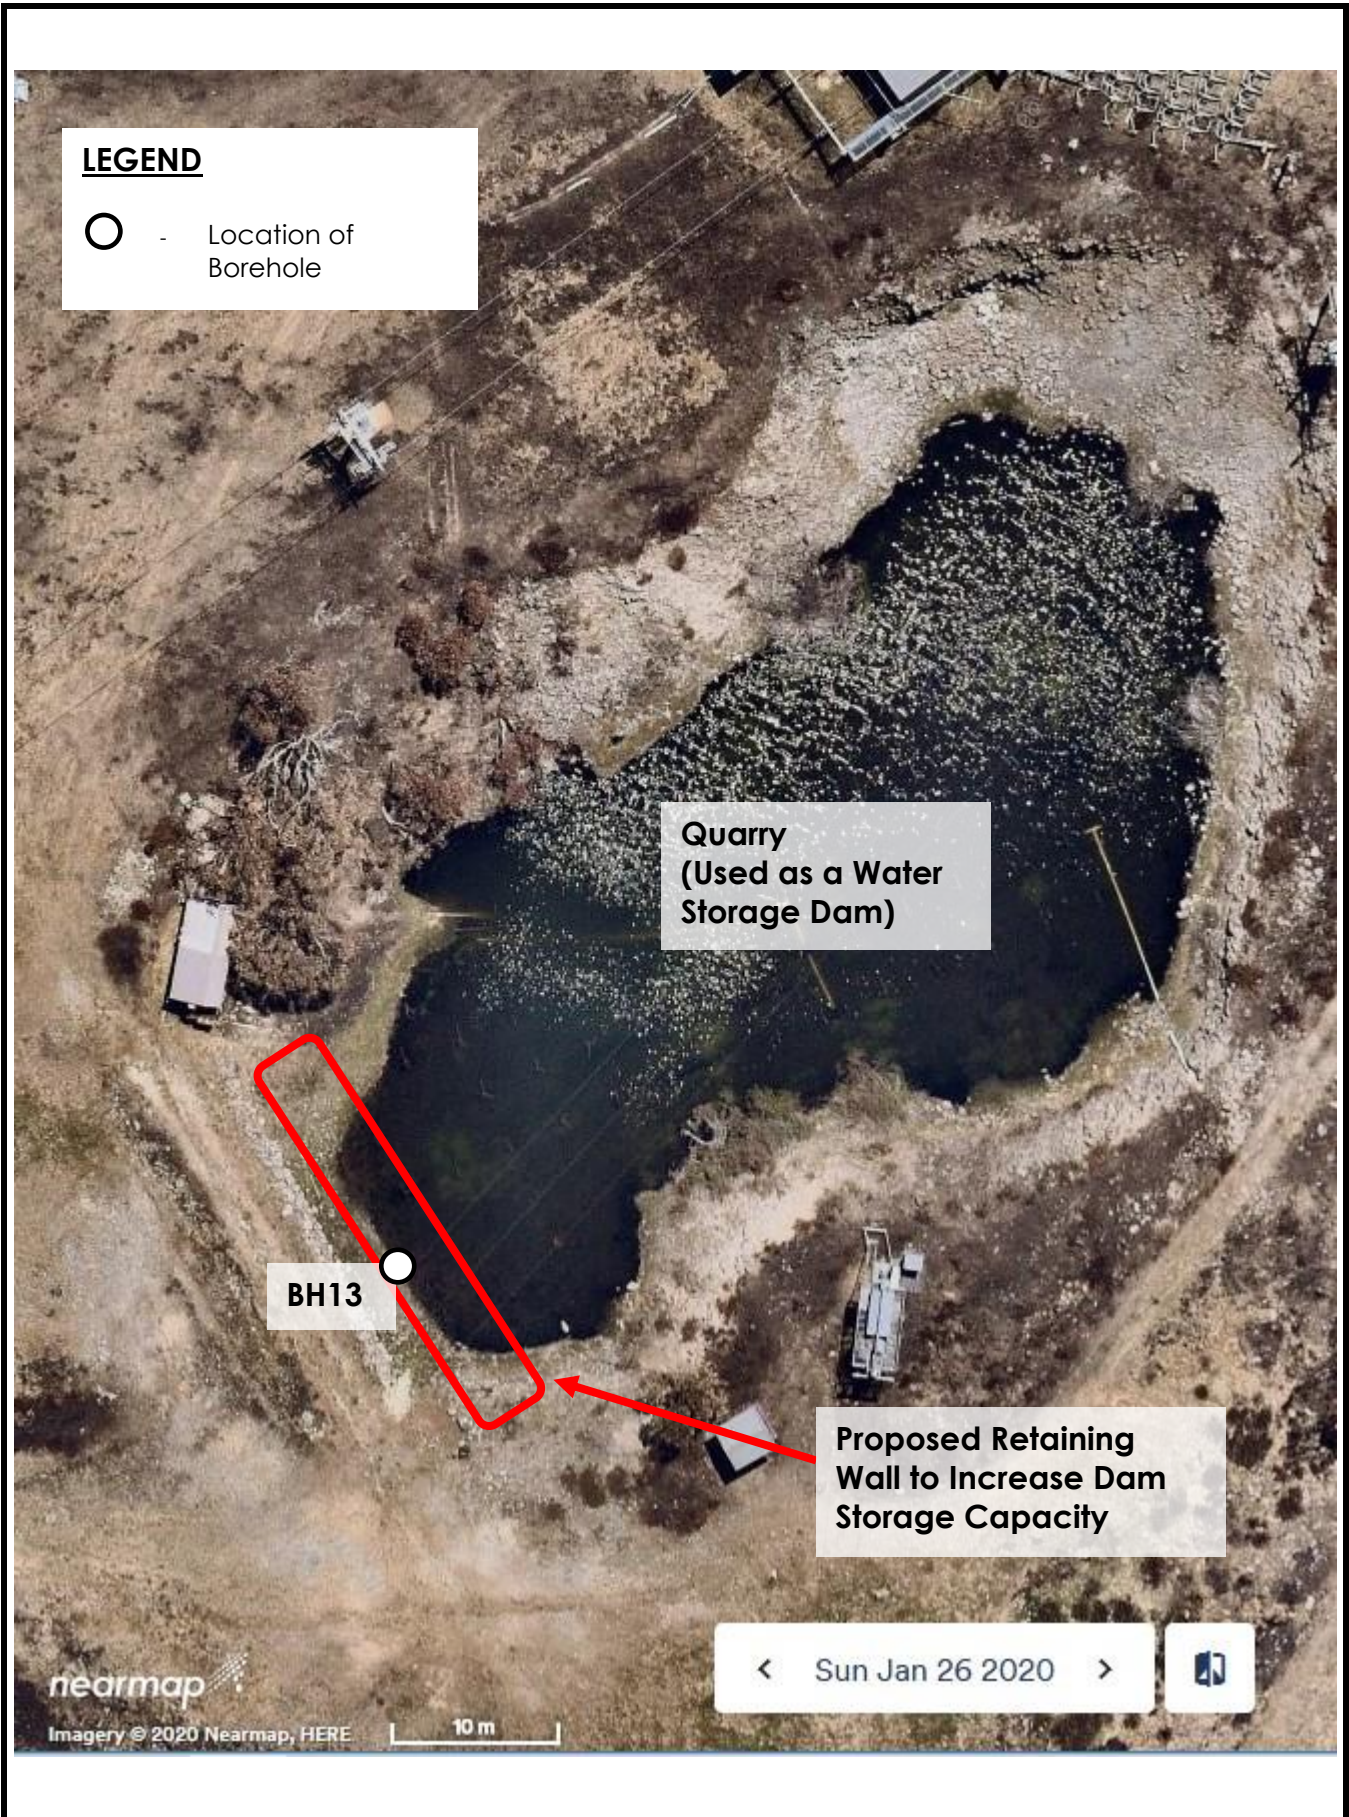
FIGURE 4B

**TSA MANAGEMENT
SELWYN SNOW RESORT REDEVELOPMENT
AERIAL PHOTO & LOCATION OF BOREHOLES – QUARRY**

Borehole BH13 found the following subsurface profile:

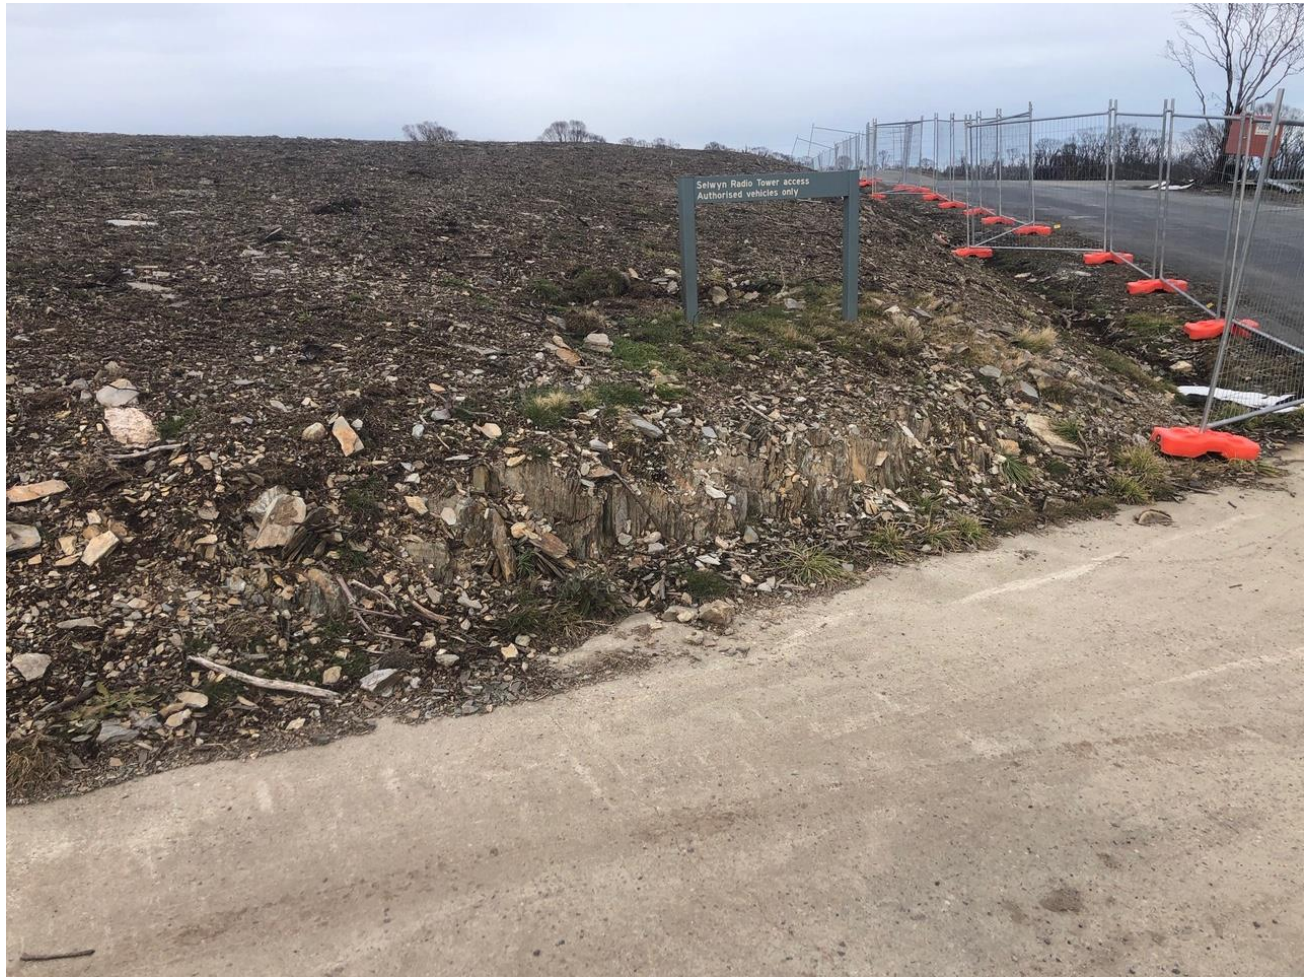
FIGURE 13

Photo 6 – 10/7/2020 – View of an existing cutting on the corner of Kings Cross Road and Selwyn Trail (near NW corner of the proposed Guest Facilities building), showing slate bedrock at shallow depth.

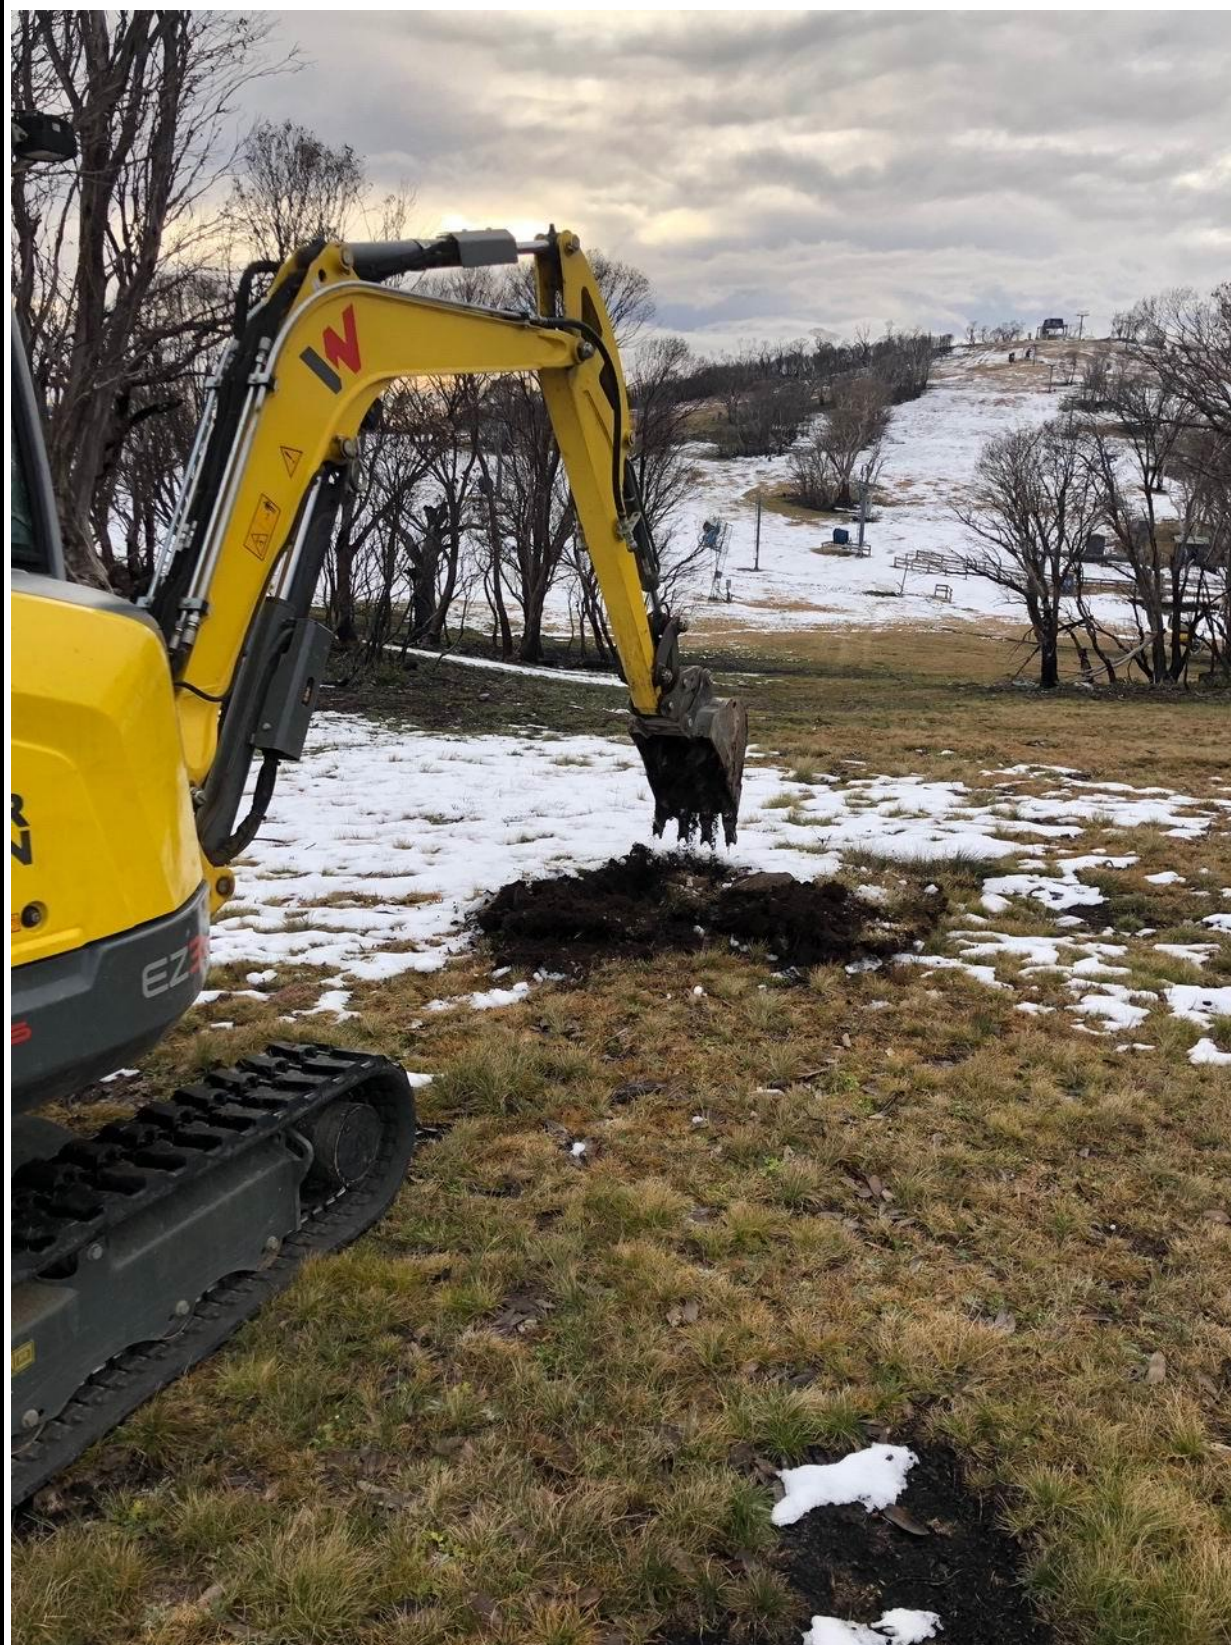
Photo 7 – 10/7/2020 – View of test pit 3T being excavated.

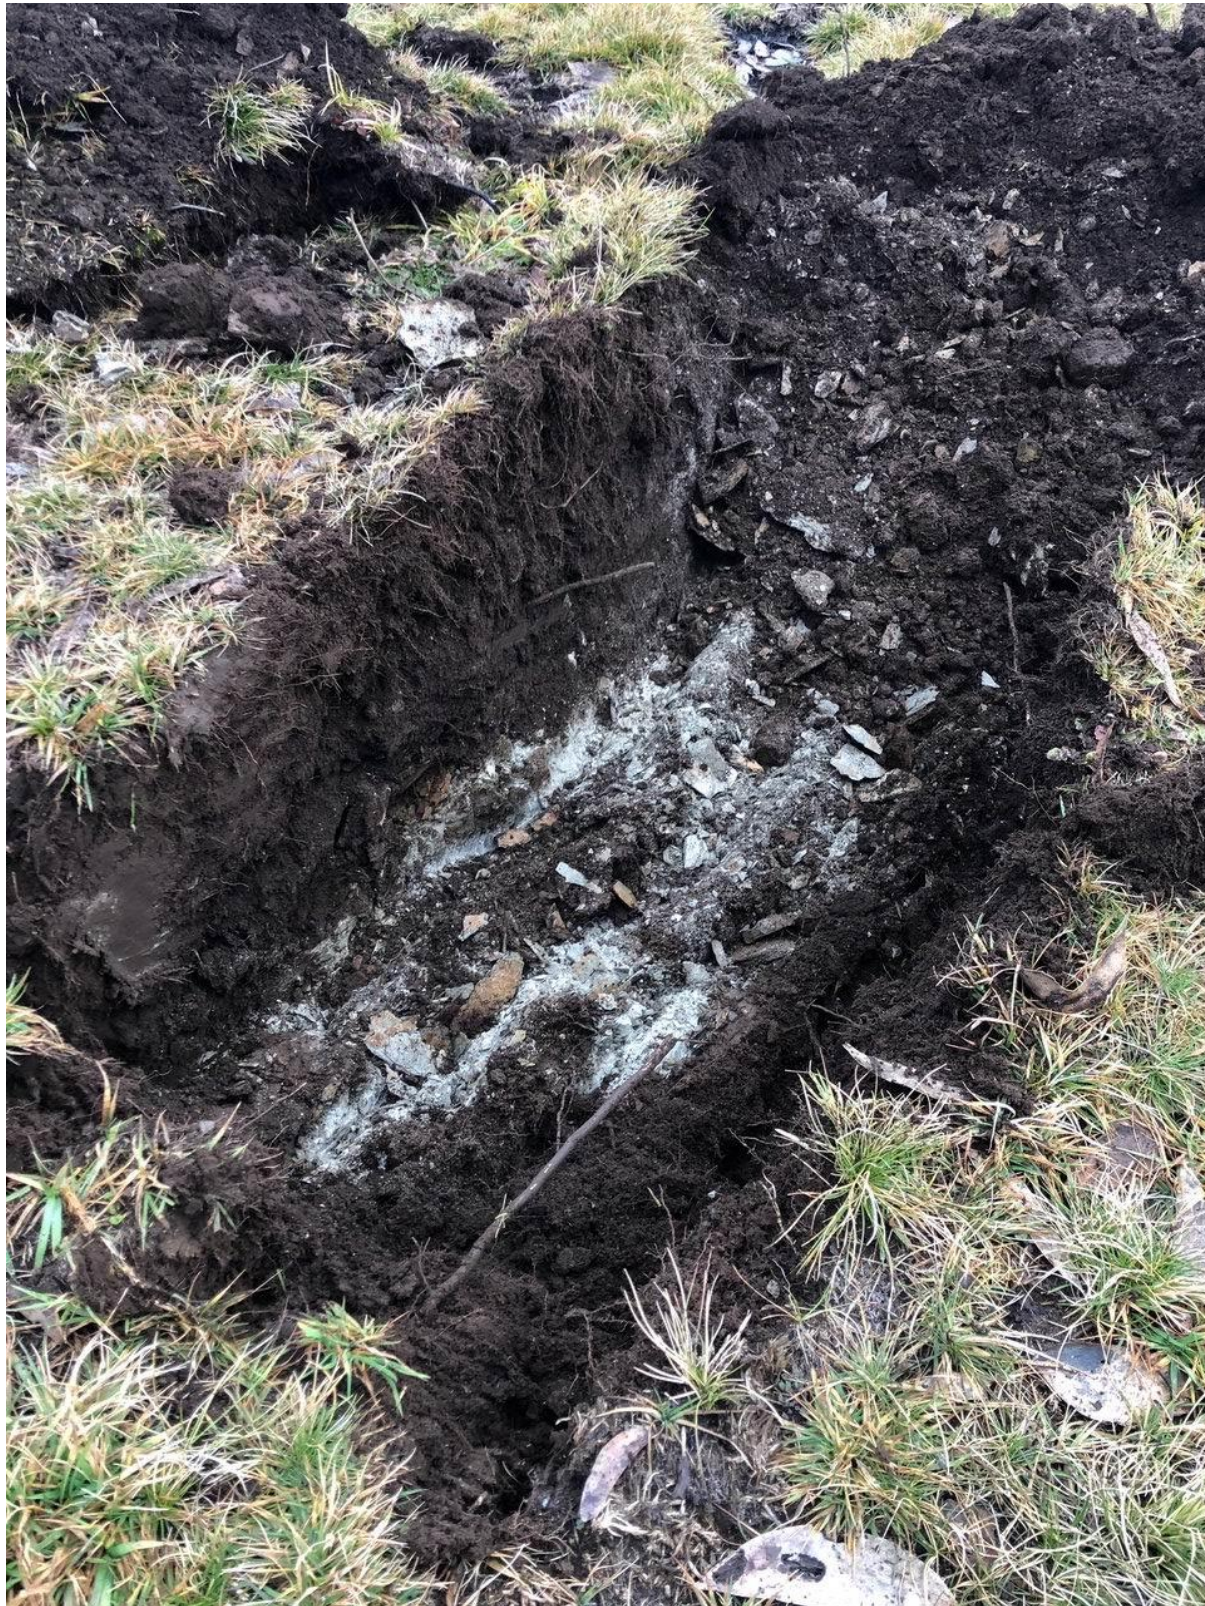
FIGURE 15

Photo 8 – 10/7/2020 – View of the subsurface profile of test pit 1T, showing topsoil, directly underlain by medium strong slate bedrock.

| Geological Profile | Depth Interval | Description |
|---|---|---|
| TOPSOIL | 0m to 0.1m/0.3m | CLAYEY SILTY SAND; fine to coarse sand, low plasticity fines, some angular slate gravels to 60mm, black, some grass roots, moist, loose. |

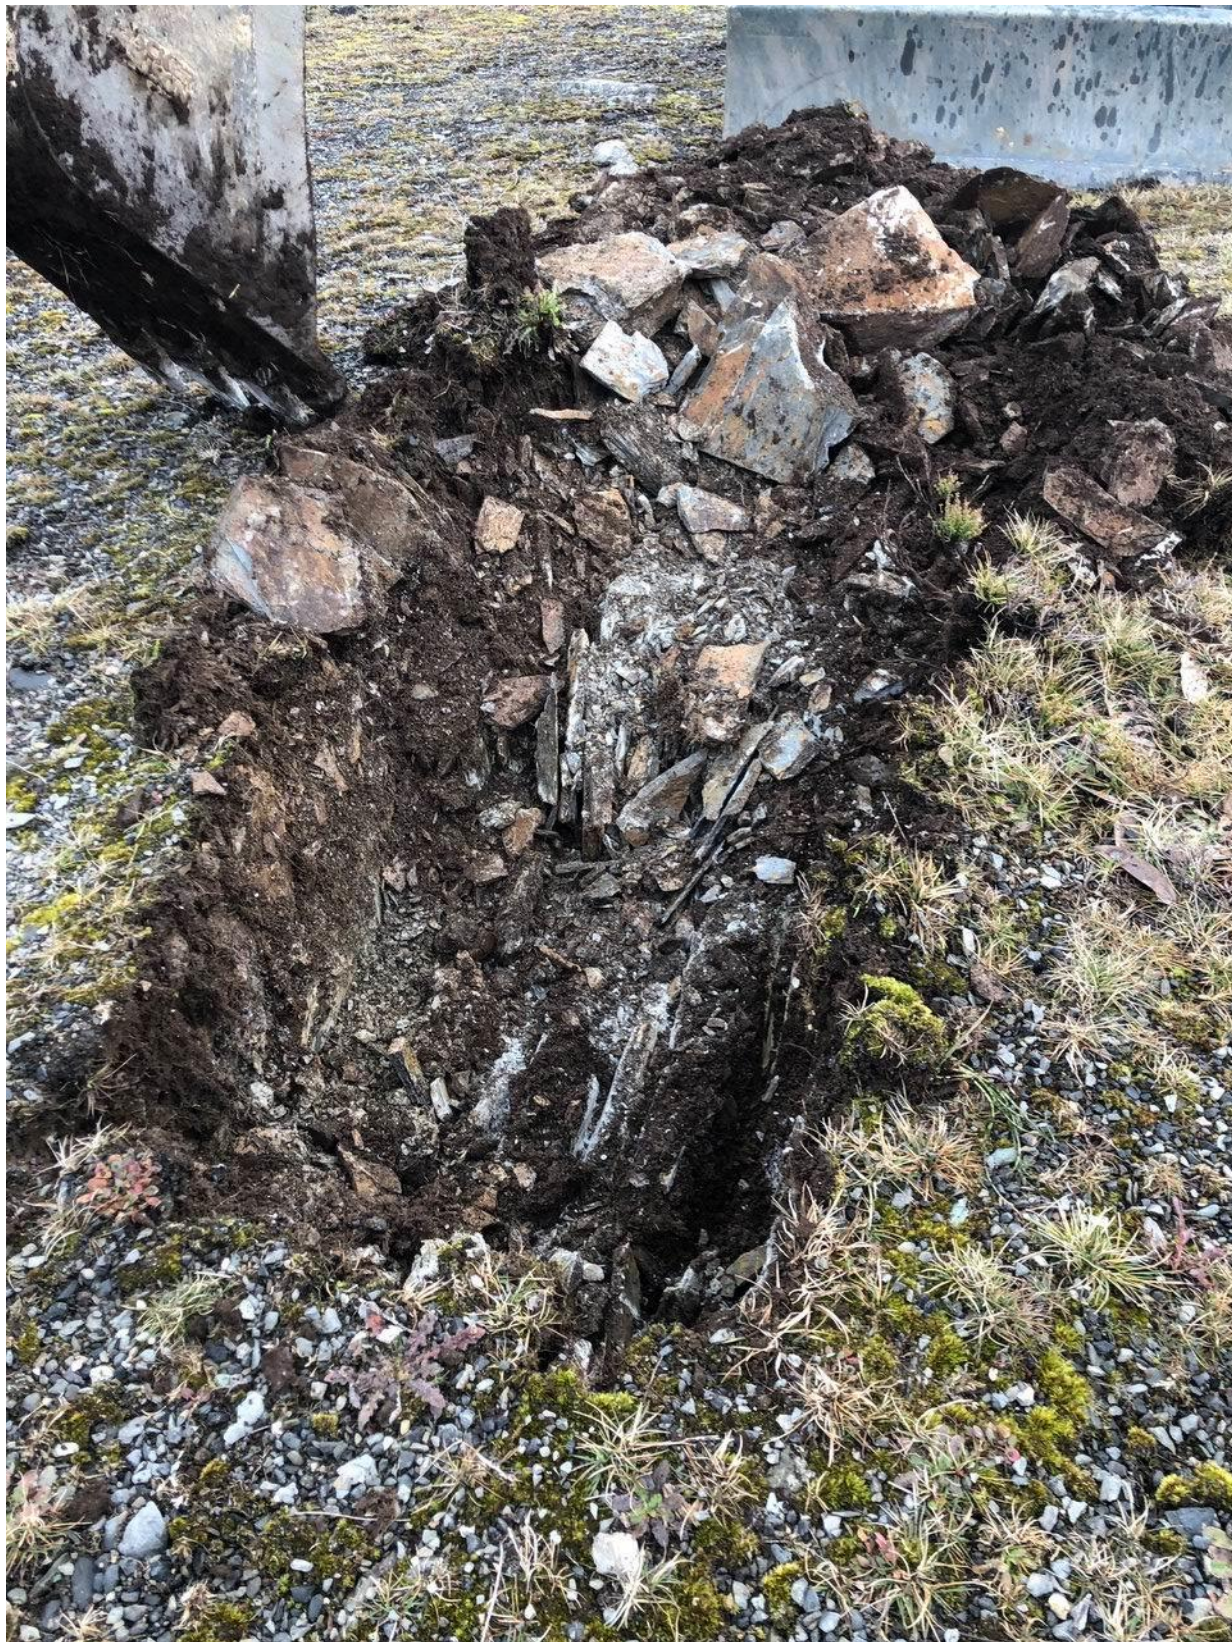
Photo 9 – 10/7/2020 – View of the subsurface profile of test pit 2T, showing shallow topsoil, directly underlain by medium strong slate bedrock.

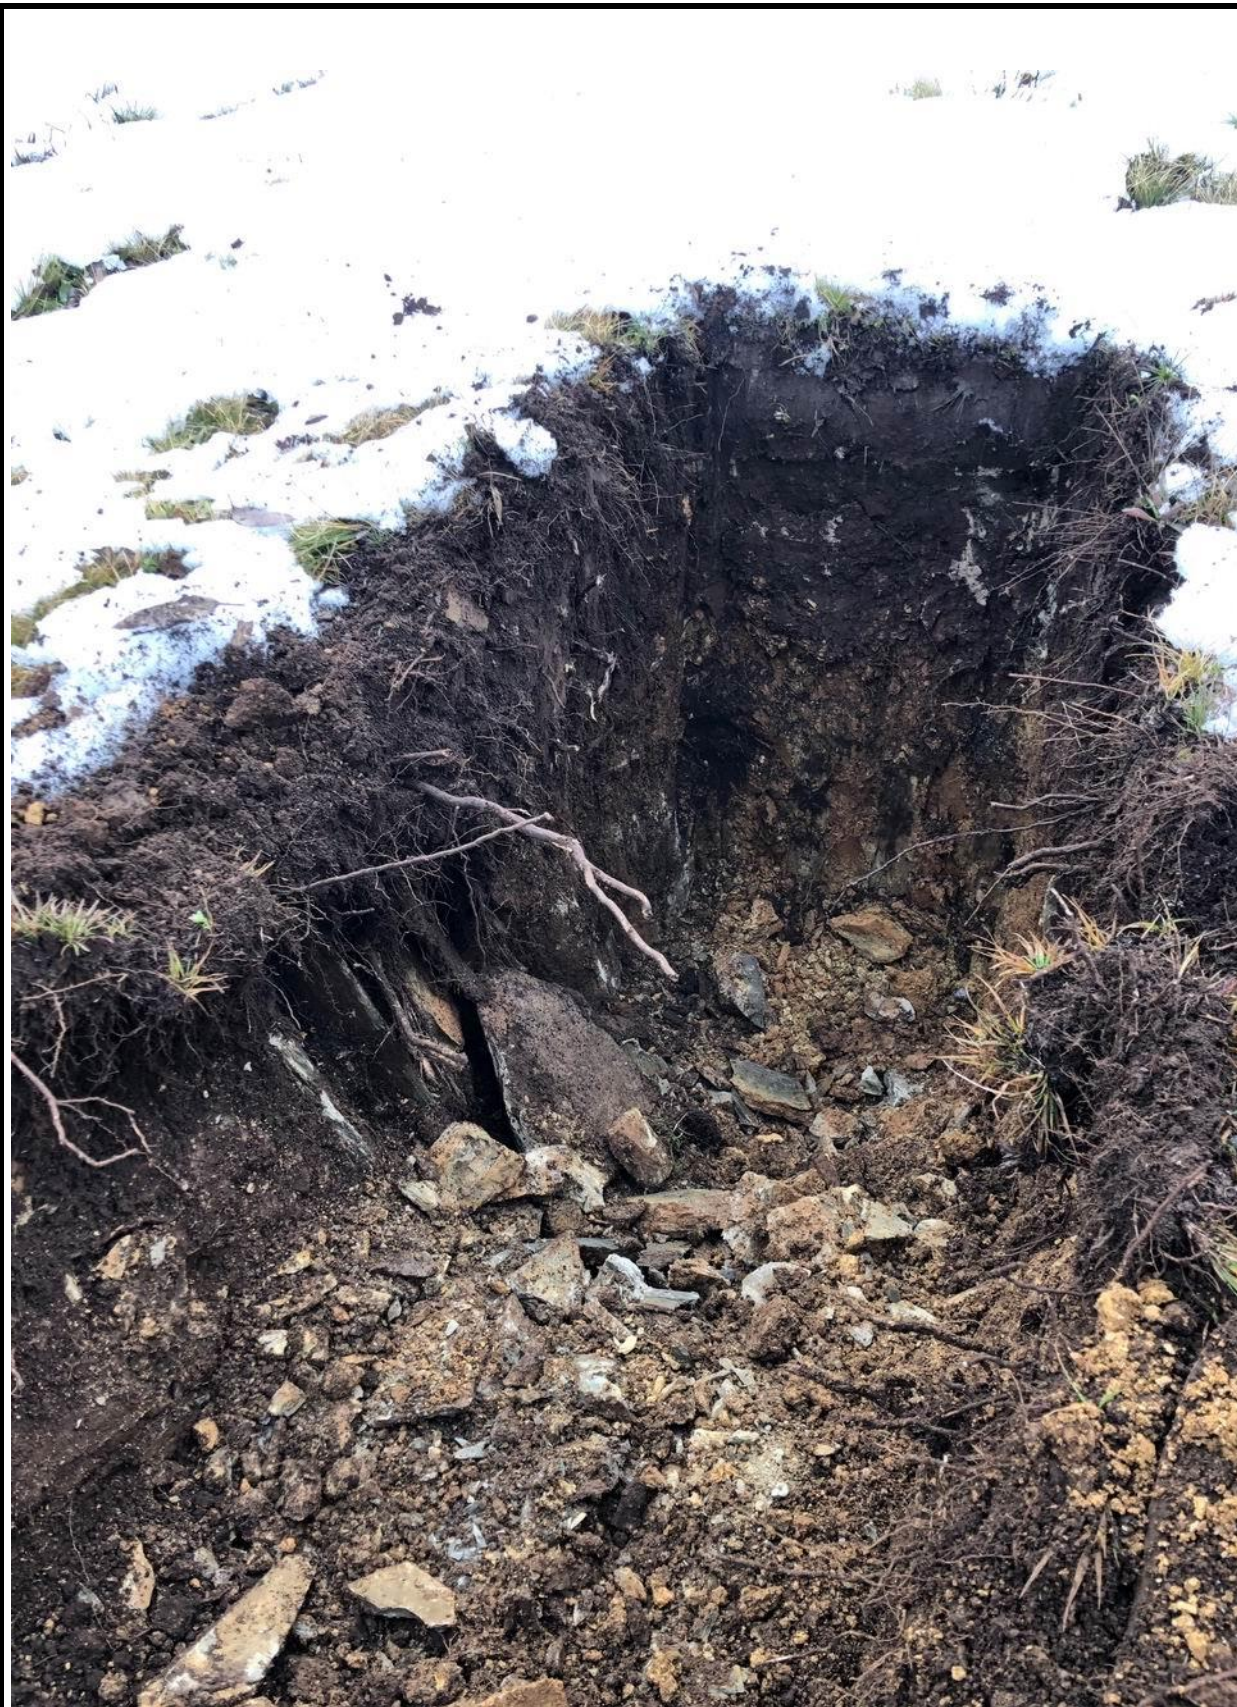
Photo 10 – 10/7/2020 – View of the subsurface profile of test pit 3T, showing topsoil, directly underlain by medium strong slate bedrock.

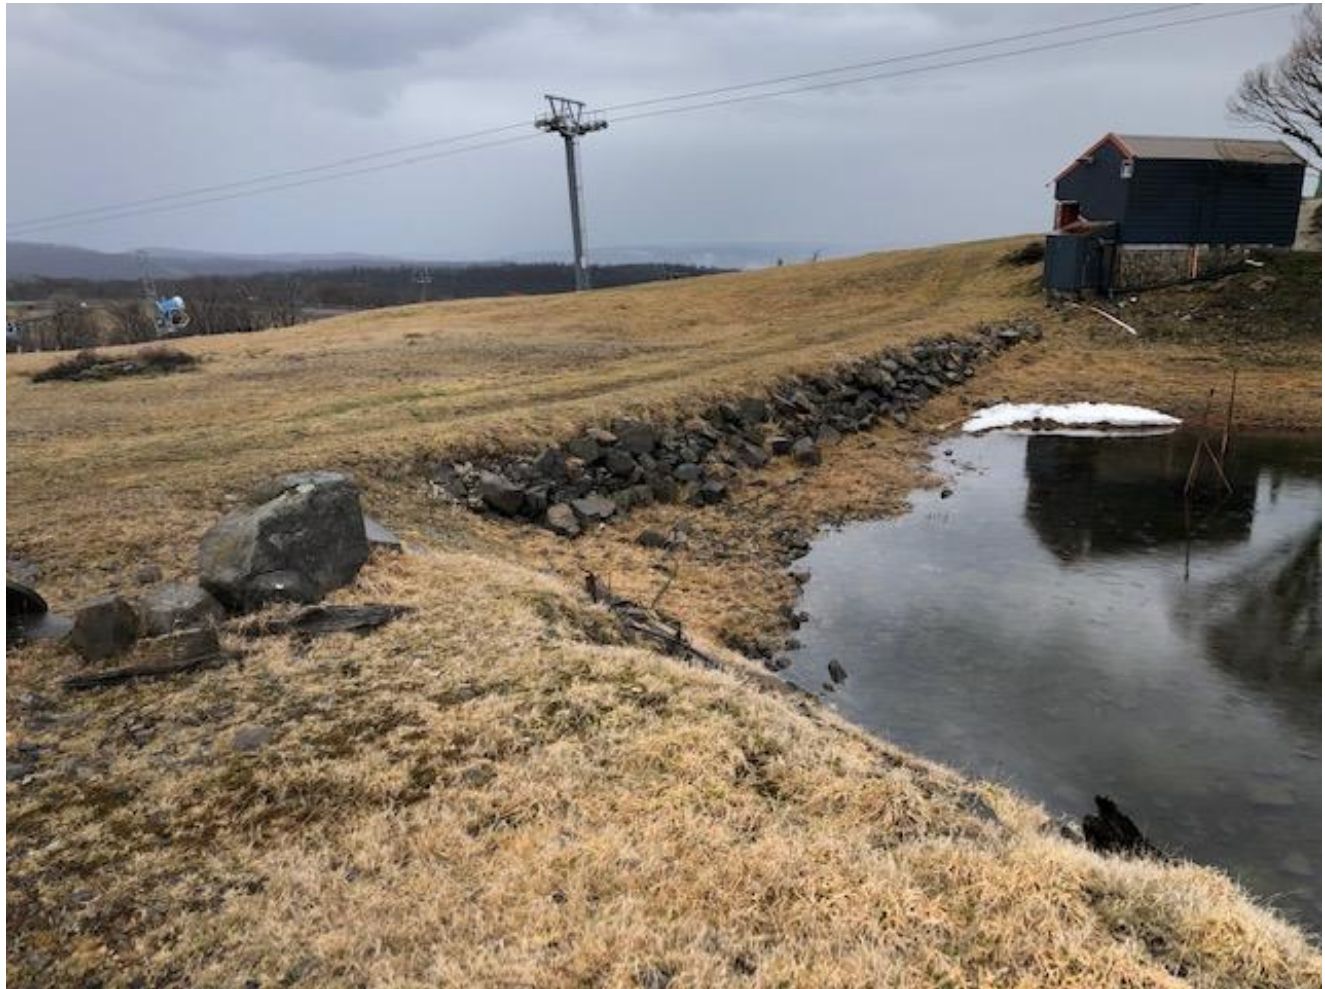
Photo 12 – 18/9/2020 – View of the quarry that is being used as a water storage dam. A retaining wall will be constructed along the downstream end to increase the water holding capacity.

Any excavations on the site will be supported by well-drained, properly designed and constructed engineered retaining walls. The likelihood of a properly designed, drained, and constructed retaining wall failure is judged to be “Rare”.

If a retaining wall failed, damage may well result to the dwelling, depending on many factors. In general, the consequences can be rated as “Minor to Medium”. The chance of persons being injured or of loss of life is low and the consequences to persons are therefore also rated as “Minor to Medium”.

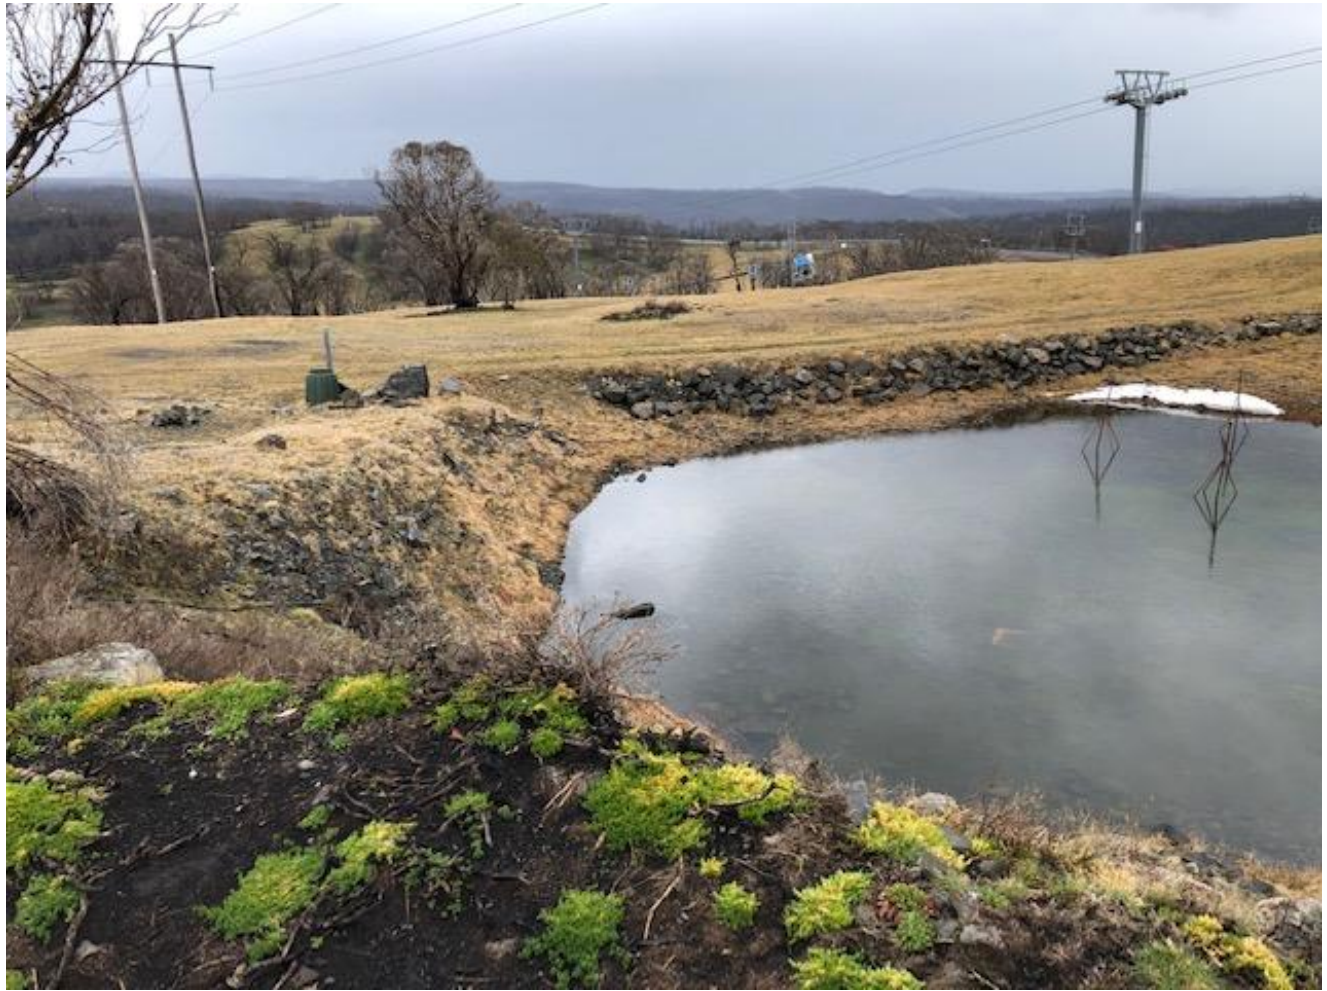
Photo 13 – 18/9/2020 – View of the quarry that is being used as a water storage dam. A retaining wall will be constructed along the downstream end to increase the water holding capacity.
