Report on Geotechnical Investigation

7A-11 Racecourse Road, 1-3 Faunce Street and 38-50 Young Street

300304375-400.5

19 July 2024

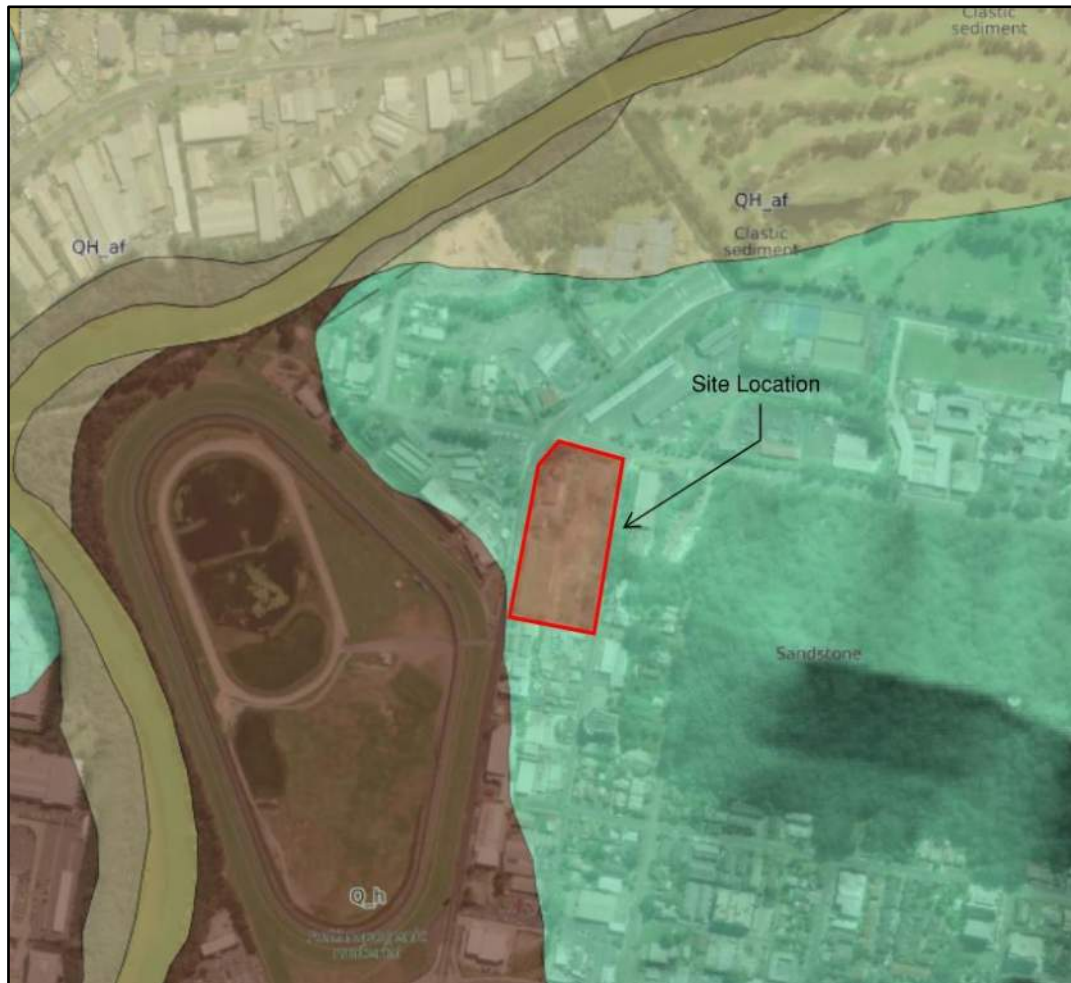
Figure 2-1 Summary of Site Geology

Reference to the New South Wales (NSW) Seamless Geology dataset accessed on NSW Governments web mapping application "Minview" [3] indicates that the site is situated within the Buralow Formation (**Tngb**) which apart of the wider Gosford Subgroup. This is known to comprise fine grained, micaceous, quartz- to quartz-lithic sandstone; interbedded with siltstone, grey shale and red-brown claystone and residual soils derived from the weathering of the parent rock.
