STATEMENT OF HERITAGE IMPACT

HADLEY PARK

In support of Section 60 Application for Remedial Works at:
14-278 Old Castlereagh Road,
Castlereagh, NSW 2749.

For NSW Department of Planning and Environment.
8th of December 2022
Issued for Development Application.

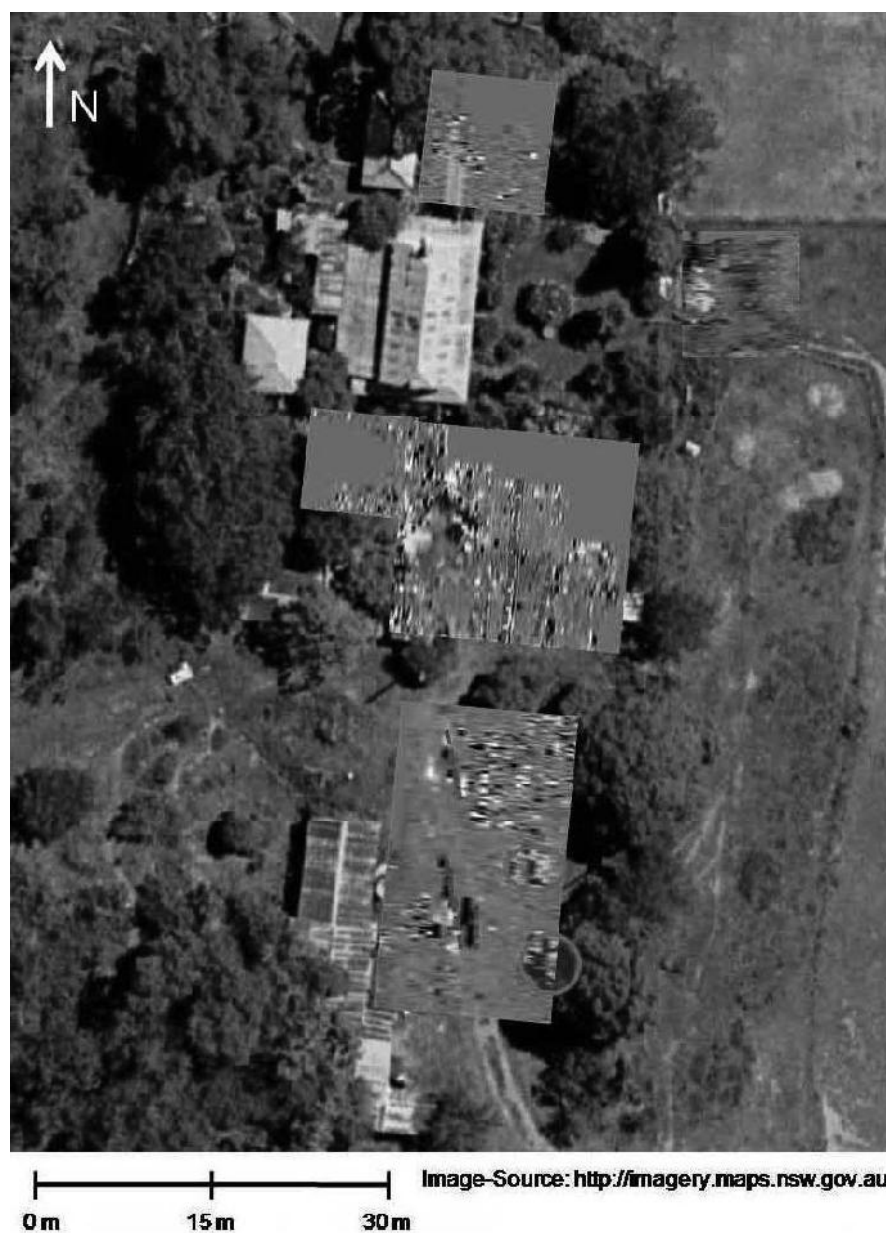
Figure 25 Ground Penetrating Radar (GPR) image showing location of former structure (dashed rectangle), silage pits (circles) and services (dashed lines). (Source: Archaeological Computing Laboratory, University of Sydney)

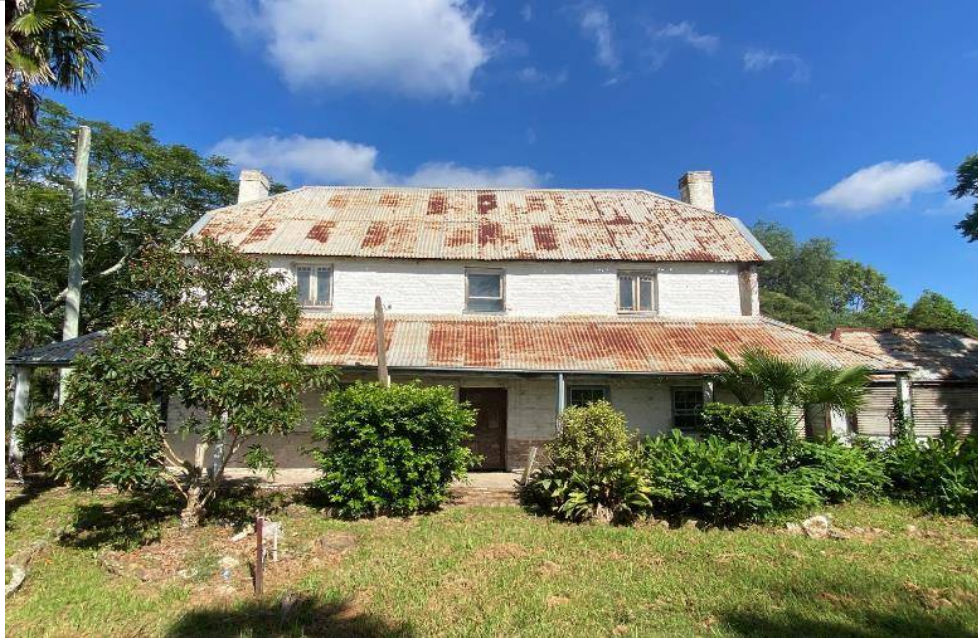
Figure 1. View of East façade of the main house. The sacrificial render is visible as the slightly darker pigmented lower section of the wall. Source: JPA&D, 2022.

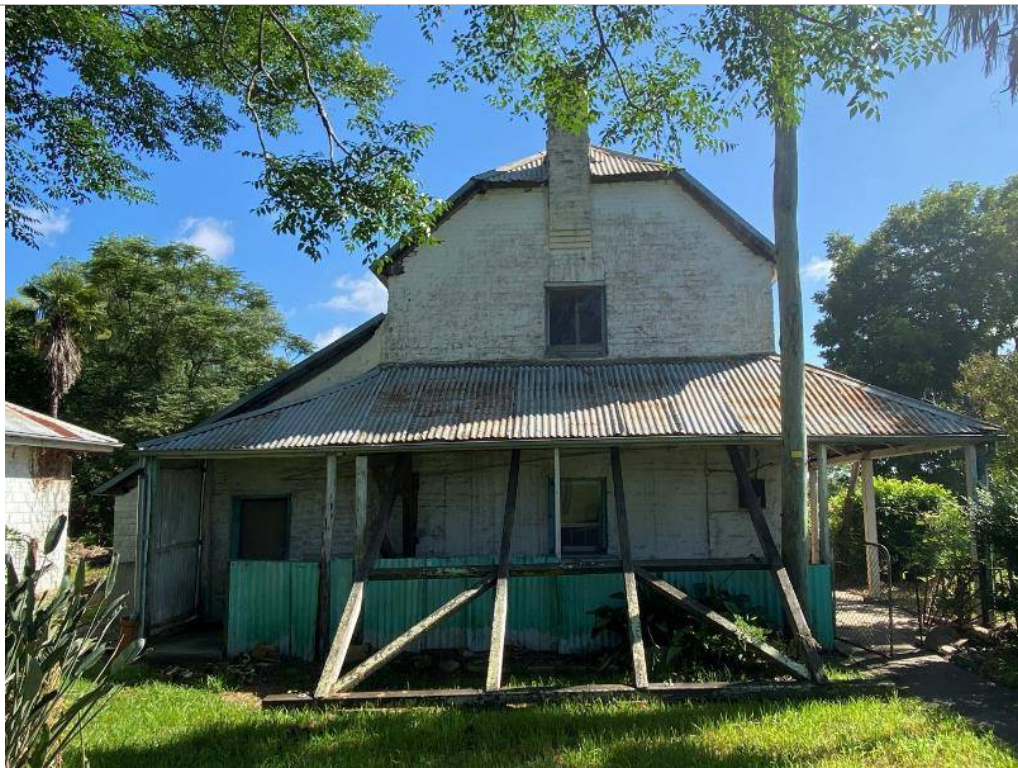
Figure 2. View of South façade of the main house. The timber structural supports impede upon the heritage significance of the building. Source: JPA&D, 2022.

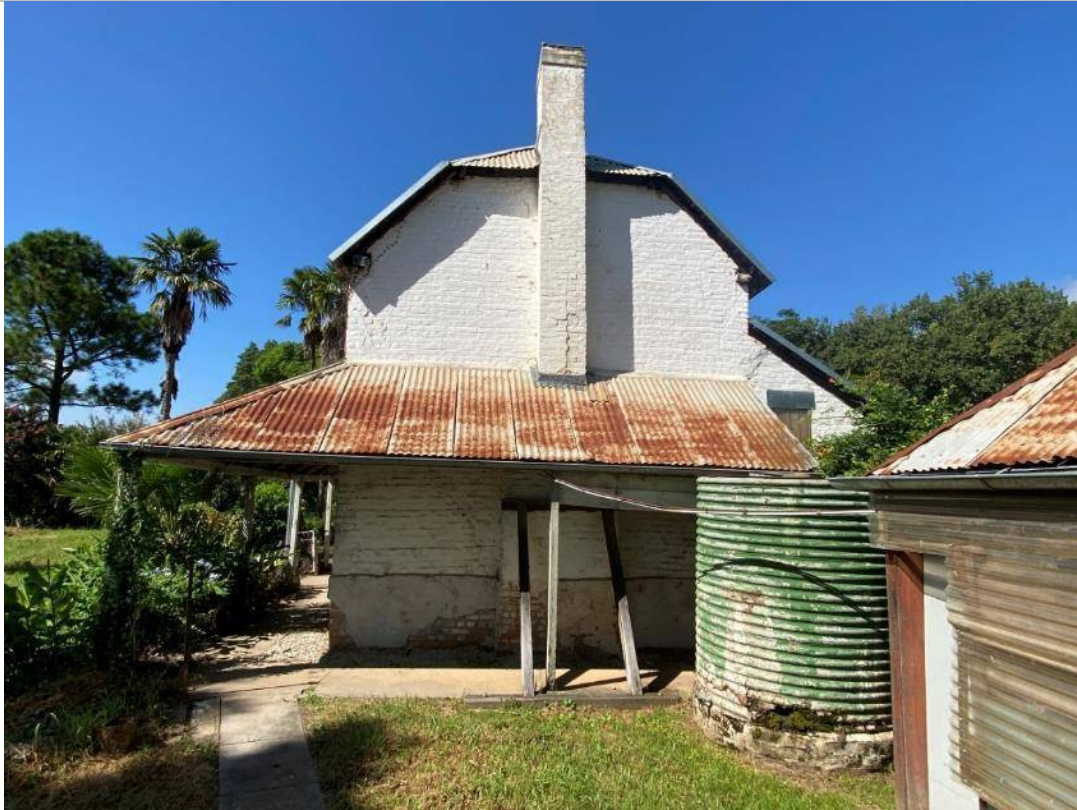
Figure 3. View of North façade of the main house. The sacrificial render and the timber structural supports and the concrete and gravel verandah are all visible and proposed to be removed. Source: JPA&D, 2022.

New proposed works include taking up the concrete verandah paving and replacing it with sandstock brick pavers. The removal and replacement of the concrete verandah paving with sandstock brick pavers should have a very positive impact to the heritage significance and future maintenance of the building, as it will improve the aesthetic of the building and assist to prevent rising damp in the future.

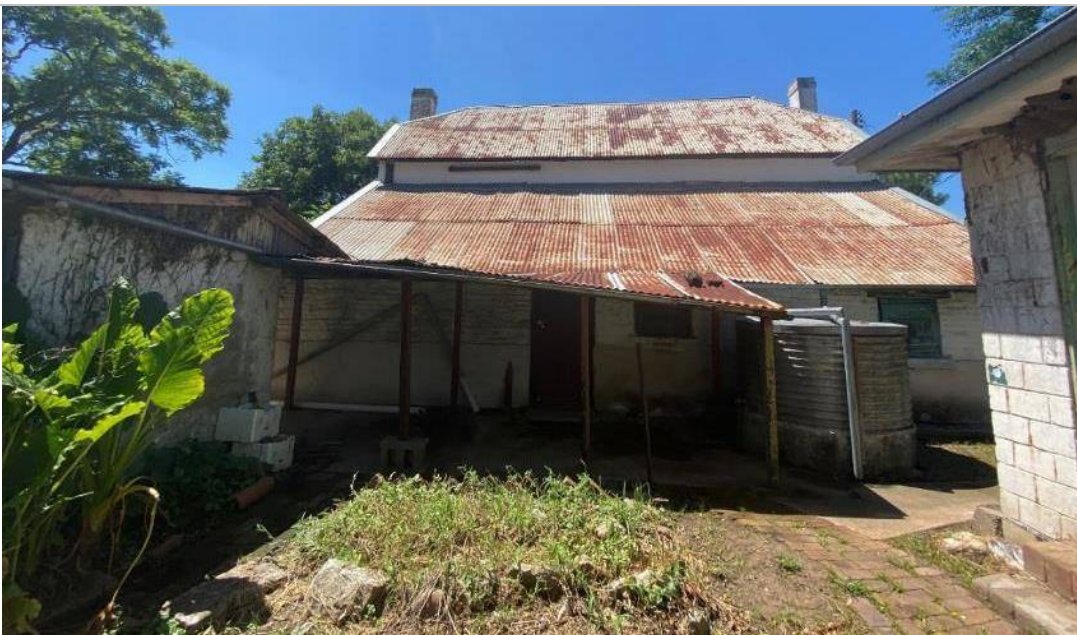
Figure 4. View of West façade of the main house. The laundry to the left and the guest house to the right impede upon the immediate curtilage of the main house, they are proposed to be demolished to restore the immediate curtilage to its former state. Source: JPA&D, 2022.

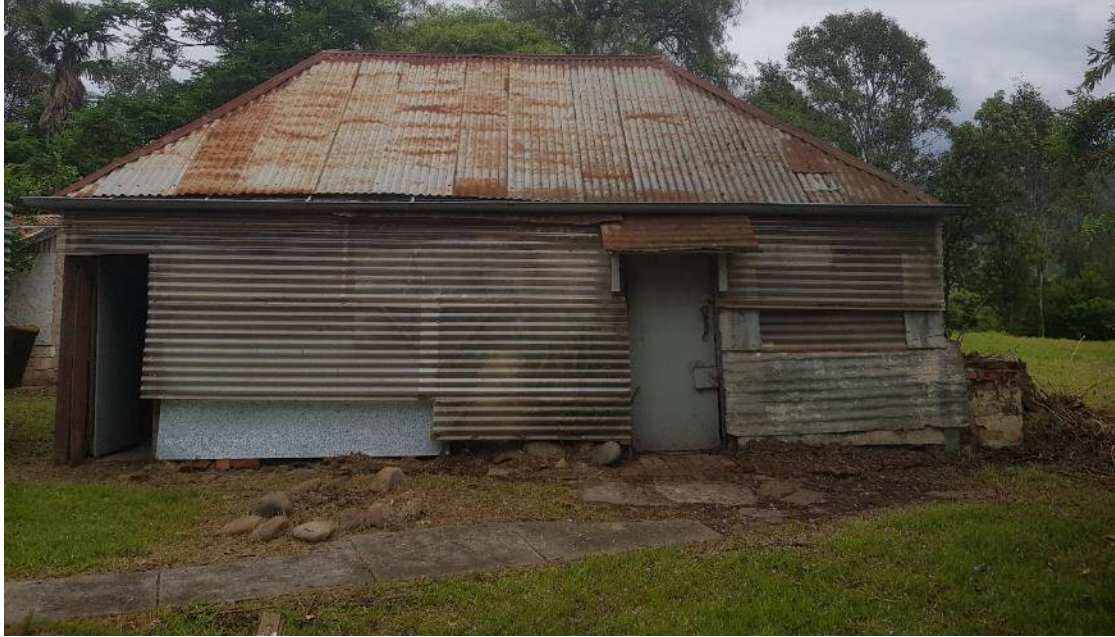
Figure 5. View of East façade of the weatherboard cottage. The protective corrugated sheeting is visible and proposed to be removed to repair the façade. Source: JPA&D, 2022.

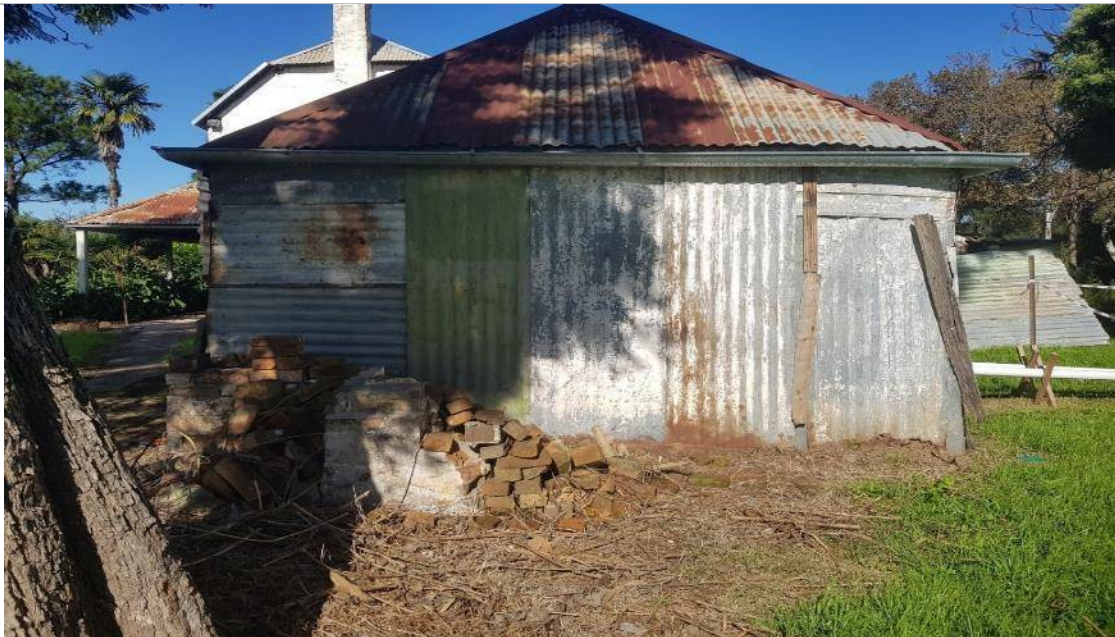
Figure 6. View of North façade of the weatherboard cottage. The brick rubble are remnants of the former chimney and are proposed to be reconstructed to the extent possible with the salvaged bricks. Source: JPA&D, 2022.

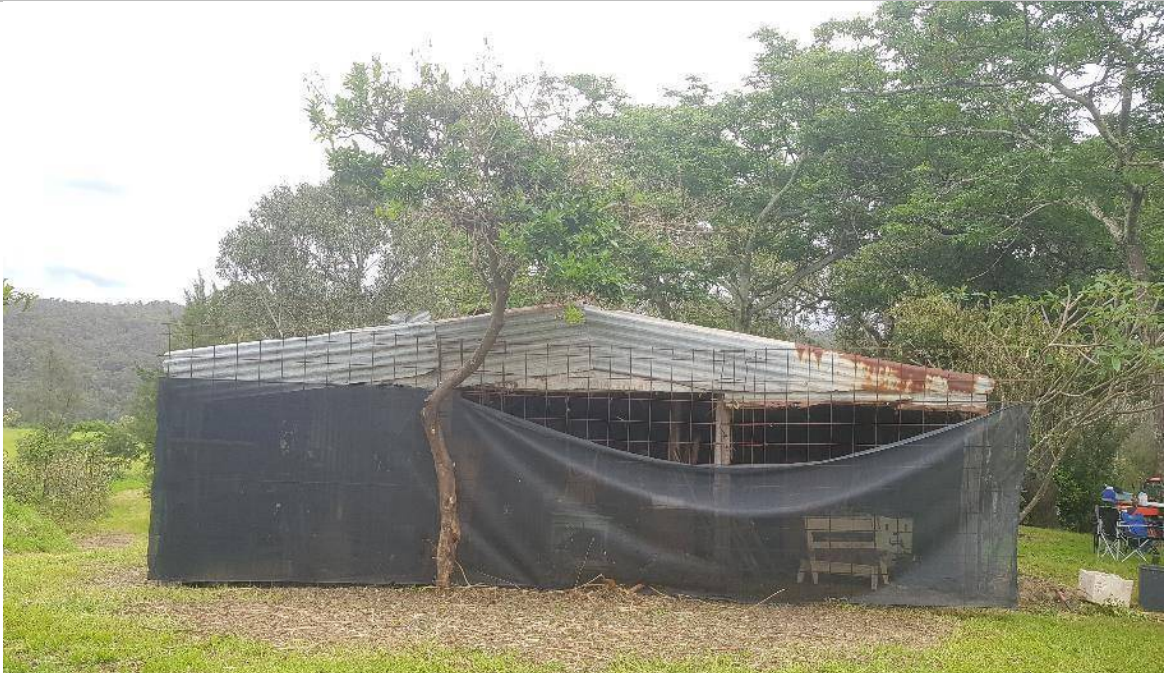
Figure 9. View of the East façade of the stables and garage. Currently a mesh wire and tarp are enclosing the building. Due to this the building is susceptible to weather, termites, and vermin.

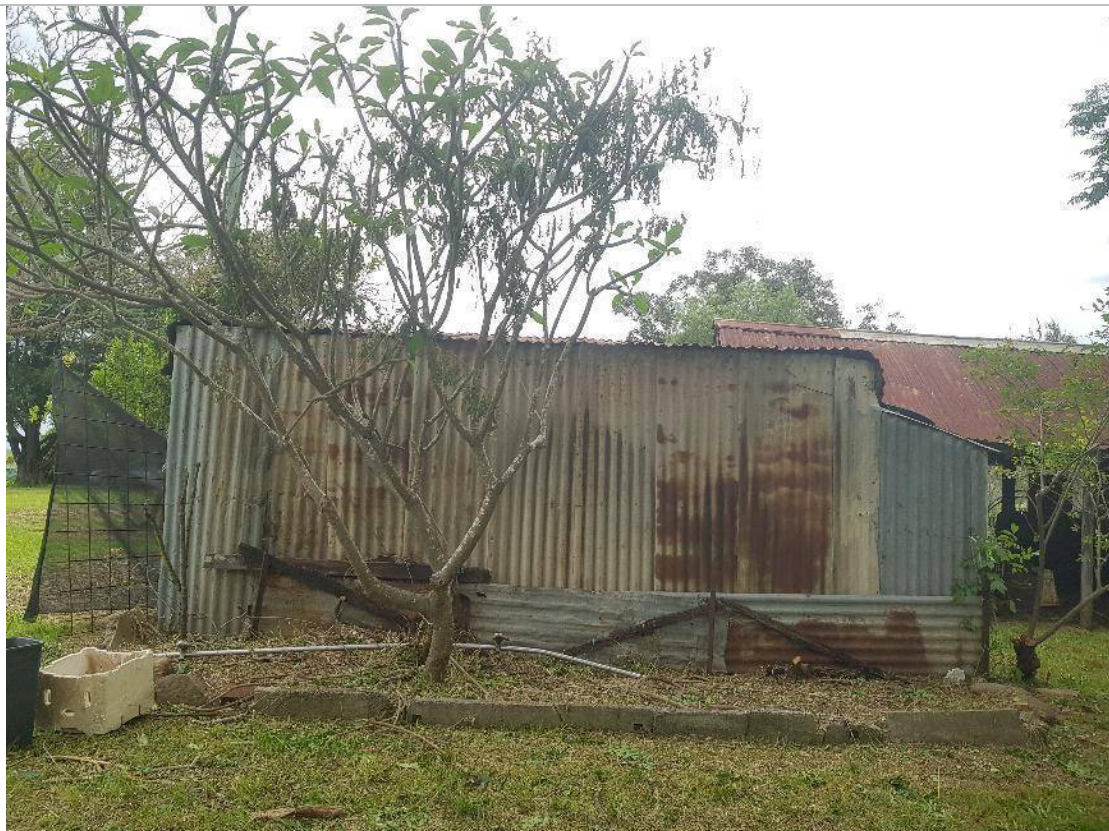
Figure 10. View of the North façade of the stables and garage. The corrugated sheeting is proposed to be examined and any loose sheets are to be re-fixed to match existing fixings and methods. Source: JPA&D, 2022.

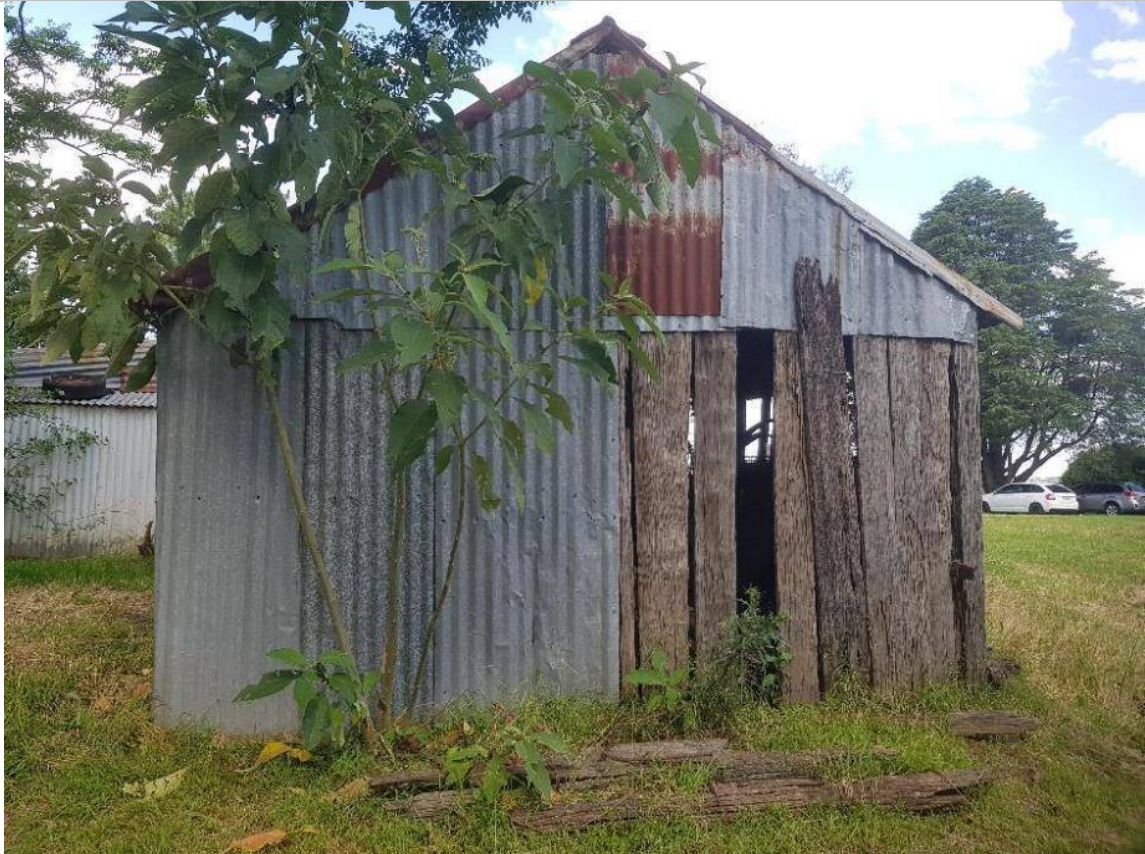
Figure 11. View of the West façade of the stables and garage. Salvaged timber slabs are stacked next to the building, it is proposed to use them to restore the facades missing timber slabs, as well as re-fixings loose timber slabs to match existing fixings and methods. Source: JPA&D, 2022.

The stables and garage are partly of timber slab construction. The proposed remedial works include the reconstruction of the façade with existing salvaged timber slabs on site and refix loose slabs to match existing. The gap in the metal sheeting is to be clad using the metal sheet on the ground adjacent to the wall. As well as examining the roof sheeting, re-securing any loose sheeting with fixings to match the existing. Any roof sheeting replacement is to match existing. Any rust is proposed to be treated with 'Penetrol'. As well as, resetting, or replacing posts, straightening beams, splicing and extending beams, replacing temporary posts with bushpoles, where necessary, all of these are to match existing.

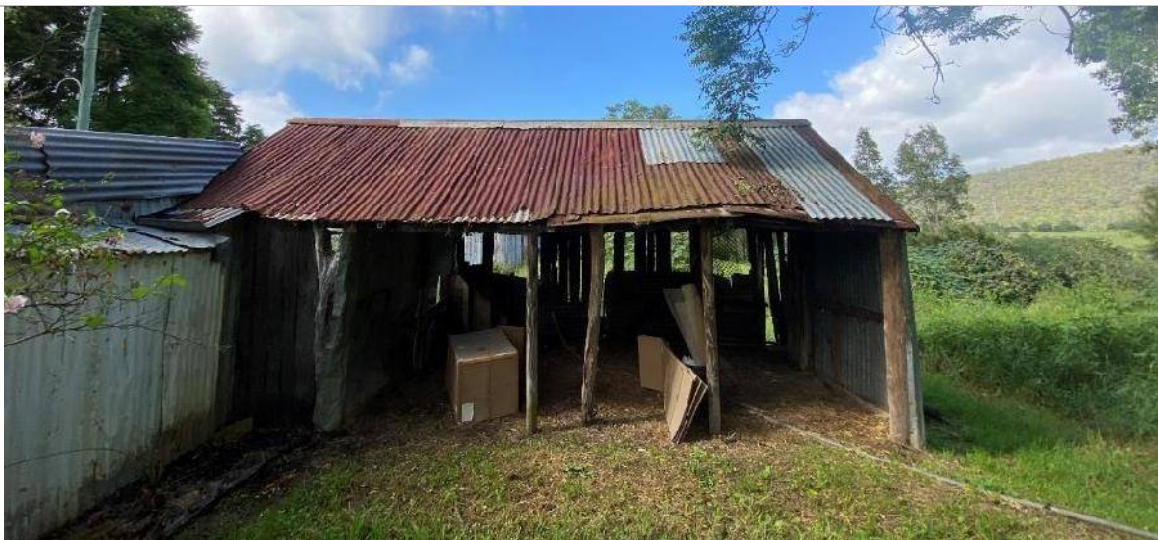
Figure 12. View of the North façade of the stables and garage building. The temporary timber posts that are assisting the building with its structural issues are proposed to be replaced with bushpoles to match the existing. Source: JPA&D, 2022.

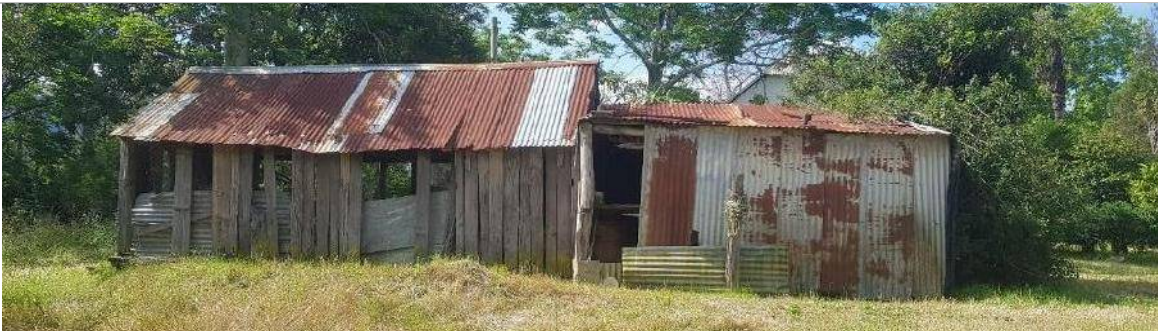
Figure 14. View of the South façade of the stables and garage. It is proposed to use the salvaged timber slabs on site to restore the façade of the building and repair the loose timber by re-fixing them to match existing fixings and methods. Source: JPA&D, 2022.

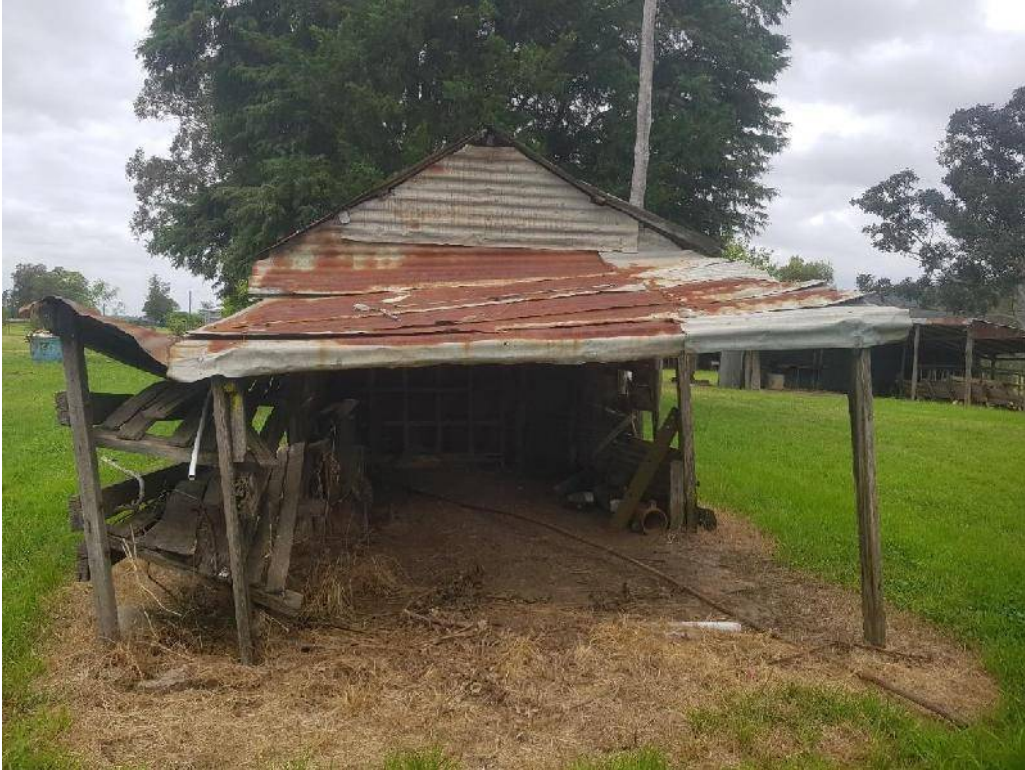
Figure 15. View of the North façade of the creamery. The intentionally curved roof is visible. The shelf on the left has structural issues. It is proposed to label and dismantle the shelf and store it securely until such time that it can be reconstructed. Source: JPA&D, 2022.

The skillion of the creamery has a unique folded curve roof shape. It is intentionally so, thus any remedial works to the roof sheeting will be custom shaped to match the existing. It is proposed to reinstate the weatherboard façade and reinstate the timber sill to the window to match the existing in the creamery. It is proposed to splice and extend the posts, open the soil at the base of the posts and apply wood preservative. The wood preservative will prevent wood rot at the base of the timber posts and maintain the structural integrity of the posts, which impacts the overall structural integrity of the building. The existing shelf is in poor condition and is to be reconstructed. The skillion roof beams are to be replaced. The metal sheeting on the west elevation is to be removed to allow for investigation of the underlying material and to allow to splice the base of the posts.

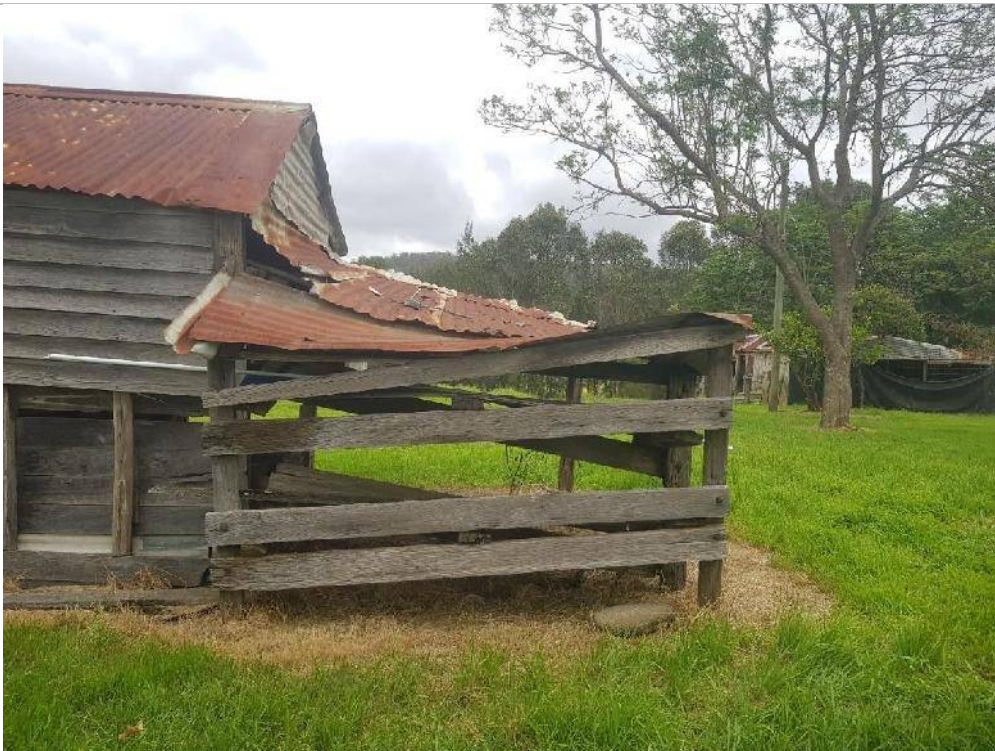
Figure 16. View of the East façade of the creamery. The structural issues of the shelf are visible. The intentionally curved roof is visible. Source: JPA&D, 2022.

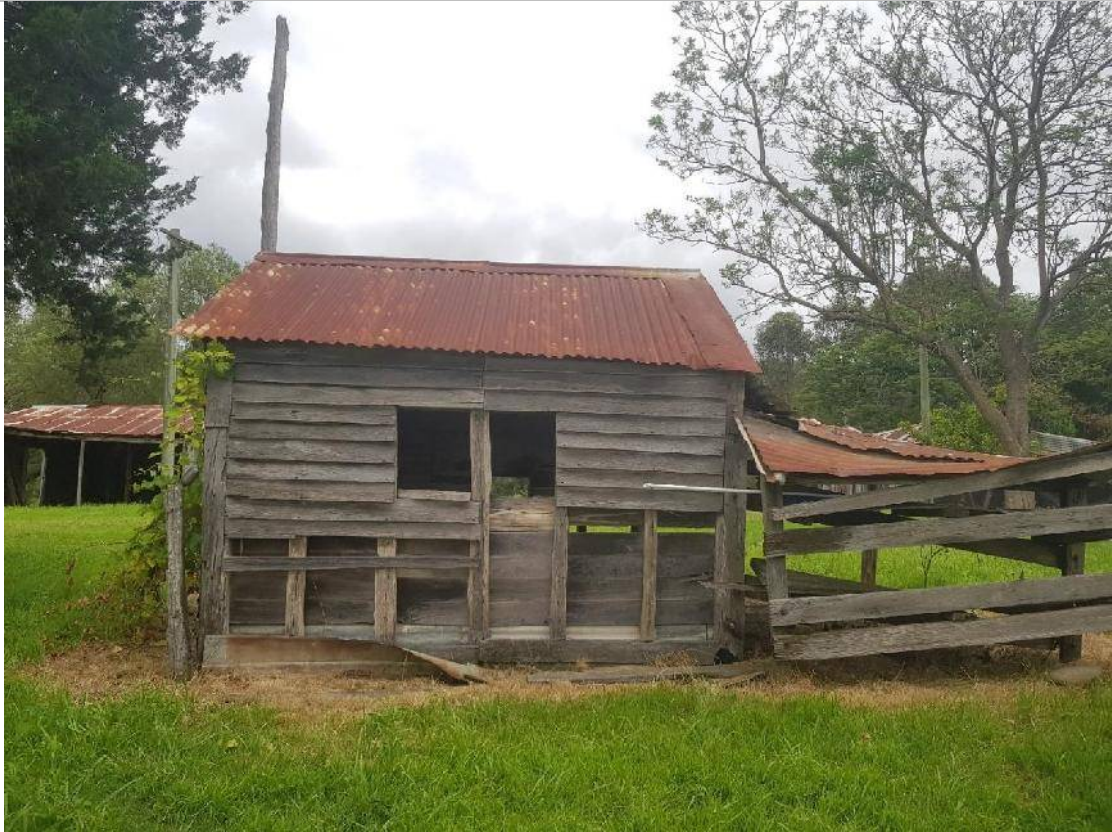
Figure 17. View of the East façade of the creamery. It is proposed to reconstruct the right window sill and the weatherboards to match the existing one. Source: JPA&D, 2022.

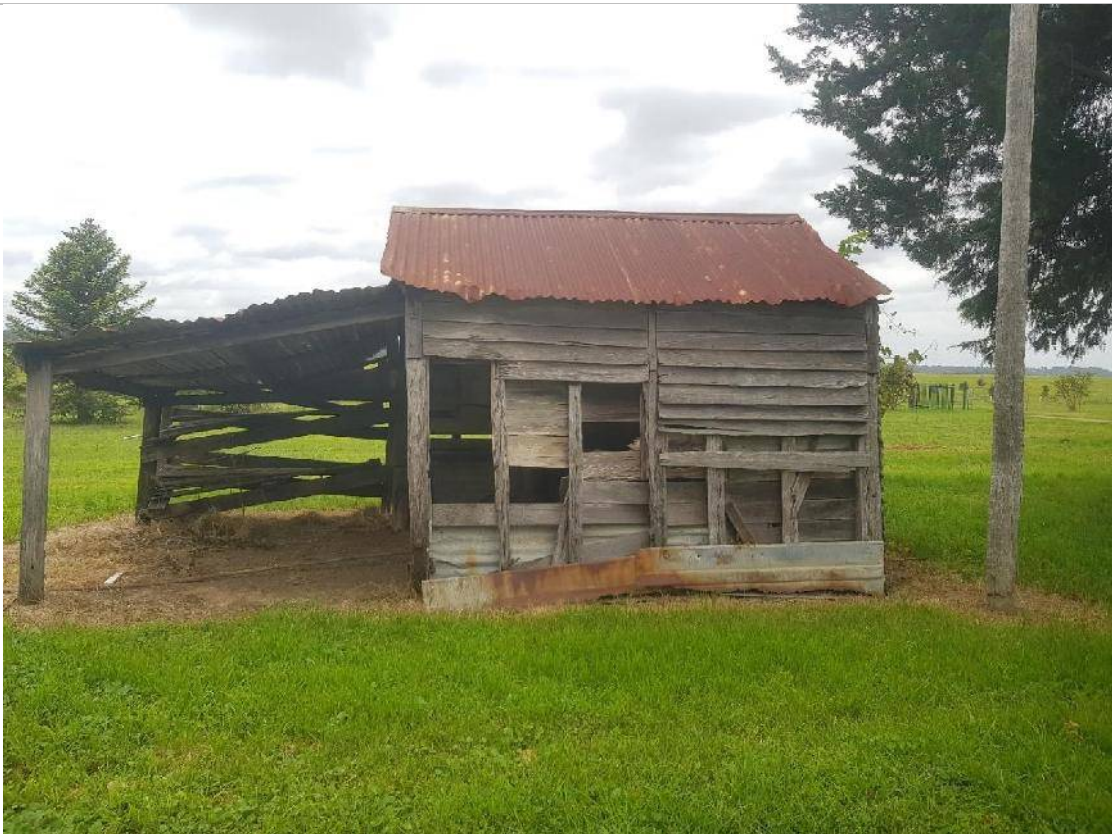
Figure 18. View of the West façade of the creamery. It is proposed to reconstruct the timber weatherboards.

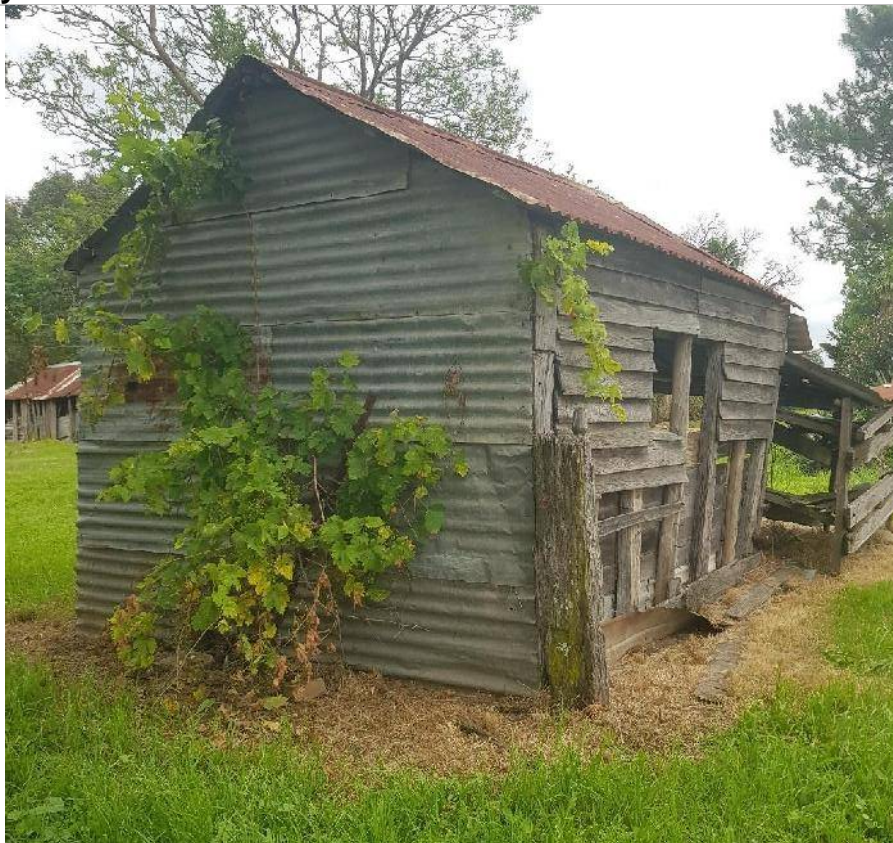
Figure 19. View of the South East corner of the creamery. It is proposed to remove the vegetation. Source: JPA&D, 2022.

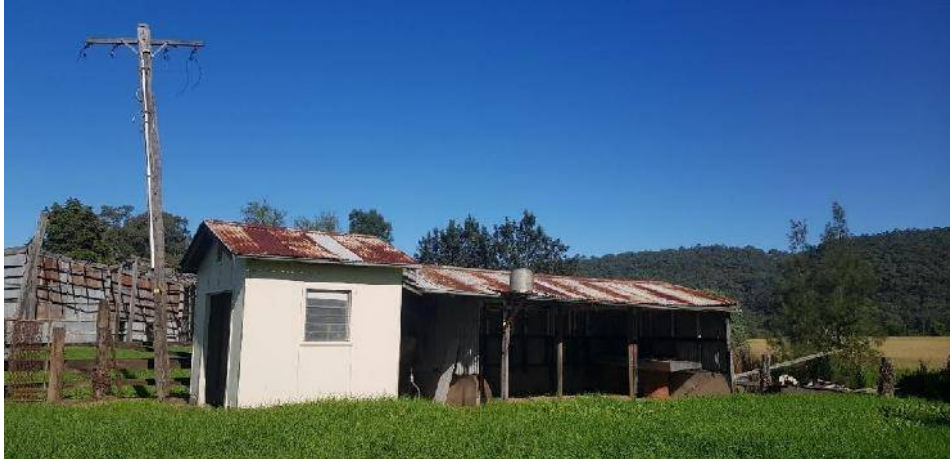
Figure 20. View of the North façade of the dairy and milk storage shed. It is proposed to replace the existing gutters. Source: JPA&D, 2022.

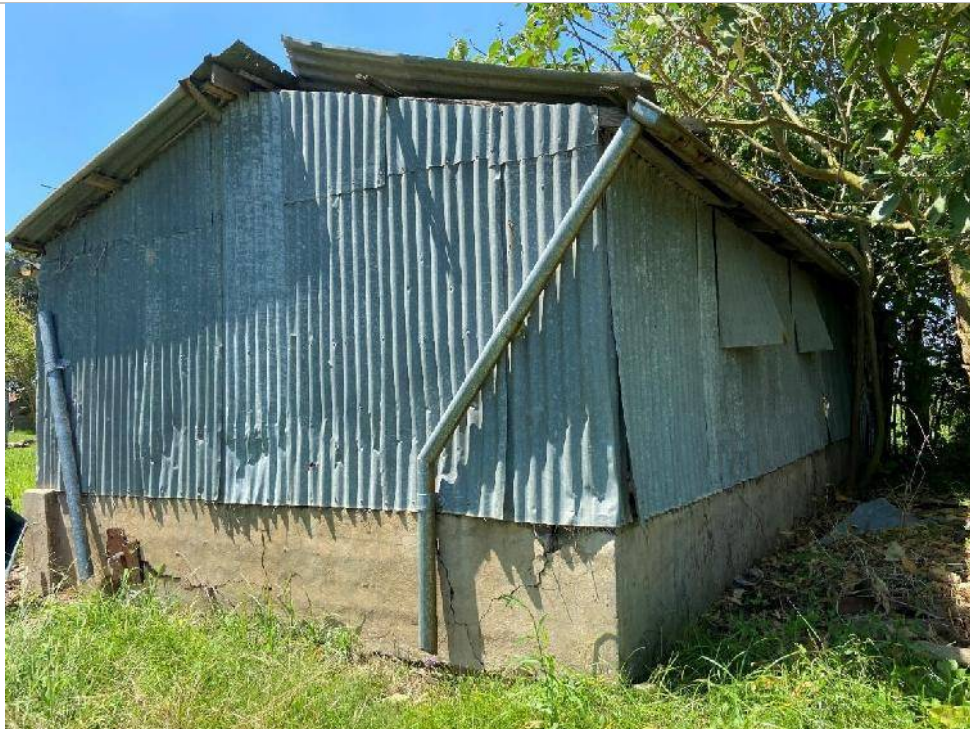
Figure 23. View of the South West corner of the dairy and milk storage shed. It is proposed to reconnect the downpipes and redirect them into the dish drain. The wall plate is proposed to be removed, treated with 'Penetrol' and reinstated. Source: JPA&D, 2022.

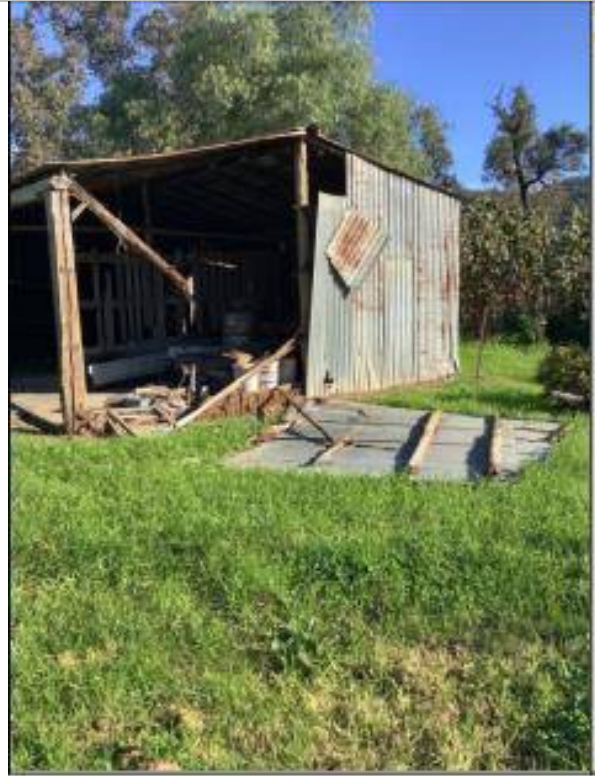
Figure 26. View of the North façade of the feed store and cow bails, this image was taken in June 2022. Due to the structural issues present in the building the extreme weather caused the wall to fall and several bushpoles have affected as well. Source: Aruma, 2022.

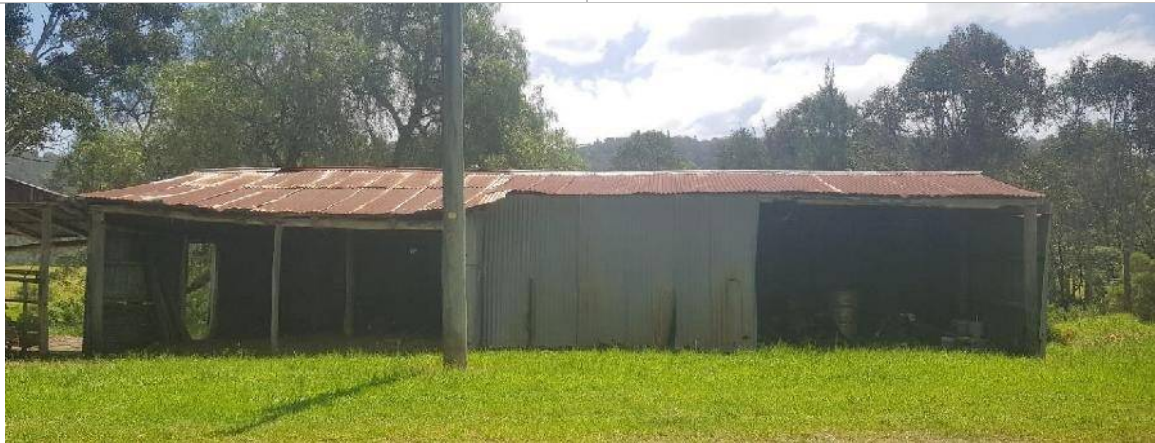
Figure 27. View of the East façade of the feed store and cow bails. The wall on the right of this building is the one that has since fallen over. It is proposed to repair and replace the timber posts to restore and reconstruct their structural integrity. Source: JPA&D, 2022.

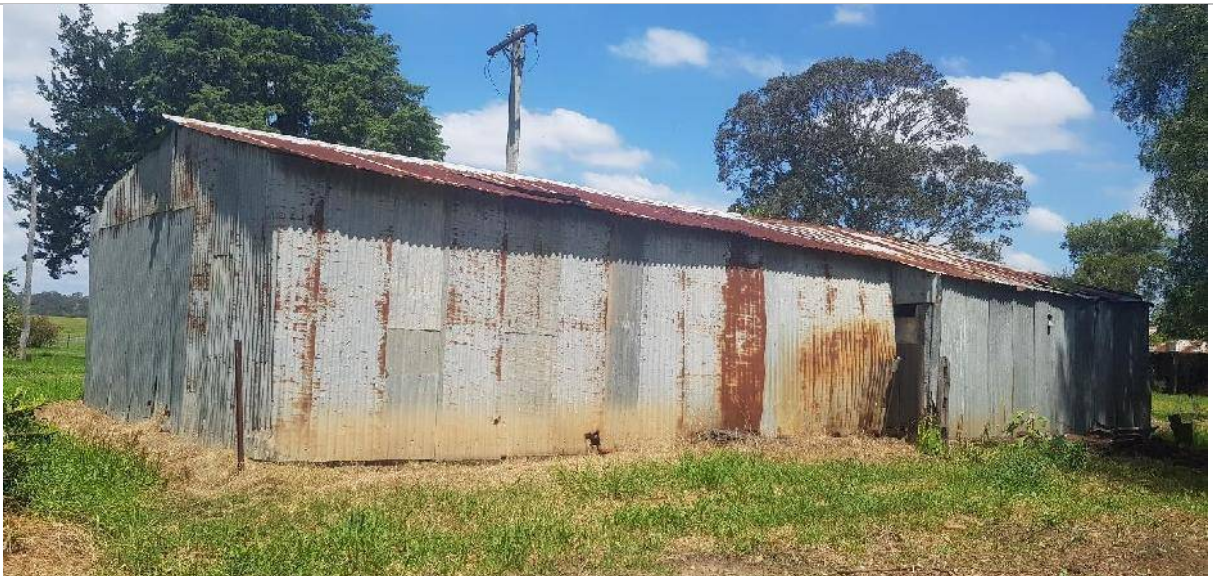
Figure 29. View of the North West corner of the feed store and cow bails. The left wall has since fallen down. Source: JPA&D, 2022.

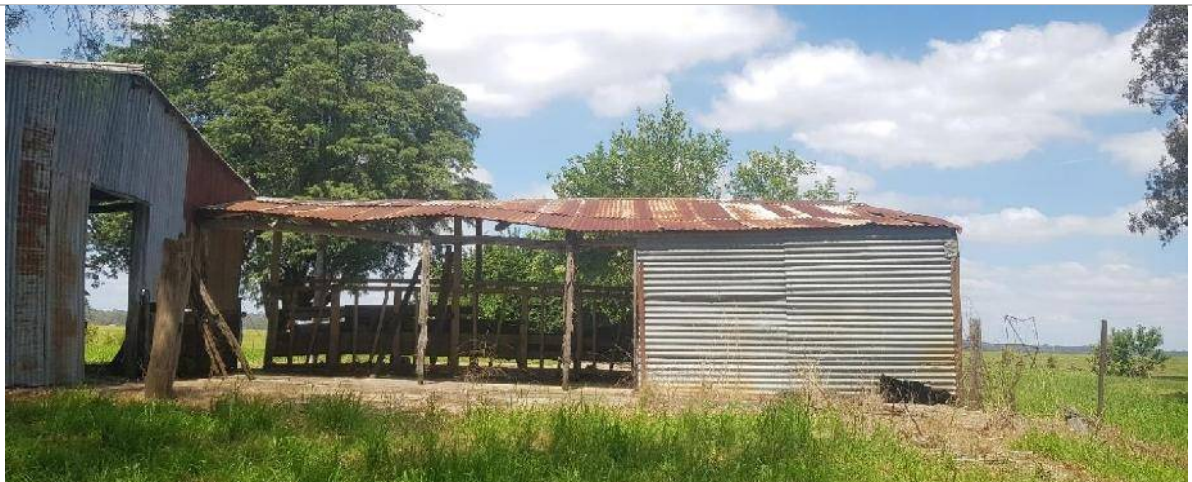
Figure 30. View of the West façade of the feed store and cow bails. It is proposed to reinstate timber posts to match existing in their former locations evidenced by the post holes in the concrete slab. Source: JPA&D, 2022.

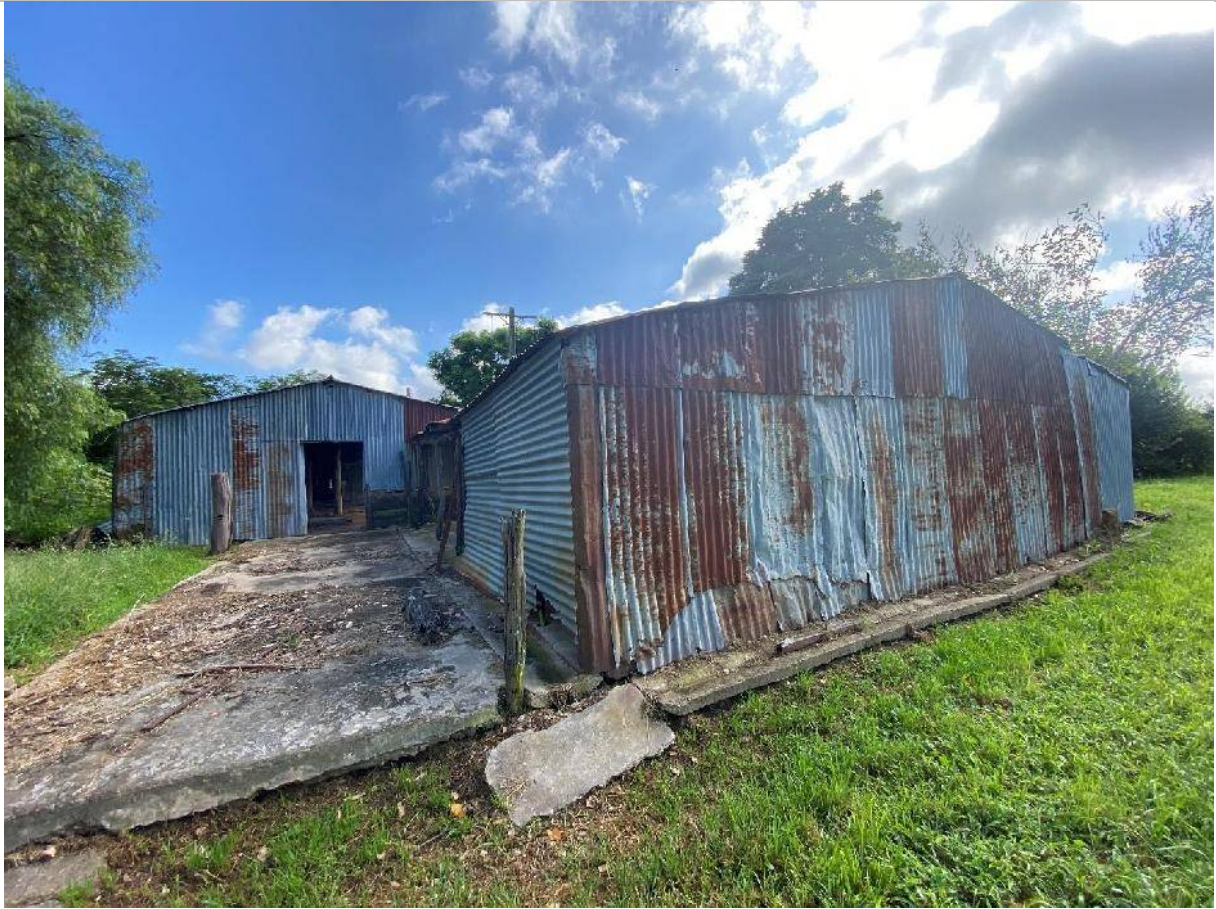
Figure 31. View of the South façade of the feed store and cow bails. It is proposed to reinstate the salvaged elements of the dish drain and hard pack sub-grade to below the concrete slab and dish drain. Source: JPA&D, 2022.

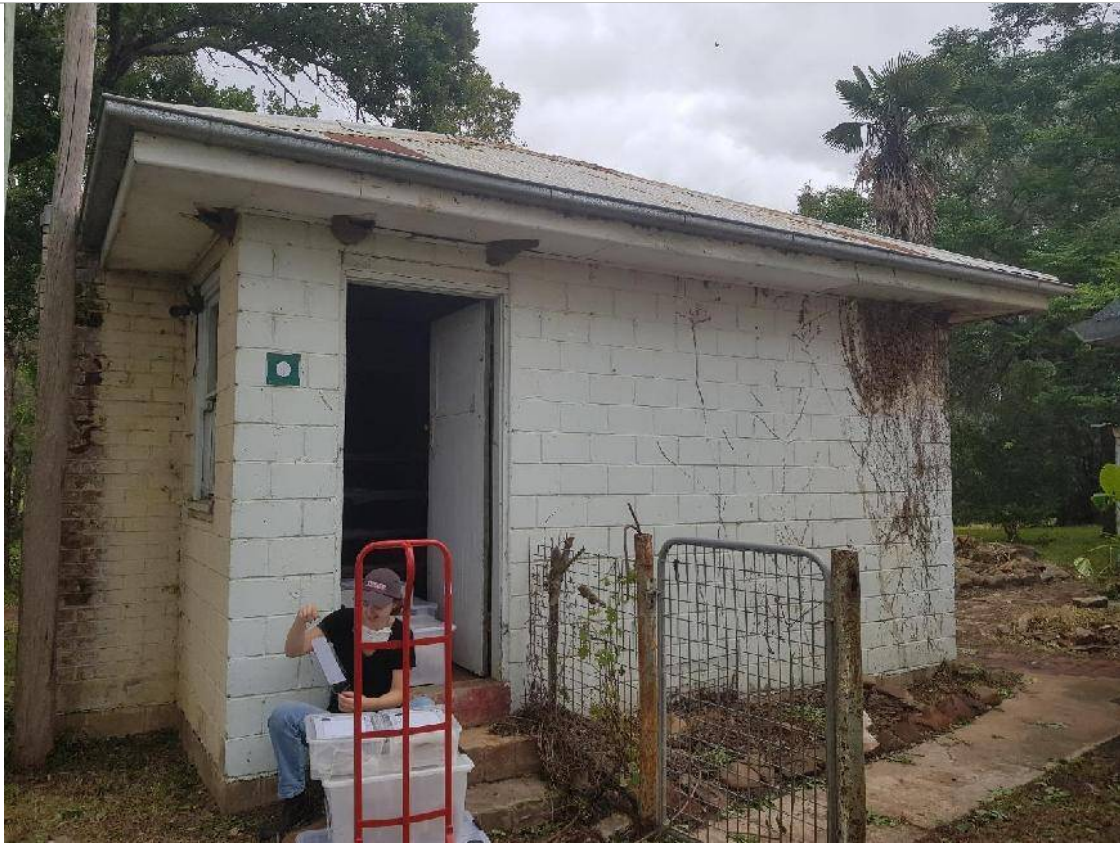
Figure 32. View of the East façade of the guest house. This building is proposed to be demolished. Source: JPA&D, 2021.

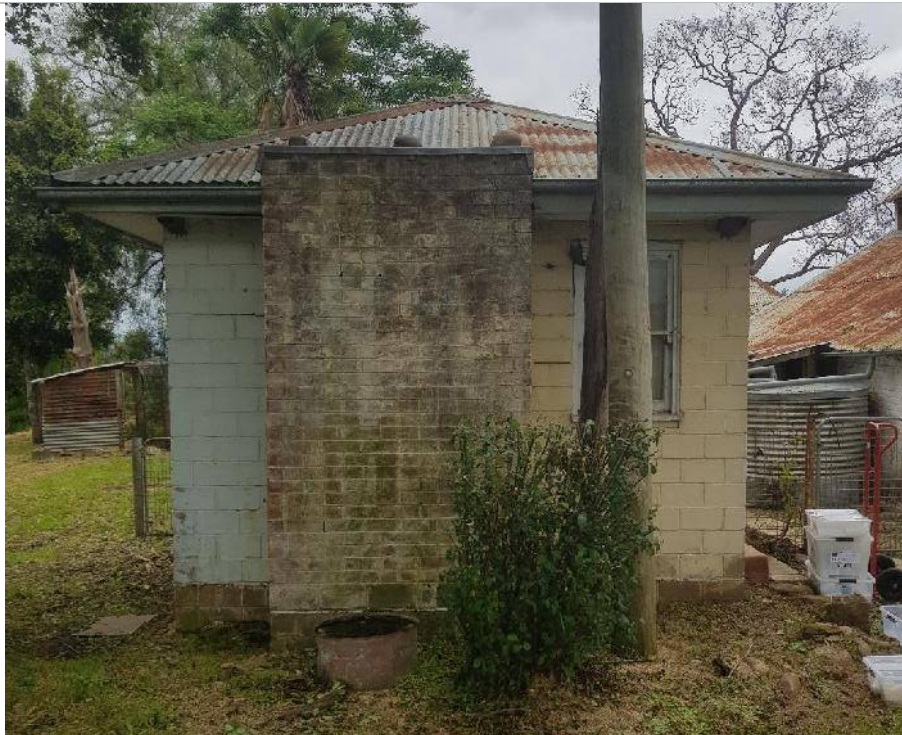
Figure 33. View of the South façade of the guest house. This building is proposed to be demolished to restore the immediate curtilage of the main house seen to the right. Source: JPA&D, 2021.

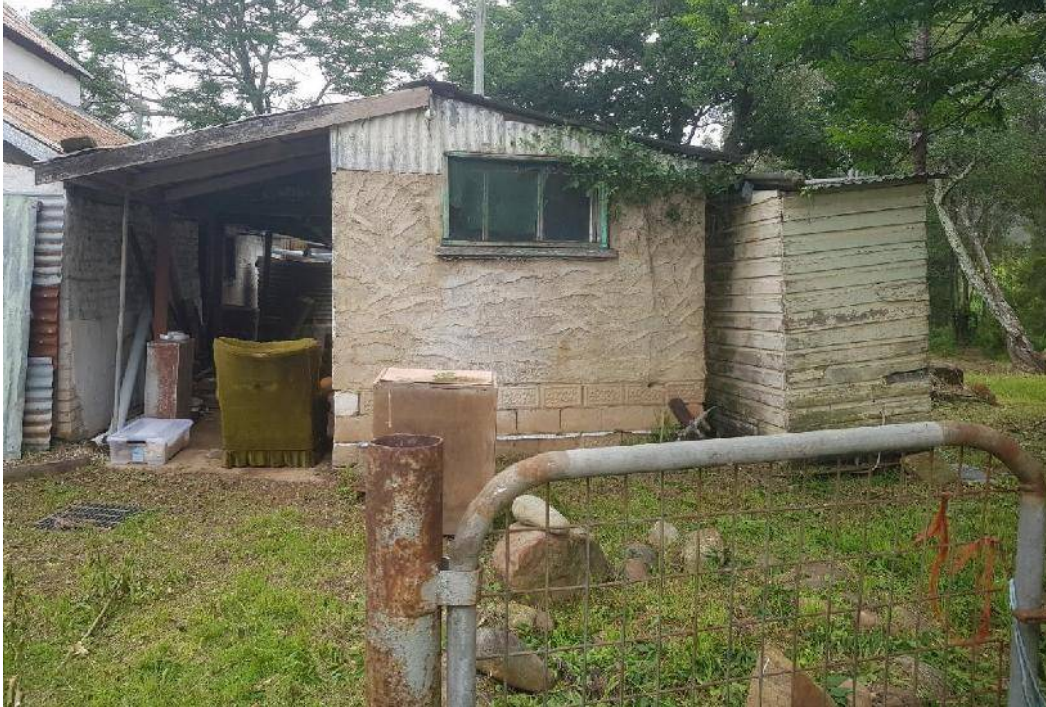
Figure 36. View of the North façade of the laundry. This building is proposed to be demolished to restore the immediate curtilage of the main house seen to the left, this demolition excludes the WC outbuilding to the right of the laundry. Source: JPA&D, 2021.

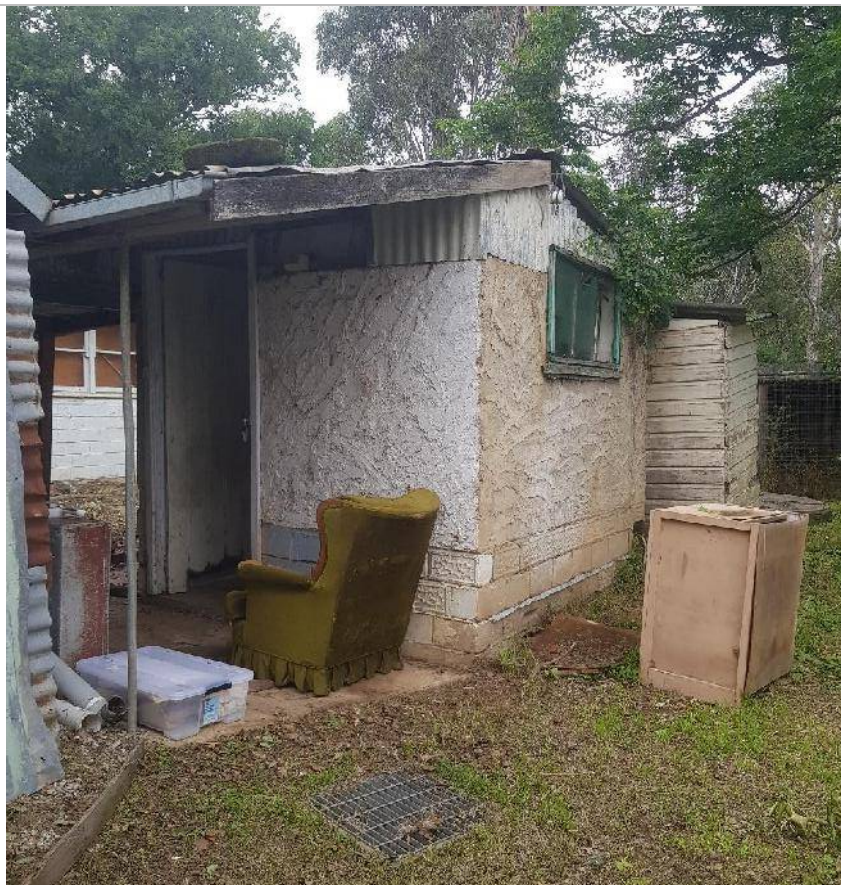
Figure 37. View of the North East corner of the laundry. The laundry is proposed to be demolished, this demolition excludes the skillion roof that is attached to the rear of the main house and forms half of the gabled roof of the laundry. Source: JPA&D, 2021.
