STATEMENT OF HERITAGE IMPACT

HADLEY PARK

In support of Section 60 Application for Remedial Works at:
14-278 Old Castlereagh Road,
Castlereagh, NSW 2749.

For NSW Department of Planning and Environment.
8th of December 2022
Issued for Development Application.

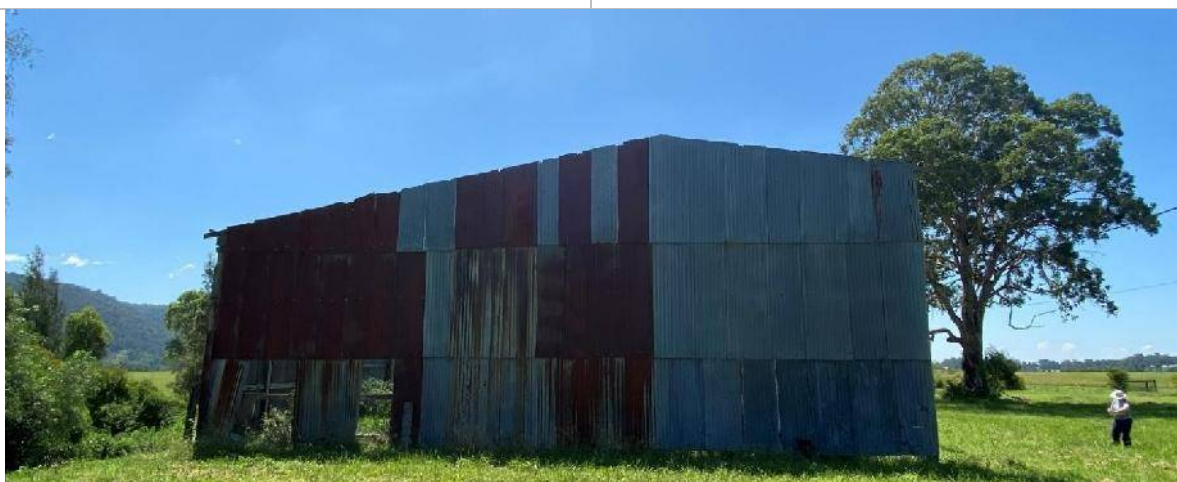
Figure 43. View of the South façade of the hay shed. The metal sheet cladding remains largely intact on this façade with a few missing sheets on the bottom left. Source: JPA&D, 2022.

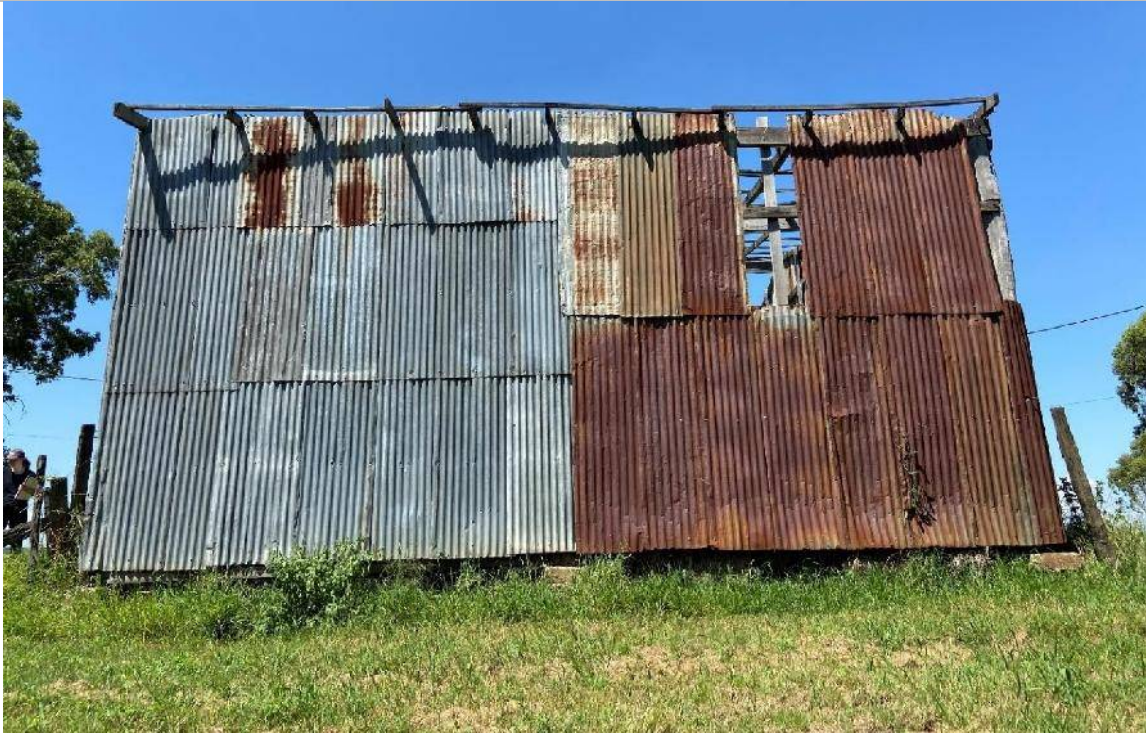
Figure 44. View of the West façade of the hay shed. It is proposed to install a timber retaining wall on this West side of the structure as the ground level recedes and to prevent soil erosion near the structural timber columns. Source: JPA&D, 2022.

Due to the deterioration of the hay shed the remedial work propose to install new timber battens and metal sheeting for the whole roof to match existing, to extend the wall studs to the bottom plate and to install a timber retaining wall on the West side where the ground level falls. It is also proposed to splice and extend the bush poles to the structural engineer's details. These proposed works will improve the aesthetic significance of the building to reconstruct it to an earlier more representative state.
