Proposed Redevelopment Preliminary Geotechnical Investigation Report

182-186 Gertrude St North Gosford

80021082

Prepared for
Lindfield Group Pty Ltd

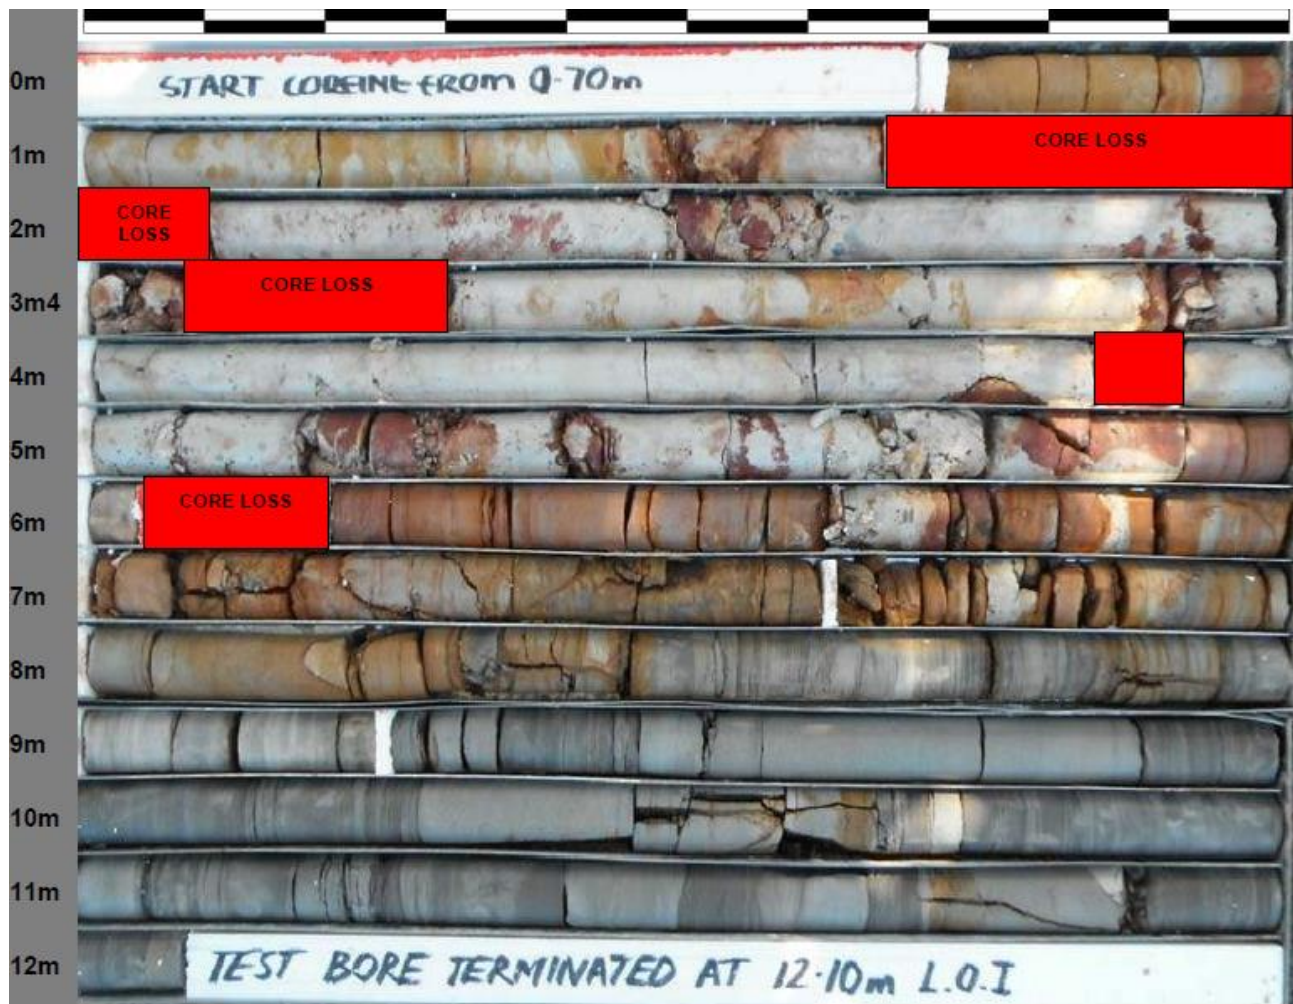
A typical Gosford station area borehole based on past experience is shown below:

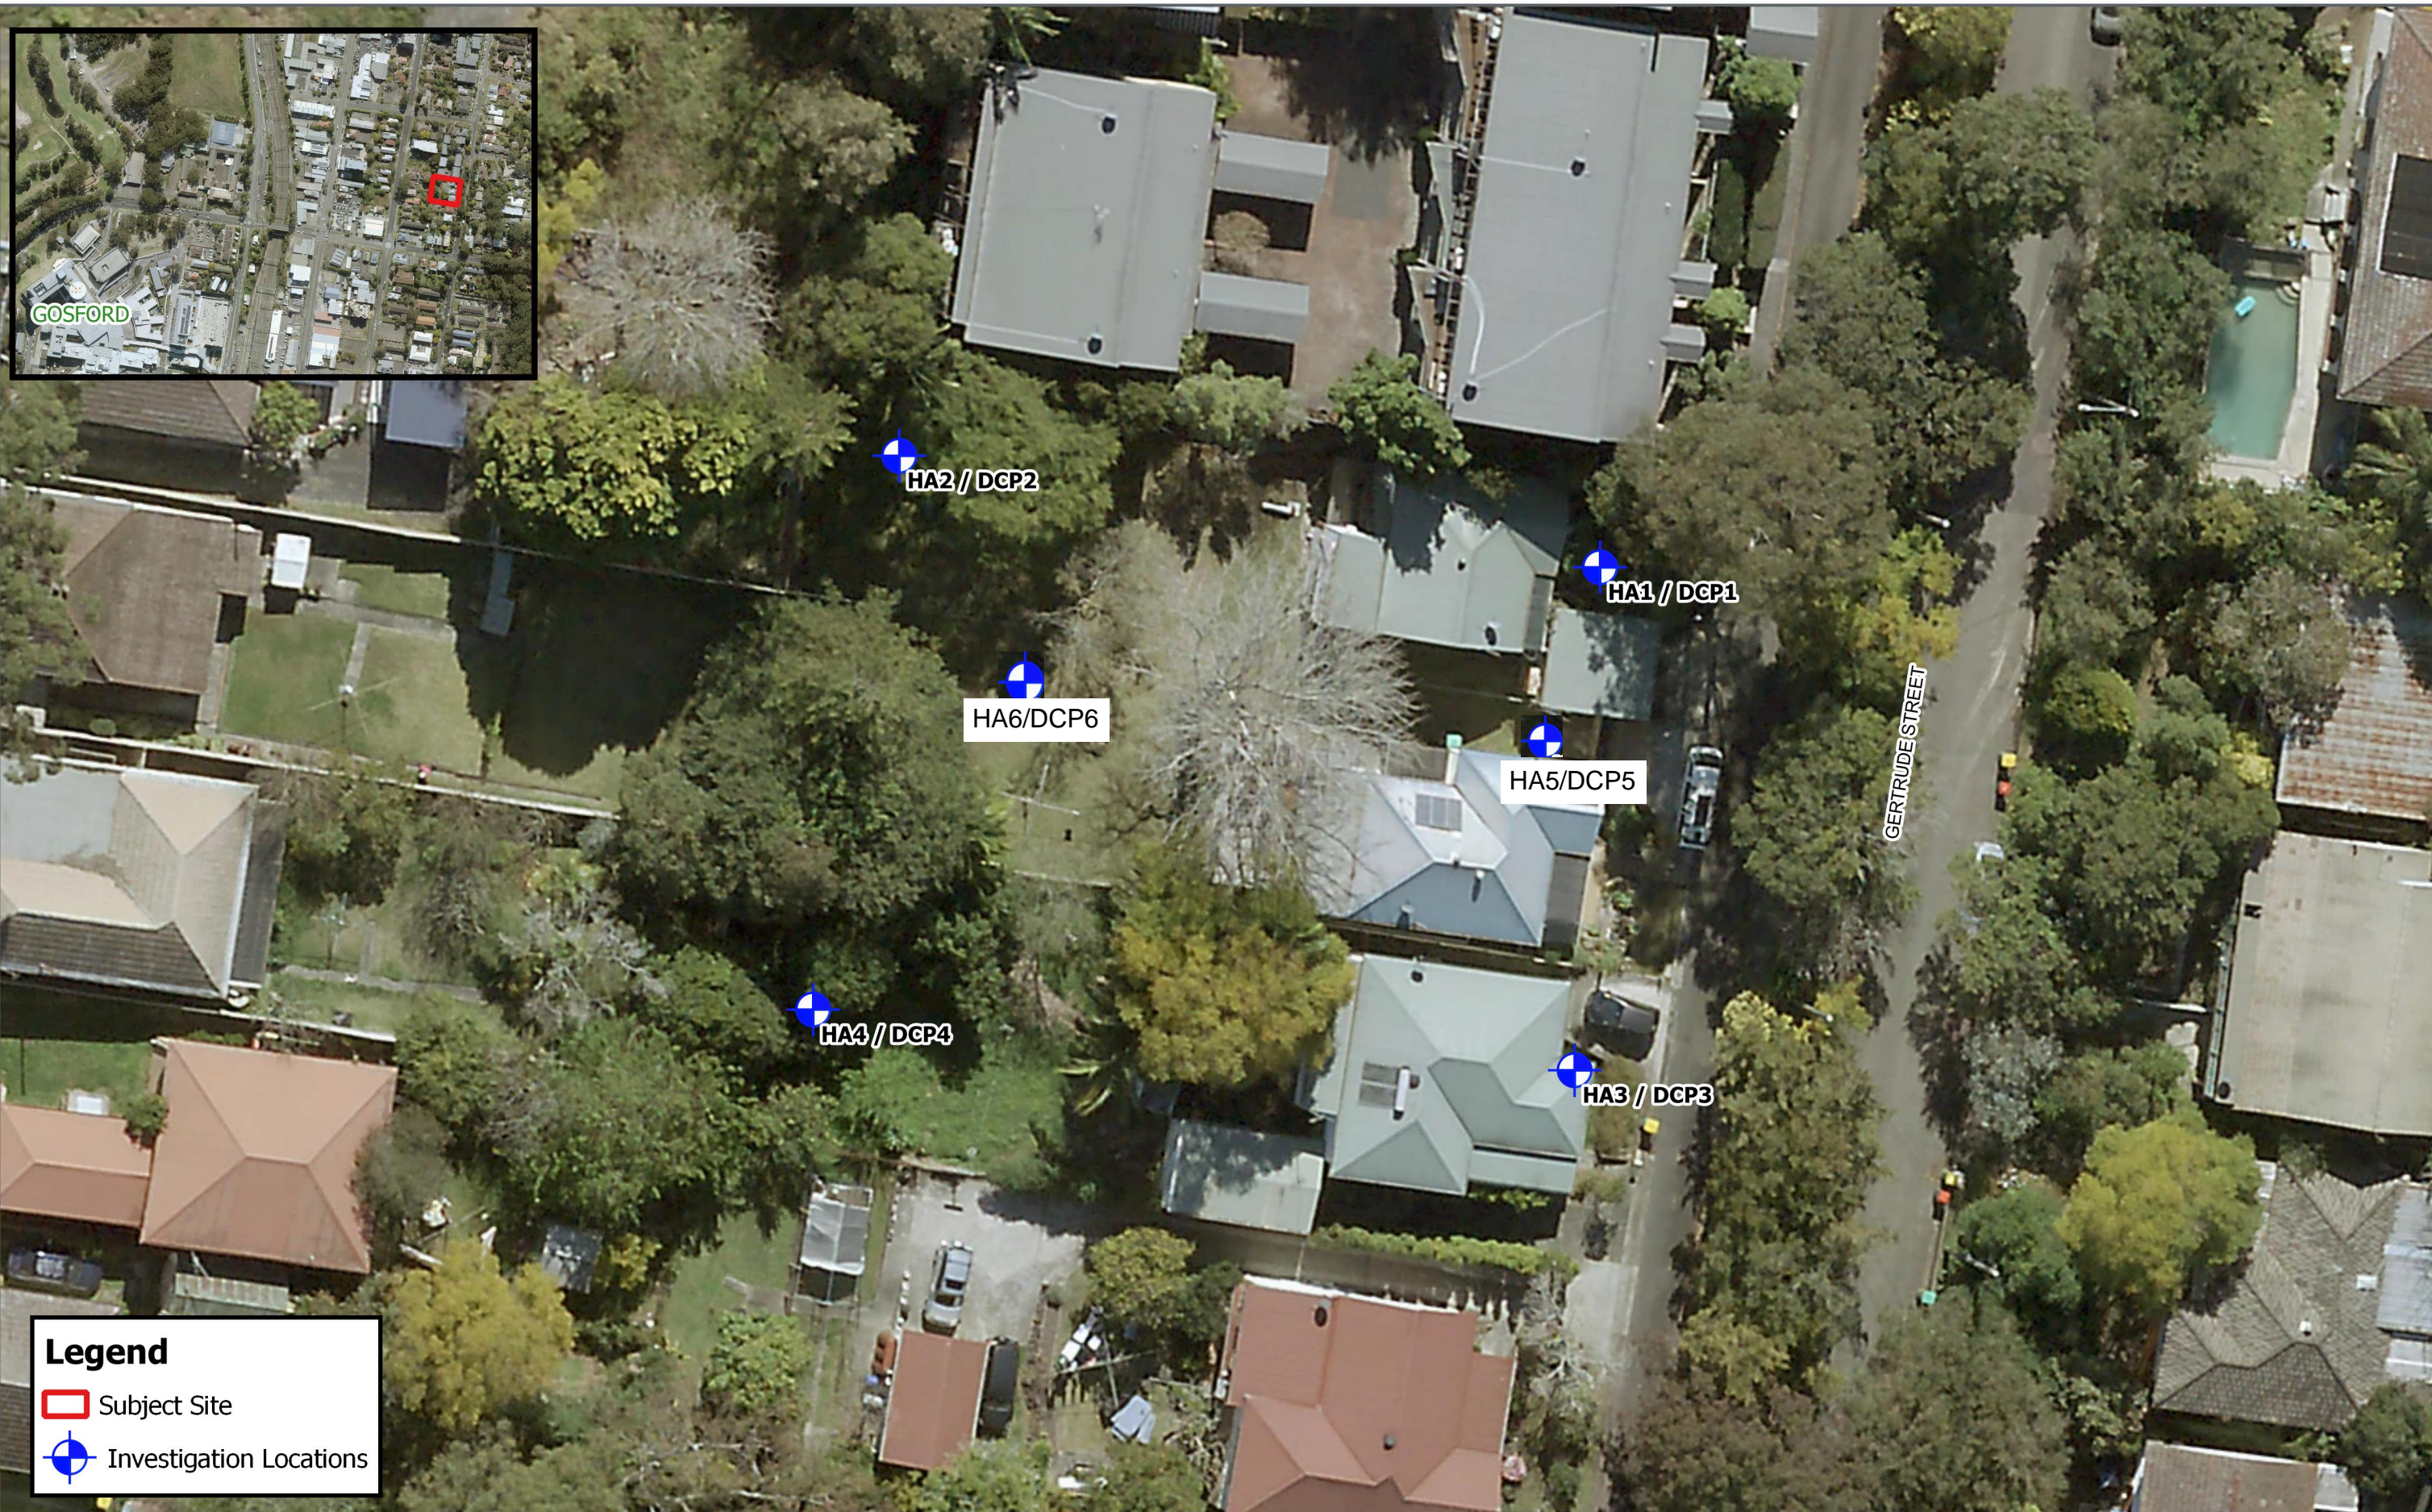
Geotechnical Investigation - Site Plan

The approximate borehole and DCP test locations are shown on the enclosed Borehole and DCP test location plan referenced as Figure 1 in Appendix A.

Assessment of the sub-surface profile at the site and the recommendations presented in this report are based on information from six (6) boreholes, drilled at locations considered representative across the site, and DCP testing at six (6) locations. Based on the results of the investigation and subsurface variability, there is a possibility that actual geotechnical conditions across the site could differ from the inferred geotechnical model presented in this report.

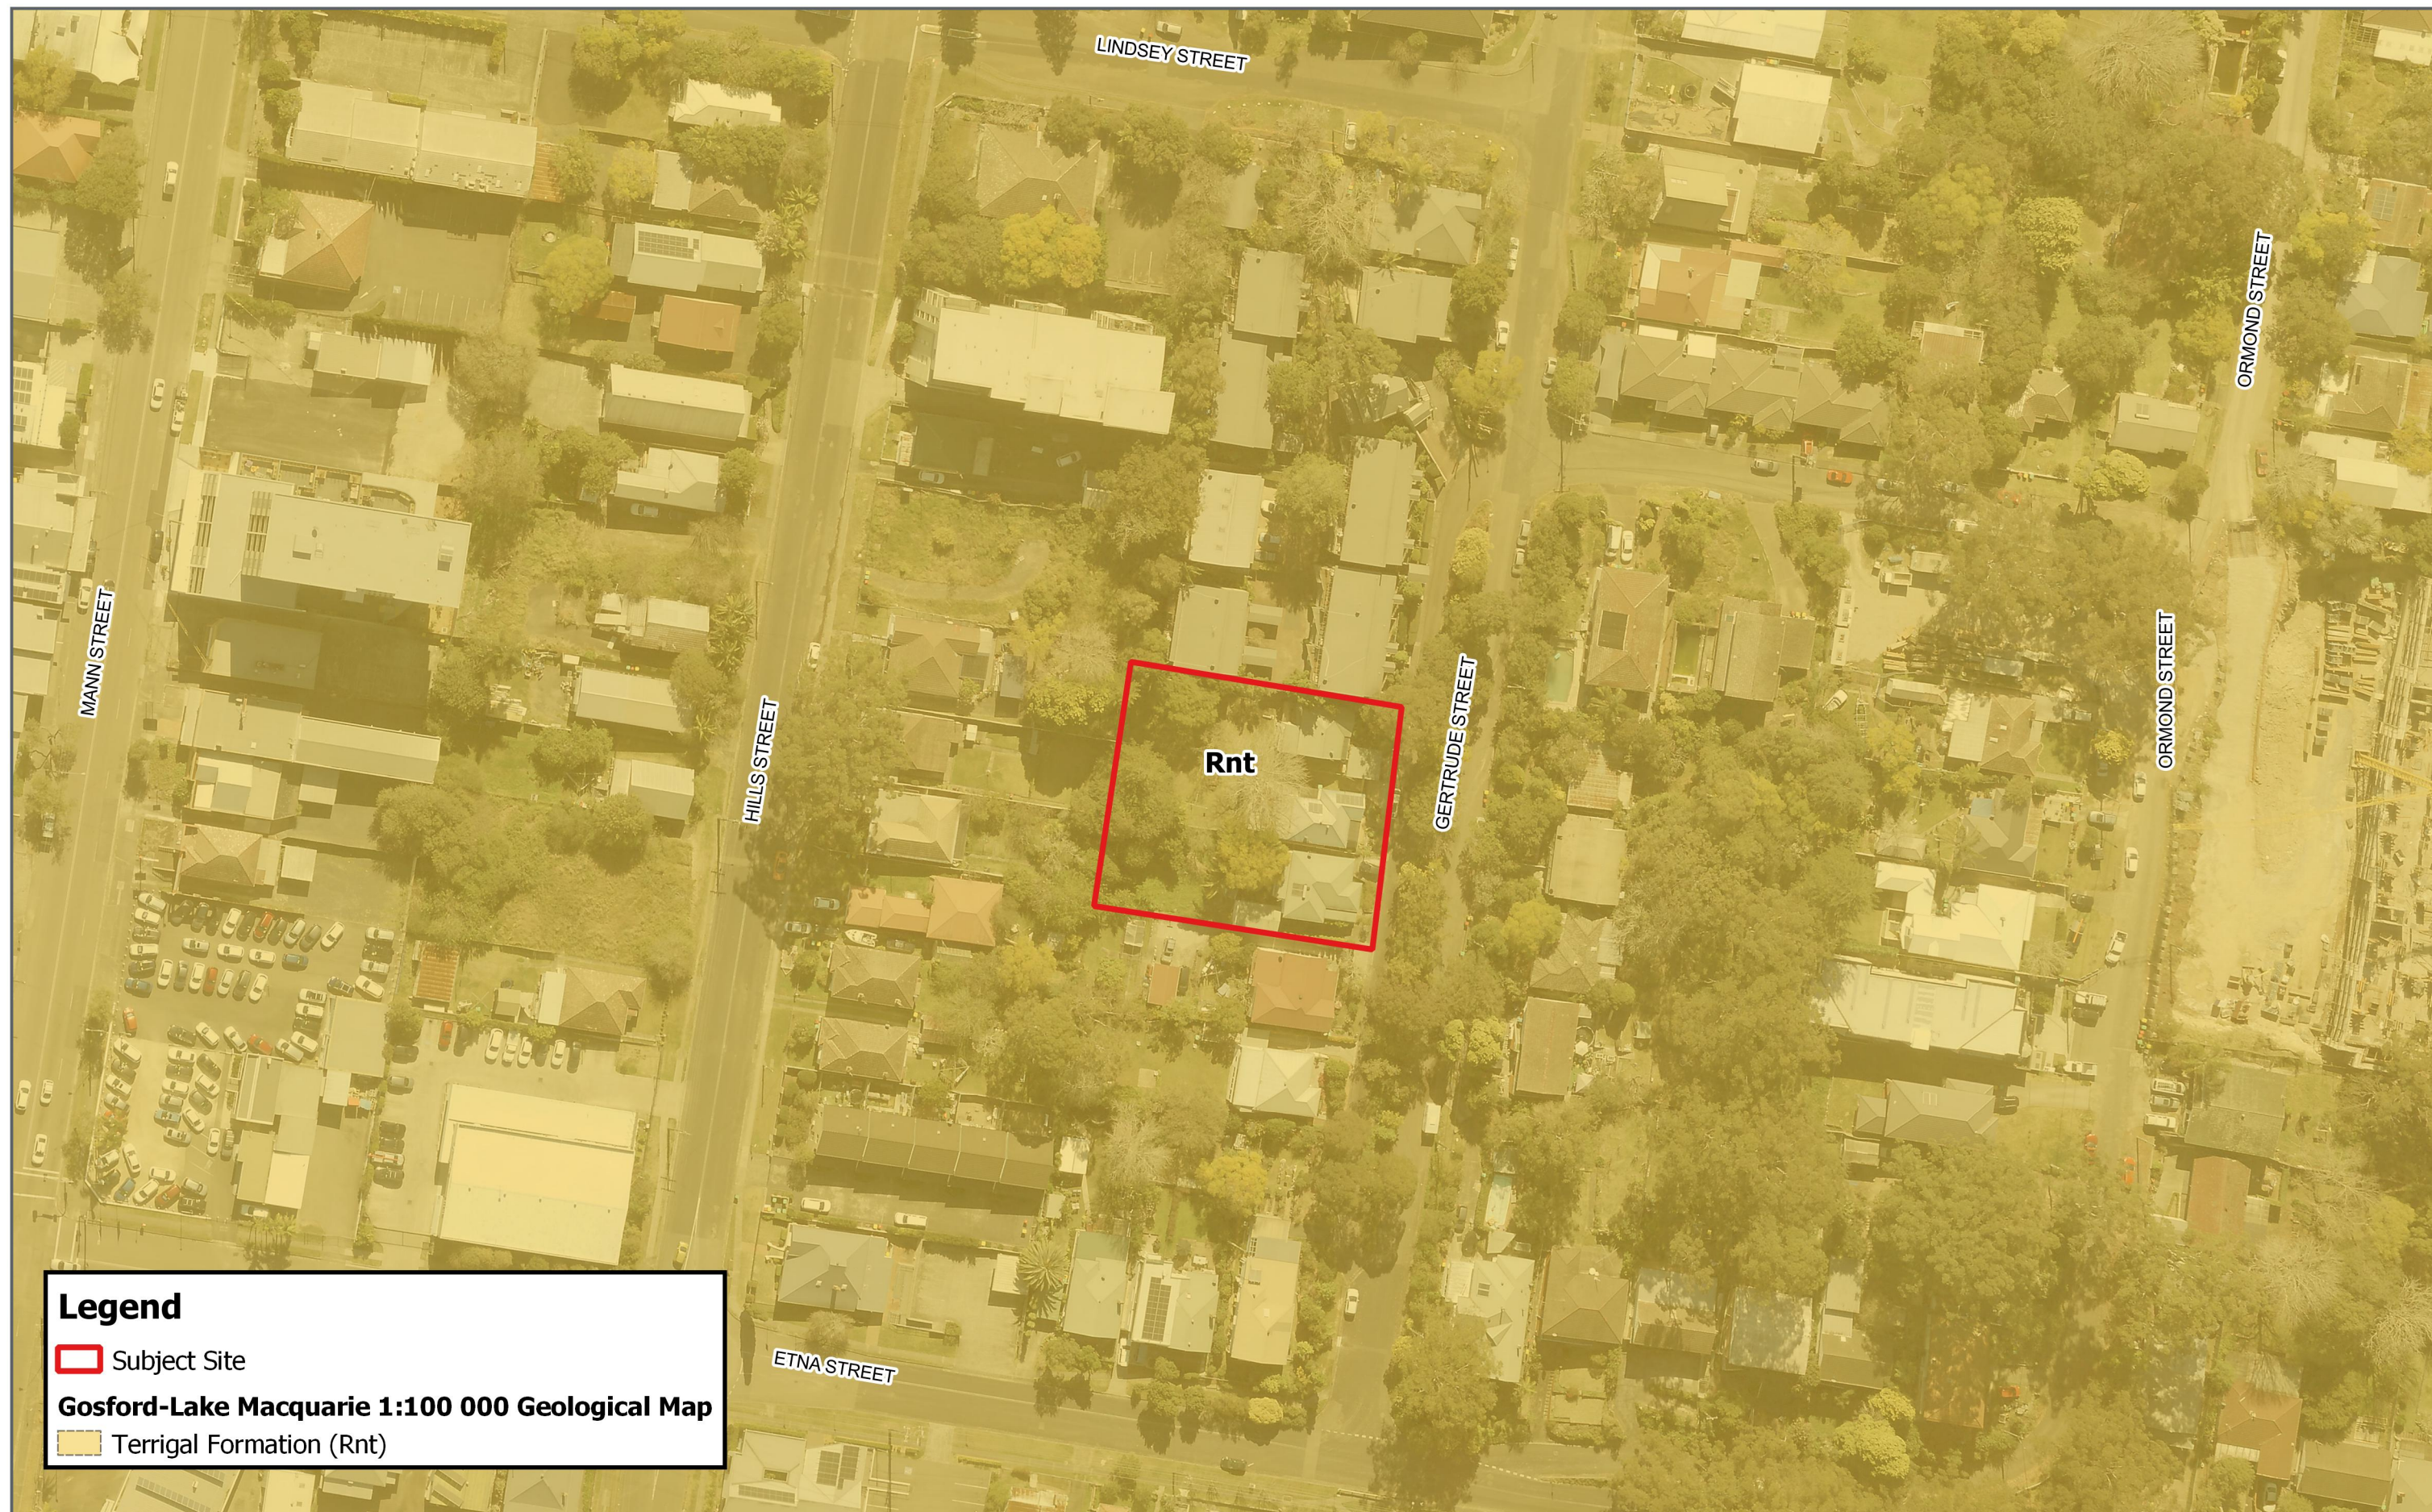
Geological Plan

Reference to the Geological Map of Gosford to Lake Macquarie (1:100,000) indicates that the site is underlain of Terrigal Formation (Rnt) which comprises interbedded laminite, shale and quartz, to lithic-quartz sandstone.

Geological plan of the site is shown in Appendix A.

Terrigal Formation (Rnt)
