Geotechnical Assessment

**REPORT TO  
THE R.A.N. SKI CLUB LIMITED**

Client:	THE R.A.N. SKI CLUB LIMITED						
Project:	PROPOSED EXTENSION						
Location:	32 BOBUCK LANE, THREDBO, NSW						
Job No.	31441RH	Hammer Weight & Drop: 9kg/510mm					
Date:	8/5/18 & 9/5/18	Rod Diameter: 16mm					
Tested By:	A.F.	Point Diameter: 20mm					
Number of Blows per 100mm Penetration							
Test Location	RL≈1370.7m	RL≈1372.0m					
Depth (mm)	<b>1</b>	<b>2</b>					
0 - 100	1	1					
100 - 200	2	2					
200 - 300	3	2					
300 - 400	3	2					
400 - 500	3	2					
500 - 600	2	2					
600 - 700	3	2					
700 - 800	4	2					
800 - 900	3	2					
900 - 1000	4	3					
1000 - 1100	4	5					
1100 - 1200	4	4					
1200 - 1300	3	6					
1300 - 1400	3	12					
1400 - 1500	4	16					
1500 - 1600	3	18					
1600 - 1700	4	13					
1700 - 1800	5	8					
1800 - 1900	6	18/50mm					
1900 - 2000	8	REFUSAL					
2000 - 2100	8						
2100 - 2200	9						
2200 - 2300	6						
2300 - 2400	4						
2400 - 2500	4						
2500 - 2600	7						
2600 - 2700	15

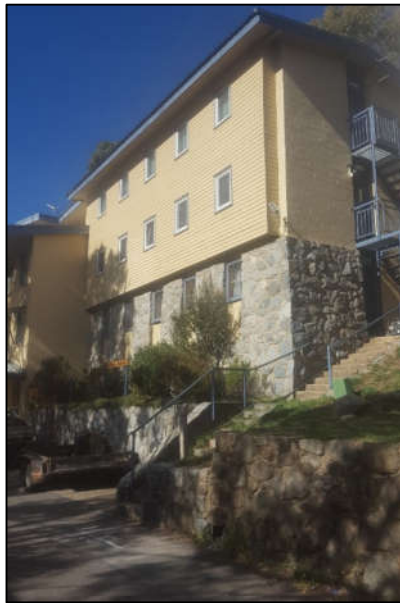
At the time of the fieldwork, the site contained a three storey brick and weatherboard lodge building with a ground floor level estimated to be between 1m to 2m higher than Bobuck Lane. The building appeared to be in good external condition, based on a cursory inspection from within the site. A garden was located on the northern side of the building adjacent to its western portion and was supported by a mortared granite block retaining wall to a height of approximately 2m above Bobuck Lane. A narrow parking lane was located along the toe of the retaining wall. A staircase was located on the western side of the building. Refer to Plate 1 below. The rear yard was covered with grass, scattered medium to tall trees and occasional granite cobbles and boulders, up to 0.7m size. A granite block retaining wall supported the lower northern portion of the rear yard to heights between approximately 1.4m to 1.8m. The retaining walls on site appeared to be in good condition.

Plate 1: Looking upslope to the south-east showing The R.A.N. Ski Club building.

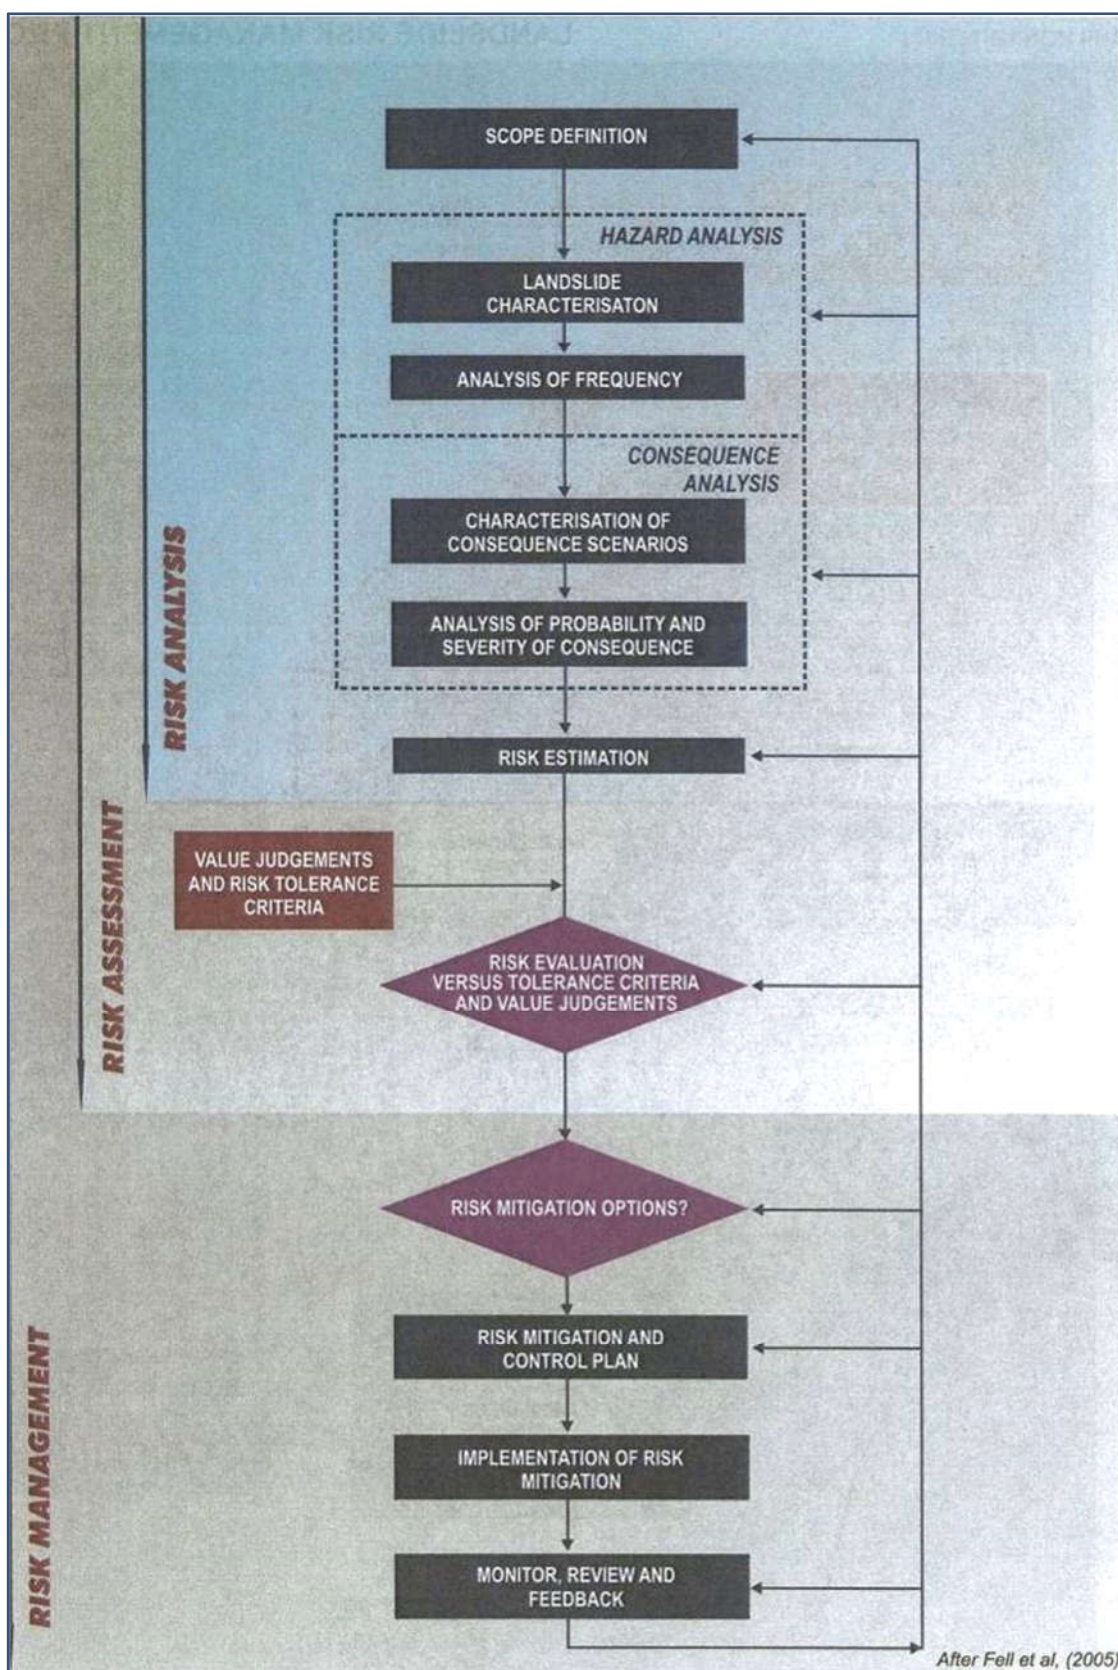
**FIGURE A1:** Flowchart for Landslide Risk Management.

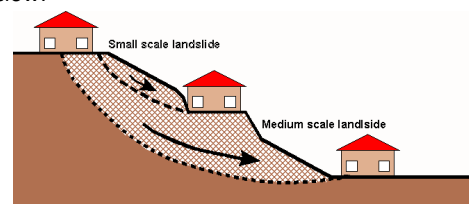
Figure 1

**Rotational or circular slip failures (Figure 1)** - can occur on moderate to very steep soil and weathered rock slopes (Table 1). The sliding surface of the moving mass tends to be deep seated. Tension cracks may open at the top of the slope and bulging may occur at the toe. The ground may move in discrete "steps" separated by long periods without movement. More rapid movement may occur after heavy rain.

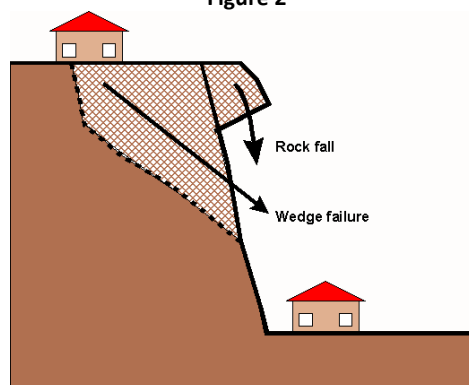
Figure 3

**Wedge failures (Figure 3)** - normally only occur on extreme slopes, or cliffs (Table 1), where discontinuities in the rock are inclined steeply downwards out of the face.

**Rock falls (Figure 3)** - tend to occur from cliffs and overhangs (Table 1).

Cliffs may remain, apparently unchanged, for hundreds of years. Collections of boulders at the foot of a cliff may indicate that rock falls are ongoing. Wedge failures and rock falls do not "creep". Familiarity with a particular local situation can instil a false sense of security since failure, when it occurs, is usually sudden and catastrophic.
