Site Classification Summary Report

Client	The Stables Perisher Management Pty Ltd	Project No.	217258.00
Project	Proposed Extensions	Date	19 Oct 2023
Address	Units 20-25, 20 Candle Heath Road, Perisher Valley	Doc No.	R.001.Rev1

Proposed Development

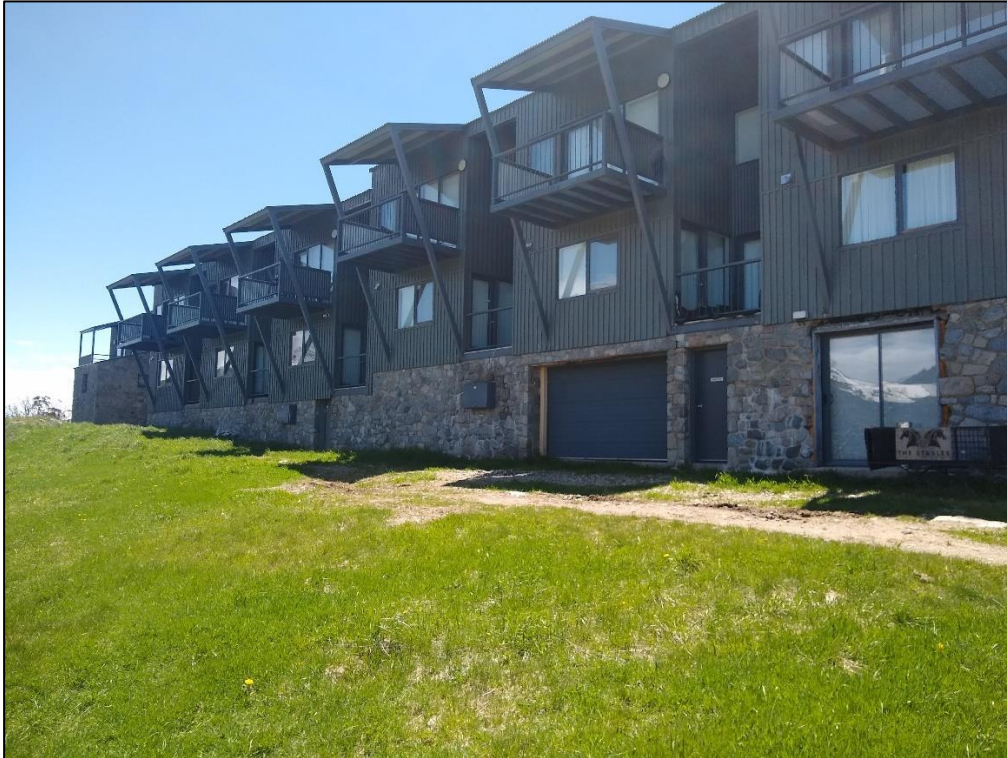
Figure 1: View of Units 20 – 25 from the south-west.

The site is located at Lot 603, DP 1158020 within the ski resort of Perisher Valley. Units 20 – 25 are located along the western boundary of the lot, and within the vicinity of the units site levels fall from the east to west. The units are bordered to the north, east and south-east by other units within The Stables development, and to the west and south-west by open space, while a concrete path extends to the units from the north. From service locating undertaken on site, it is understood that multiple service trenches extend to Units 20 – 25 from all directions. No trees are located within the zone of influence of Units 20 – 25. Drawing 1 attached to this report illustrates an aerial view of the location of Units 20 – 25 within The Stables' complex, while Figures 1 and 2 on the following page illustrates site features at the time of investigation.

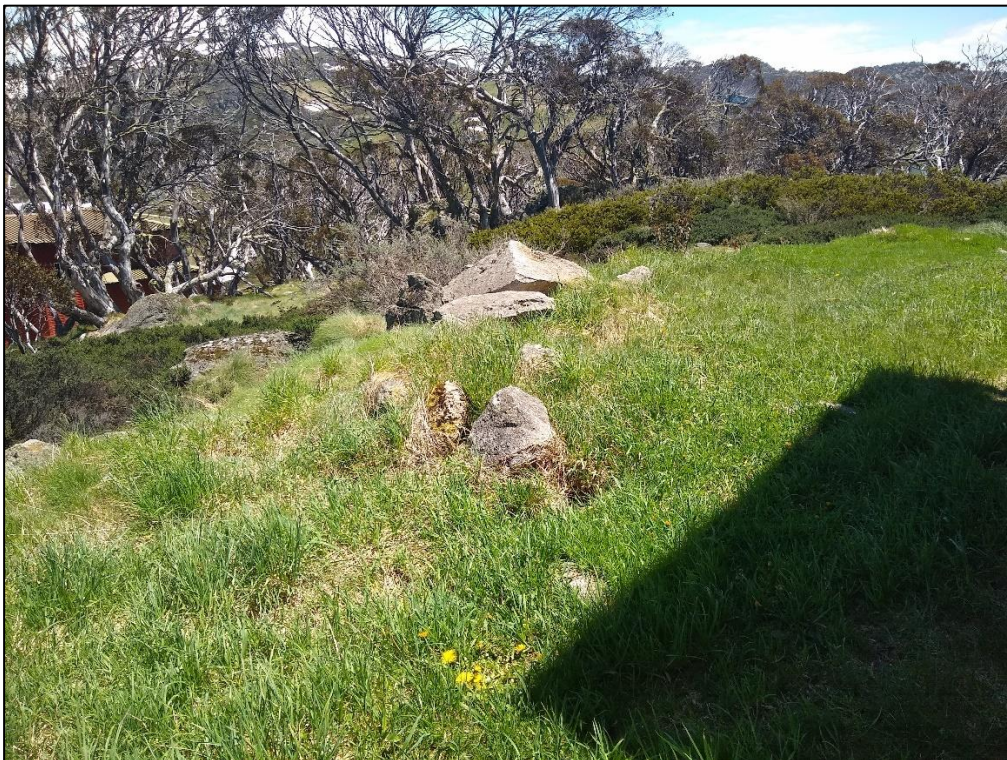
Figure 2: View of large boulders and rock outcrops to the north-west of Units 20 – 25.

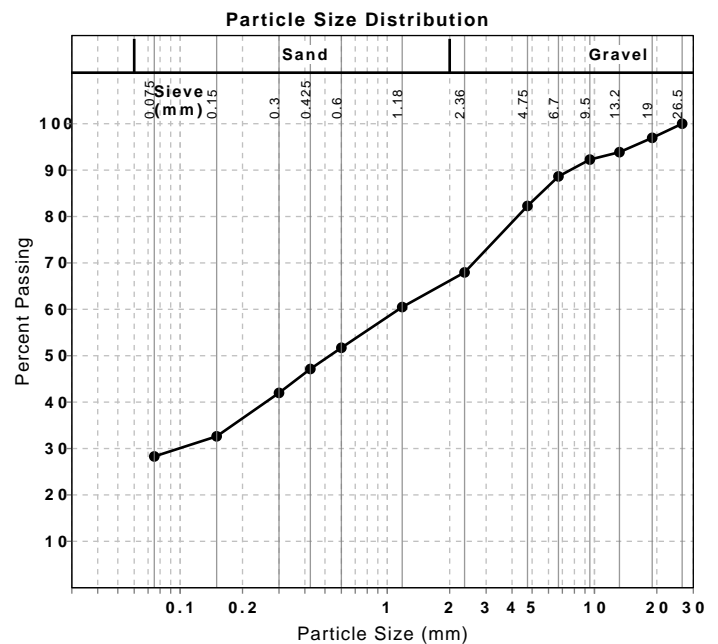
Atterberg Limit (AS1289 3.1.2 & 3.2.1 & 3.3.1)		Min	Max
Sample History	Oven Dried		
Preparation Method	Dry Sieve		
Liquid Limit (%)	33		
Plastic Limit (%)	20		
Plasticity Index (%)	13

Linear Shrinkage (AS1289 3.4.1)		Min	Max
Moisture Condition Determined By	AS 1289.3.1.2		
Linear Shrinkage (%)	6.0		
Cracking Crumbling Curling	Curling

Two samples collected from the test pits were tested for their field moisture content, Atterberg limits, linear shrinkage, and particle size distribution. The results of the laboratory testing are provided in Table 1 below, and the laboratory test result sheet is attached to this report.
