M2 Hills Motorway: Beecroft Road Overpass

Proposed Digital Sign Traffic Safety Assessment

Manboom Signage

24 November 2022

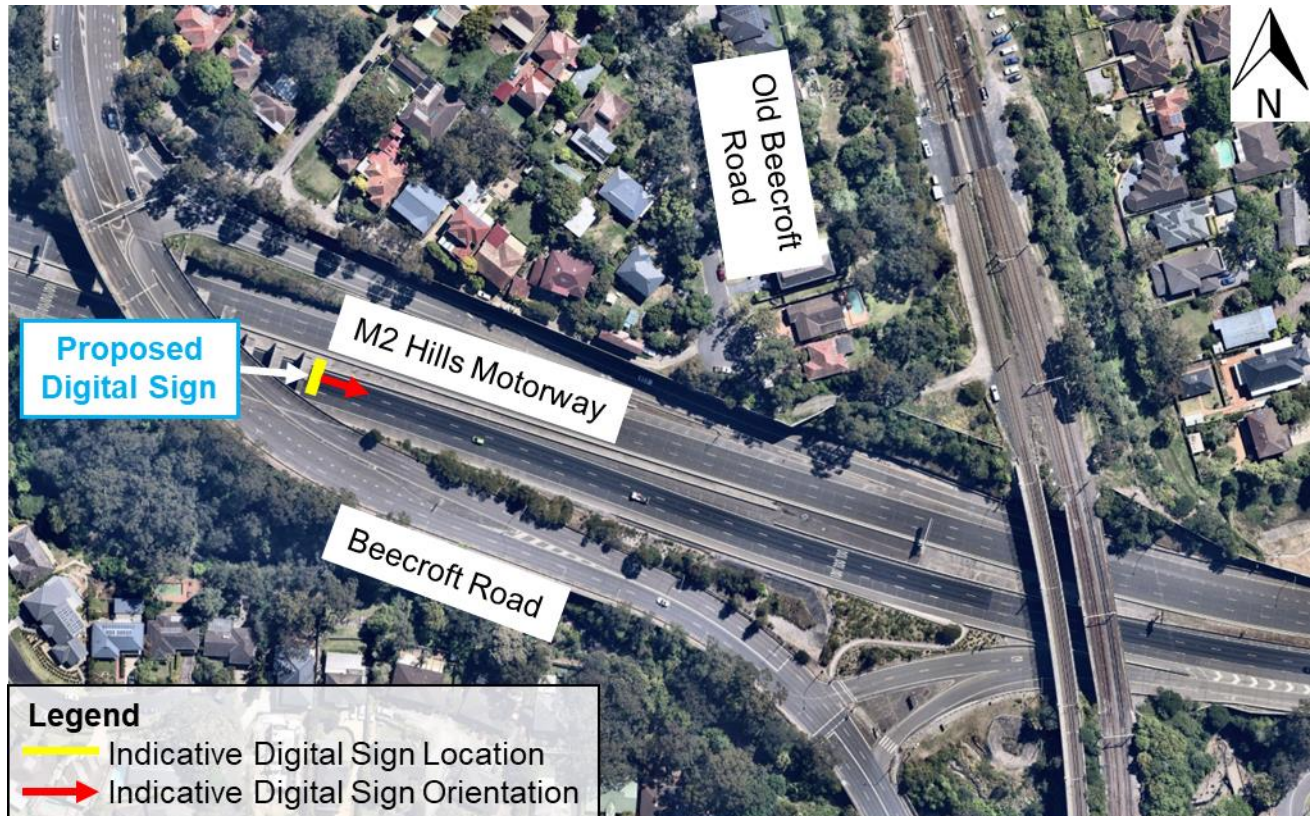
Figure 1.1: Location of the Proposed Digital Sign

Manboom Signage is seeking development approval for the installation of a digital LED advertising sign. The sign is proposed to be located above the westbound carriageway of the M2 Hills Motorway (M2) on the Beecroft Road overpass in Cheltenham as shown in Figure 1.1.

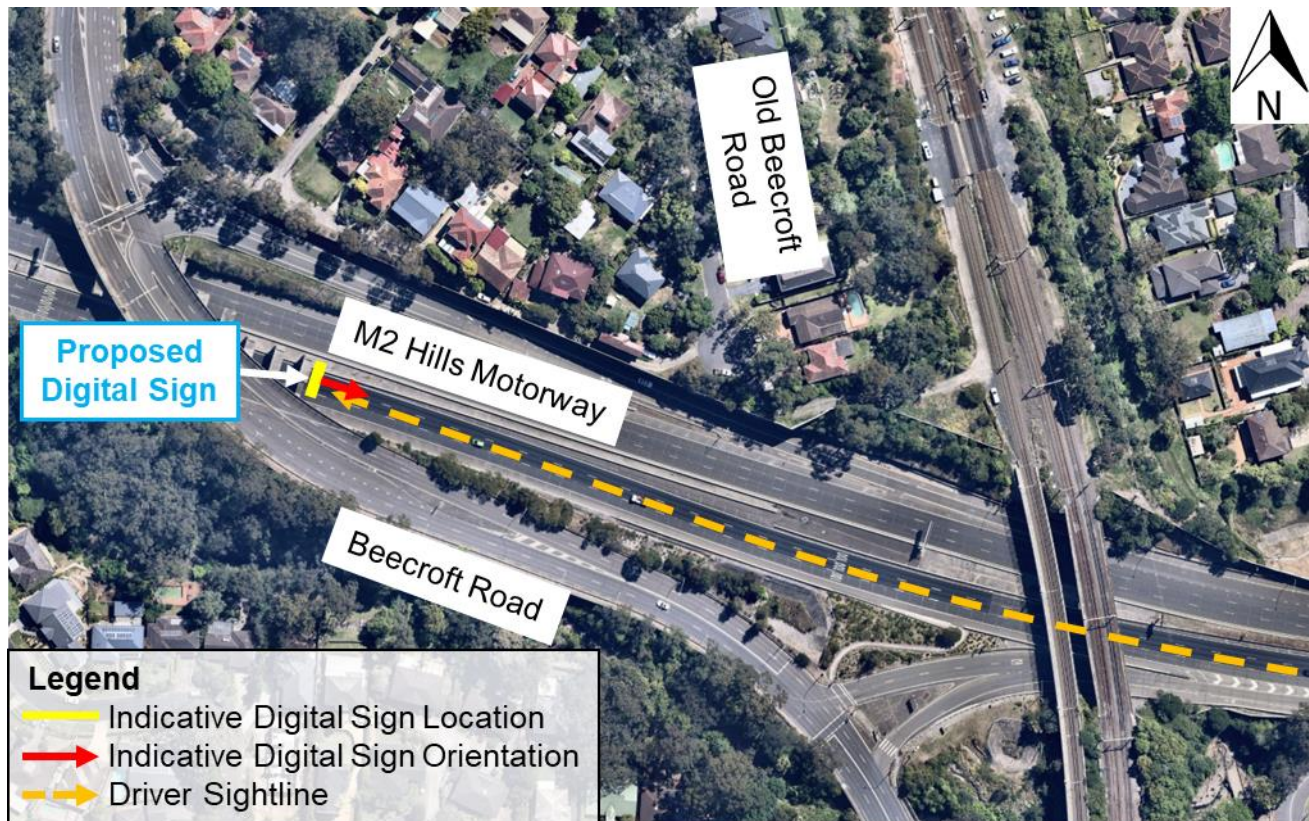
Figure 2.1: Driver Viewing Range to the Proposed Sign

The digital sign is proposed to face south-east towards westbound drivers along the M2. The driver viewing range to the sign from this approach is illustrated in Figure 2.1 and demonstrates a relatively long distance on approach to the proposed sign from which it can be identified.

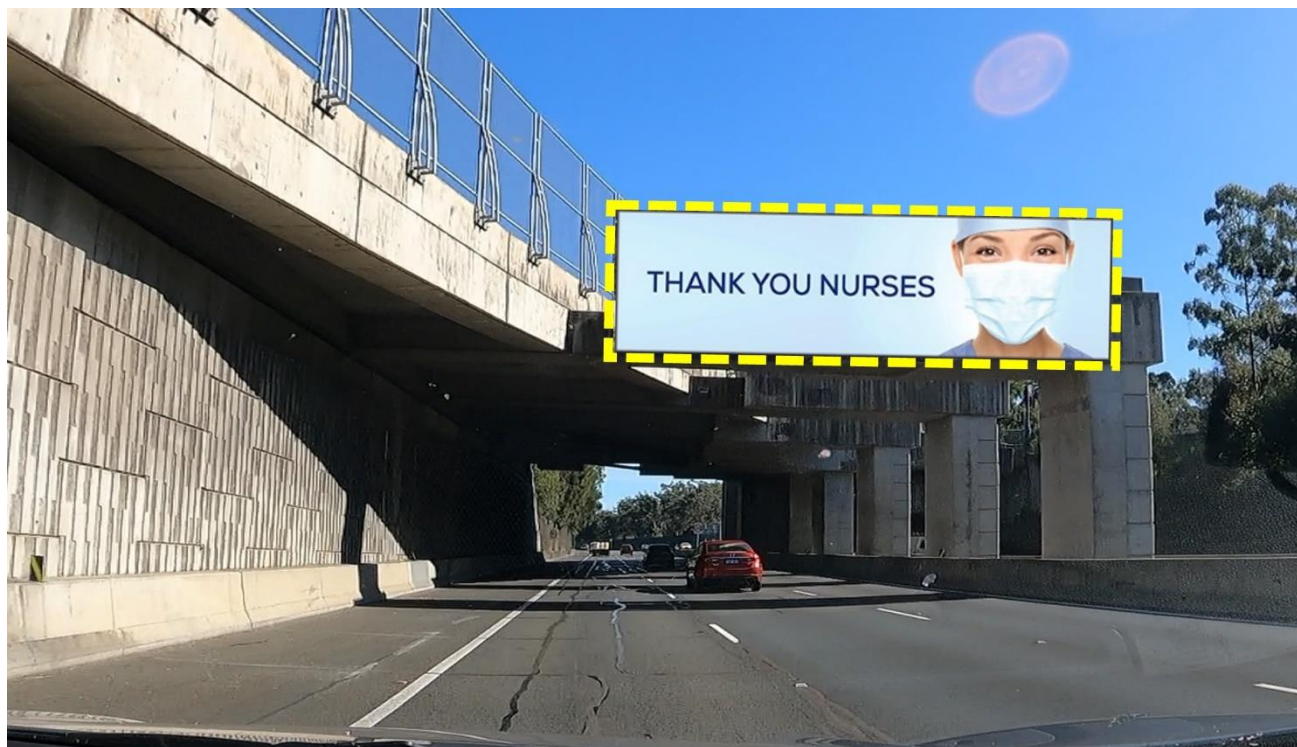
Figure 2.2: Daytime view from the M2 westbound lane 1

The westbound sign view from the M2 lanes 1 and 3 during the daytime period is shown in Figure 2.2 and Figure 2.3 respectively.

**Sign location is indicative, not to scale and for illustration purposes only.*

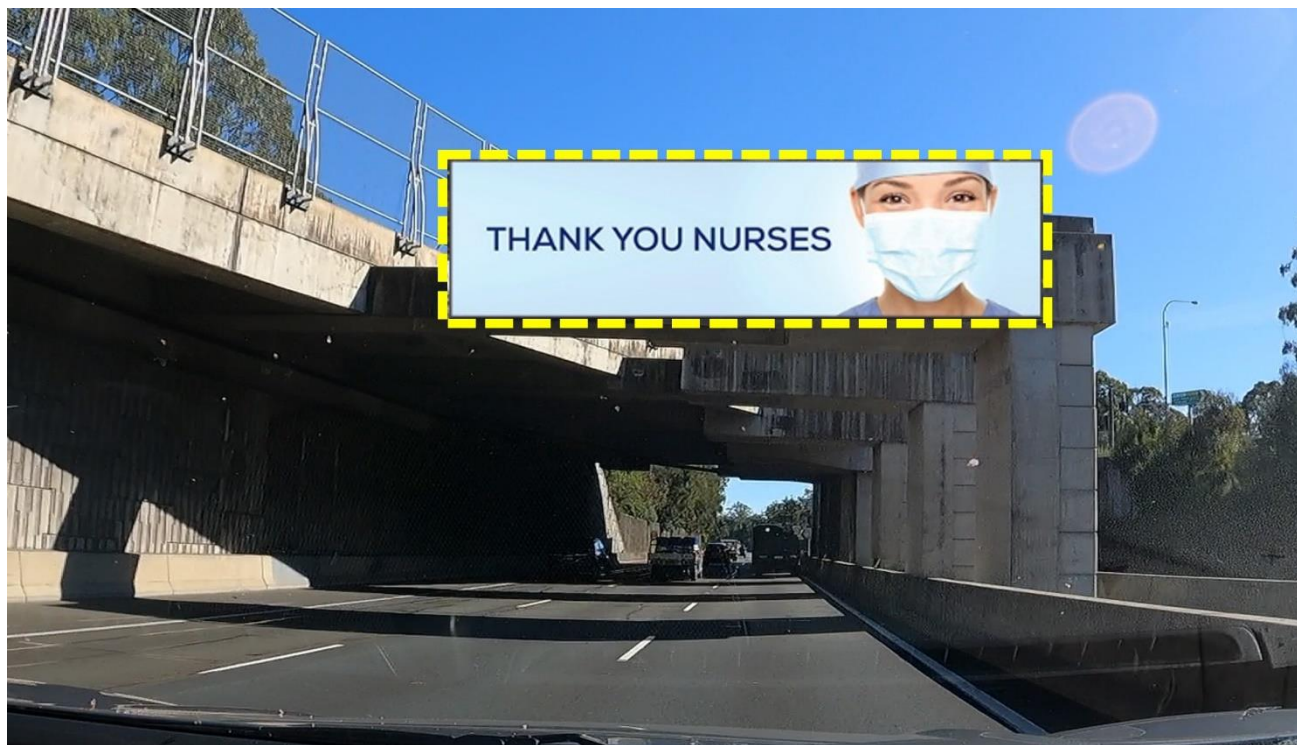
Figure 2.3: Daytime view from the M2 westbound lane 3

**Sign location is indicative, not to scale and for illustration purposes only.*

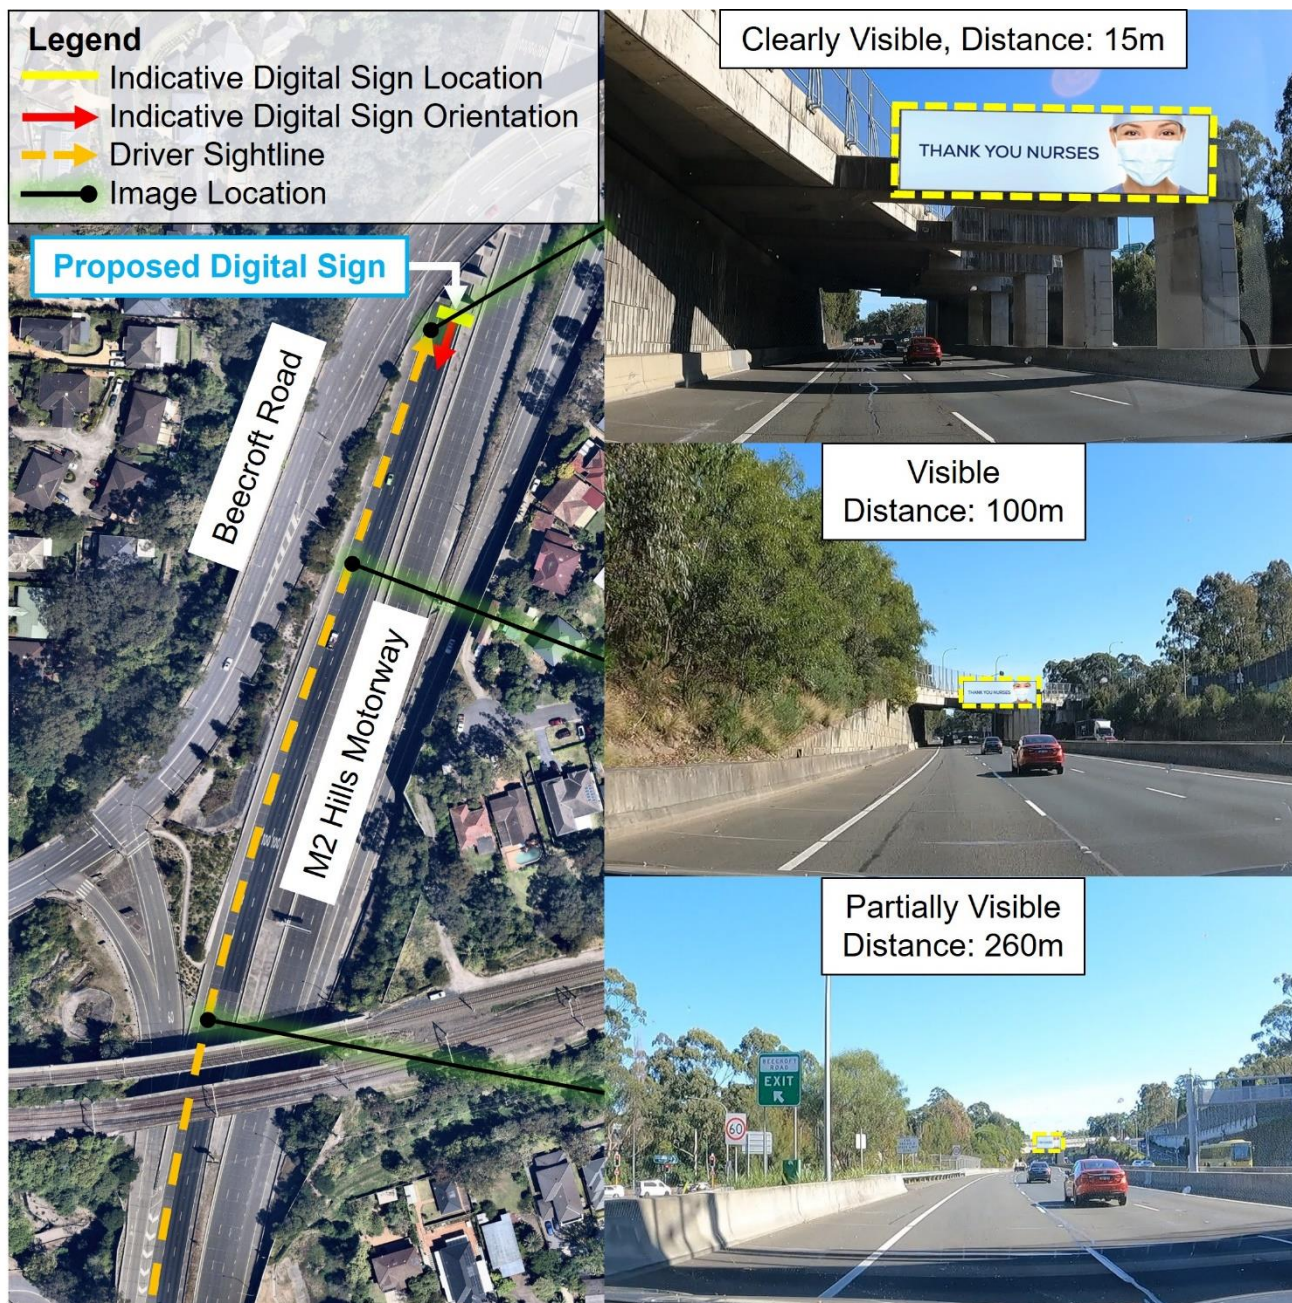
The in-vehicle sightlines from the M2 westbound are shown in Figure 5.1, clearly demonstrating that all vehicle movements are in the same sightline as the digital sign, which means no risk of distraction away from the forward roadway when glancing to it.

¹Distances measured in Nearthmap.

²Sign location is indicative, not to scale and for illustration purposes only.

A digital sign in this location will not obstruct sightlines to, or influence the messaging of, traffic control devices or signs. Despite the 100km/h speed limit, the approach to it does not require rapid, complex decision making by drivers and is not a location of high cognitive load. There are no on-ramps or off-ramps in proximity to the approach to the sign and no directional signs or signals to be aware of at distances where the advertising content is recognisable. The decision point for the diverge movement to the Beecroft Road westbound off-ramp is approximately 535m back from the sign at which point the sign would be unrecognisable and smaller than a postage stamp in size at the windscreen, also due to the Main North rail bridge.

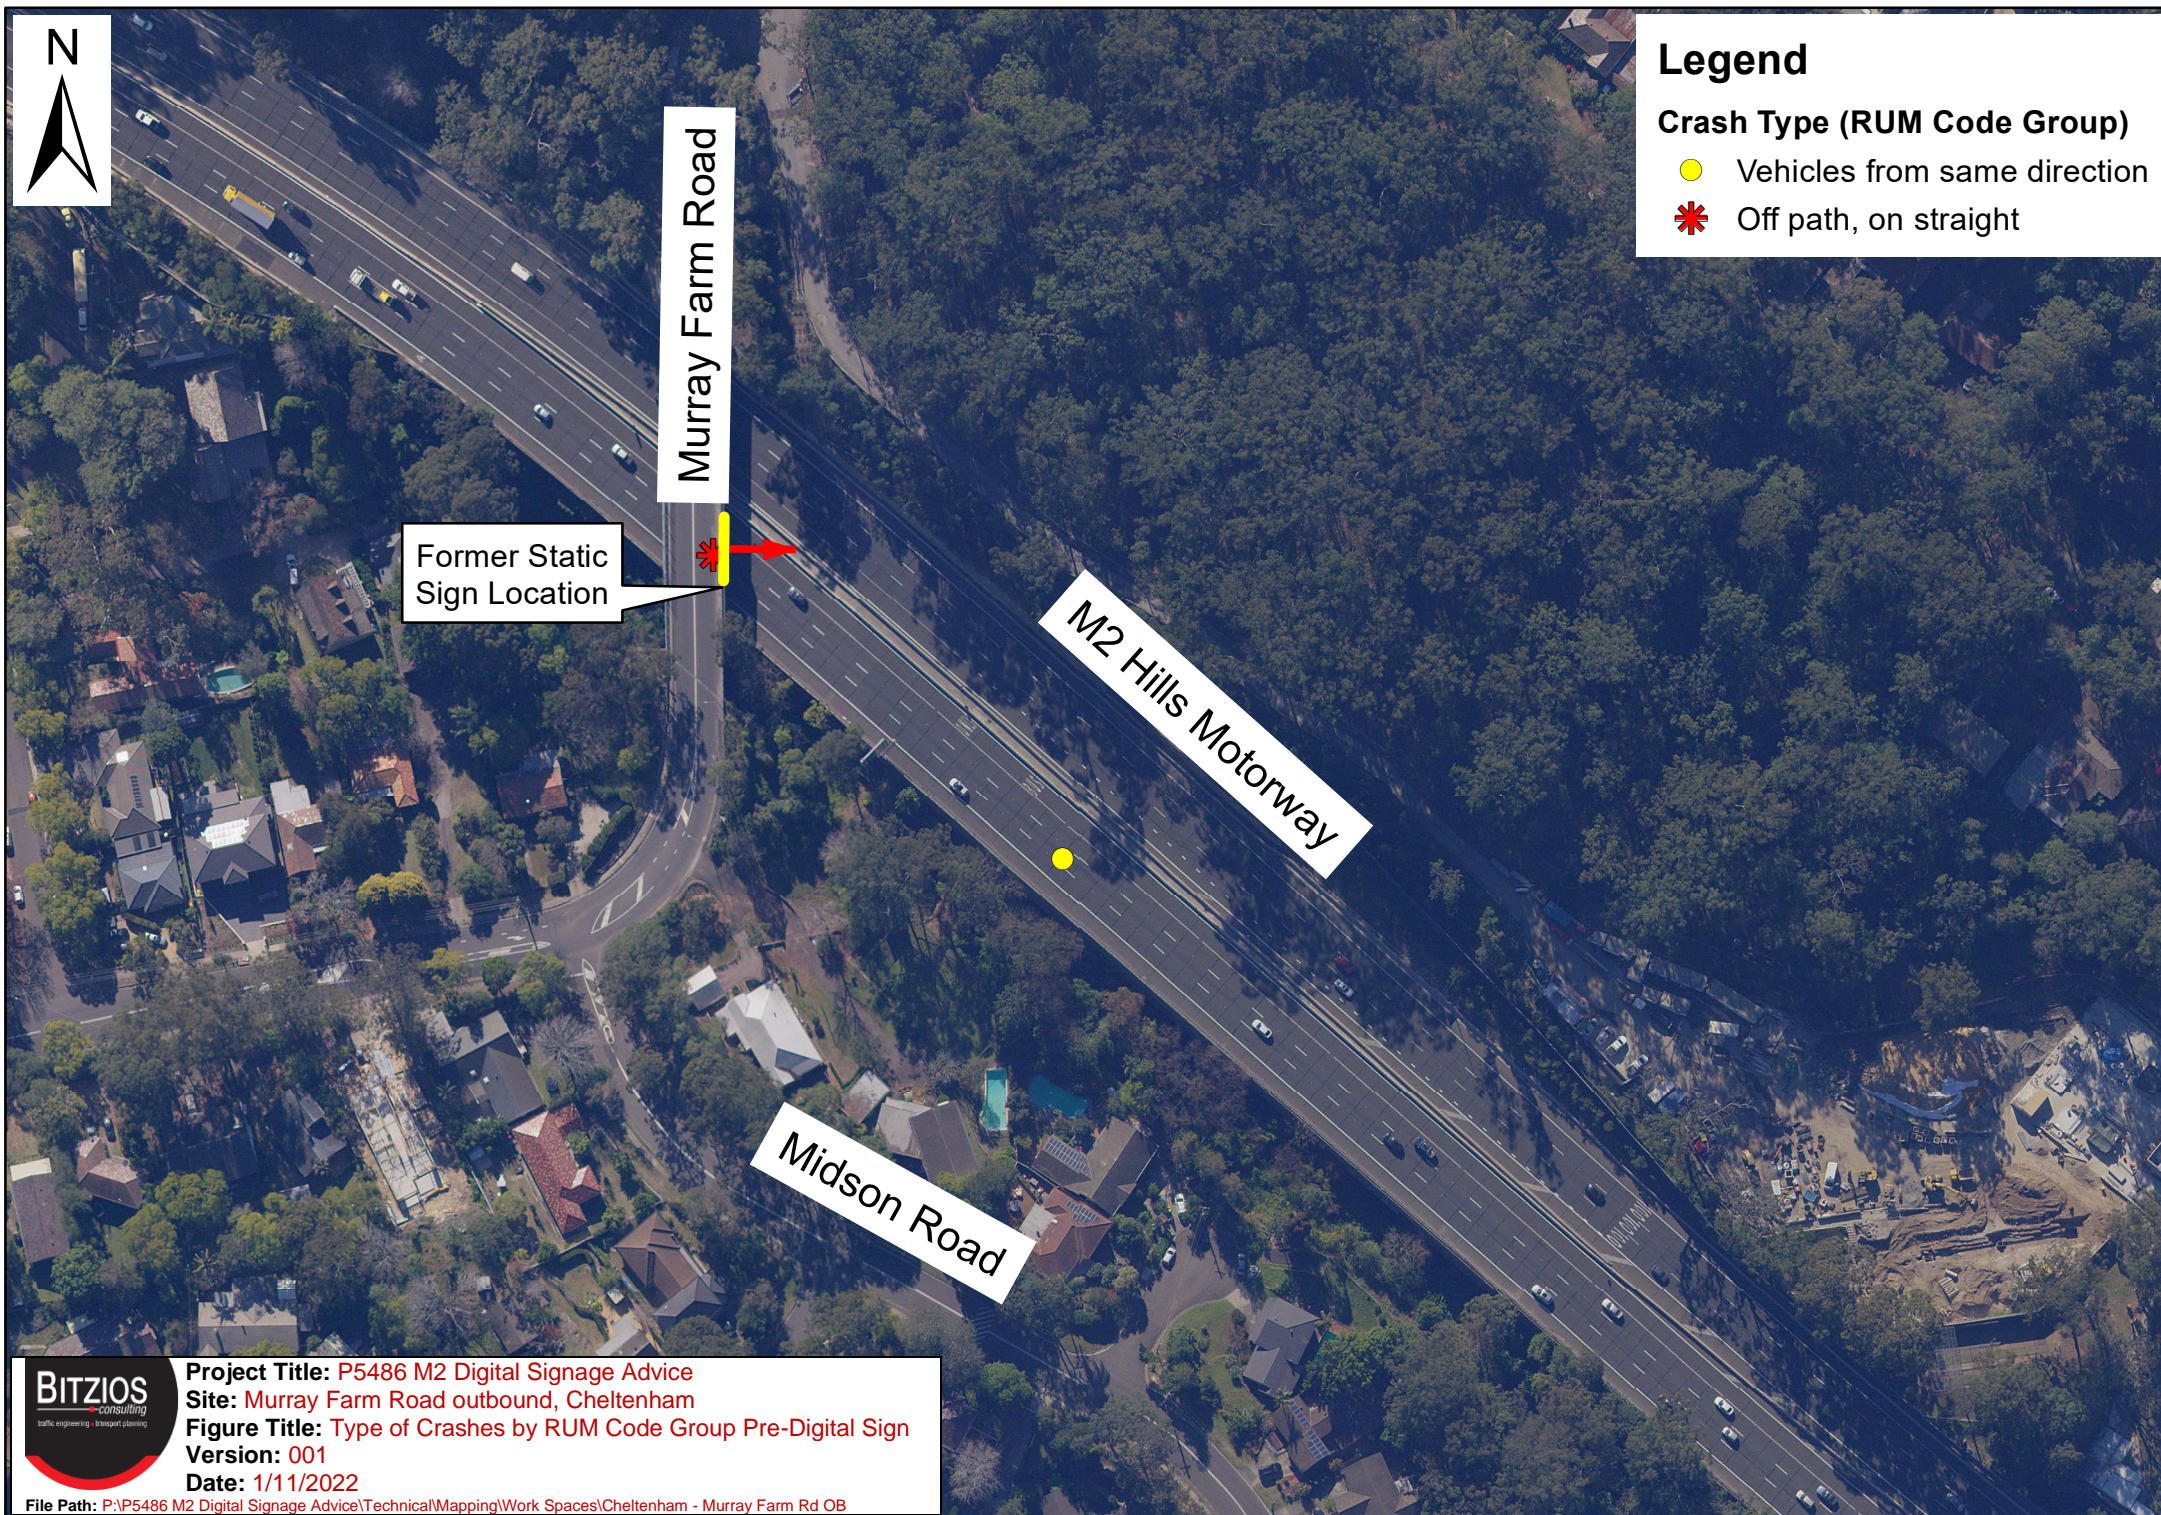
Project Title: P5486 M2 Digital Signage Advice

Crash Type (RUM Code Group)

- Vehicles from same direction
- * Off path, on straight

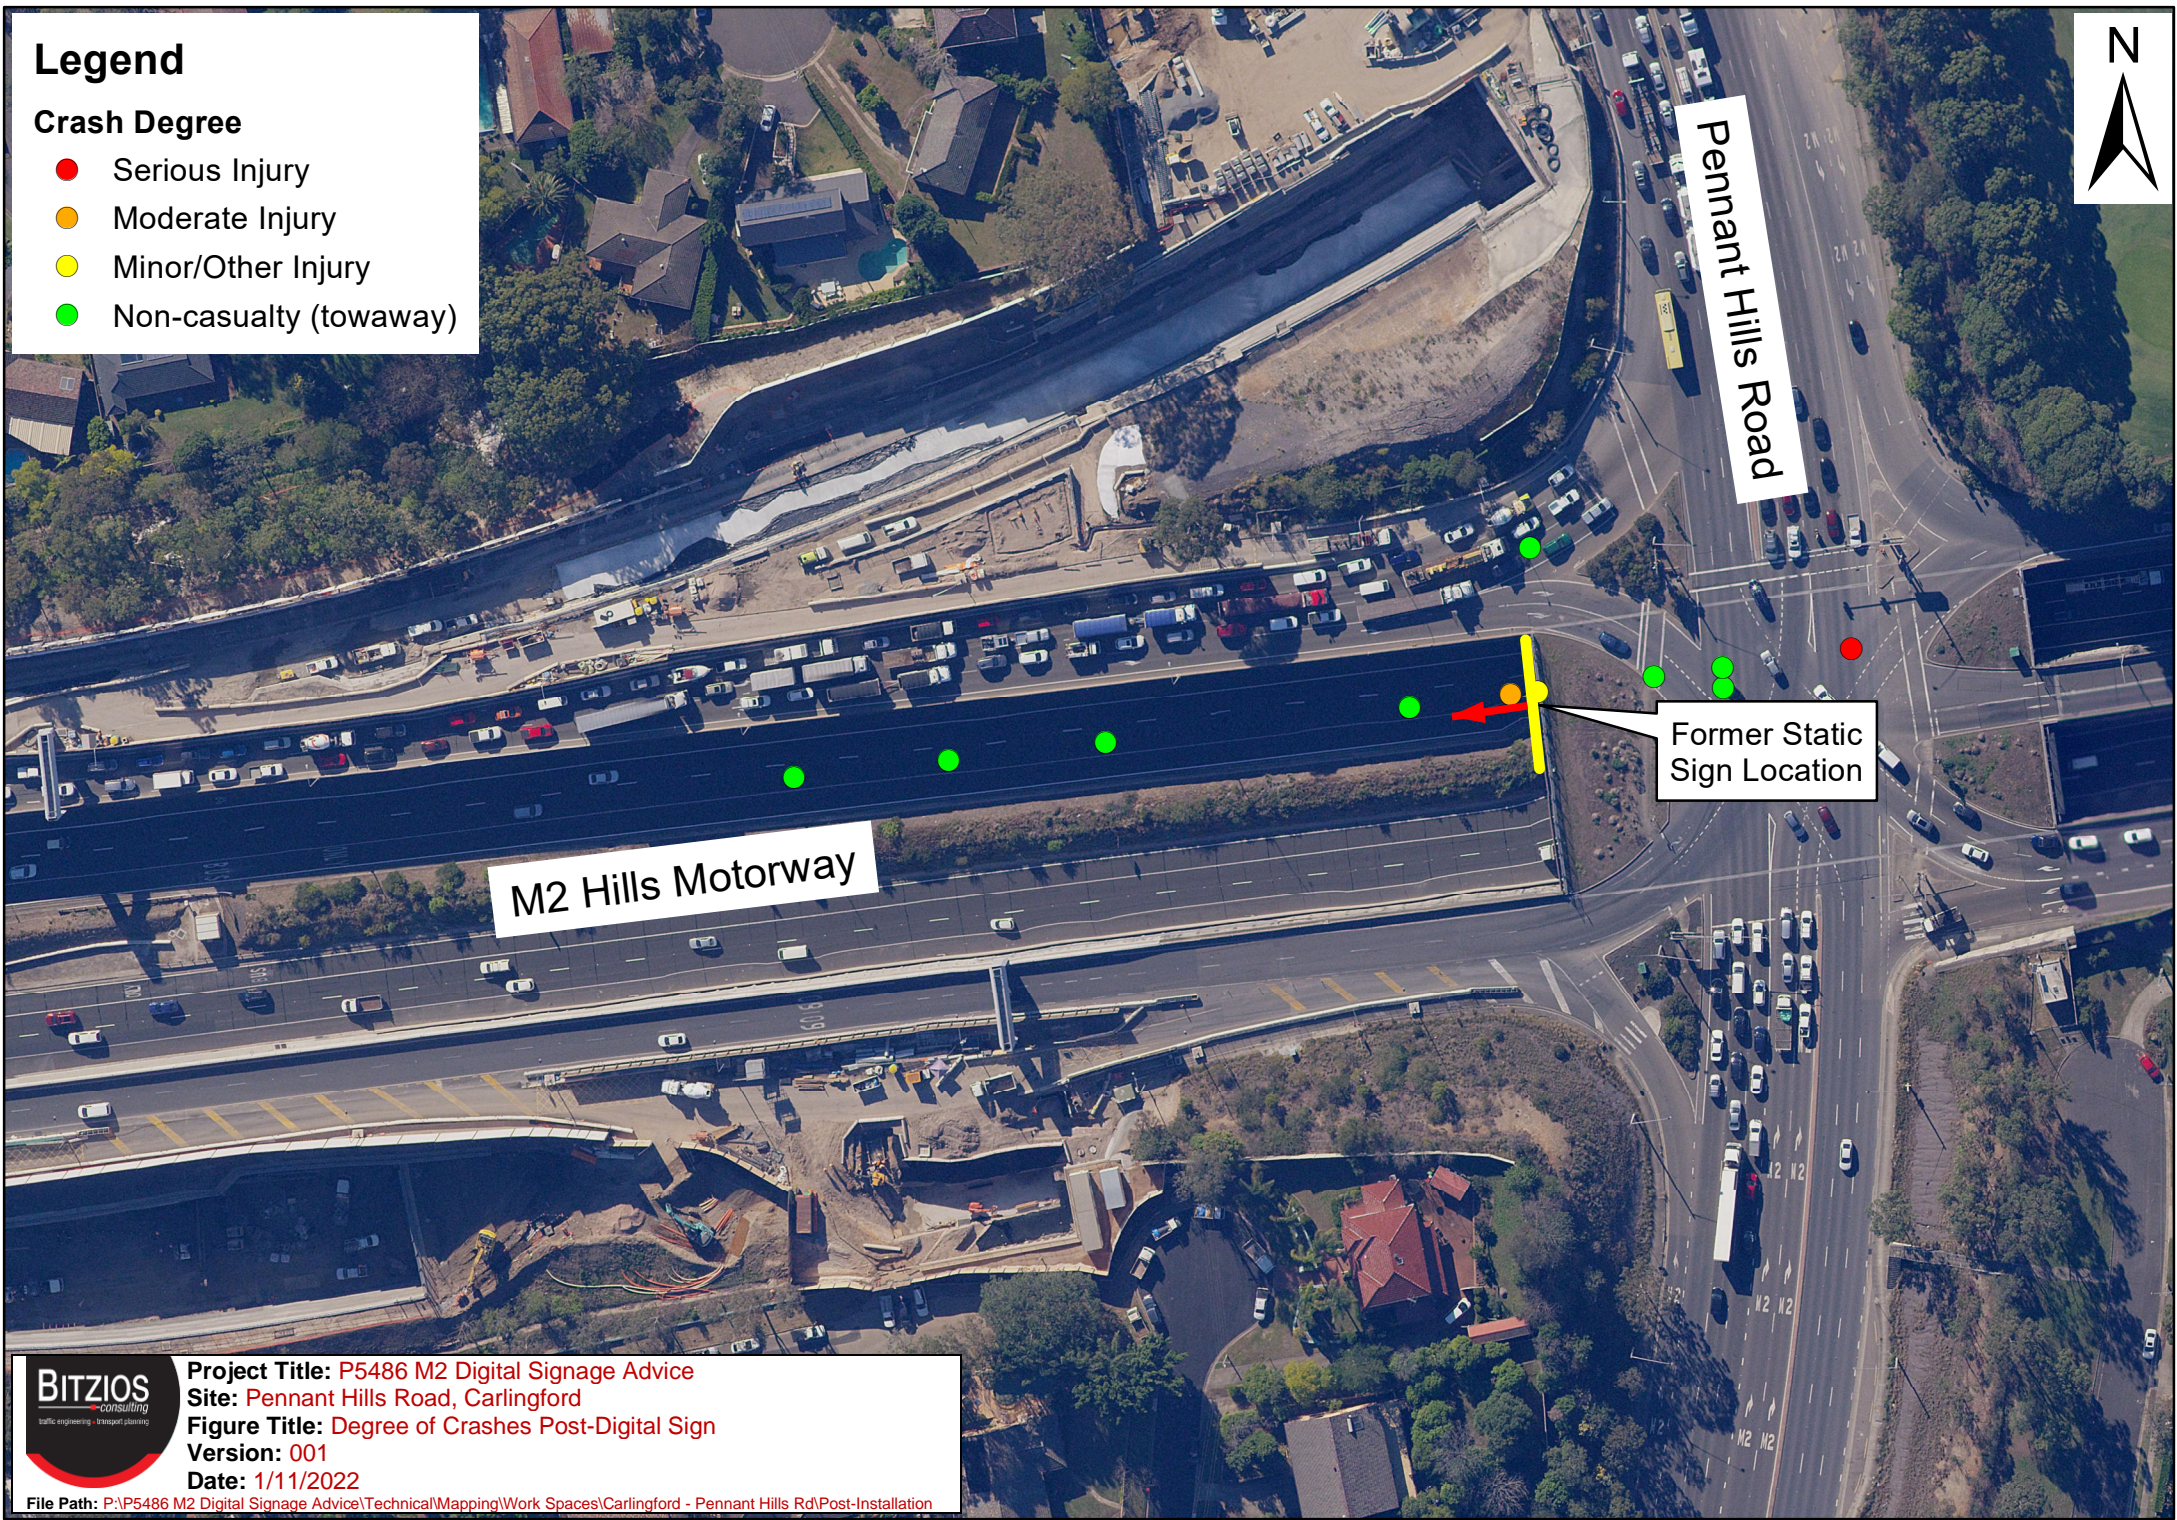
- Serious Injury
- Moderate Injury
- Minor/Other Injury
- Non-casualty (towaway)

Project Title: P5486 M2 Digital Signage Advice
Site: Pennant Hills Road, Carlingford
Figure Title: Degree of Crashes Post-Digital Sign
Version: 001
Date: 1/11/2022

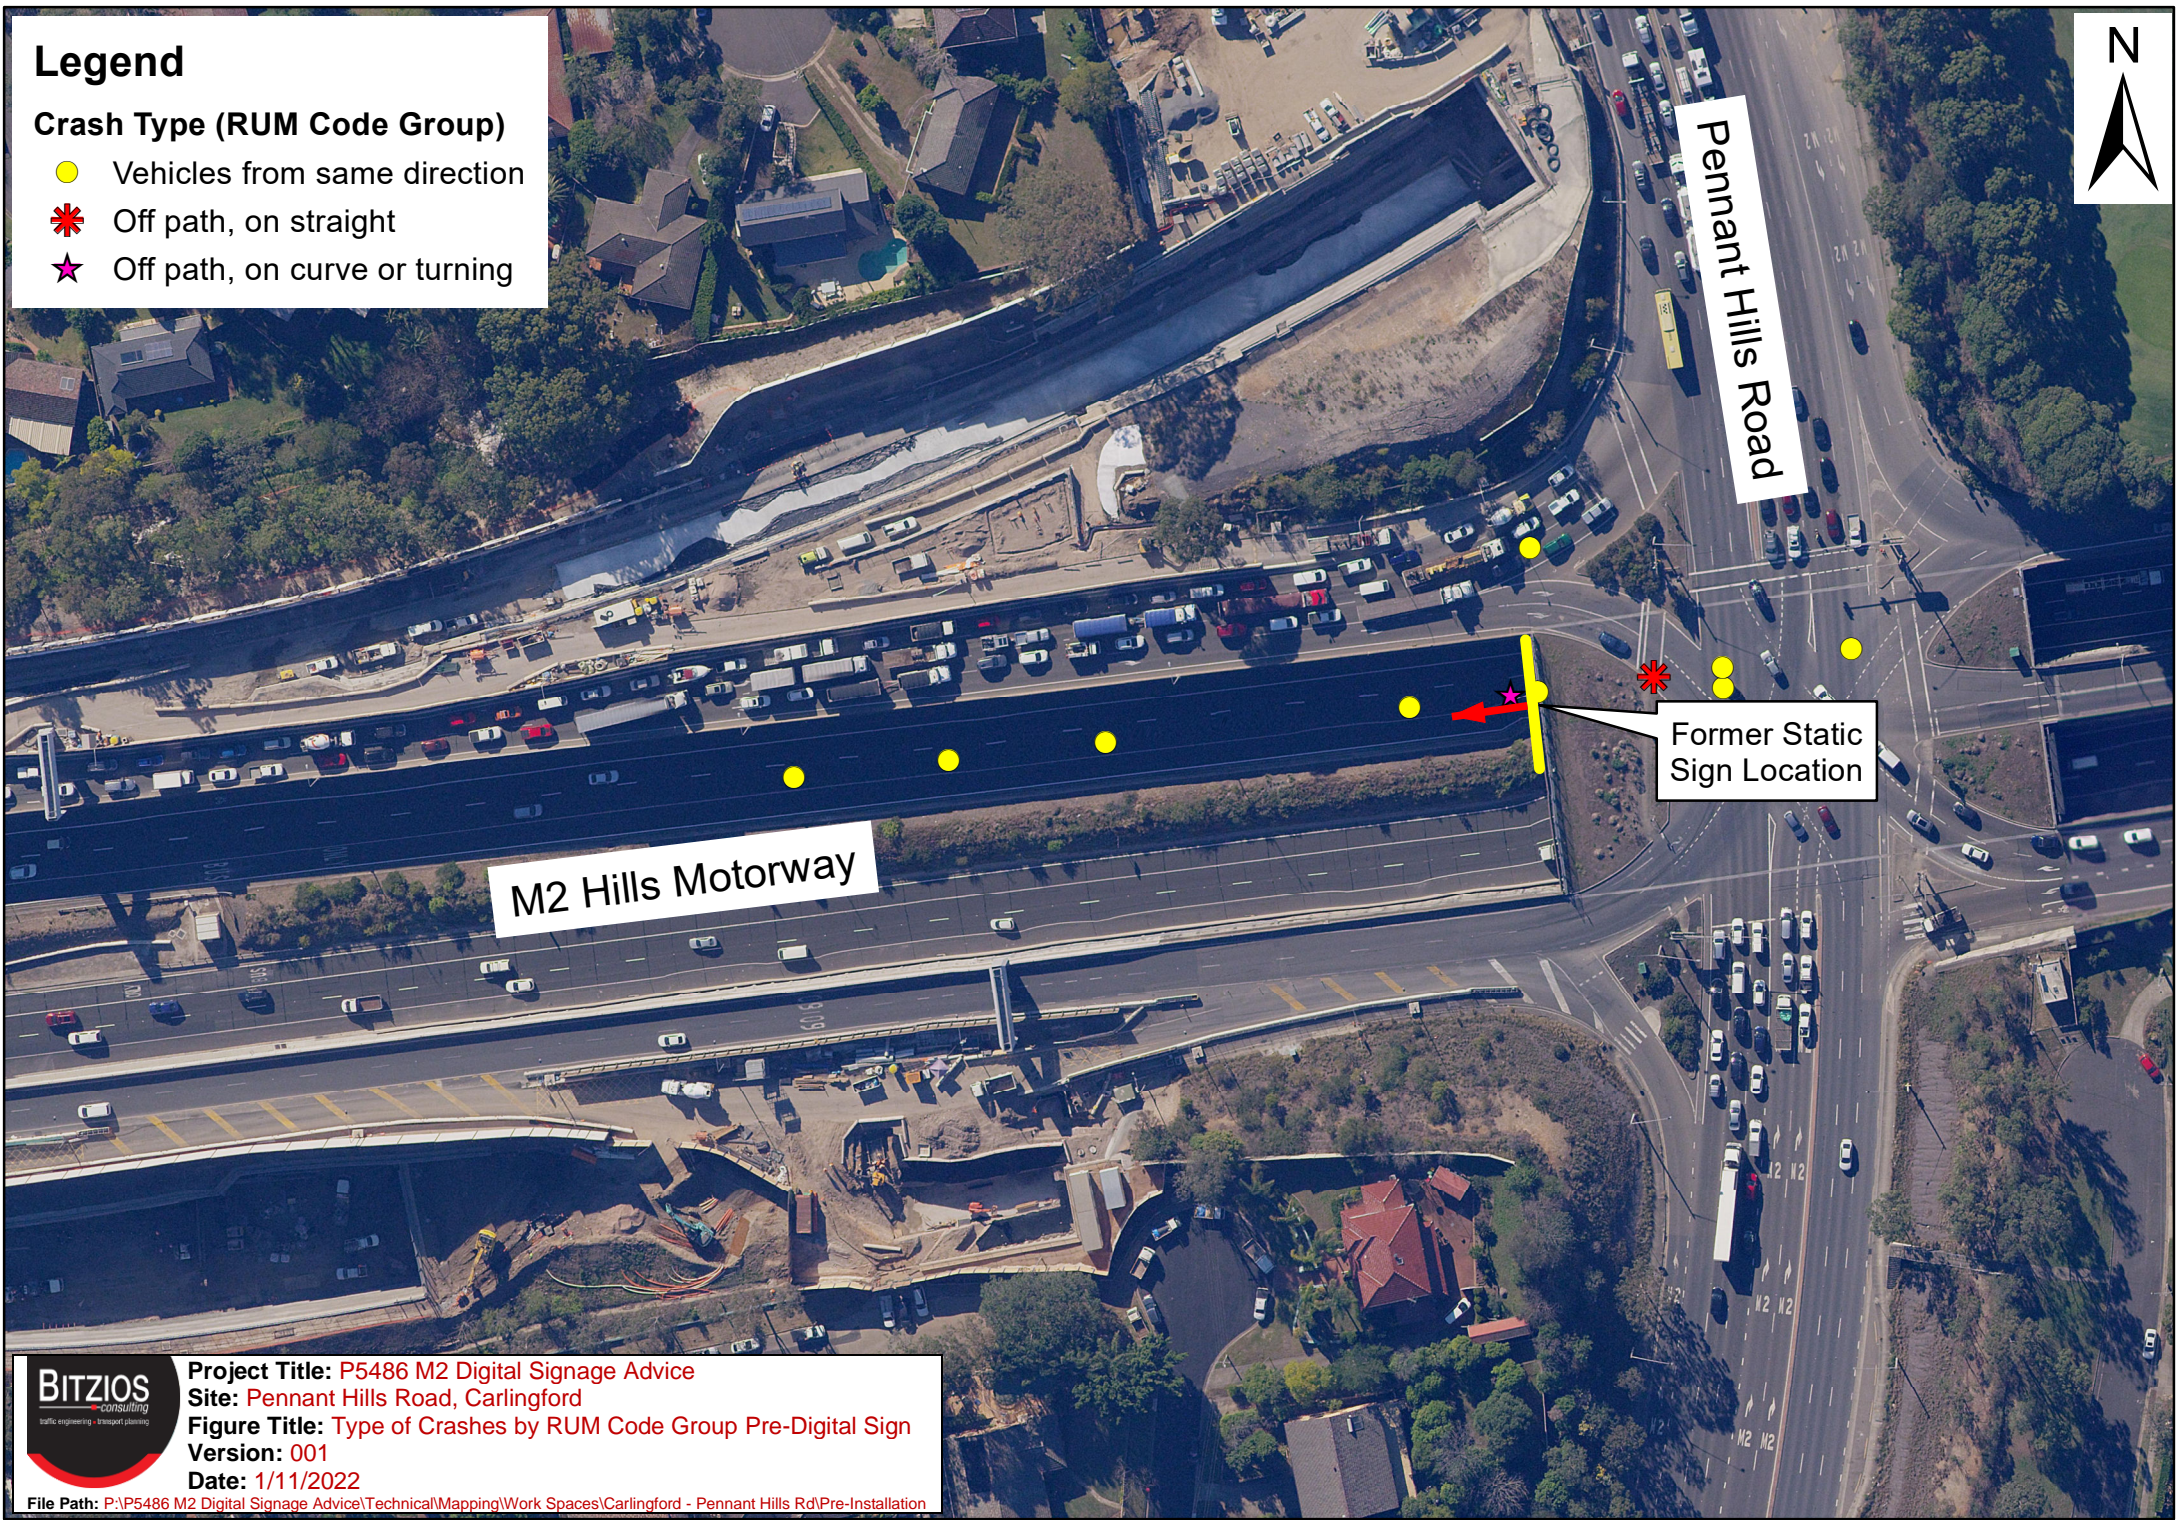
Project Title: P5486 M2 Digital Signage Advice

Crash Type (RUM Code Group)

- Vehicles from same direction
- ✱ Off path, on straight
- ★ Off path, on curve or turning

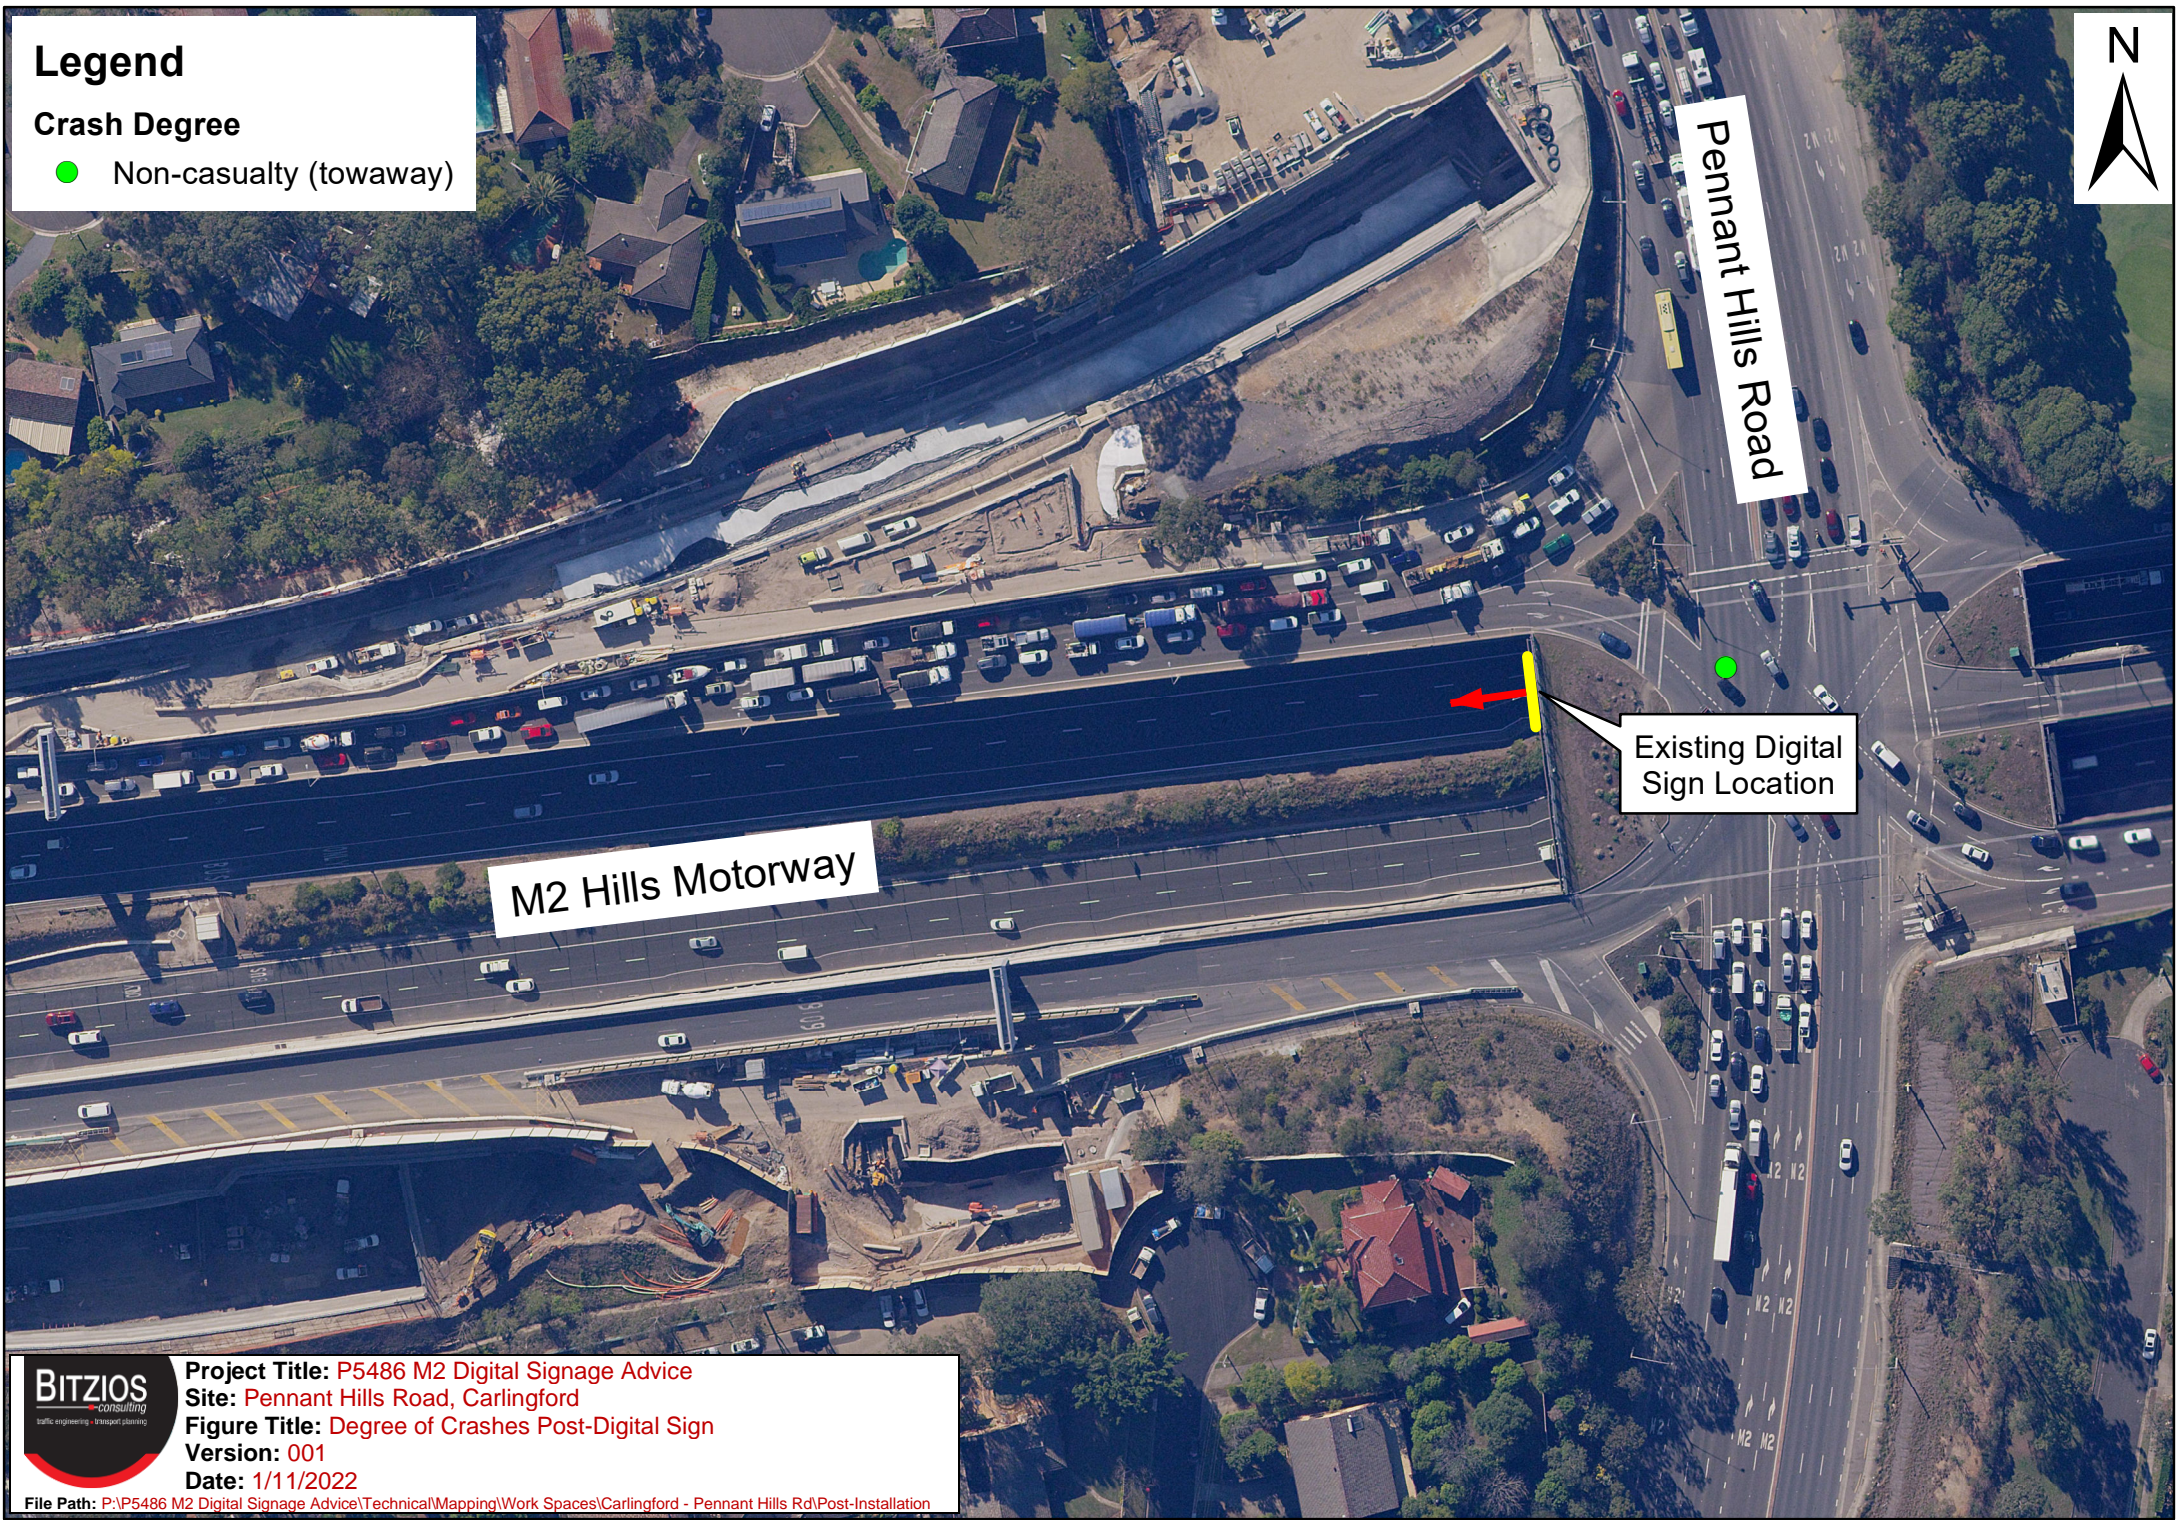
Project Title: P5486 M2 Digital Signage Advice

Crash Degree

- Non-casualty (towaway)

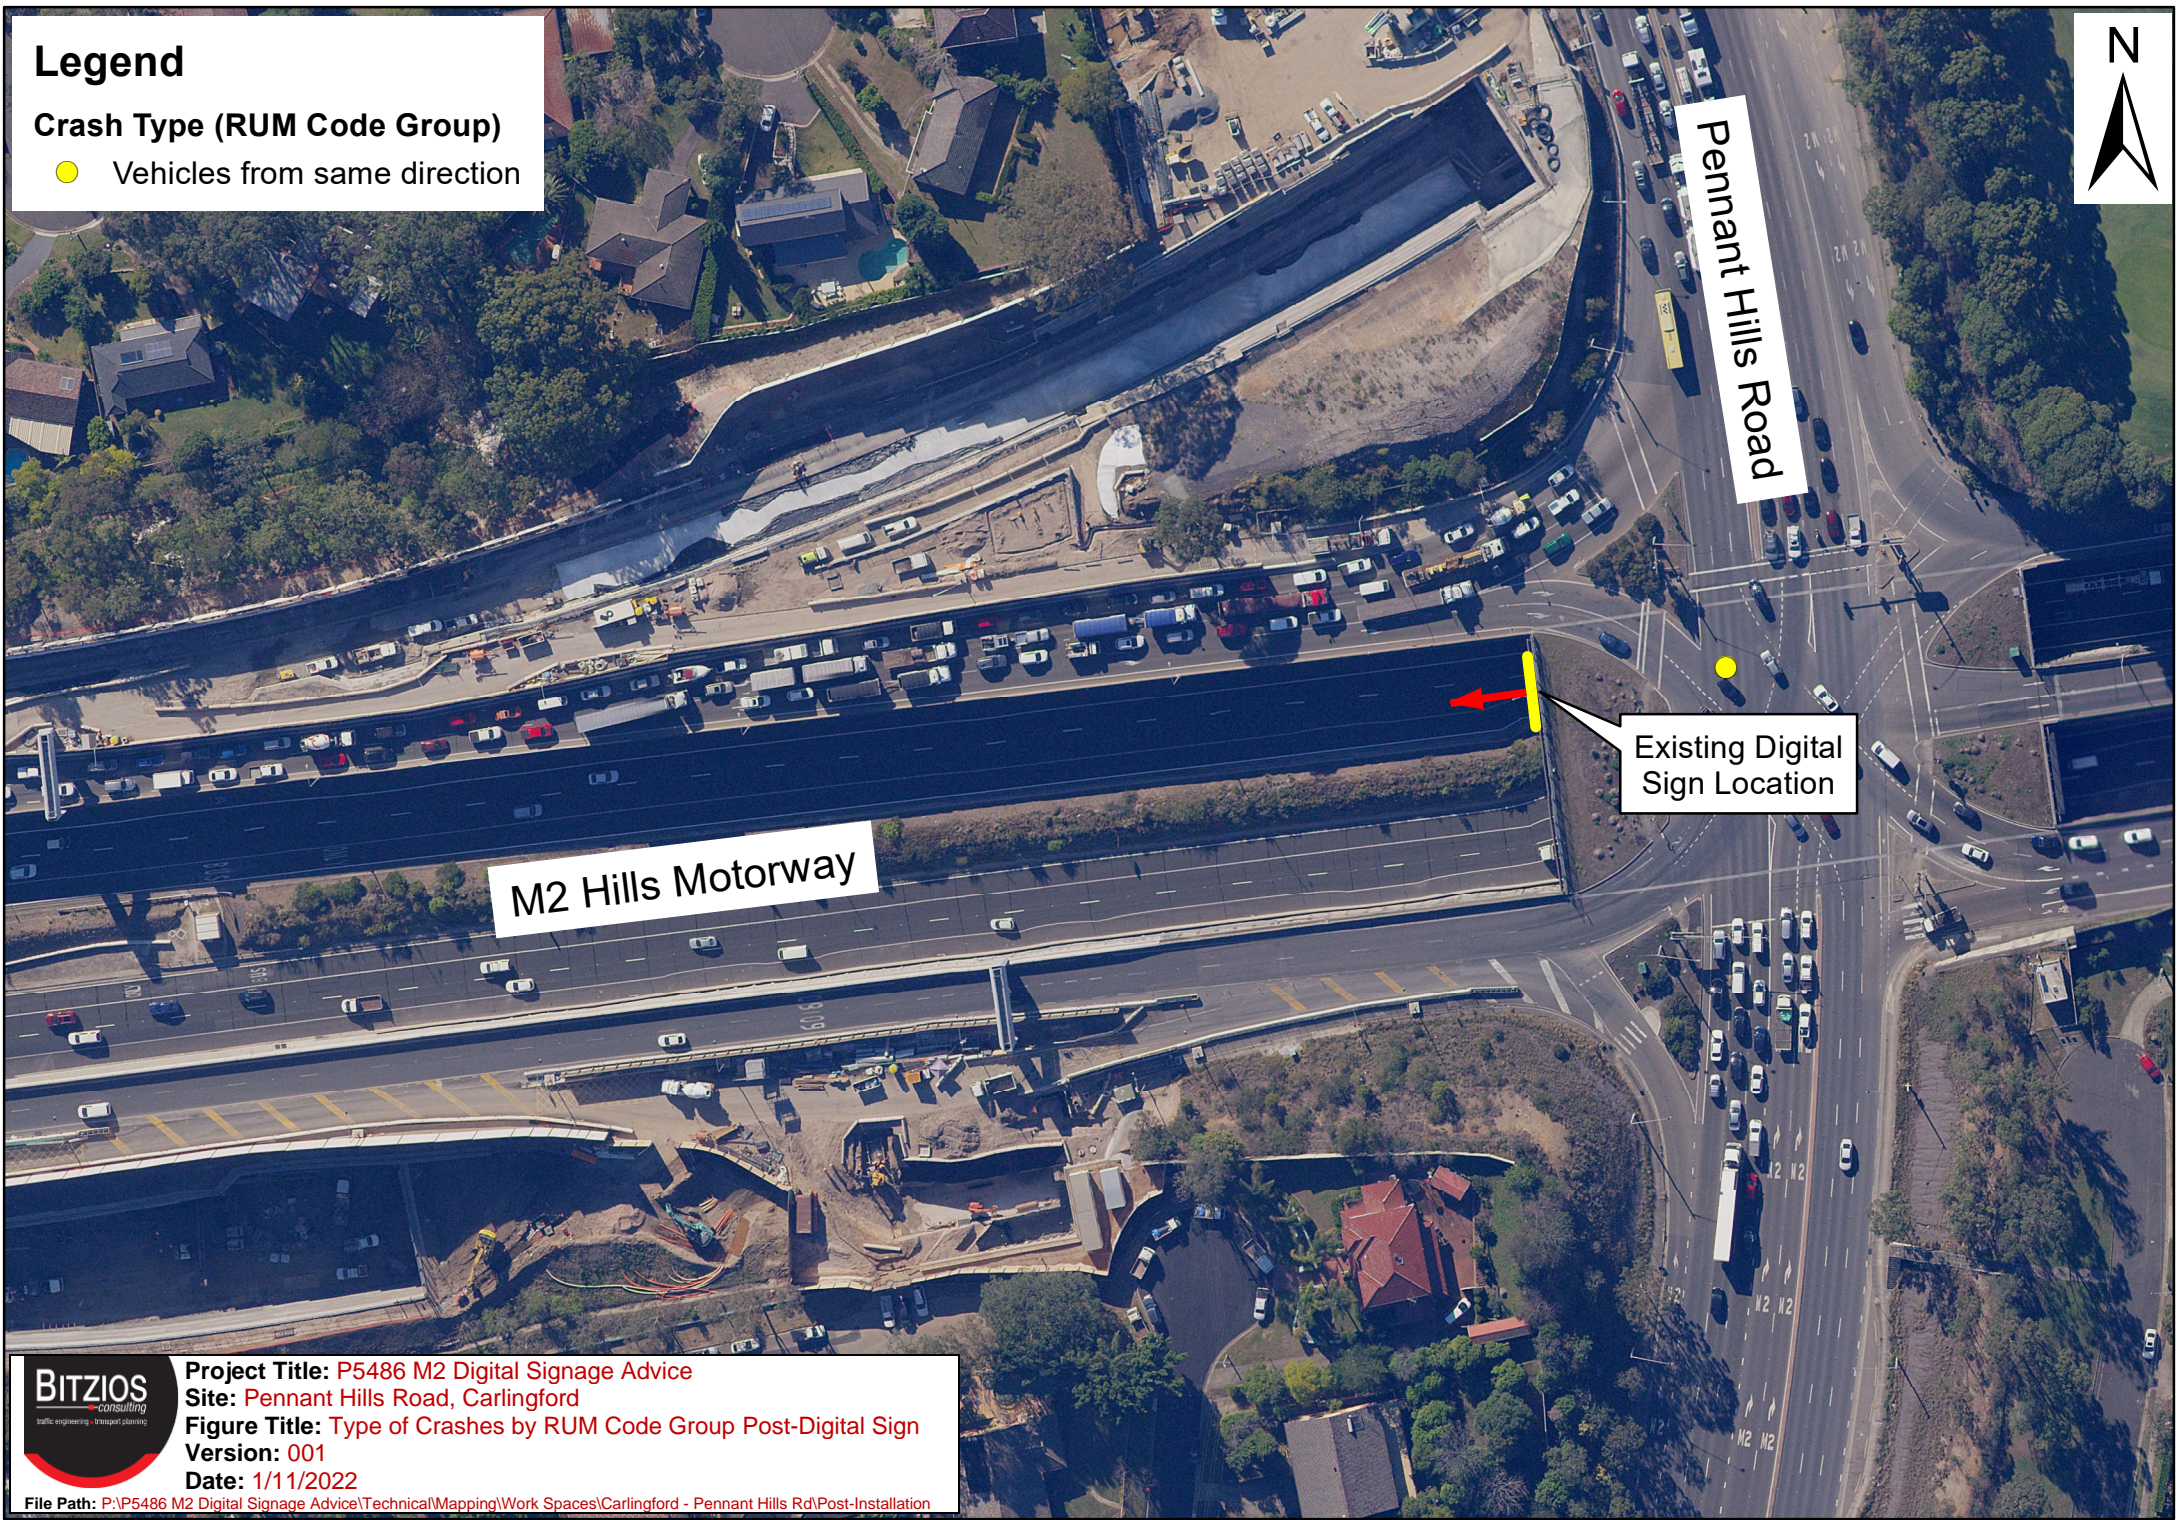
Project Title: P5486 M2 Digital Signage Advice

Crash Type (RUM Code Group)

- Vehicles from same direction

Site: Pennant Hills Road, Carlingford
