M2 Hills Motorway: Beecroft Road Overpass

Proposed Digital Sign Traffic Safety Assessment

Manboom Signage

24 November 2022

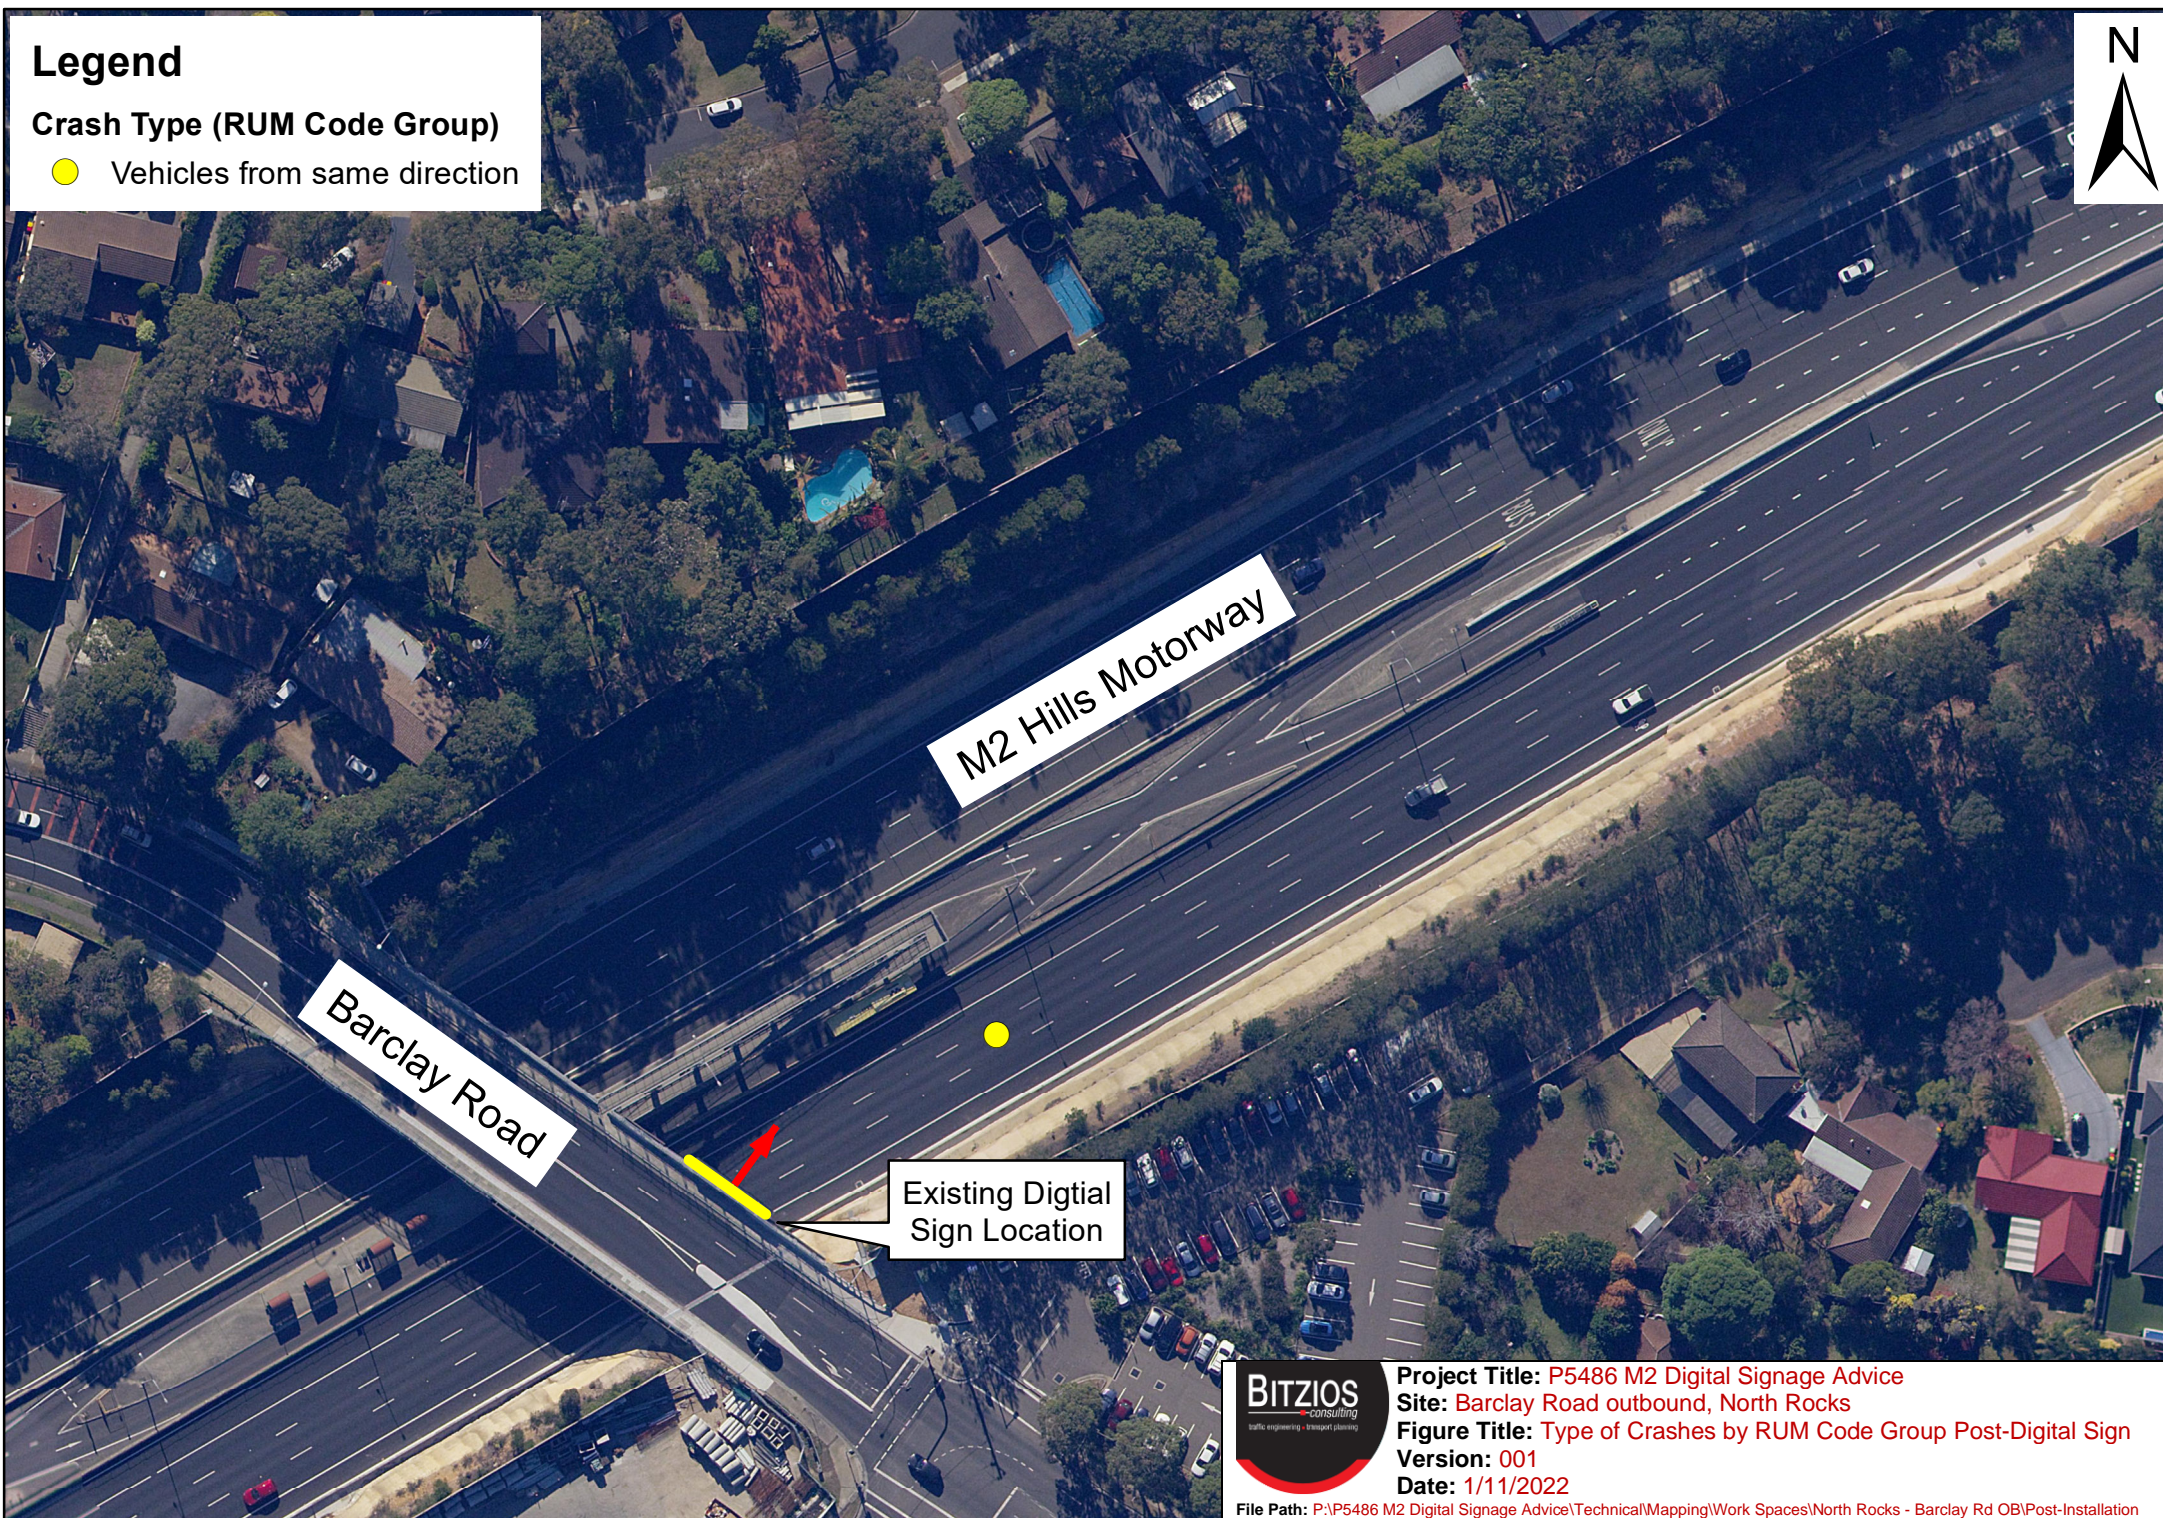
Project Title: P5486 M2 Digital Signage Advice

Crash Type (RUM Code Group)

- Vehicles from same direction

Site: Barclay Road outbound, North Rocks

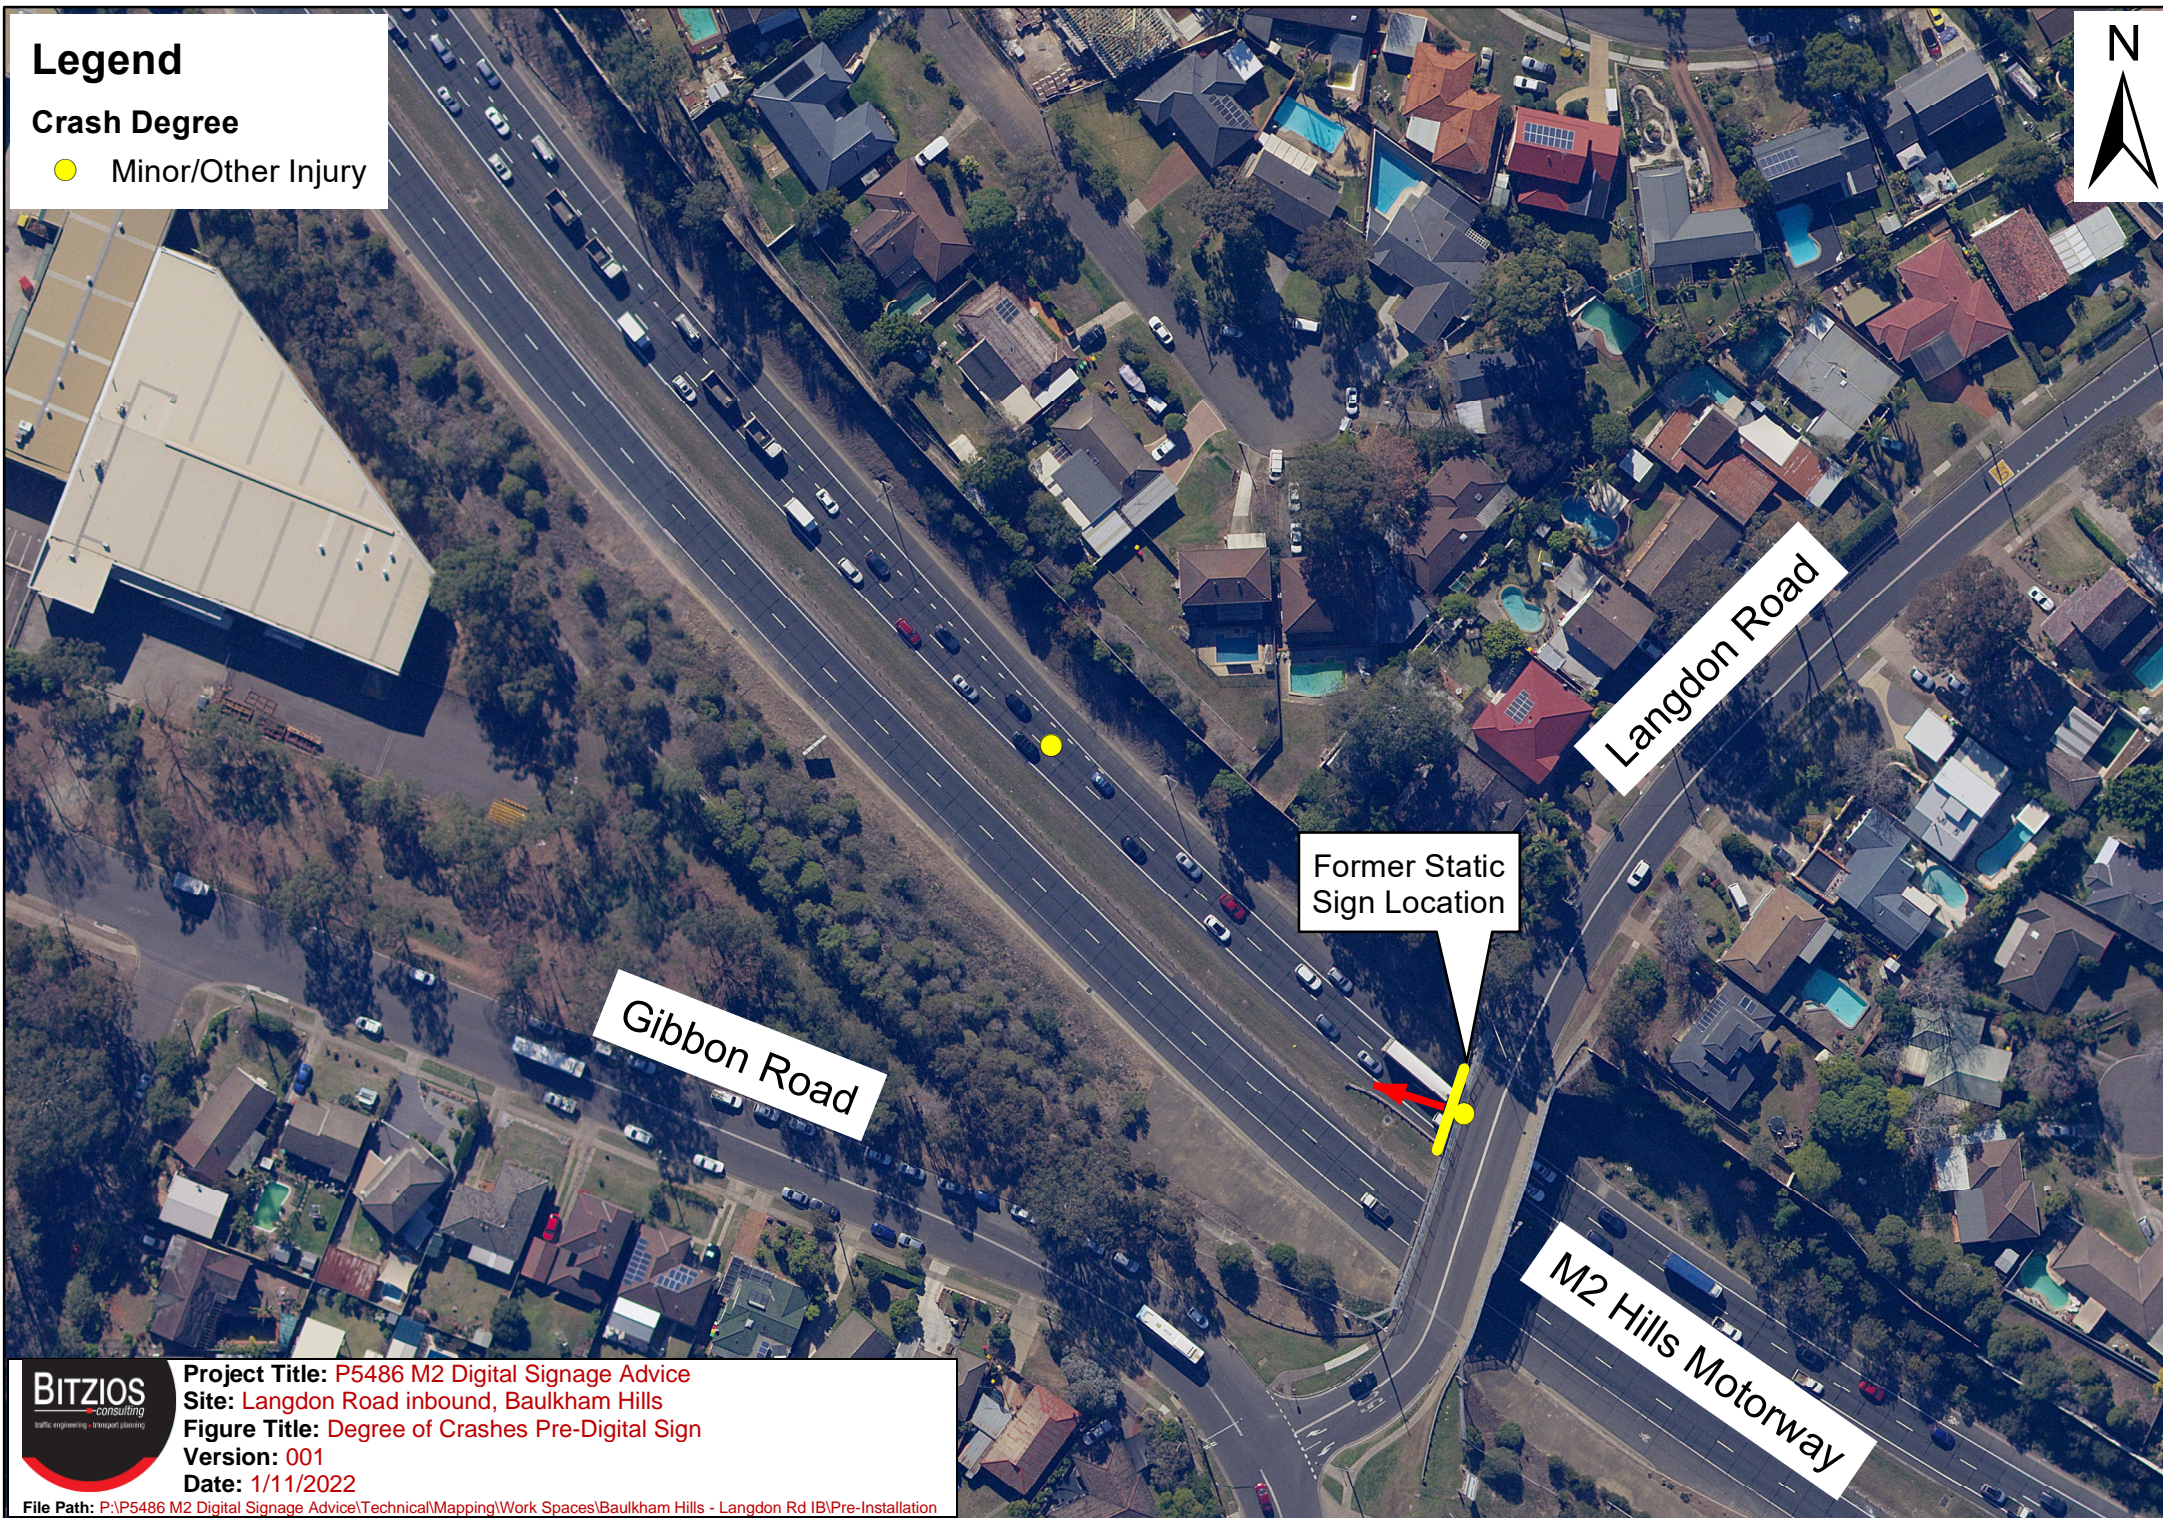
Project Title: P5486 M2 Digital Signage Advice

Crash Degree

● Minor/Other Injury

Site: Langdon Road inbound, Baulkham Hills

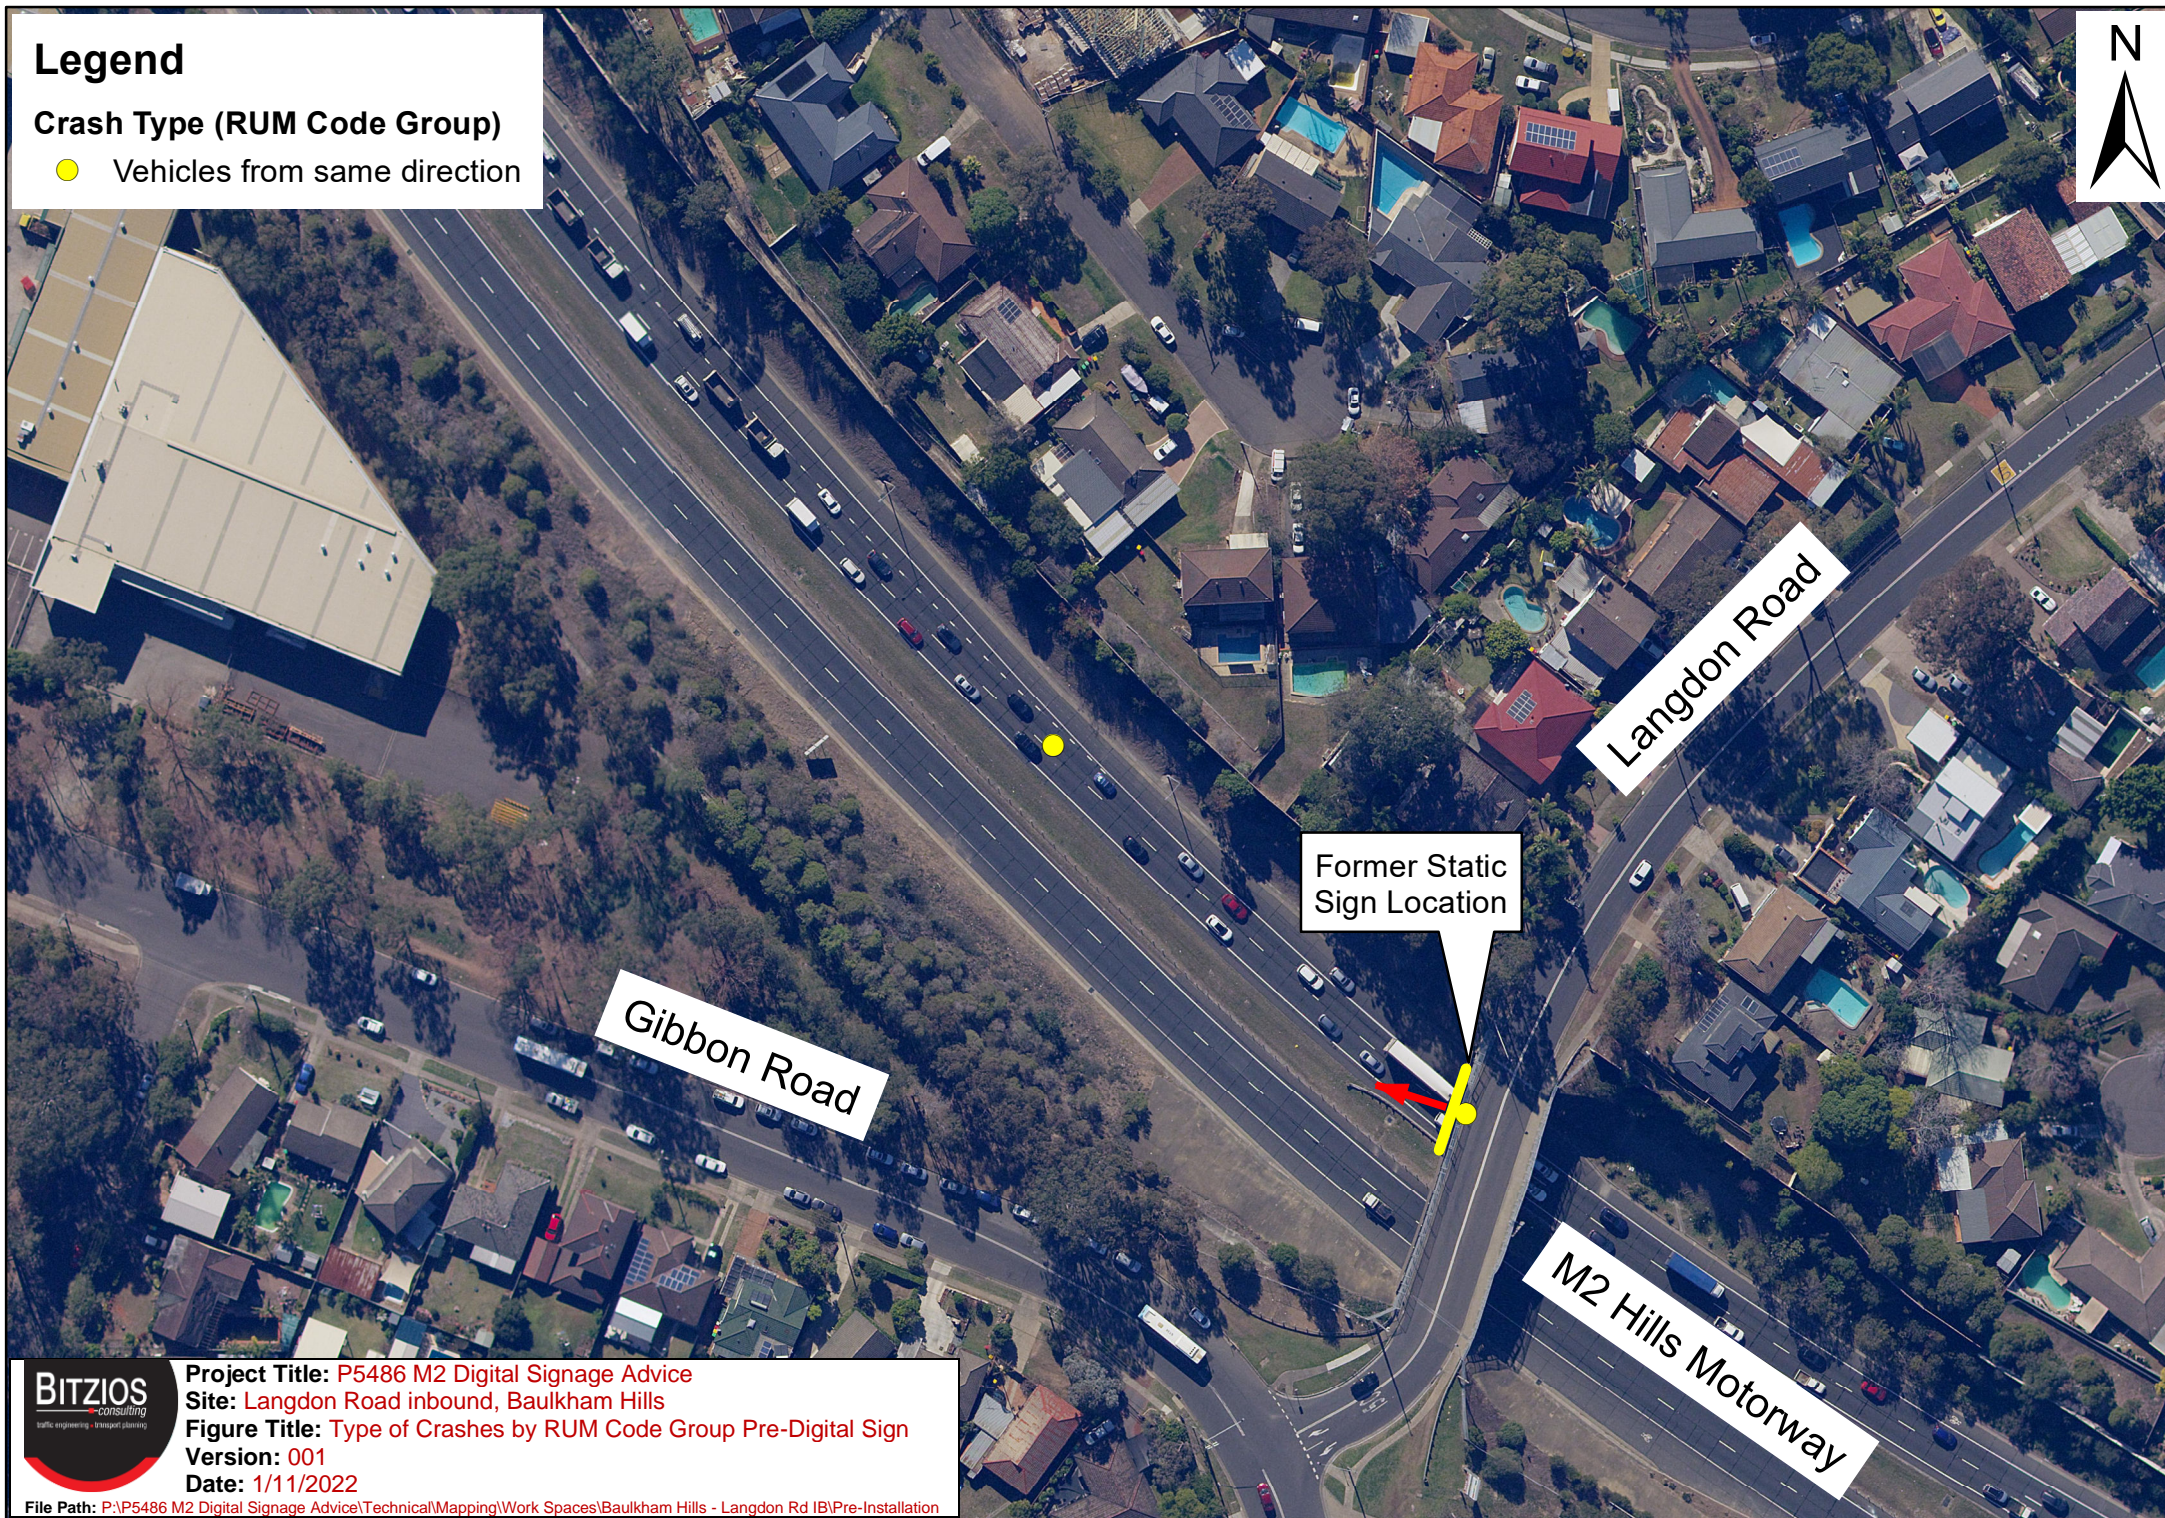
Project Title: P5486 M2 Digital Signage Advice

Crash Type (RUM Code Group)

- Vehicles from same direction

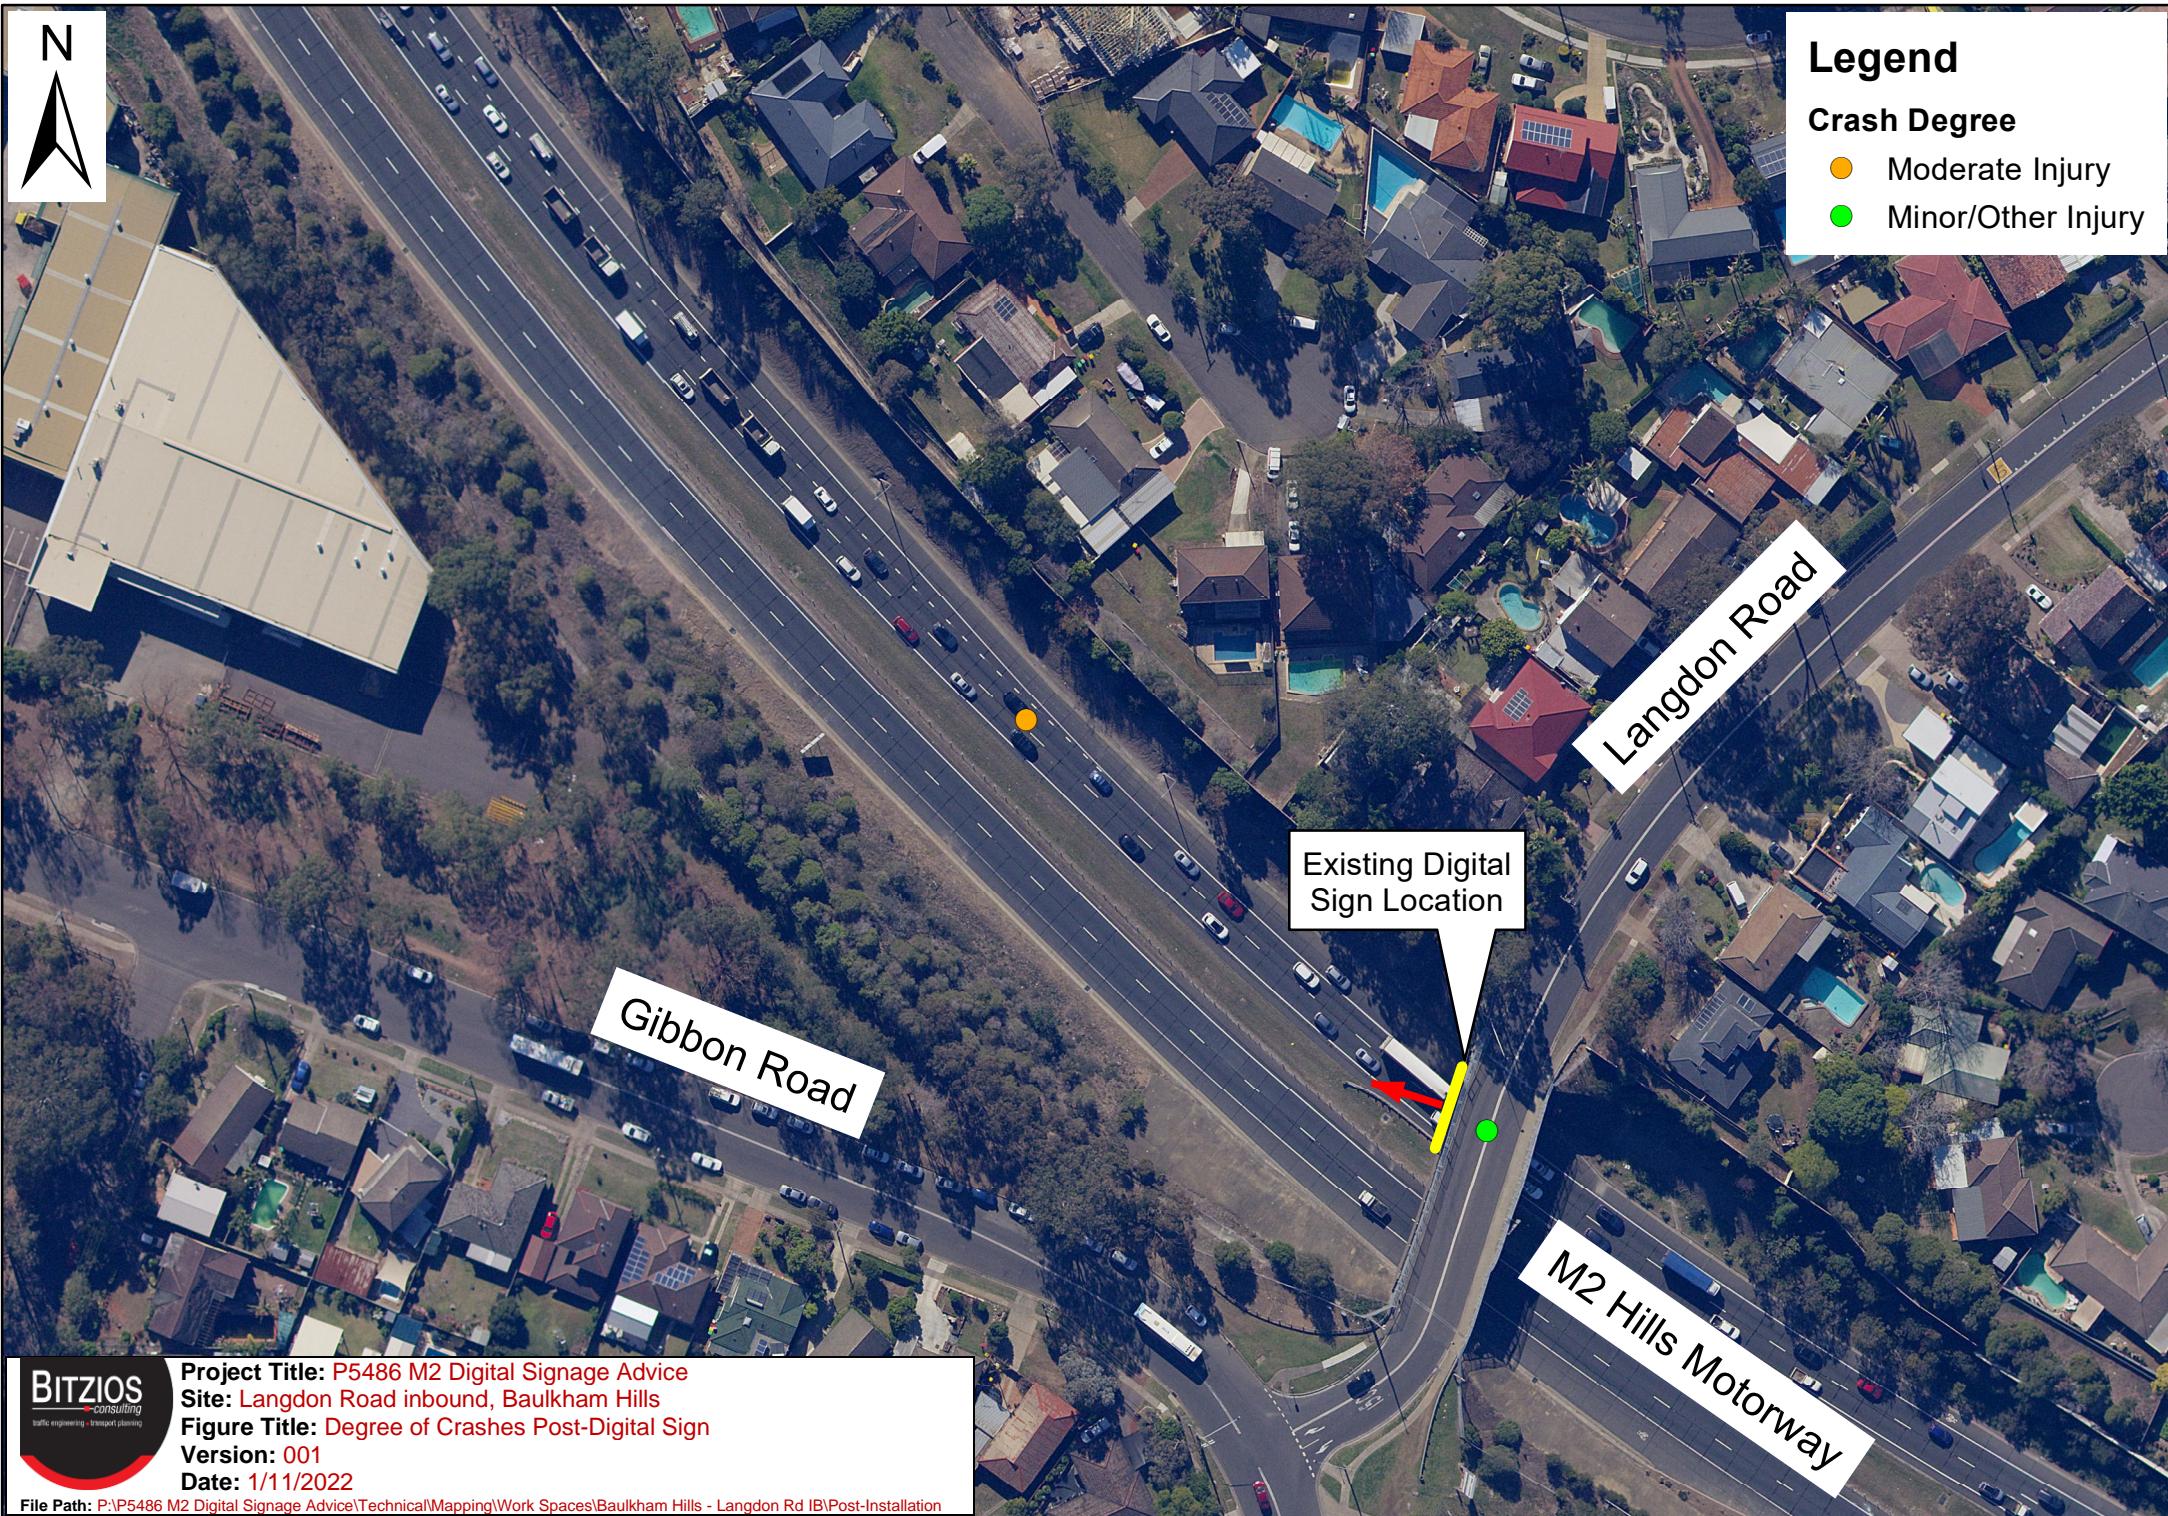
Project Title: P5486 M2 Digital Signage Advice
Site: Langdon Road inbound, Baulkham Hills
Figure Title: Degree of Crashes Post-Digital Sign
Version: 001
Date: 1/11/2022
