M2 Hills Motorway: Murray Farm Road Overpass

Proposed Digital Sign Traffic Safety Assessment

Manboom Signage

24 November 2022

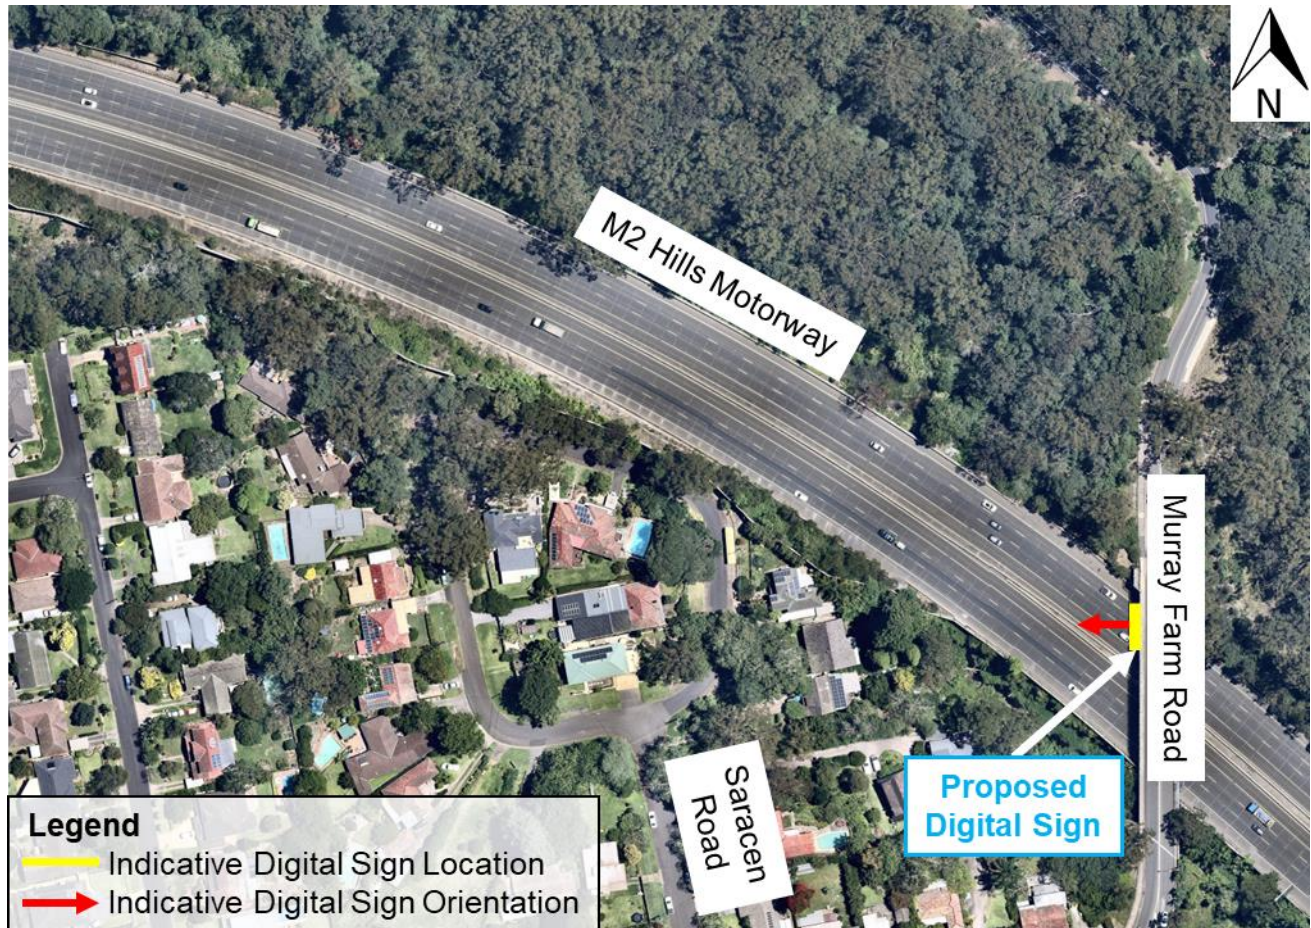
Figure 1.1: Location of the Proposed Digital Sign

Manboom Signage is seeking development approval for the installation of a digital LED advertising sign. The sign is proposed to be located above the eastbound carriageway of the M2 Hills Motorway (M2) on the Murray Farm Road overpass in Cheltenham as shown in Figure 1.1.

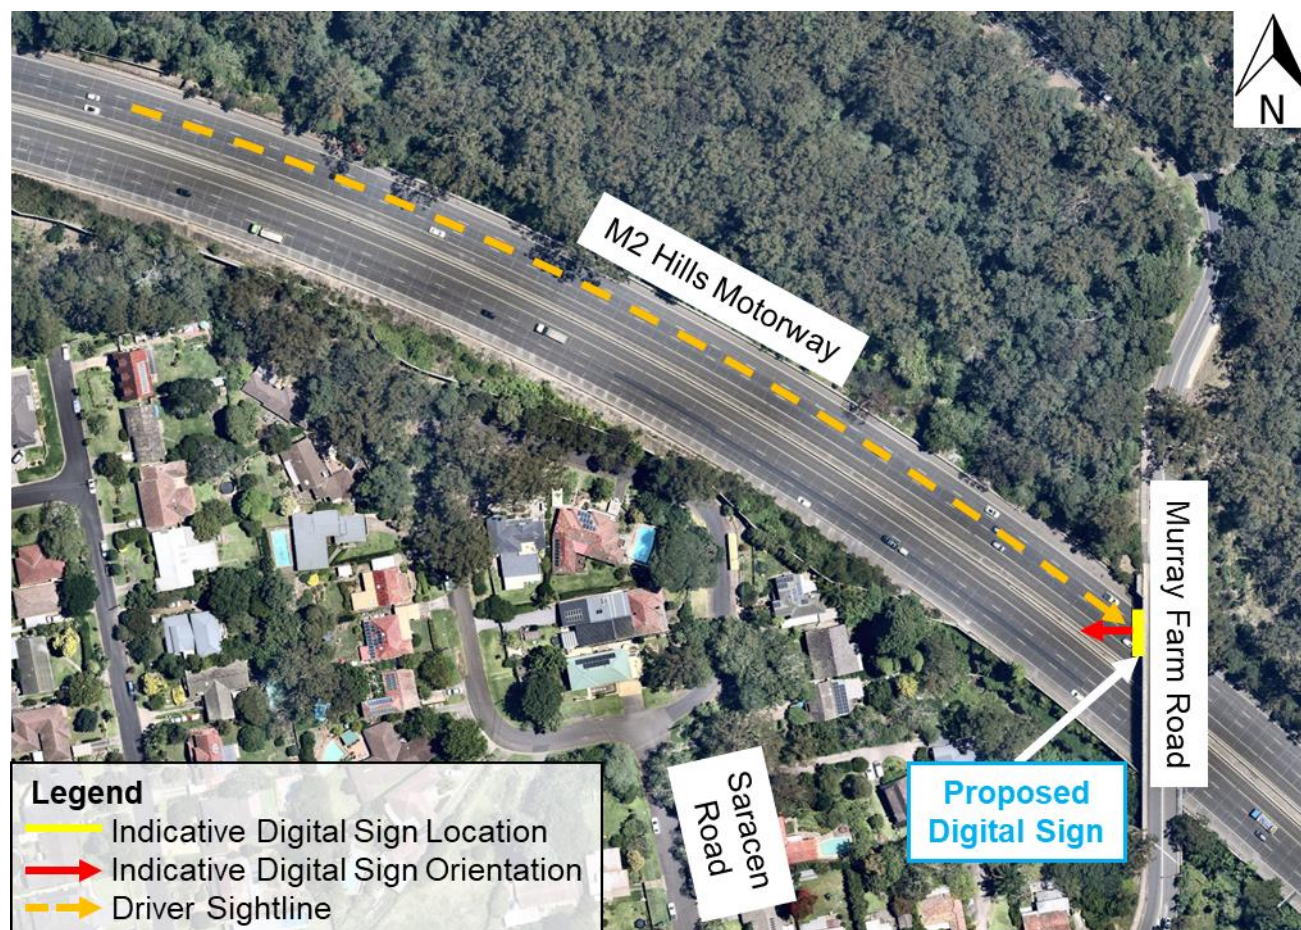
Figure 2.1: Driver Viewing Range to the Proposed Sign

The digital sign is proposed to face west towards eastbound drivers along the M2. The driver viewing range to the sign from this approach is illustrated in Figure 2.1 and demonstrates a relatively long distance on approach to the proposed sign from which it can be identified.

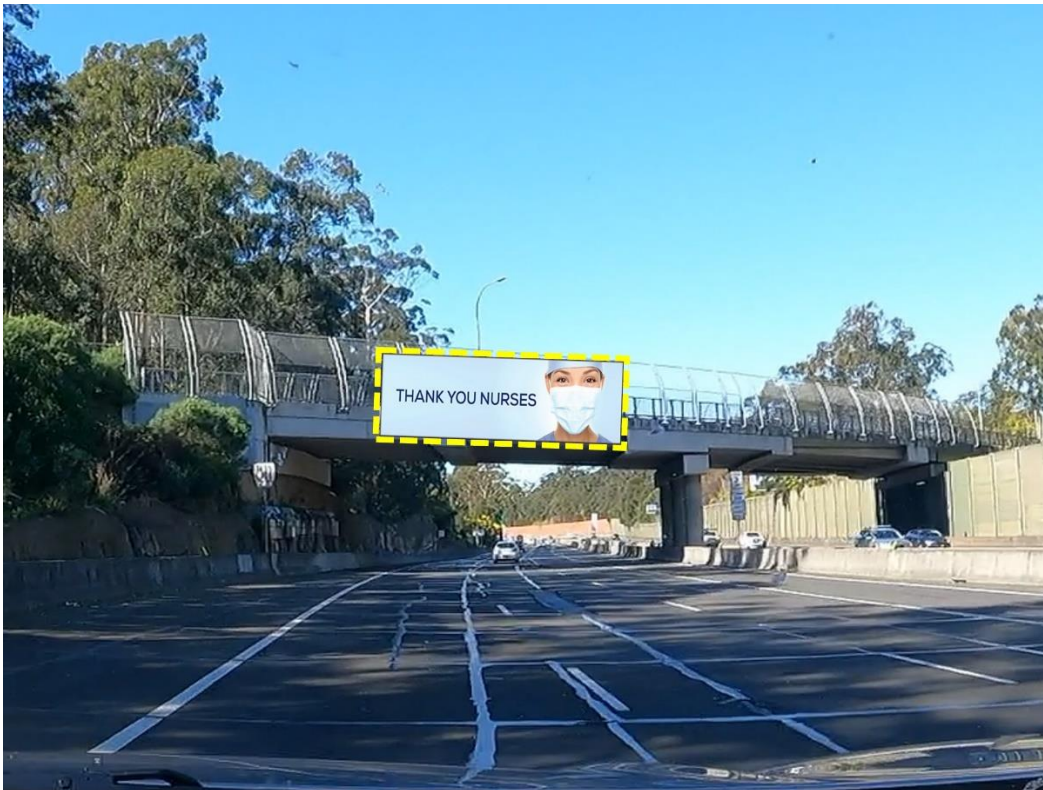
Figure 2.2: Daytime view from the M2 eastbound lane 1

The eastbound sign view from the M2 lanes 1 and 3 during the daytime period is shown in Figure 2.2 and Figure 2.3 respectively.

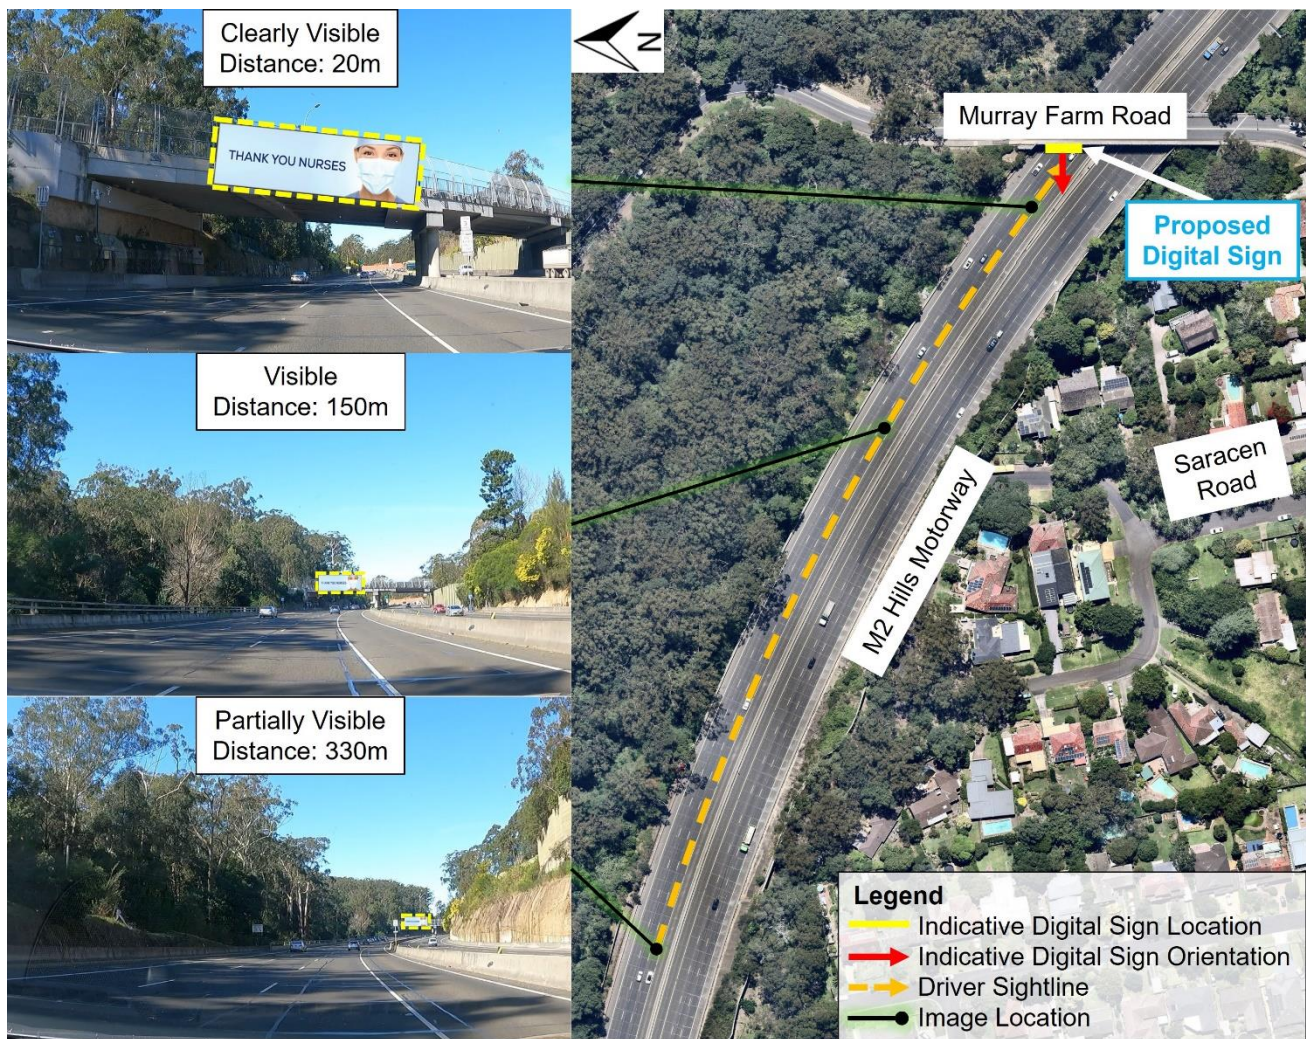
The in-vehicle sightlines from the M2 eastbound are shown in Figure 5.1, clearly demonstrating that all vehicle movements are in the same sightline as the digital sign, and that there are no directional signs for drivers to observe, which means no risk of distraction away from important traffic information or the forward roadway when glancing to the proposed sign.

¹Distances measured in Nearmap

²Sign location is indicative, not to scale and for illustration purposes only.

A digital sign in this location will not obstruct sightlines to, or influence the messaging of, traffic control devices or signs. The approach to it does not require rapid, complex decision making by drivers and is a location of low cognitive load. There are no directional signs on approach to the proposed digital sign either.

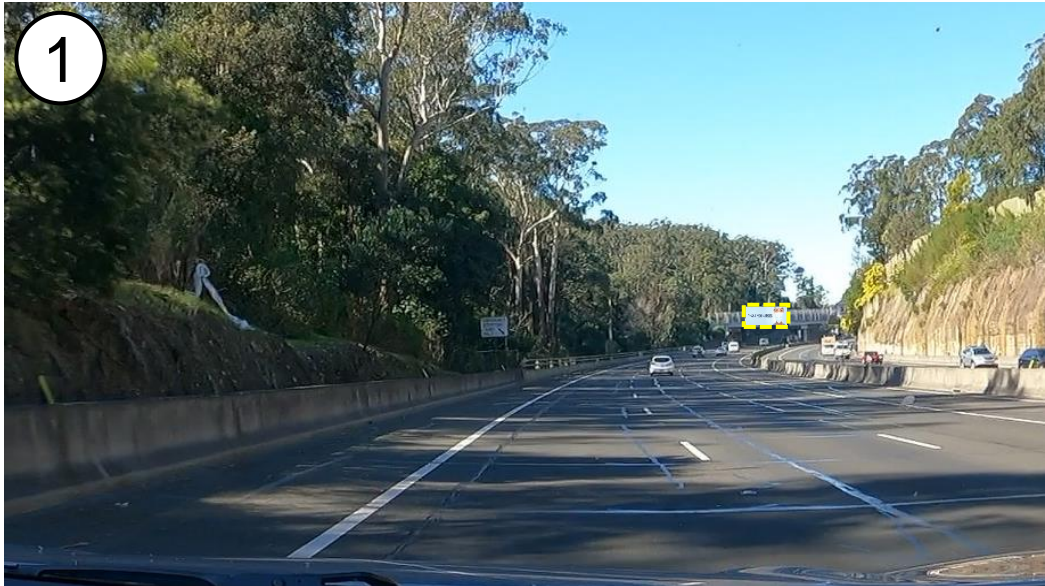
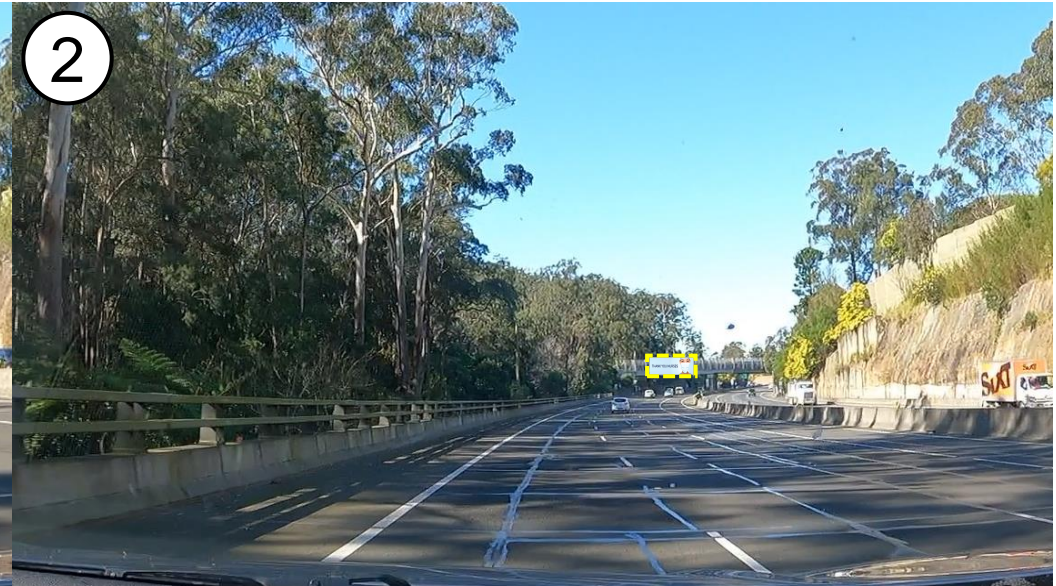
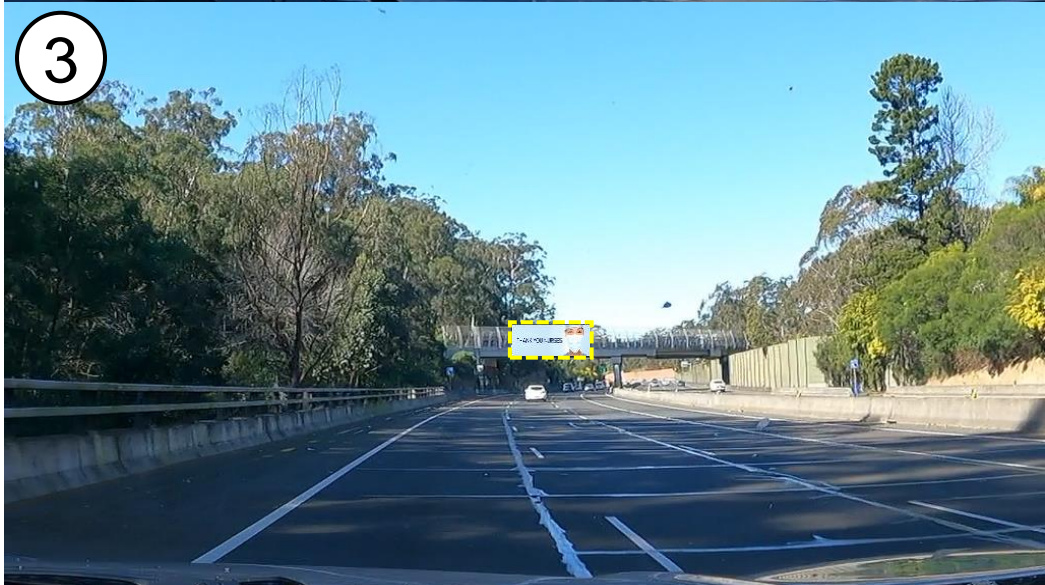
1. M2 Hills Motorway eastbound approach – Lane 1 (Day)

A site inspection was undertaken on Thursday, 28 July 2022 during daytime hours (around 12:30pm). The weather was clear and traffic conditions were moderate. In-vehicle video recordings were taken for further analysis and for use in compiling photo montages of the driver's perspective on the approaches to the site.
