17 August 2022

## Re: Heritage impact of signage proposed for M2 on Murray Farm Road Overpass

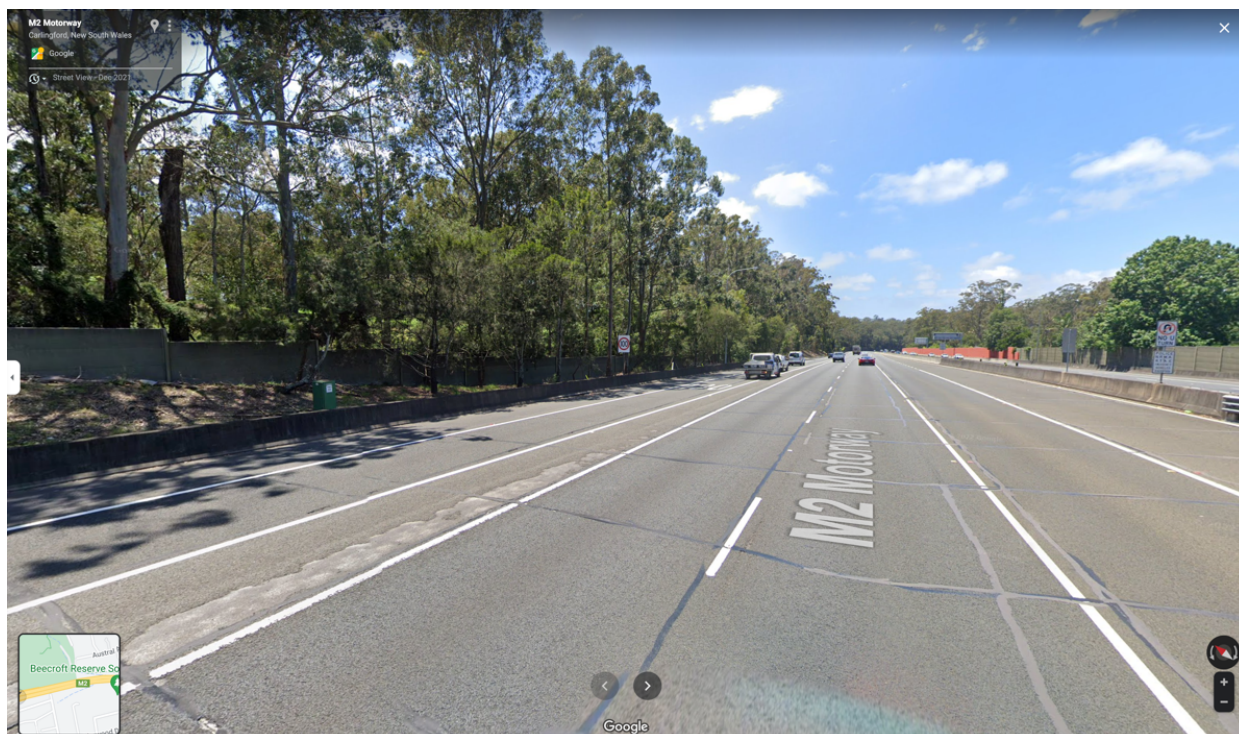
**Figure 7:** View from Pennant Hills Road access point.

The M2 motorway east bound through Beecroft (northern side) and Epping (southern side) from the intersection with Pennant Hills Road approaches the Murray Farm Road overpass in a long gradually descending sweep through a series of curves. On both the north and south, from the Pennant Hills Road eastward entrance, the motorway is fringed by sound barriers and eucalypts, with a forested horizon. For the eastbound motorist, there are glimpses of the open lawns of the Pennant Hills Golf Club on the left. **Figure 7**

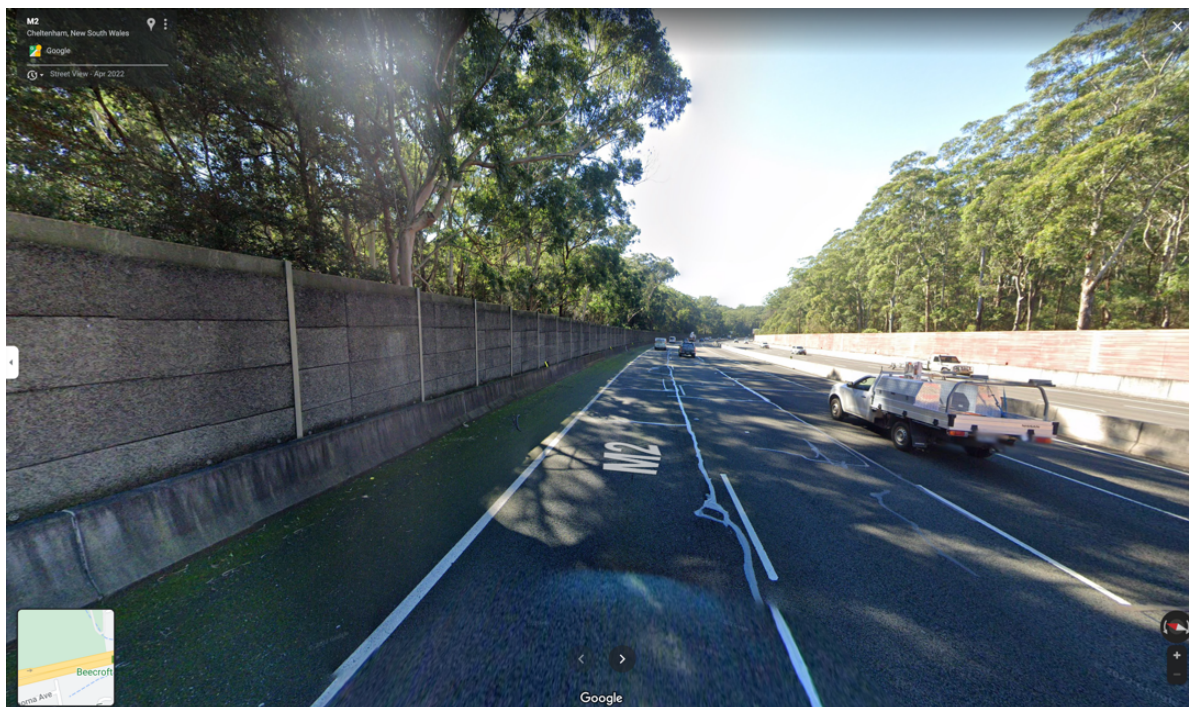
**Figure 8:** View along east along the motorway after crossing Devlin's Creek toward the curve in the distance.

Further east, after crossing Devlin's Creek the road curves to the south midway between Pennant Hills Road and Murray Farm Road, the sound barriers edge the road on both sides with dense trees/woodland above and behind the barriers. The view ahead for motorists is of sound barriers with forest framing the horizon and the motorway corridor. **Figure 8**

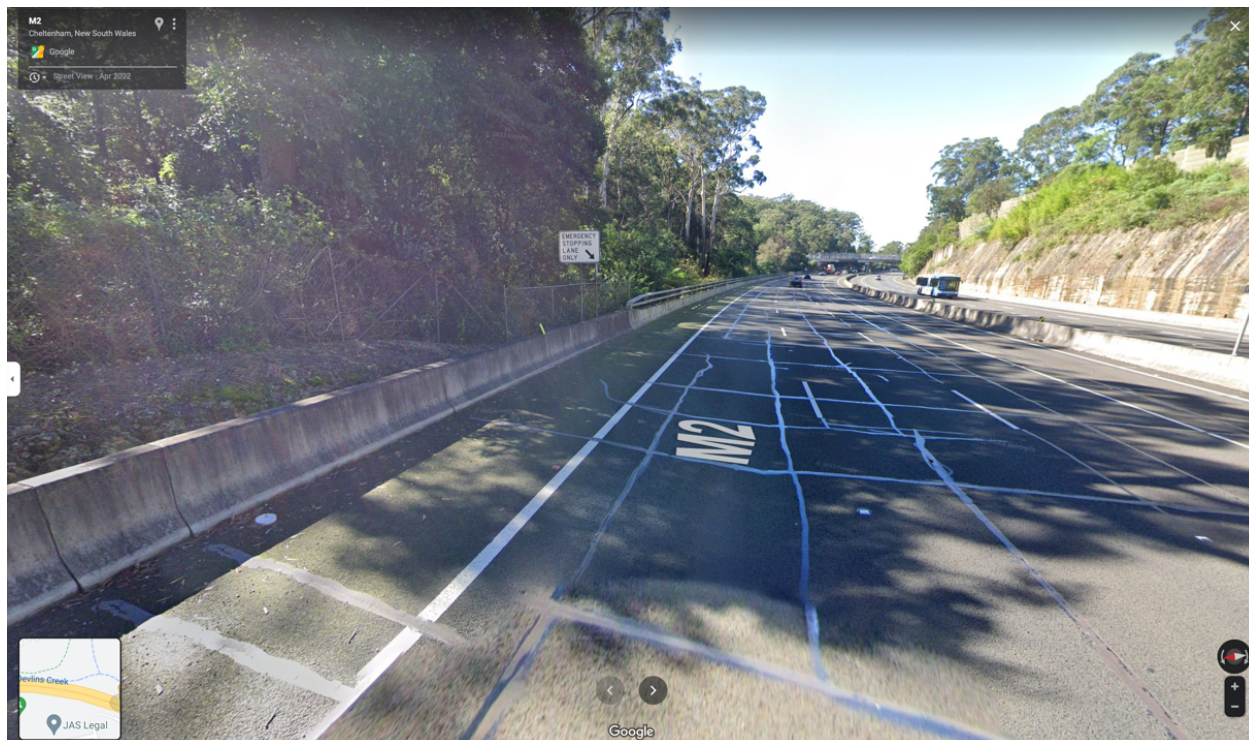
**Figure 7:** View along east along the motorway the overpass can be seen in the distance on a curve in the line of road. on the left is item 70 of Schedule 5 on the Hornsby LEP

As the overpass is approached, on the south, the road cuts through sandstone topped by sand barriers with shrubs in front and forest behind. On the northern side, the barriers continue for some distance until they become unnecessary with the natural topography and bush, shielding the line of road across a valley through which Devlin Creek flows. A chain wire fence runs along this section. **Figure 7**

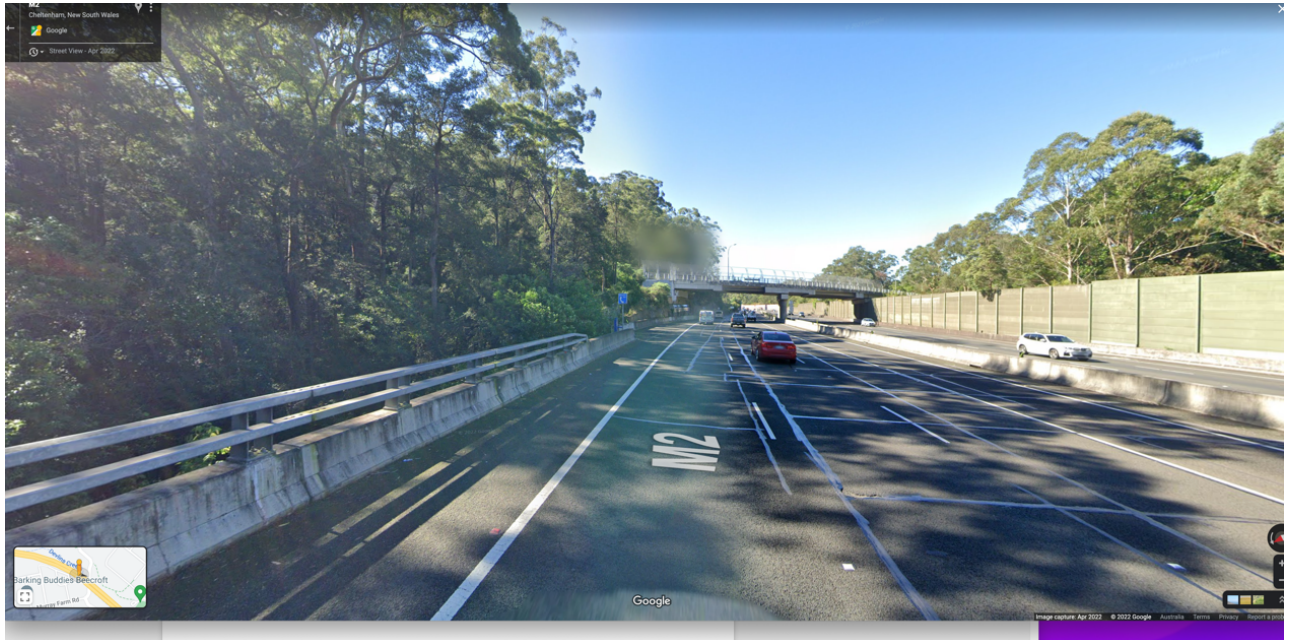
**Figure 8:** A motorists view approaching the proposed site of the signage. The HCA and Item 70 is on the left. They eye of the motorist is drawn to the east by the line of road and the bridge.

The motorway is carried over a bridge crossing Devlin's Creek with forest visible on the northern side and high sound barriers on the south. The overpass dominates the horizon to the east. **Figure 8.**

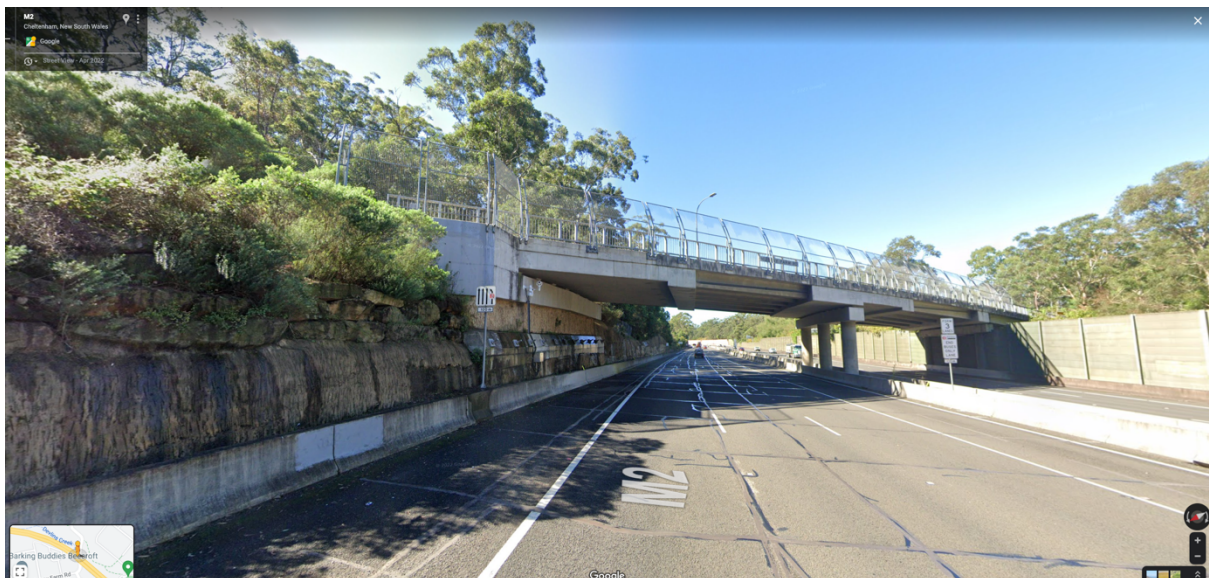
**Figure 9:** Detail of immediate western approach to the proposed site of the signage.

The overpass obscures views of the HCA and forest. **Figure 9.**

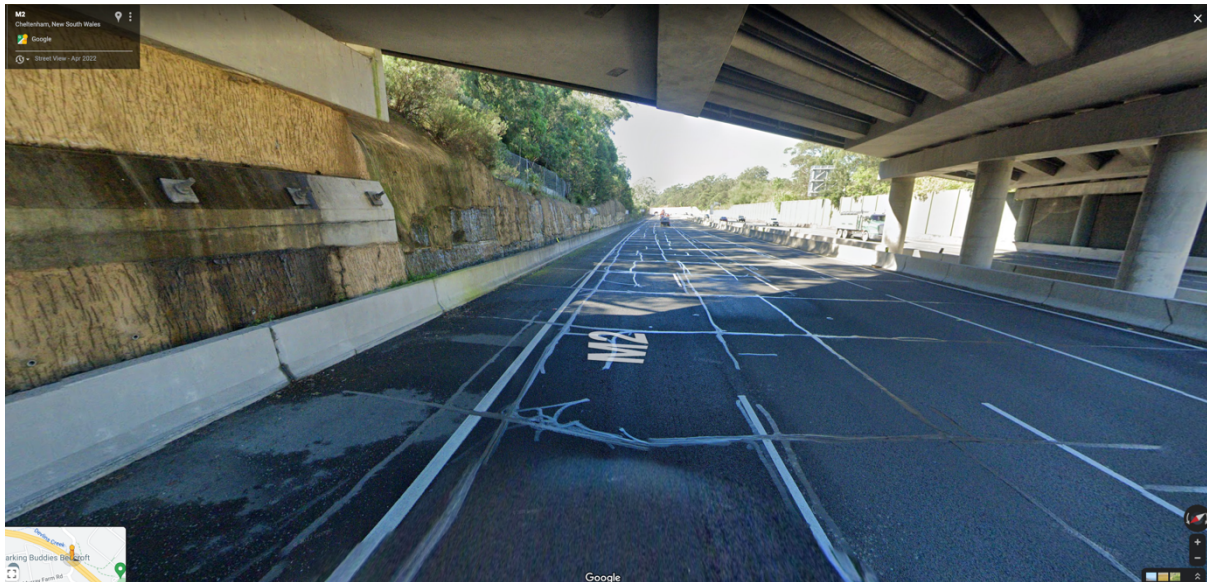
**Figure 10:** The view experienced passing through the underpass and under the proposed sign.

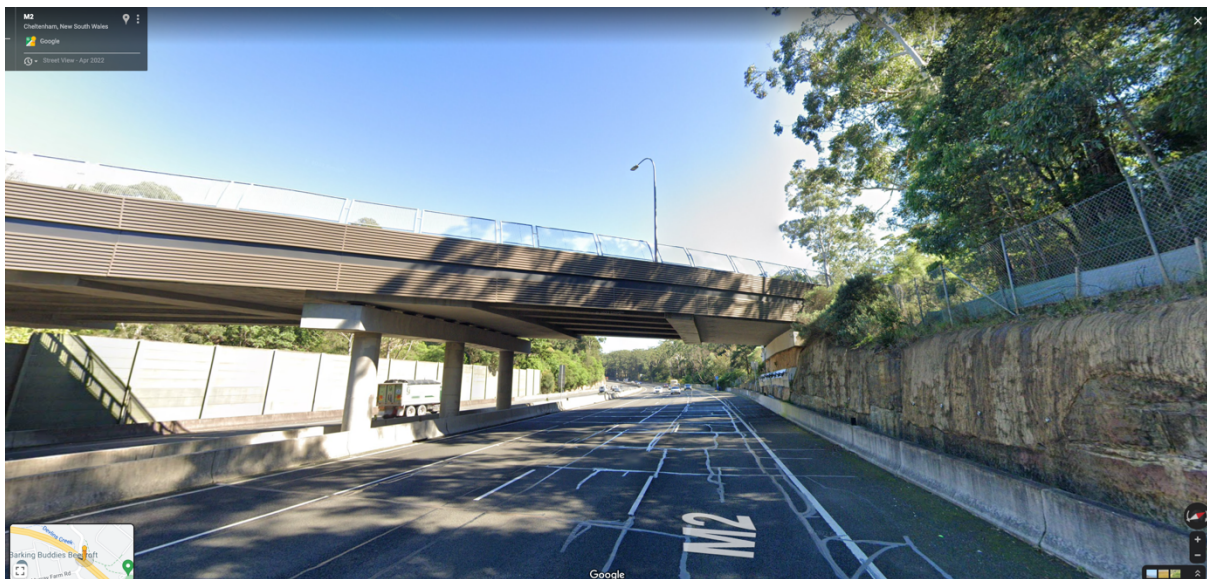
**Figure 11:** Motorists view in the rear-view mirror after passing through the underpass.

The eastern façade of the bridge is covered by paneling to half the height of the safety fencing, well above the handrail. **Figure 11:**

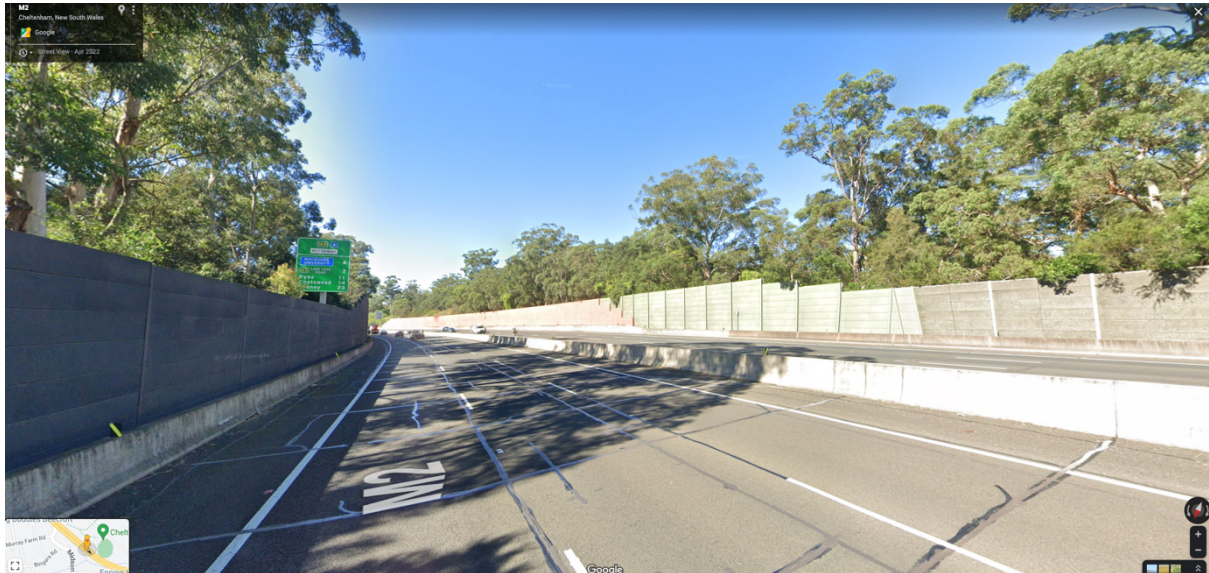
**Figure 12:** The line of road is increasingly delineated by sound barriers after passing through the underpass.

Within a short distance high sound walls border the line of road on both sides until the next overpass and beyond. Trees, increasingly thinly are evident over the top of the walls. **Figure 12.**

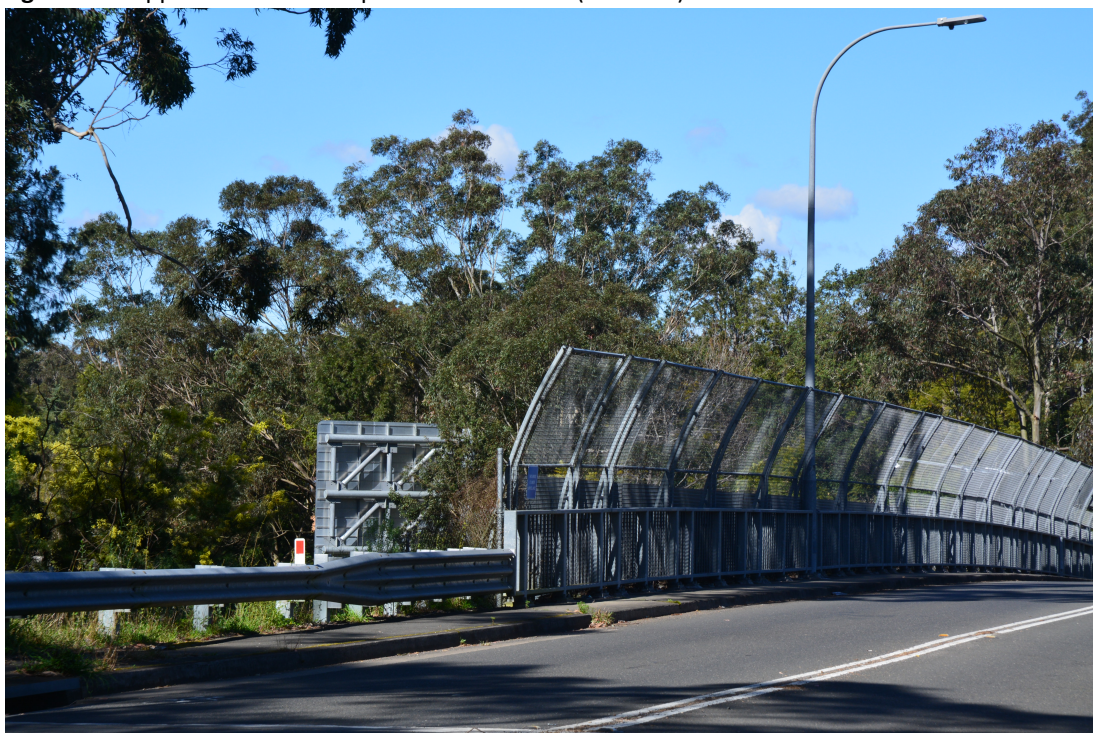
**Figure 14:** Approach to the overpass from northern (Beecroft) side. Focus on eastern façade. Note screening that extends to handrail height.

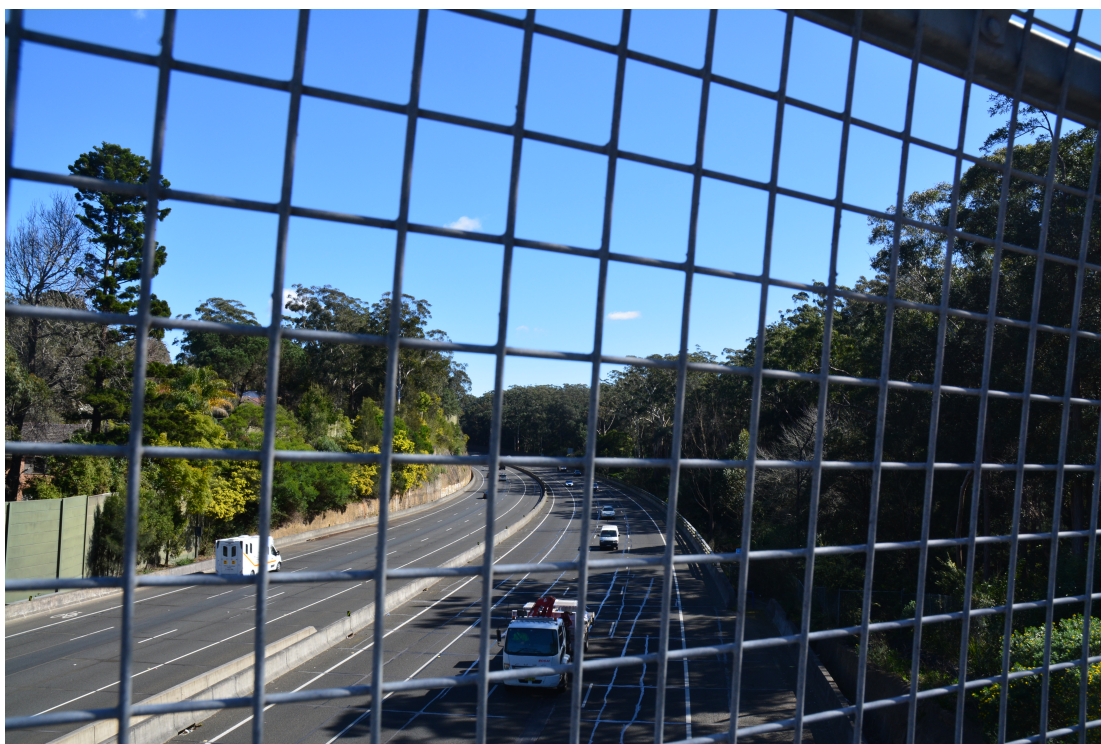
**Figure 16:** View from overpass west along motorway, with HCA and part of Heritage Item 70 on right. The sign will hang below the point from which this image was taken.

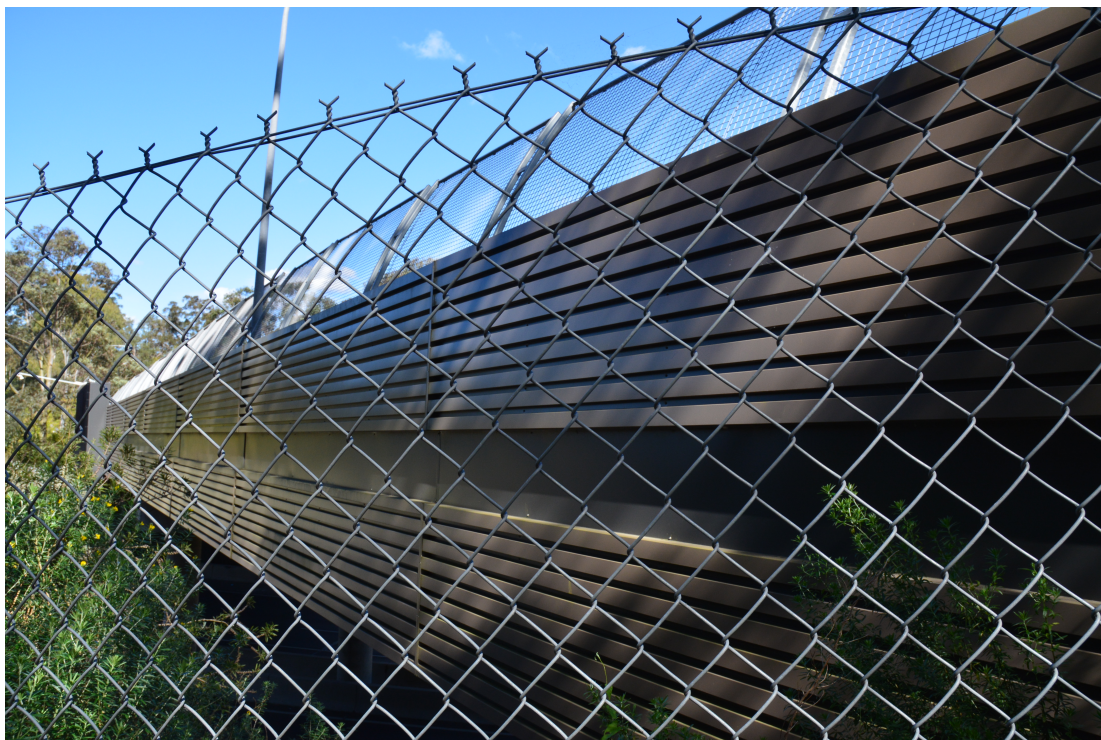
**Figure 17:** Screening on eastern façade that obscures views.

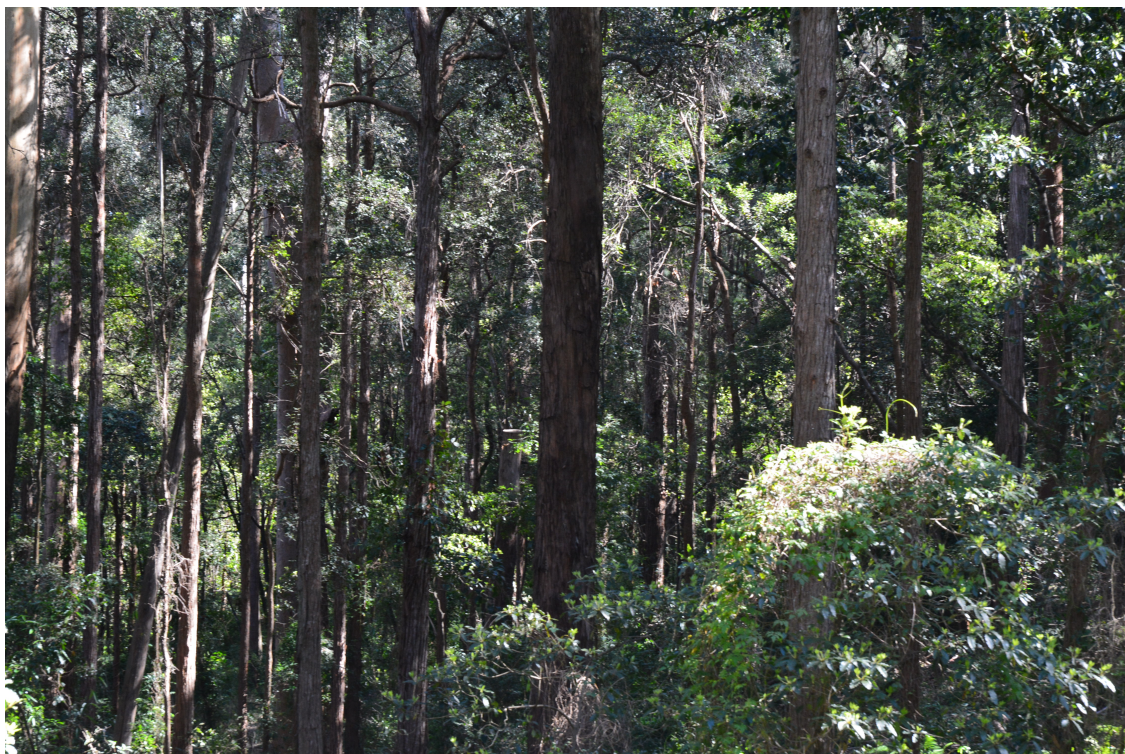
**Figure 19:** Item 70 is very densely vegetated. Track near the motorway have been blocked off – public access is now on the high ground above.

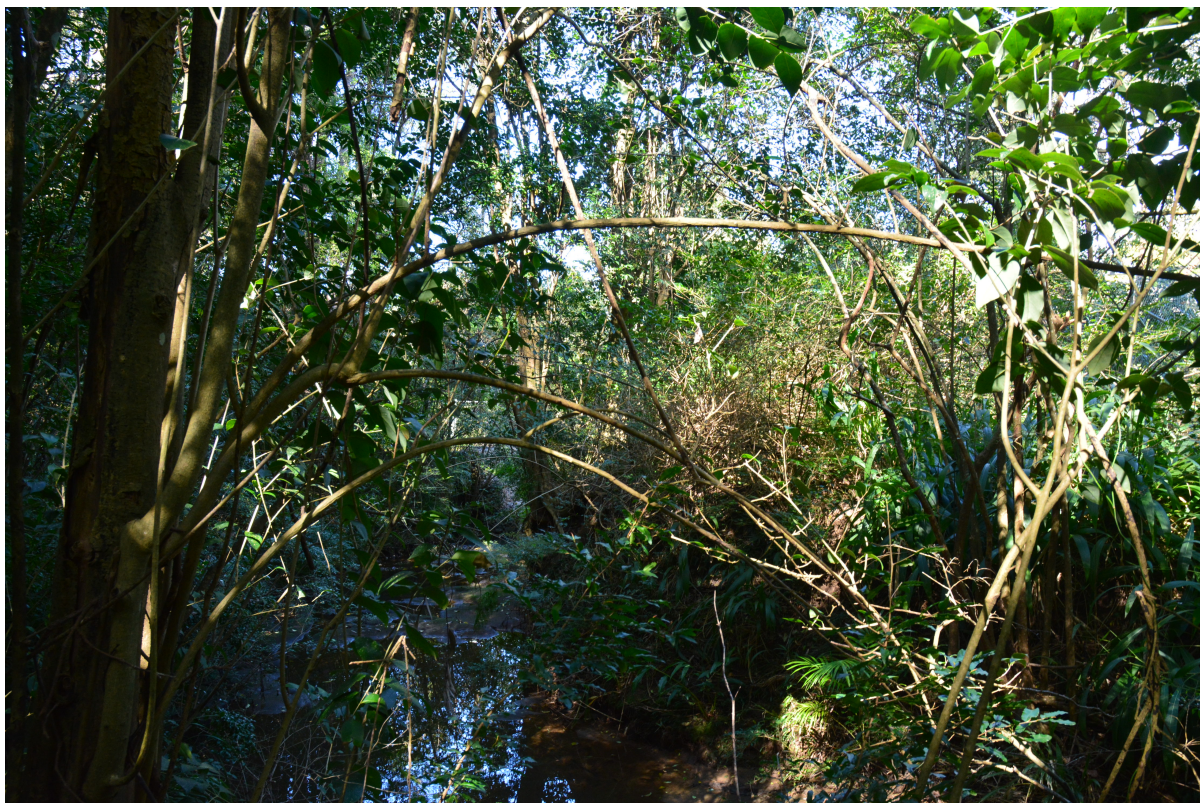
**Figure 20:** In the centre of the image there is a glimpse of the overpass approximating where the sign will be located. This photo was taken well down the slope and off the track.

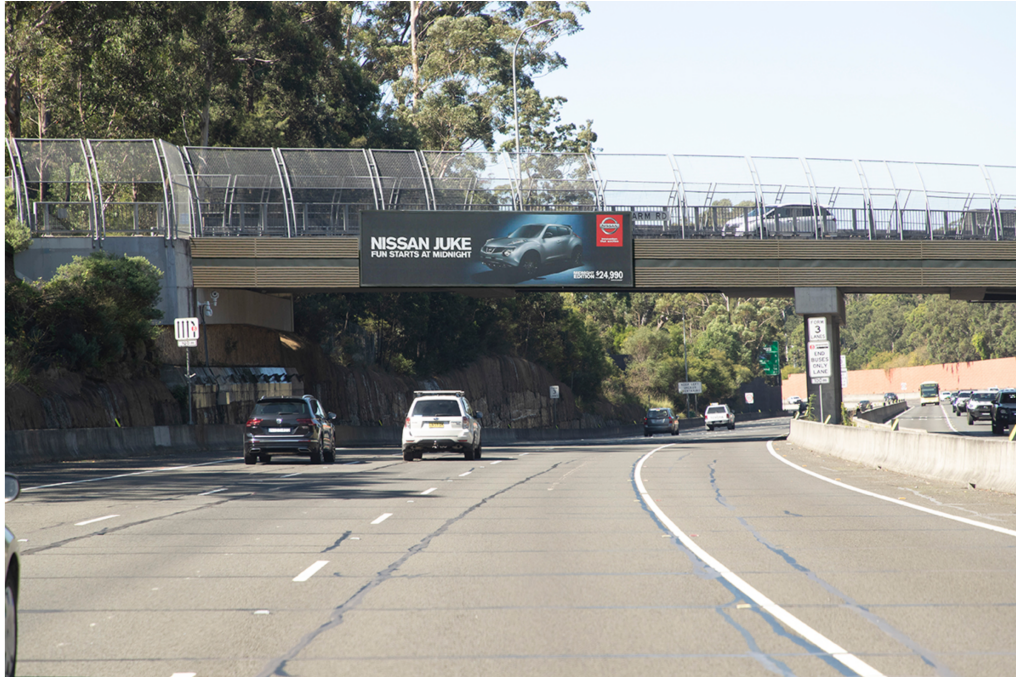
**Figure 21:** Indicative sign design and proportions in relation to the overpass. Note that the sign is in line with the screening on the eastern façade and below the handrail. Views from the overpass and to the HCA and Item 70 will not be impacted by its construction.

While the site for the proposed signage is within the vicinity of the HCA and item 70 on the HELP it will not obscure views to the HCA or heritage item because it will be sited low on the overpass and will not add further visual obstructions that those posed by the existing overpass structure. Motorists will have the HCA and Item 70 on their left as they travel east. The sign will not impede their views of the Heritage.
