M2 Hills Motorway: Lane Cove Road Overpass

Proposed Digital Sign Traffic Safety Assessment

Manboom Signage

24 November 2022

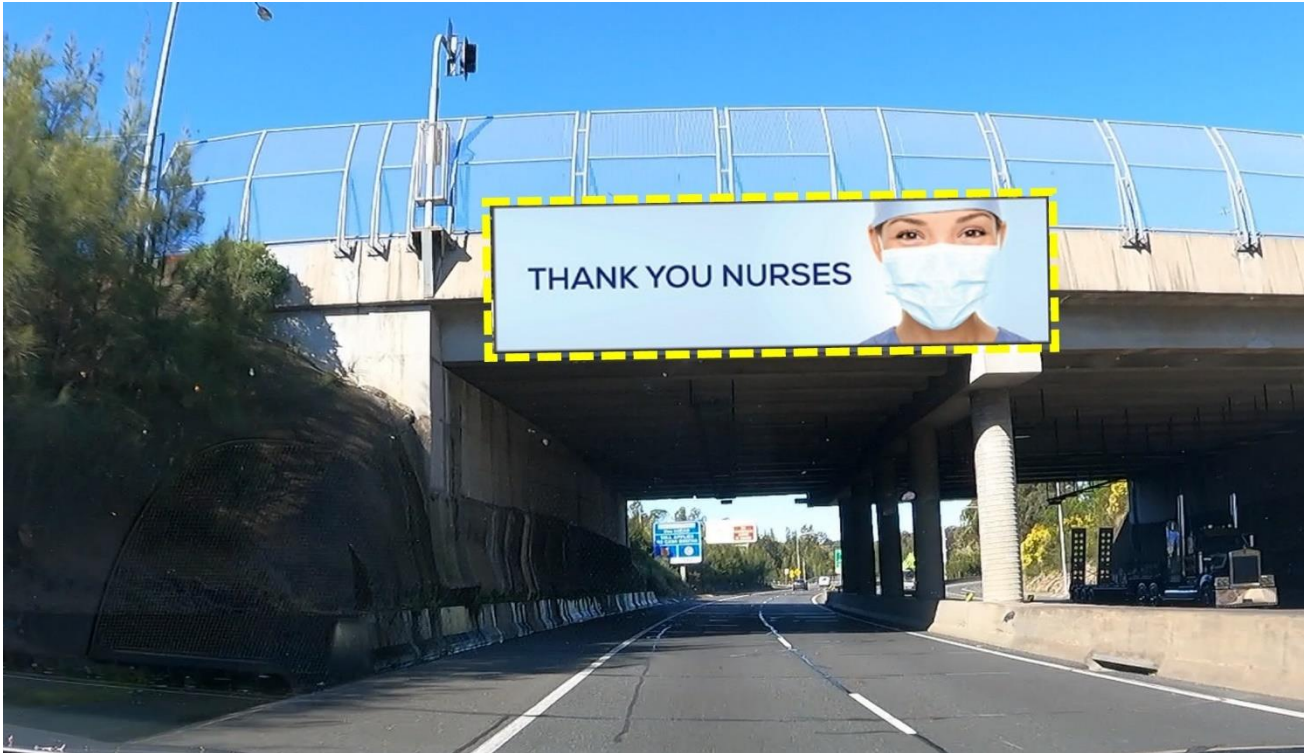
Figure 2.2: Daytime view from the M2 eastbound

The eastbound sign view from the M2 during the daytime period is shown in Figure 2.2.

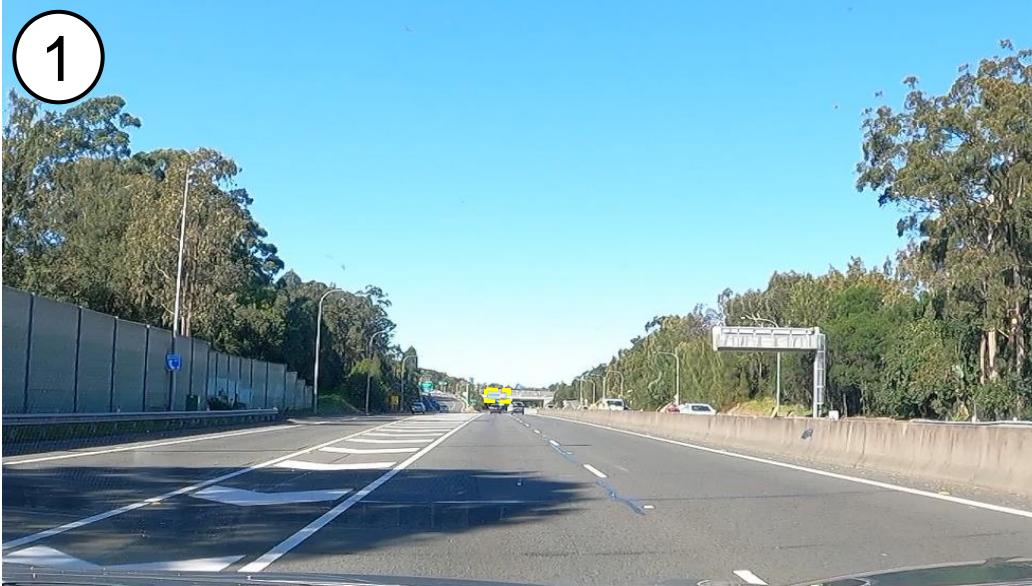
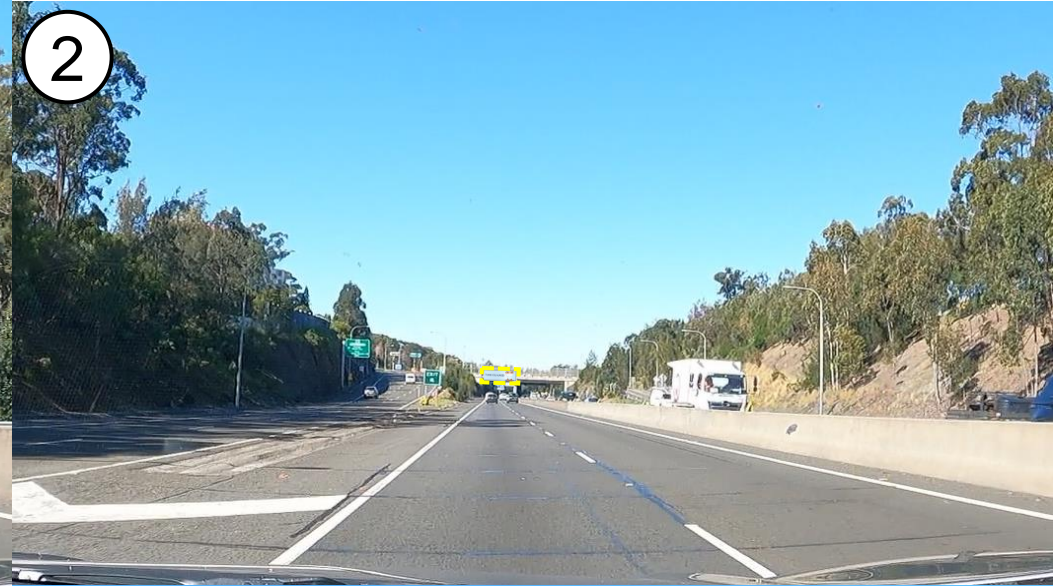
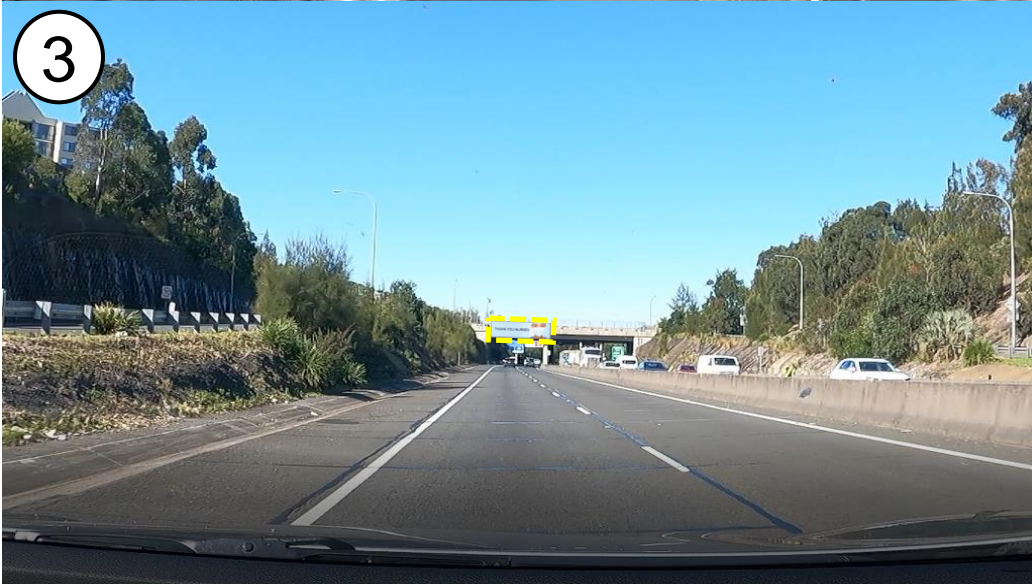
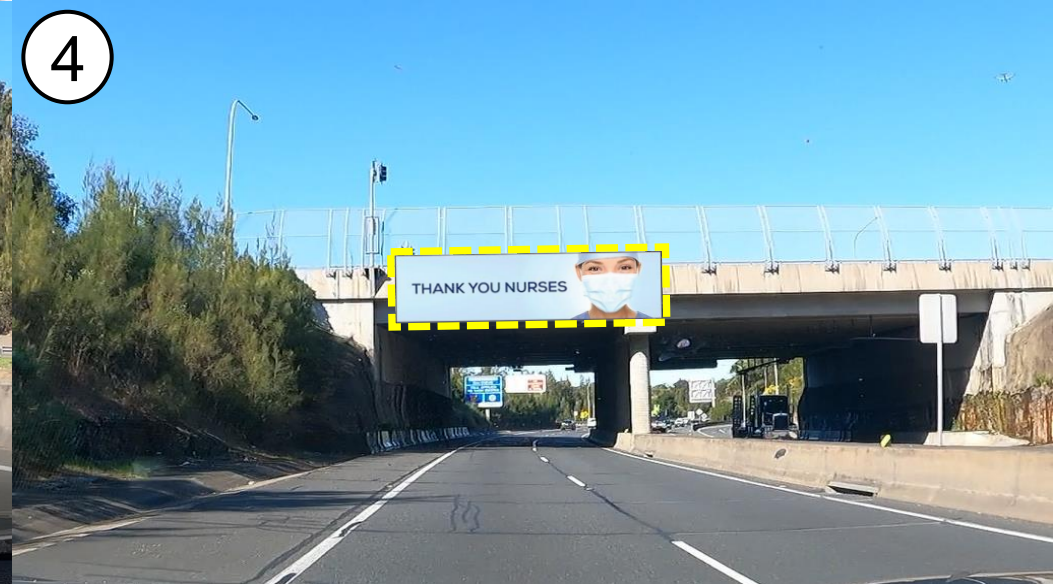
1. M2 Hills Motorway eastbound approach – Lane 1 (Day)

A site inspection was undertaken on Thursday, 28 July 2022 during daytime hours (around 12:30pm). The weather was clear and traffic conditions were moderate. In-vehicle video recordings were taken for further analysis and for use in compiling photo montages of the driver's perspective on the approaches to the site.

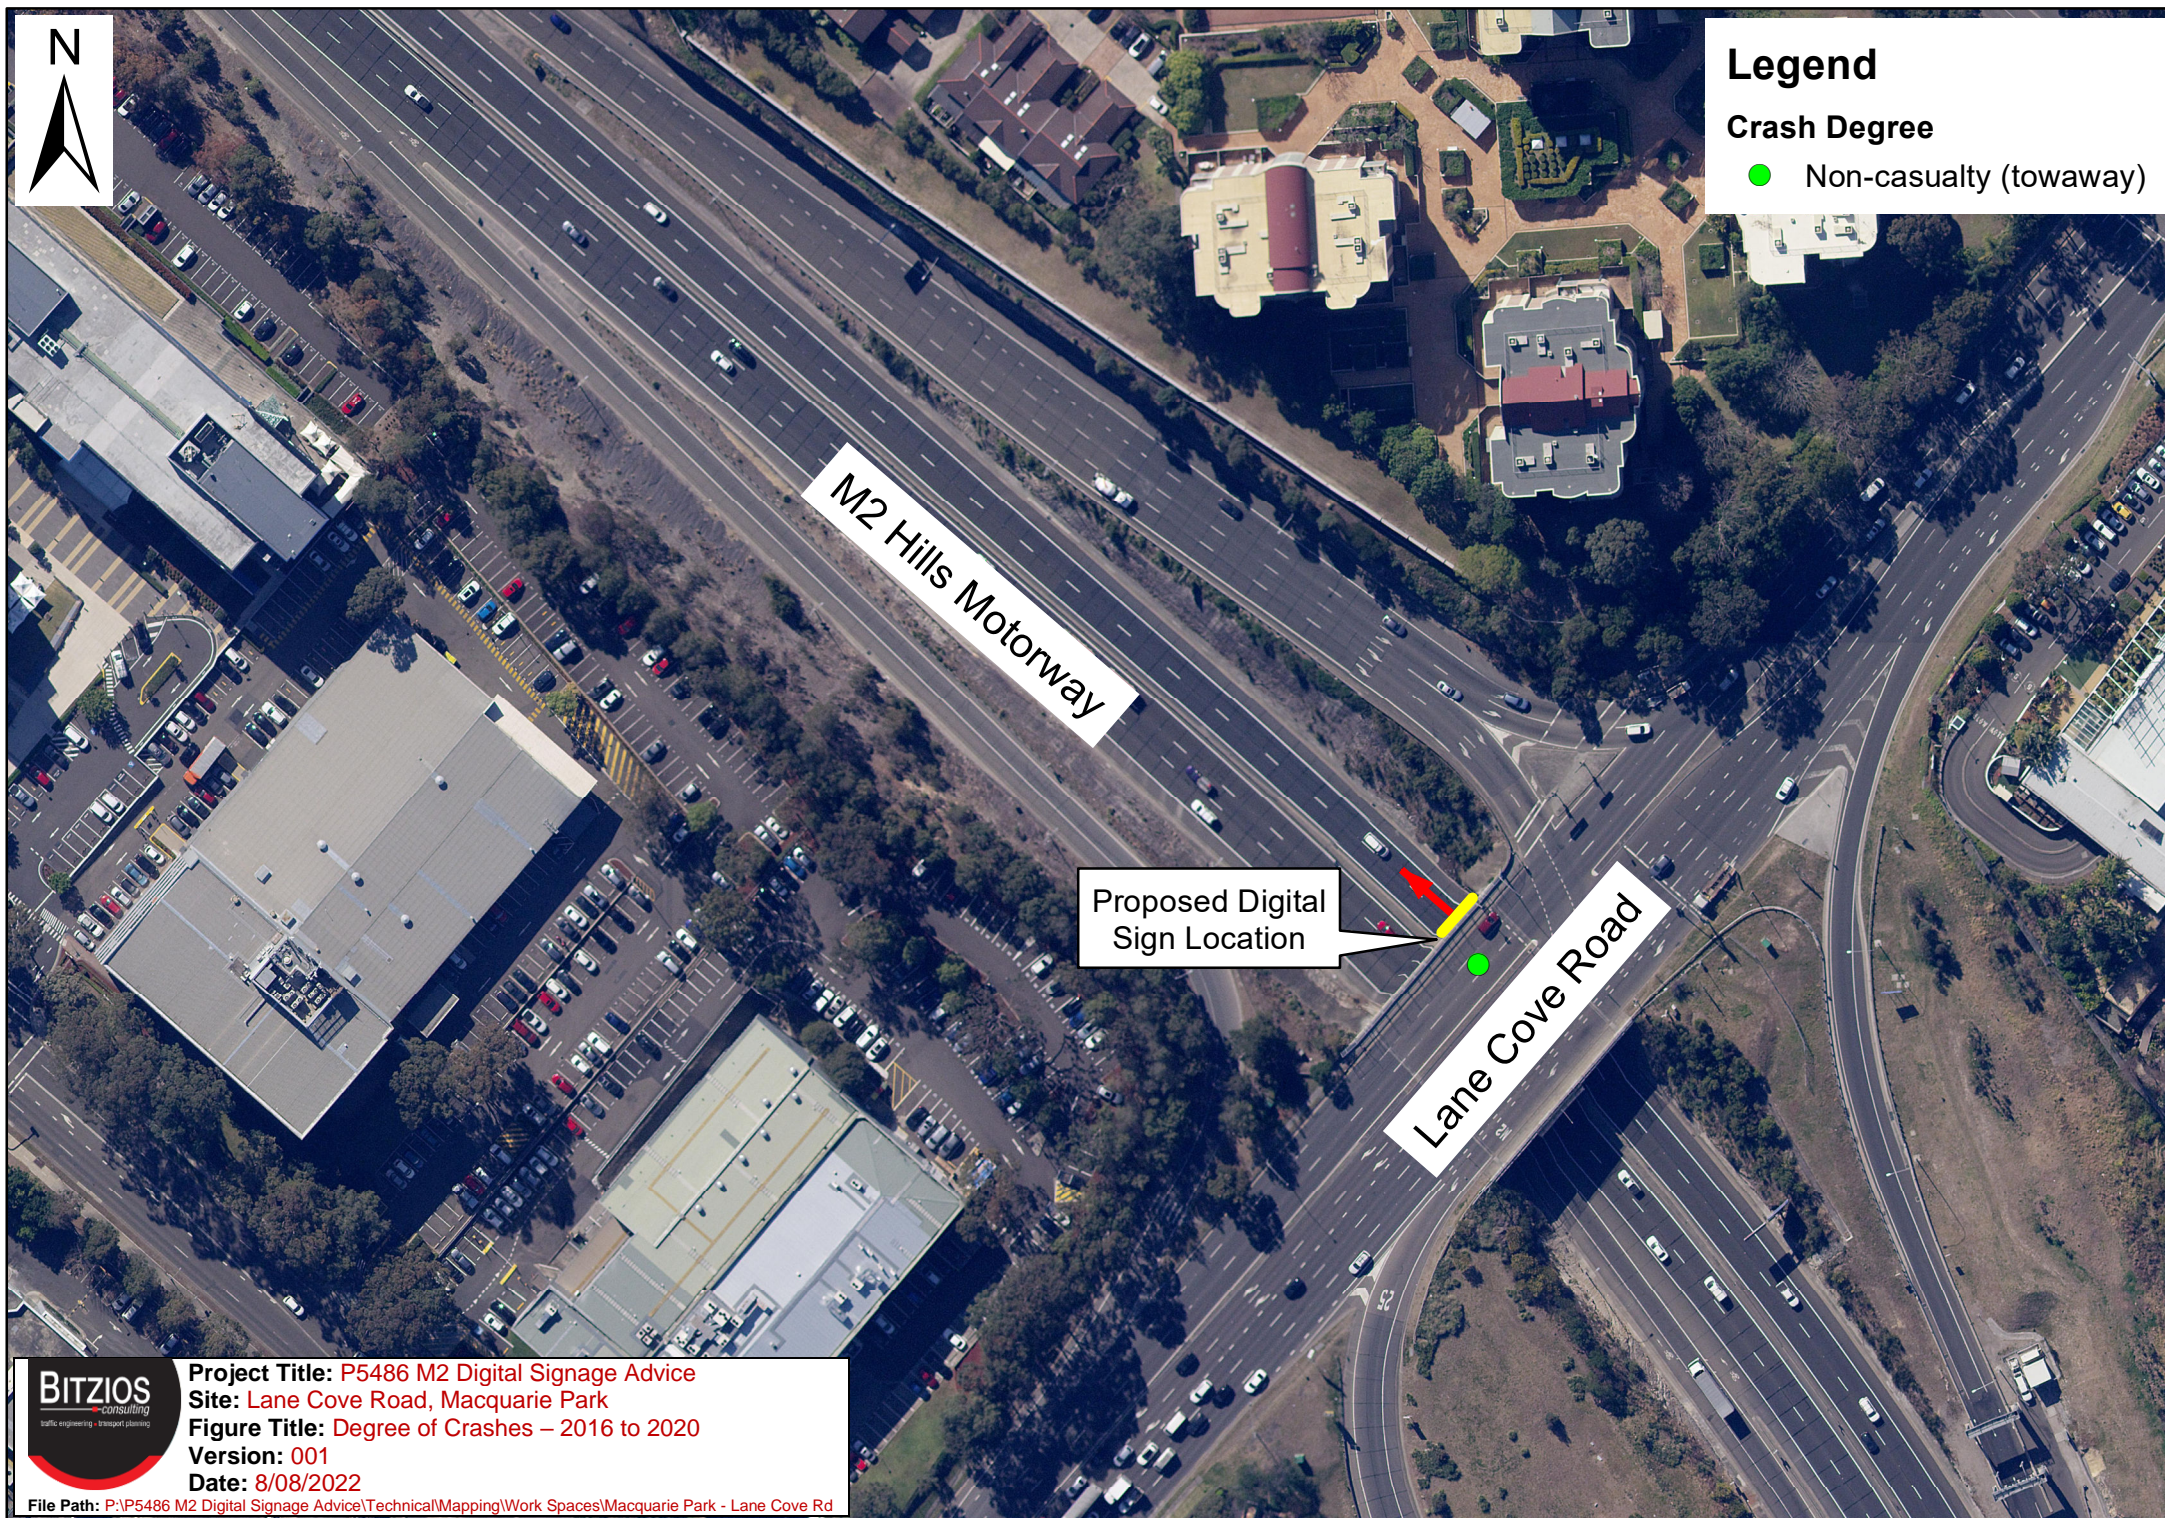
Project Title: P5486 M2 Digital Signage Advice
Site: Lane Cove Road, Macquarie Park
Figure Title: Degree of Crashes – 2016 to 2020
Version: 001
Date: 8/08/2022

Crash Degree

● Non-casualty (towaway)

As shown in the above table, **only one crash was reported between January 2016 and December 2020**. It occurred in February 2016 during daylight and in dry road surface conditions, right below the Lane Cove Road overpass. The crash was classified as ‘other same direction’ and resulted in a towaway.

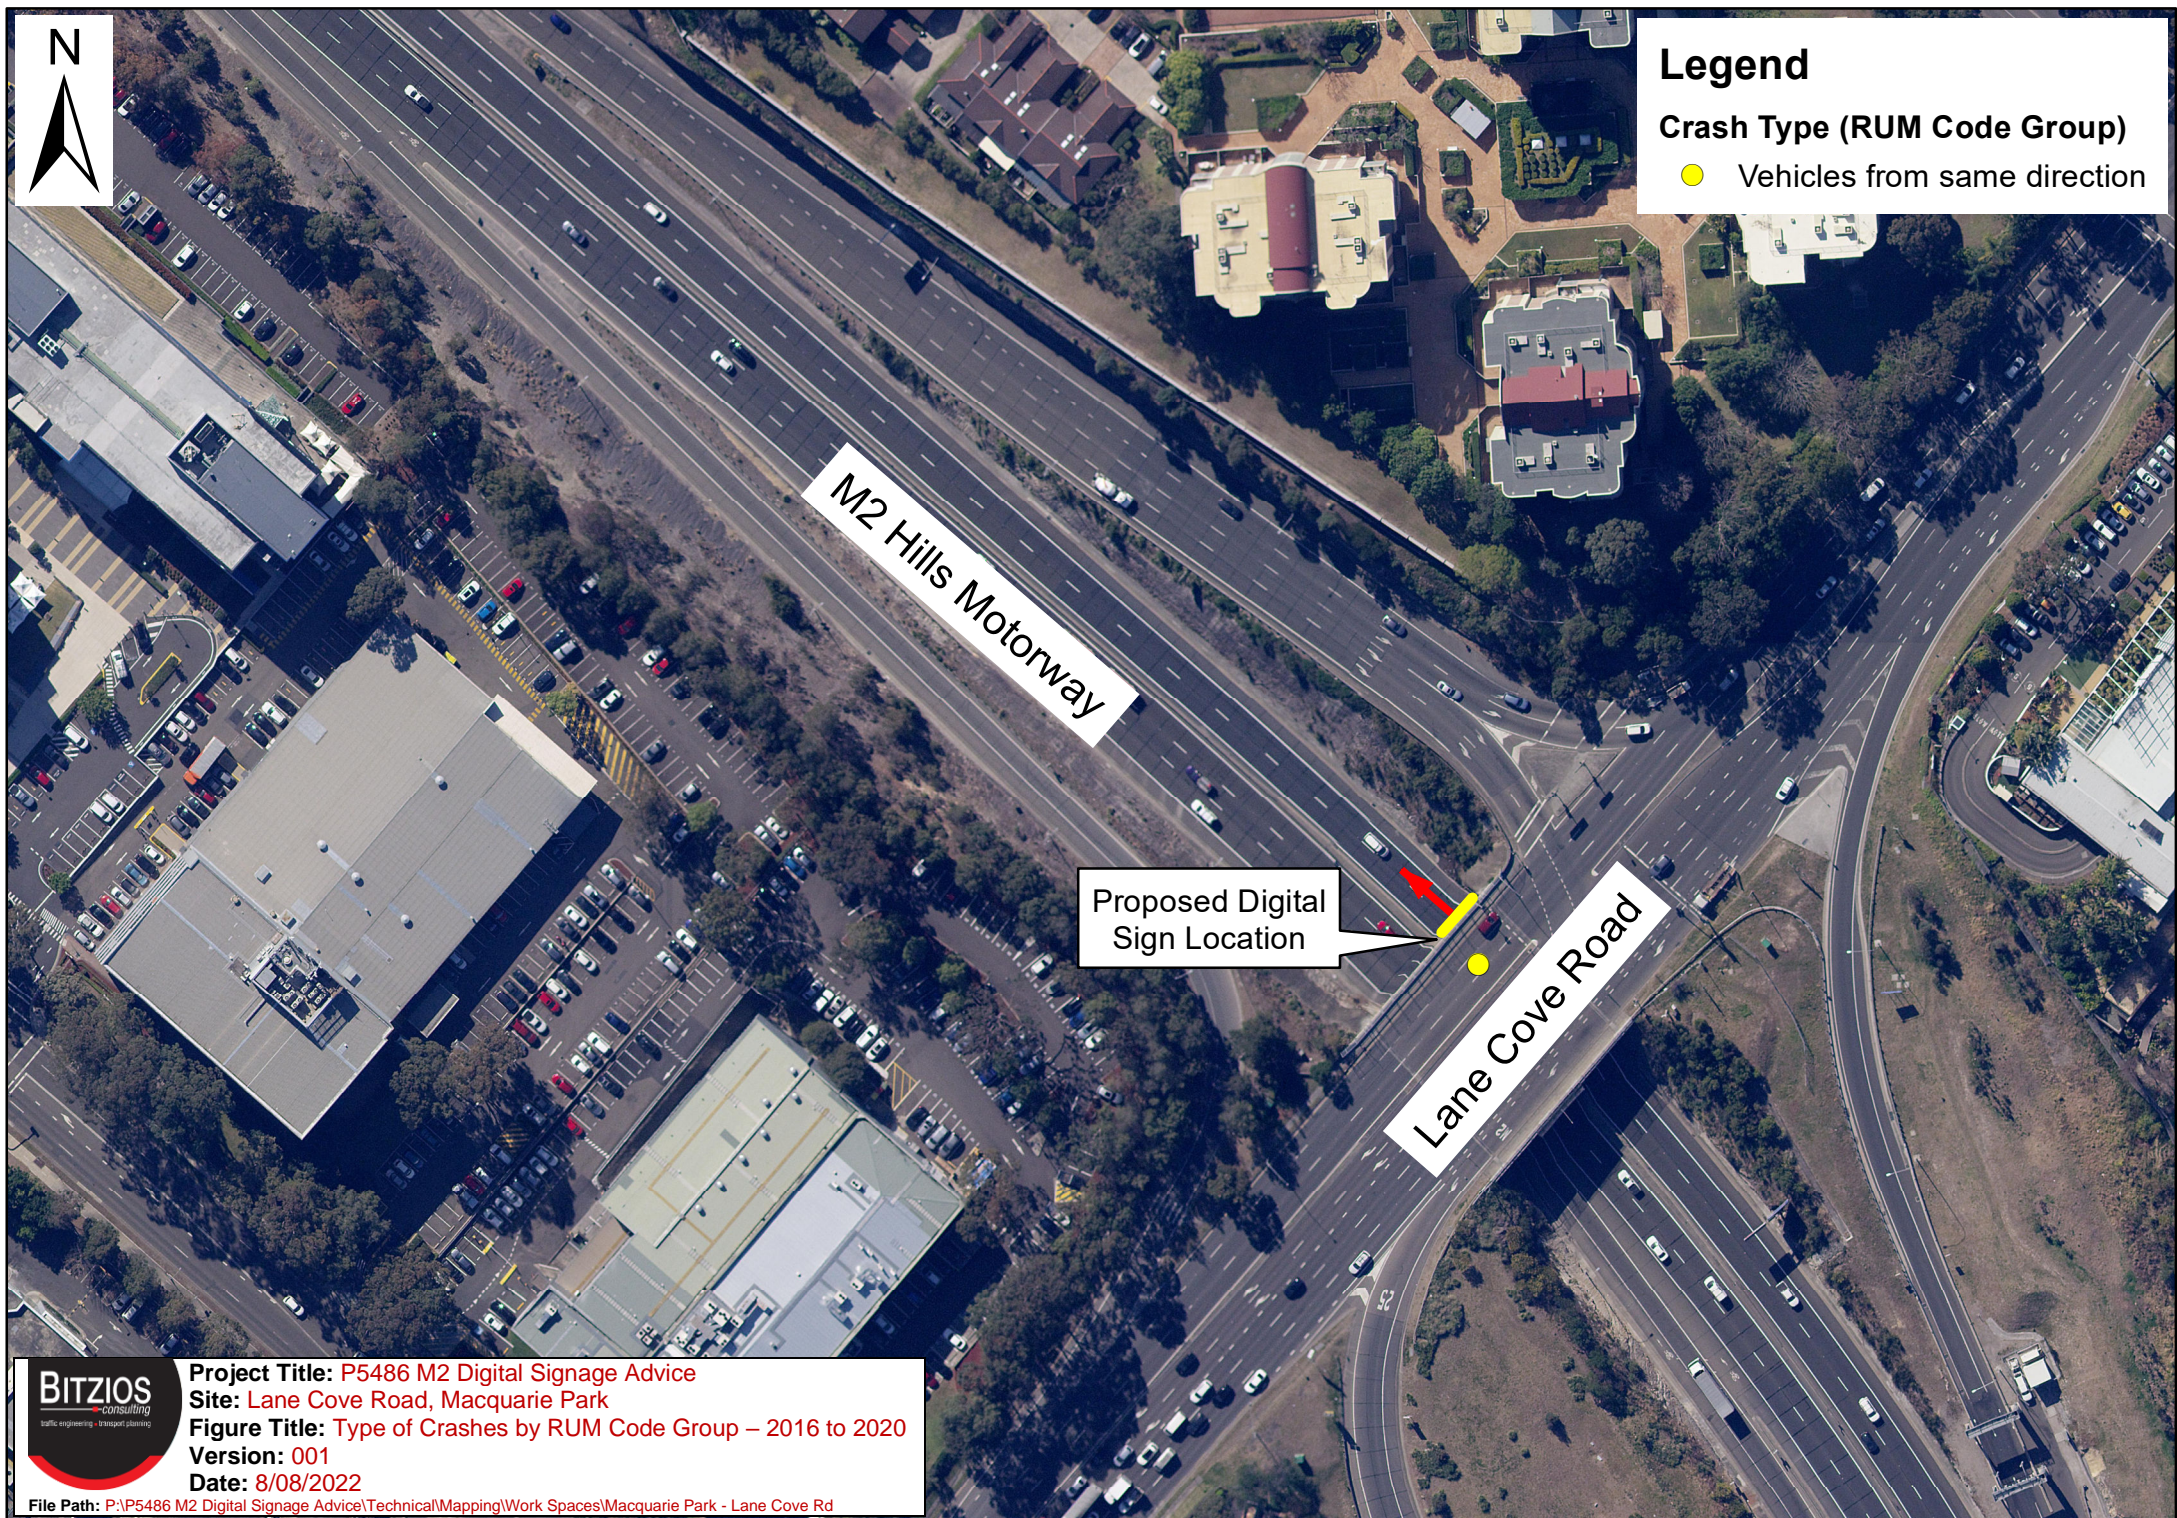
Project Title: P5486 M2 Digital Signage Advice

Crash Type (RUM Code Group)

- Vehicles from same direction
