M2 Hills Motorway: Cropley Drive Overpass

Proposed Inbound Digital Sign Traffic Safety Assessment

Manboom Signage

17 March 2023

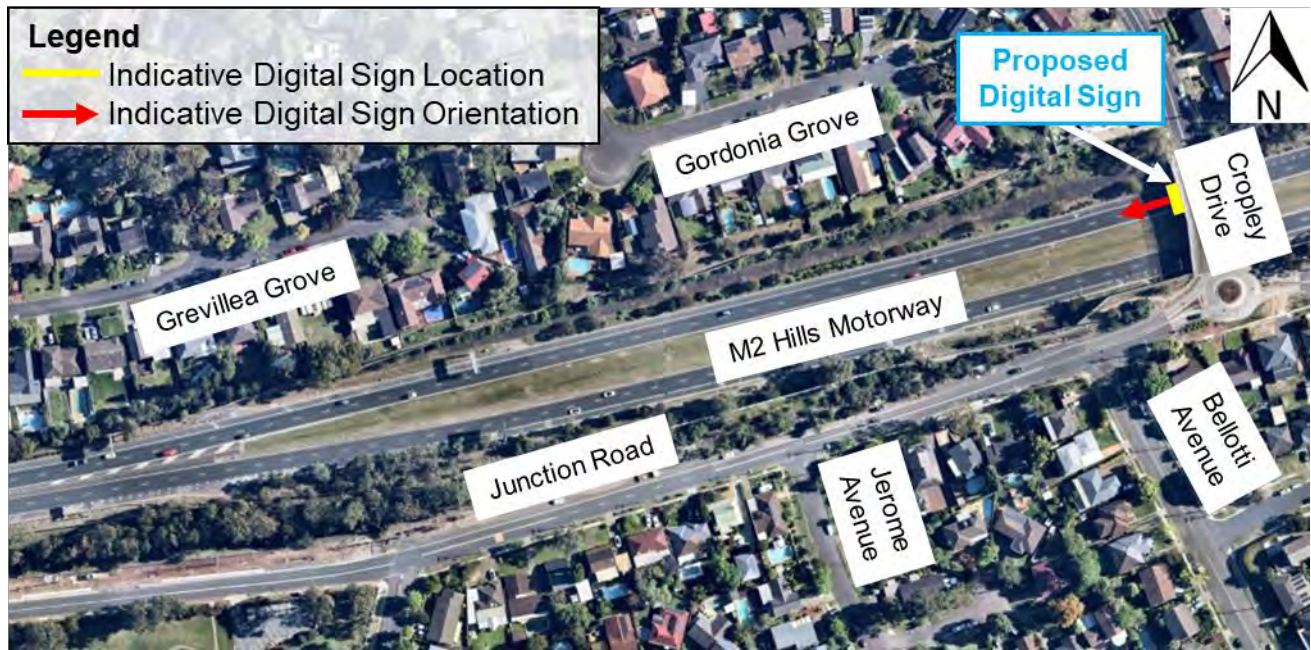
Figure 1.1: Location of the Proposed Digital Sign

Manboom Signage is seeking development approval for the installation of a digital LED advertising sign. The sign is proposed to be located above the eastbound carriageway of the M2 Hills Motorway (M2) Cropley Drive overpass in Baulkham Hills as shown in Figure 1.1.

**Sign location is indicative.
Adapted from Nearmap*

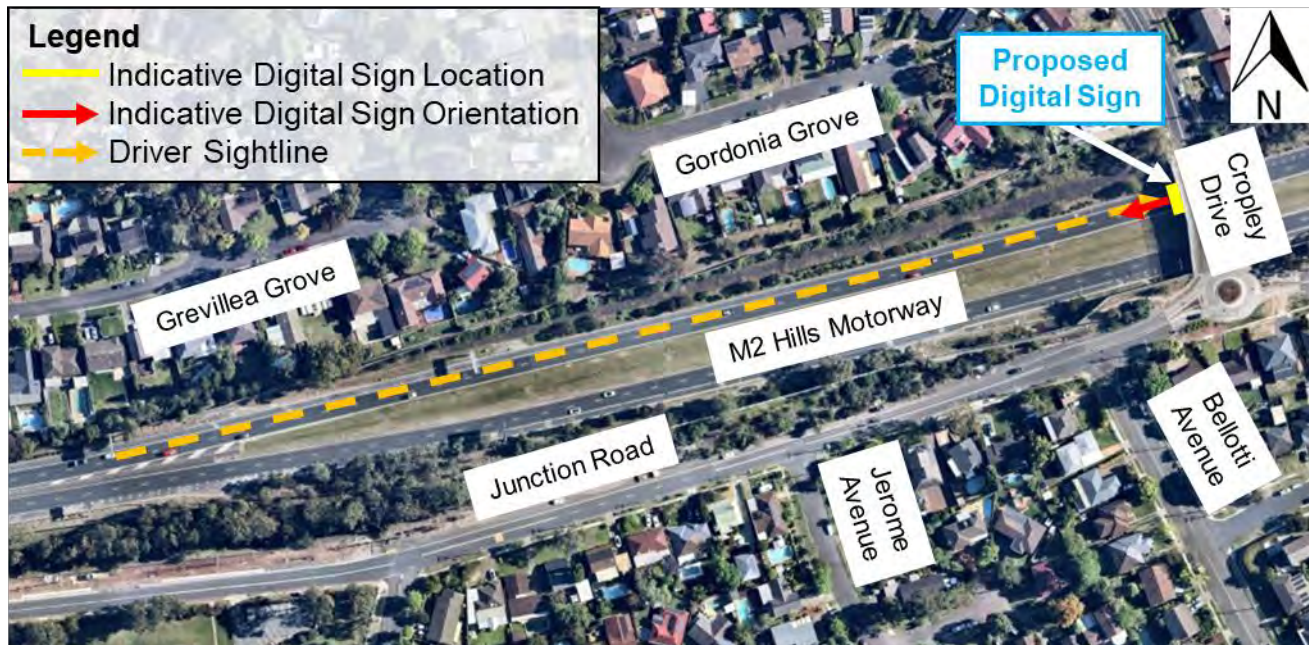
Figure 2.1: Driver Viewing Range to the Proposed Sign

The digital sign is proposed to face south-west towards eastbound drivers along the M2. The driver viewing range to the sign from this approach is illustrated in Figure 2.1 and demonstrates a relatively long distance on approach to the proposed sign from which it can be identified.

**Sign location is indicative.
Adapted from Nearmap.*

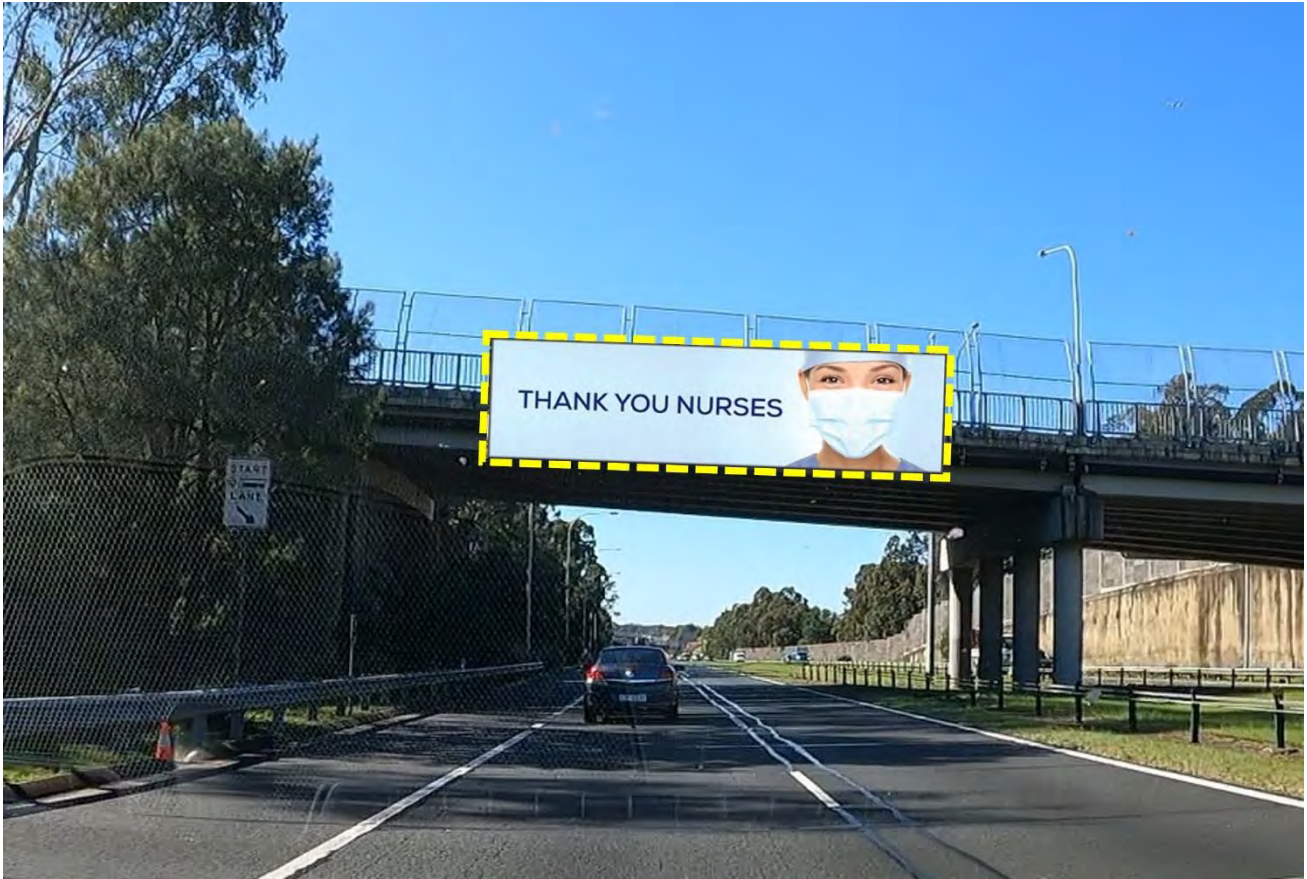
Figure 2.2: Daytime view from the M2 eastbound

The eastbound sign view from the M2 during the daytime period is shown in Figure 2.2.

**Sign location is indicative, not to scale and for illustration purposes only.*

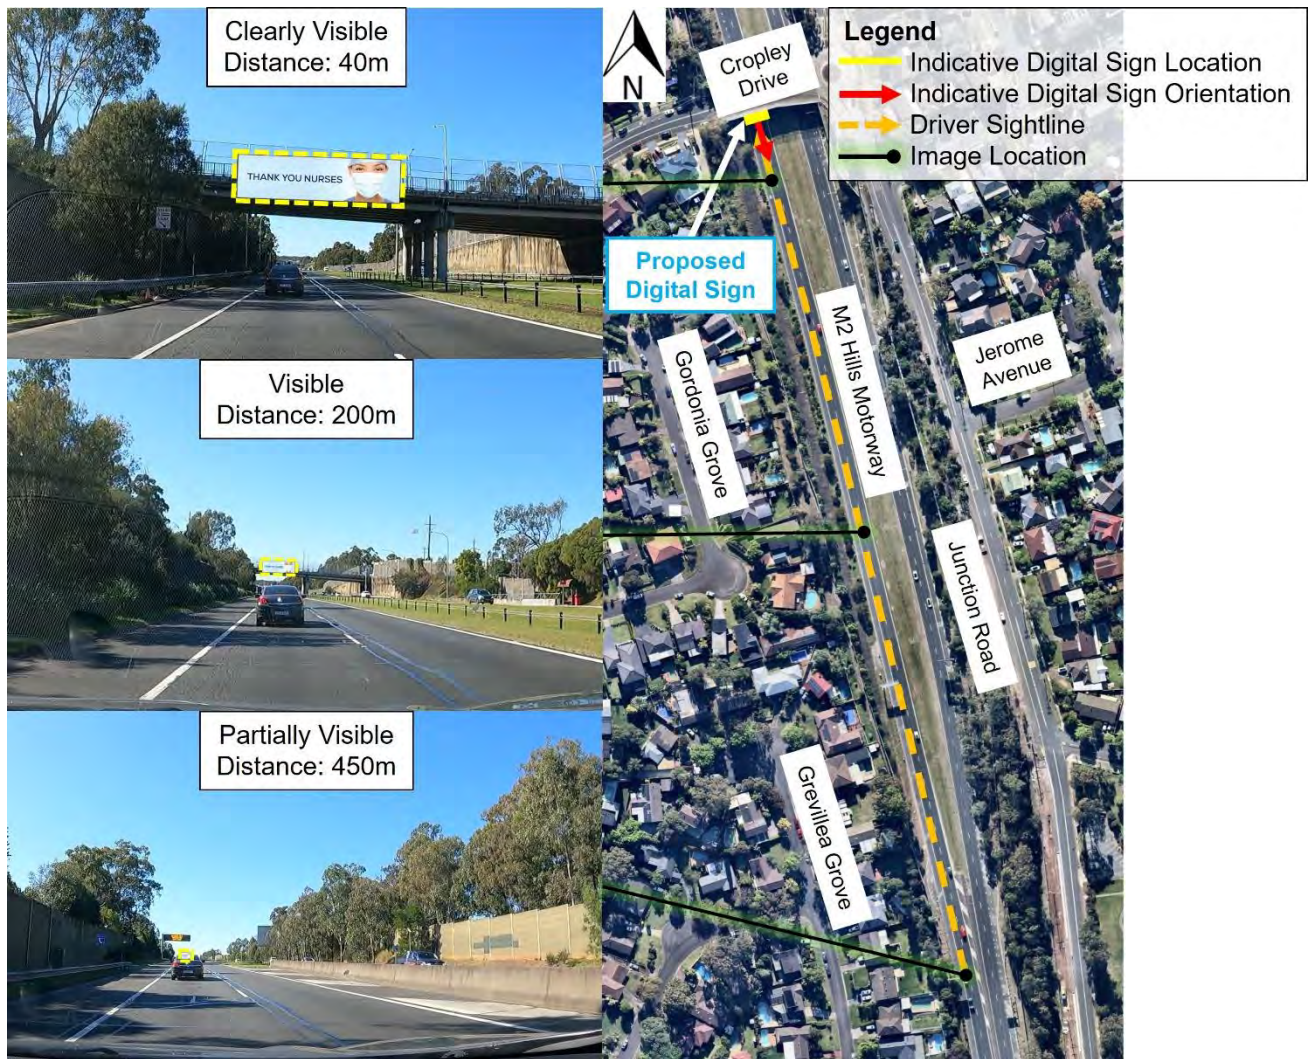
Figure 5.1: In-vehicle viewing range and views along the M2 eastbound

The in-vehicle sightlines from the M2 eastbound are shown in Figure 5.1, clearly demonstrating that all vehicle movements are in the same sightline as the digital sign, which means no risk of distraction away from the forward roadway when glancing to it.

¹Distances measured in Nearmap. / ²Sign location is indicative, not to scale and for illustration purposes only.

In-vehicle observations were undertaken to assess the subject site considering key decision points and the influence on or from traffic control devices. An assessment of still images taken from the driver's perspective with a windscreen-mounted camera is presented in the following section. It should be noted that the assessment was undertaken based on a standard passenger car and as such a driver's eye height may vary for larger and smaller vehicles.

Furthermore, there are no on-ramps or off-ramps in proximity to the approach to the sign. This means that the approach to the proposed digital sign does not require any rapid or complex decision making by drivers. It is in a location of very low cognitive load and a location where a glance to the digital sign is in the forward field of view that allows for recognition of brake lights, indicators or moving vehicles to be unaffected by the presence of the sign.

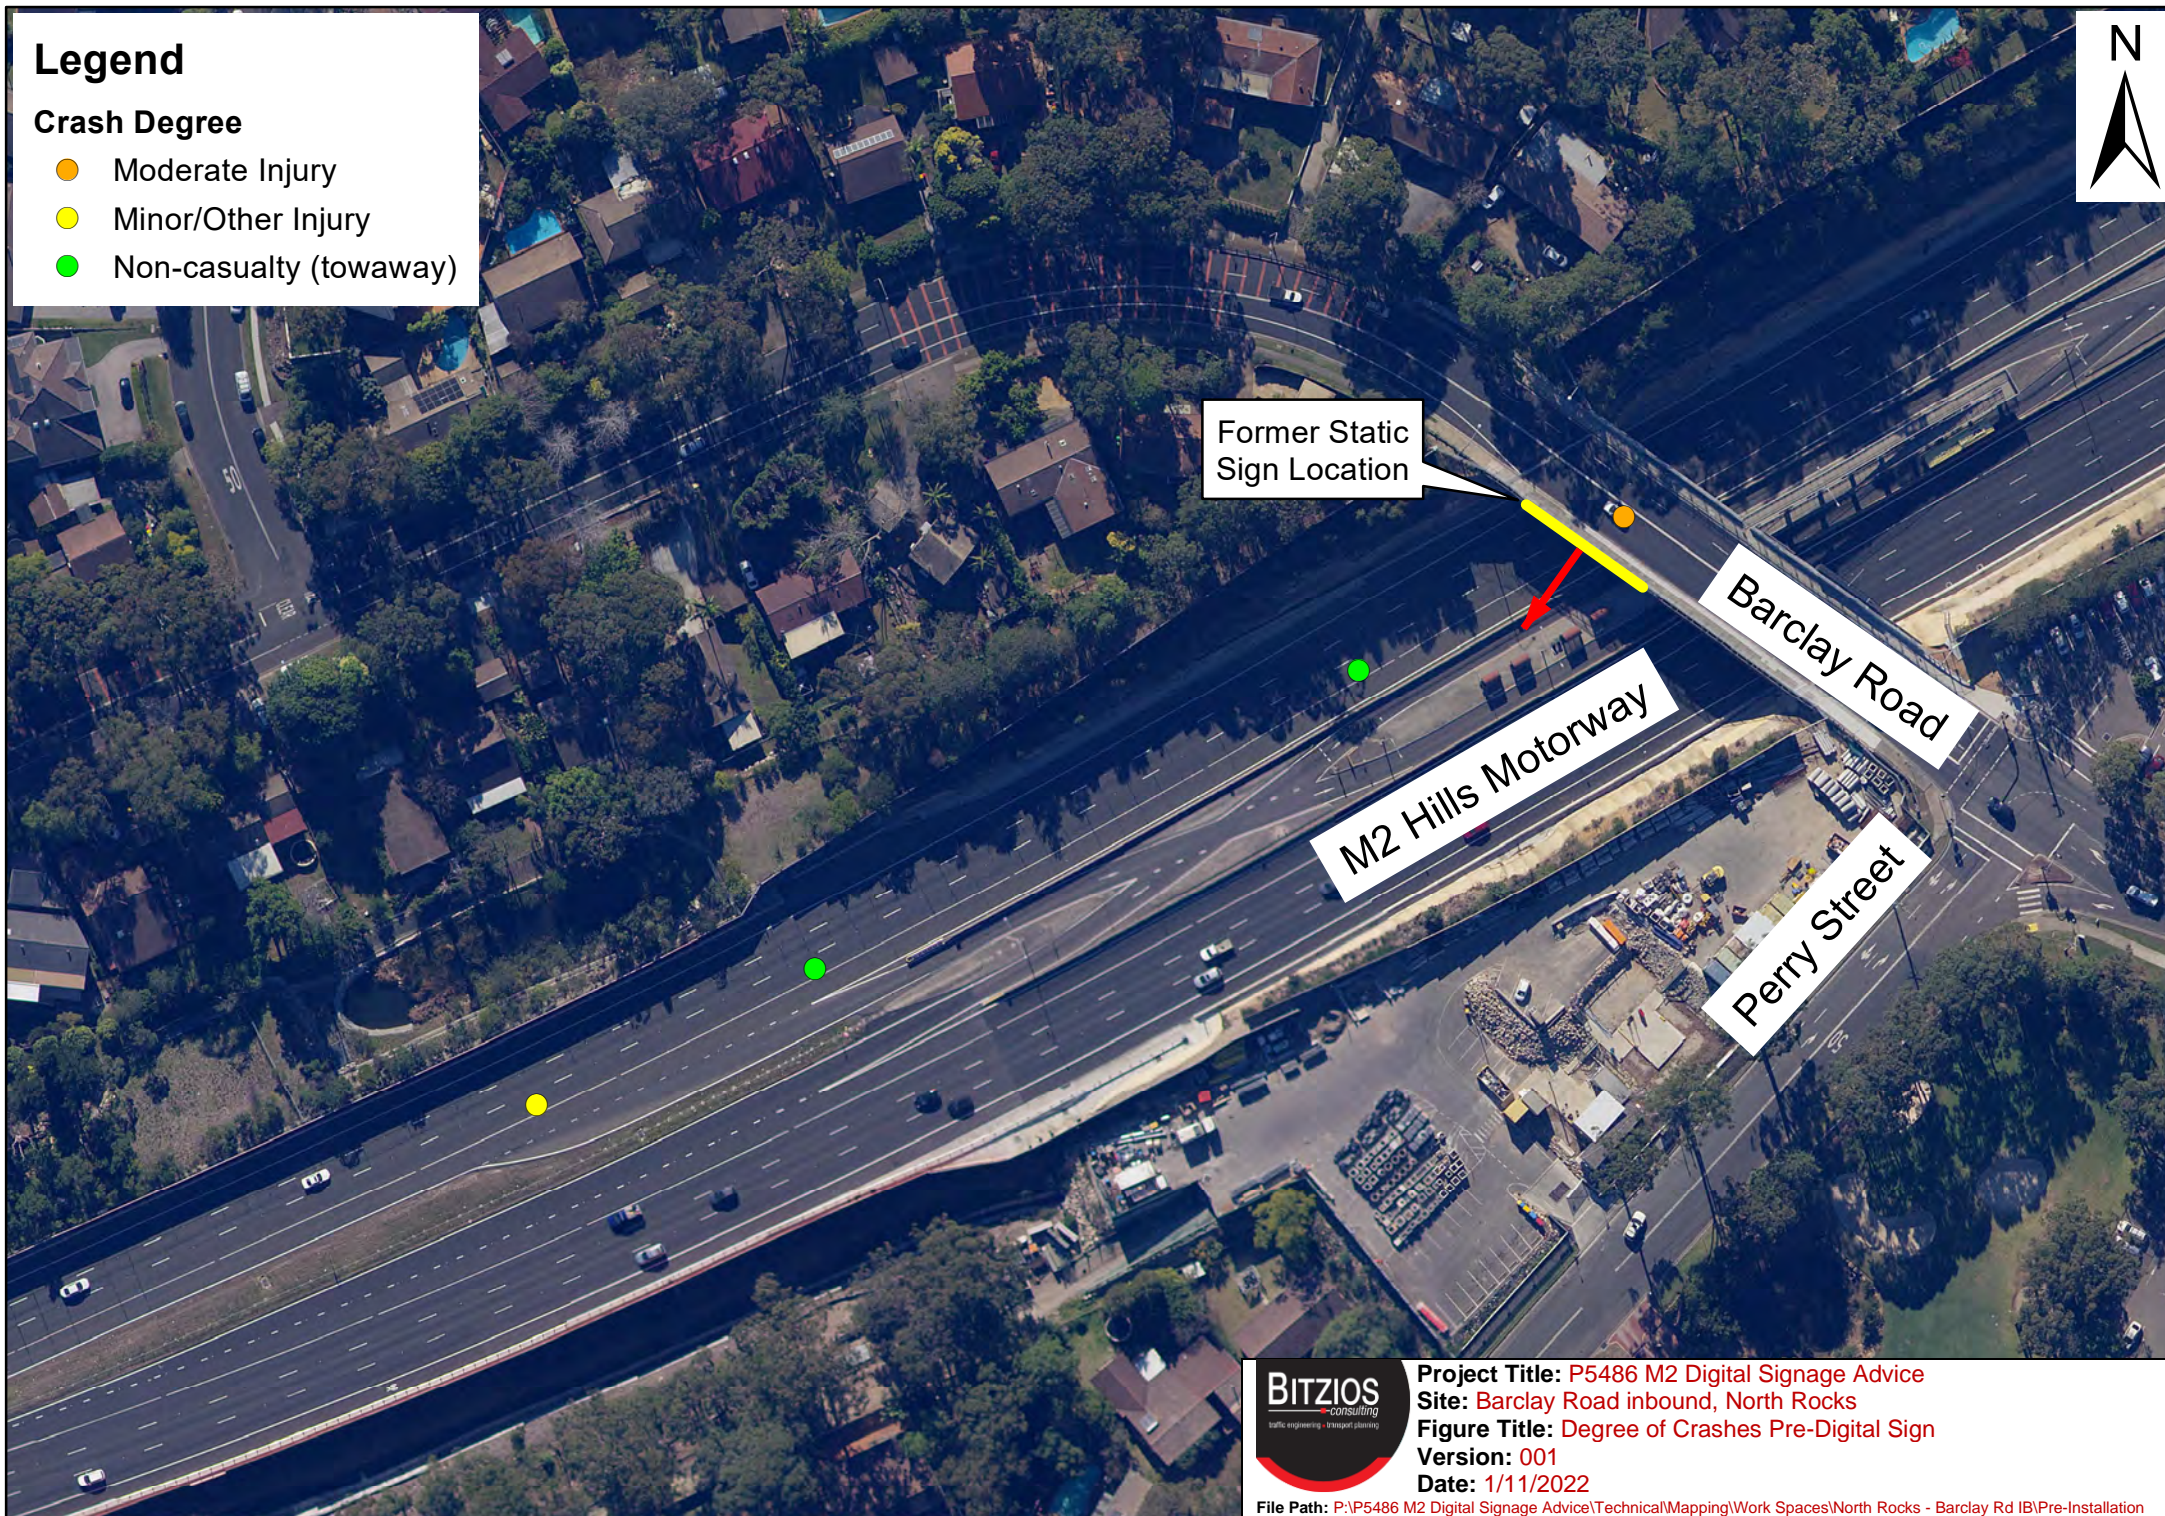
Project Title: P5486 M2 Digital Signage Advice
Site: Barclay Road inbound, North Rocks
Figure Title: Degree of Crashes Pre-Digital Sign
Version: 001
Date: 1/11/2022

Crash Degree

- Moderate Injury
- Minor/Other Injury
- Non-casualty (towaway)

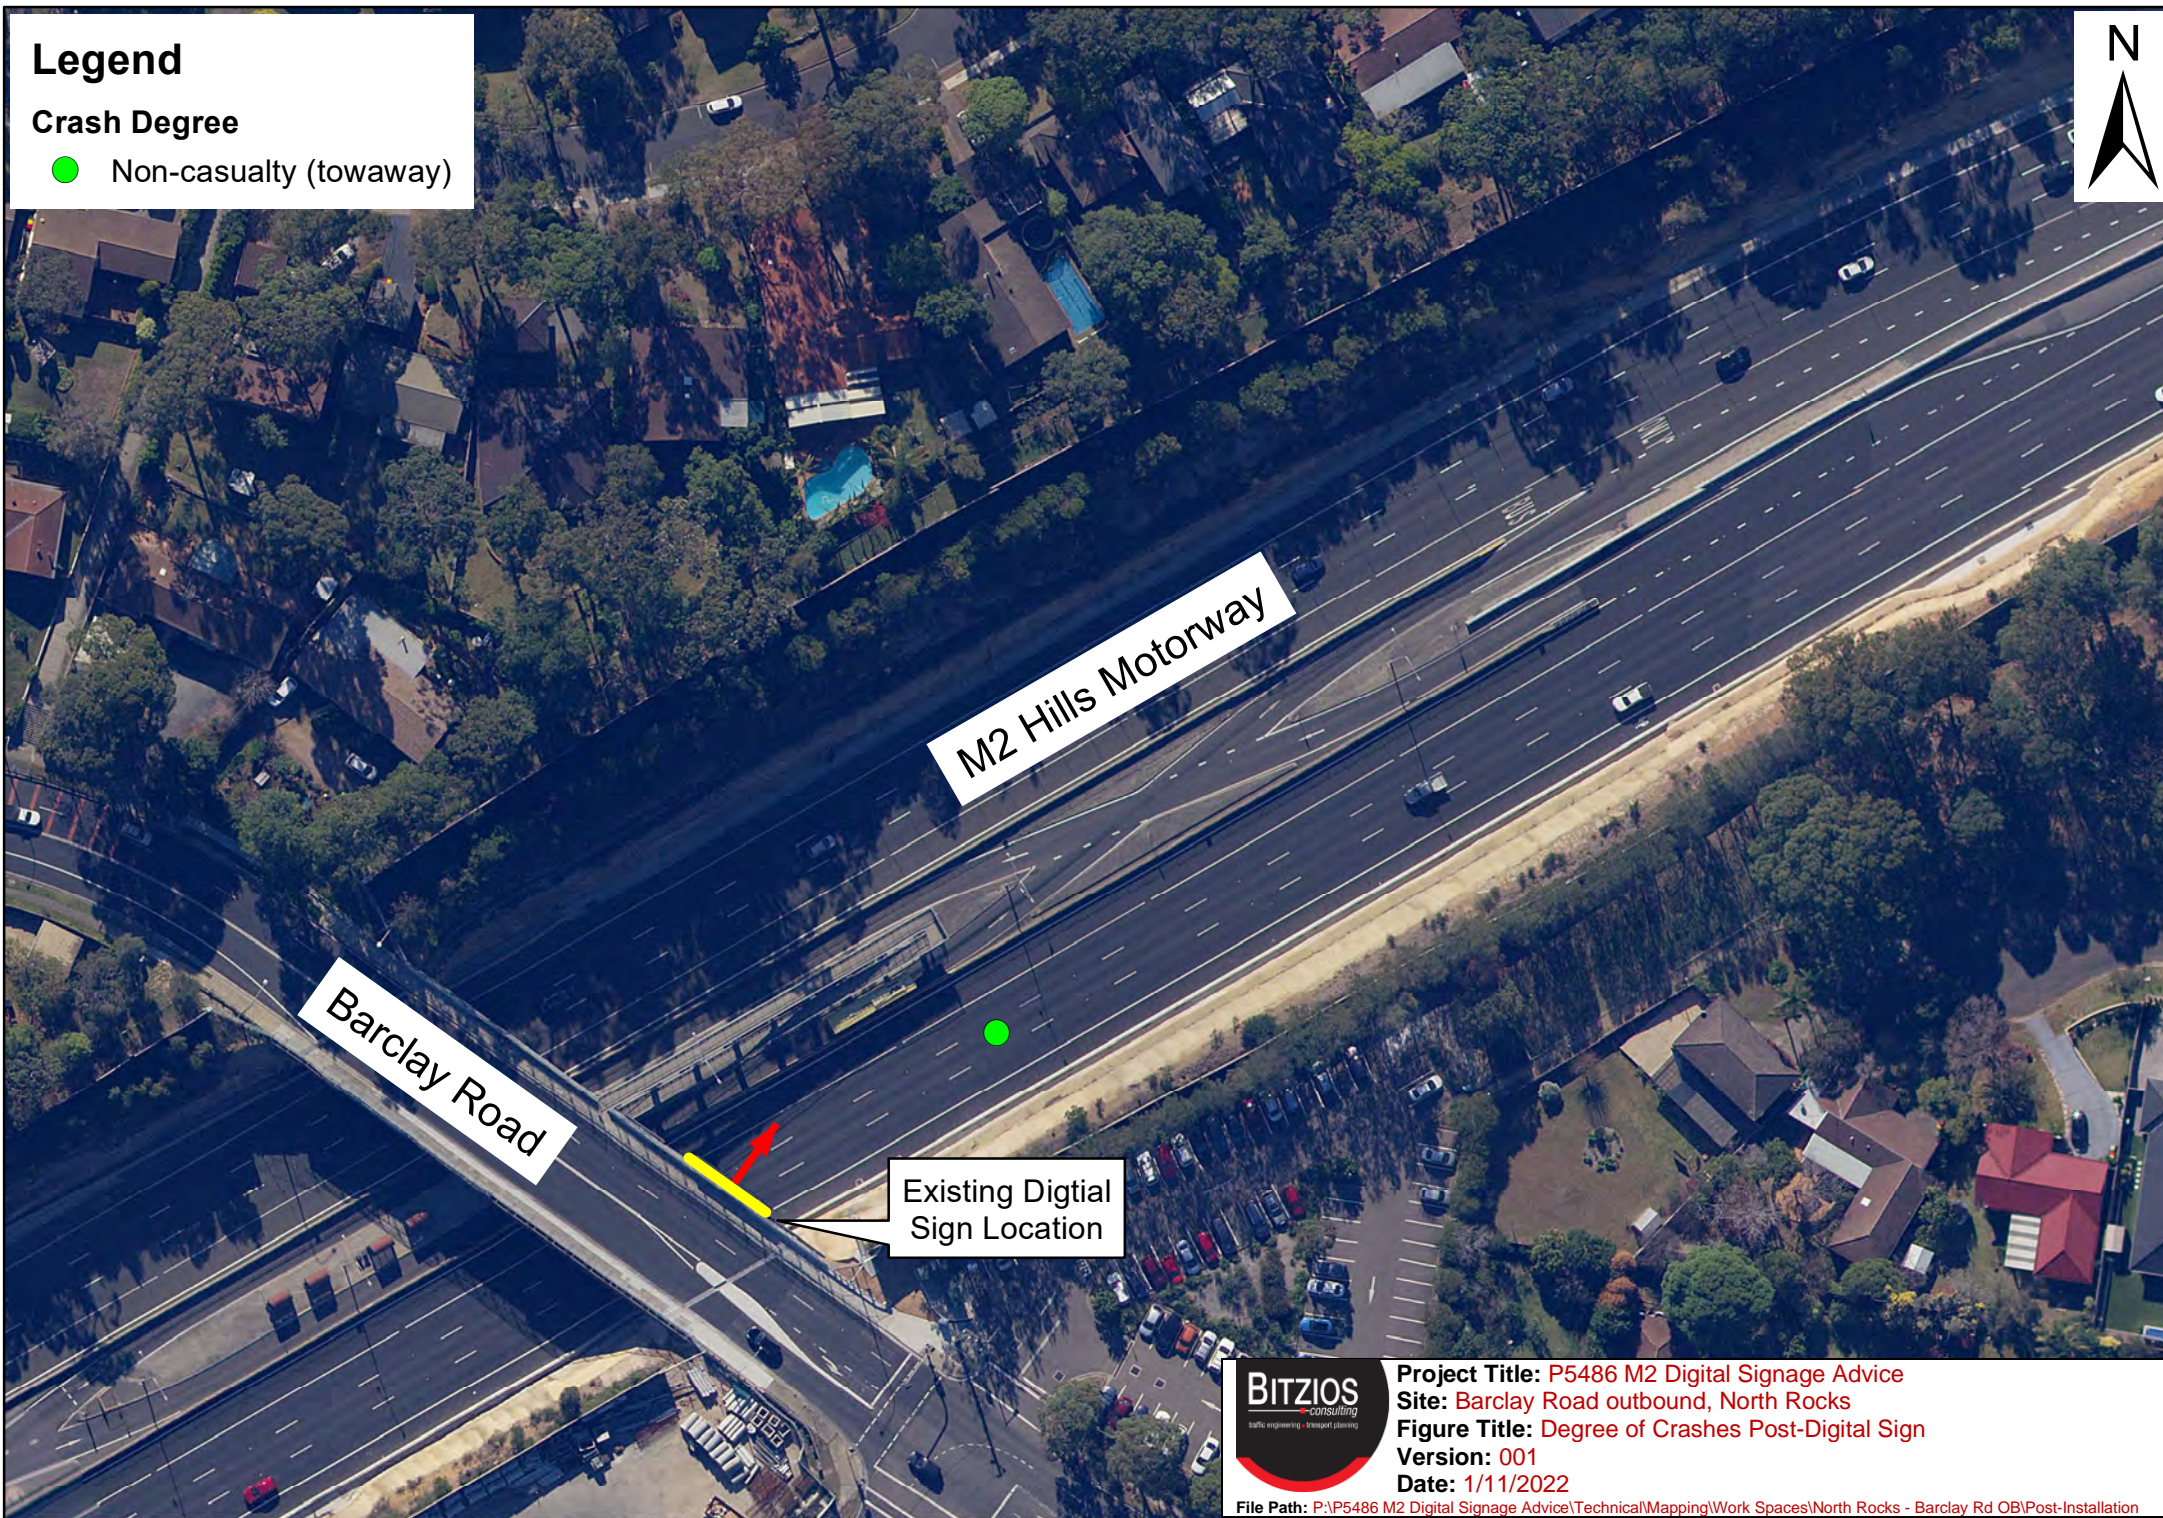
Project Title: P5486 M2 Digital Signage Advice
Site: Barclay Road outbound, North Rocks
Figure Title: Degree of Crashes Post-Digital Sign
Version: 001
Date: 1/11/2022

Crash Degree

- Non-casualty (towaway)

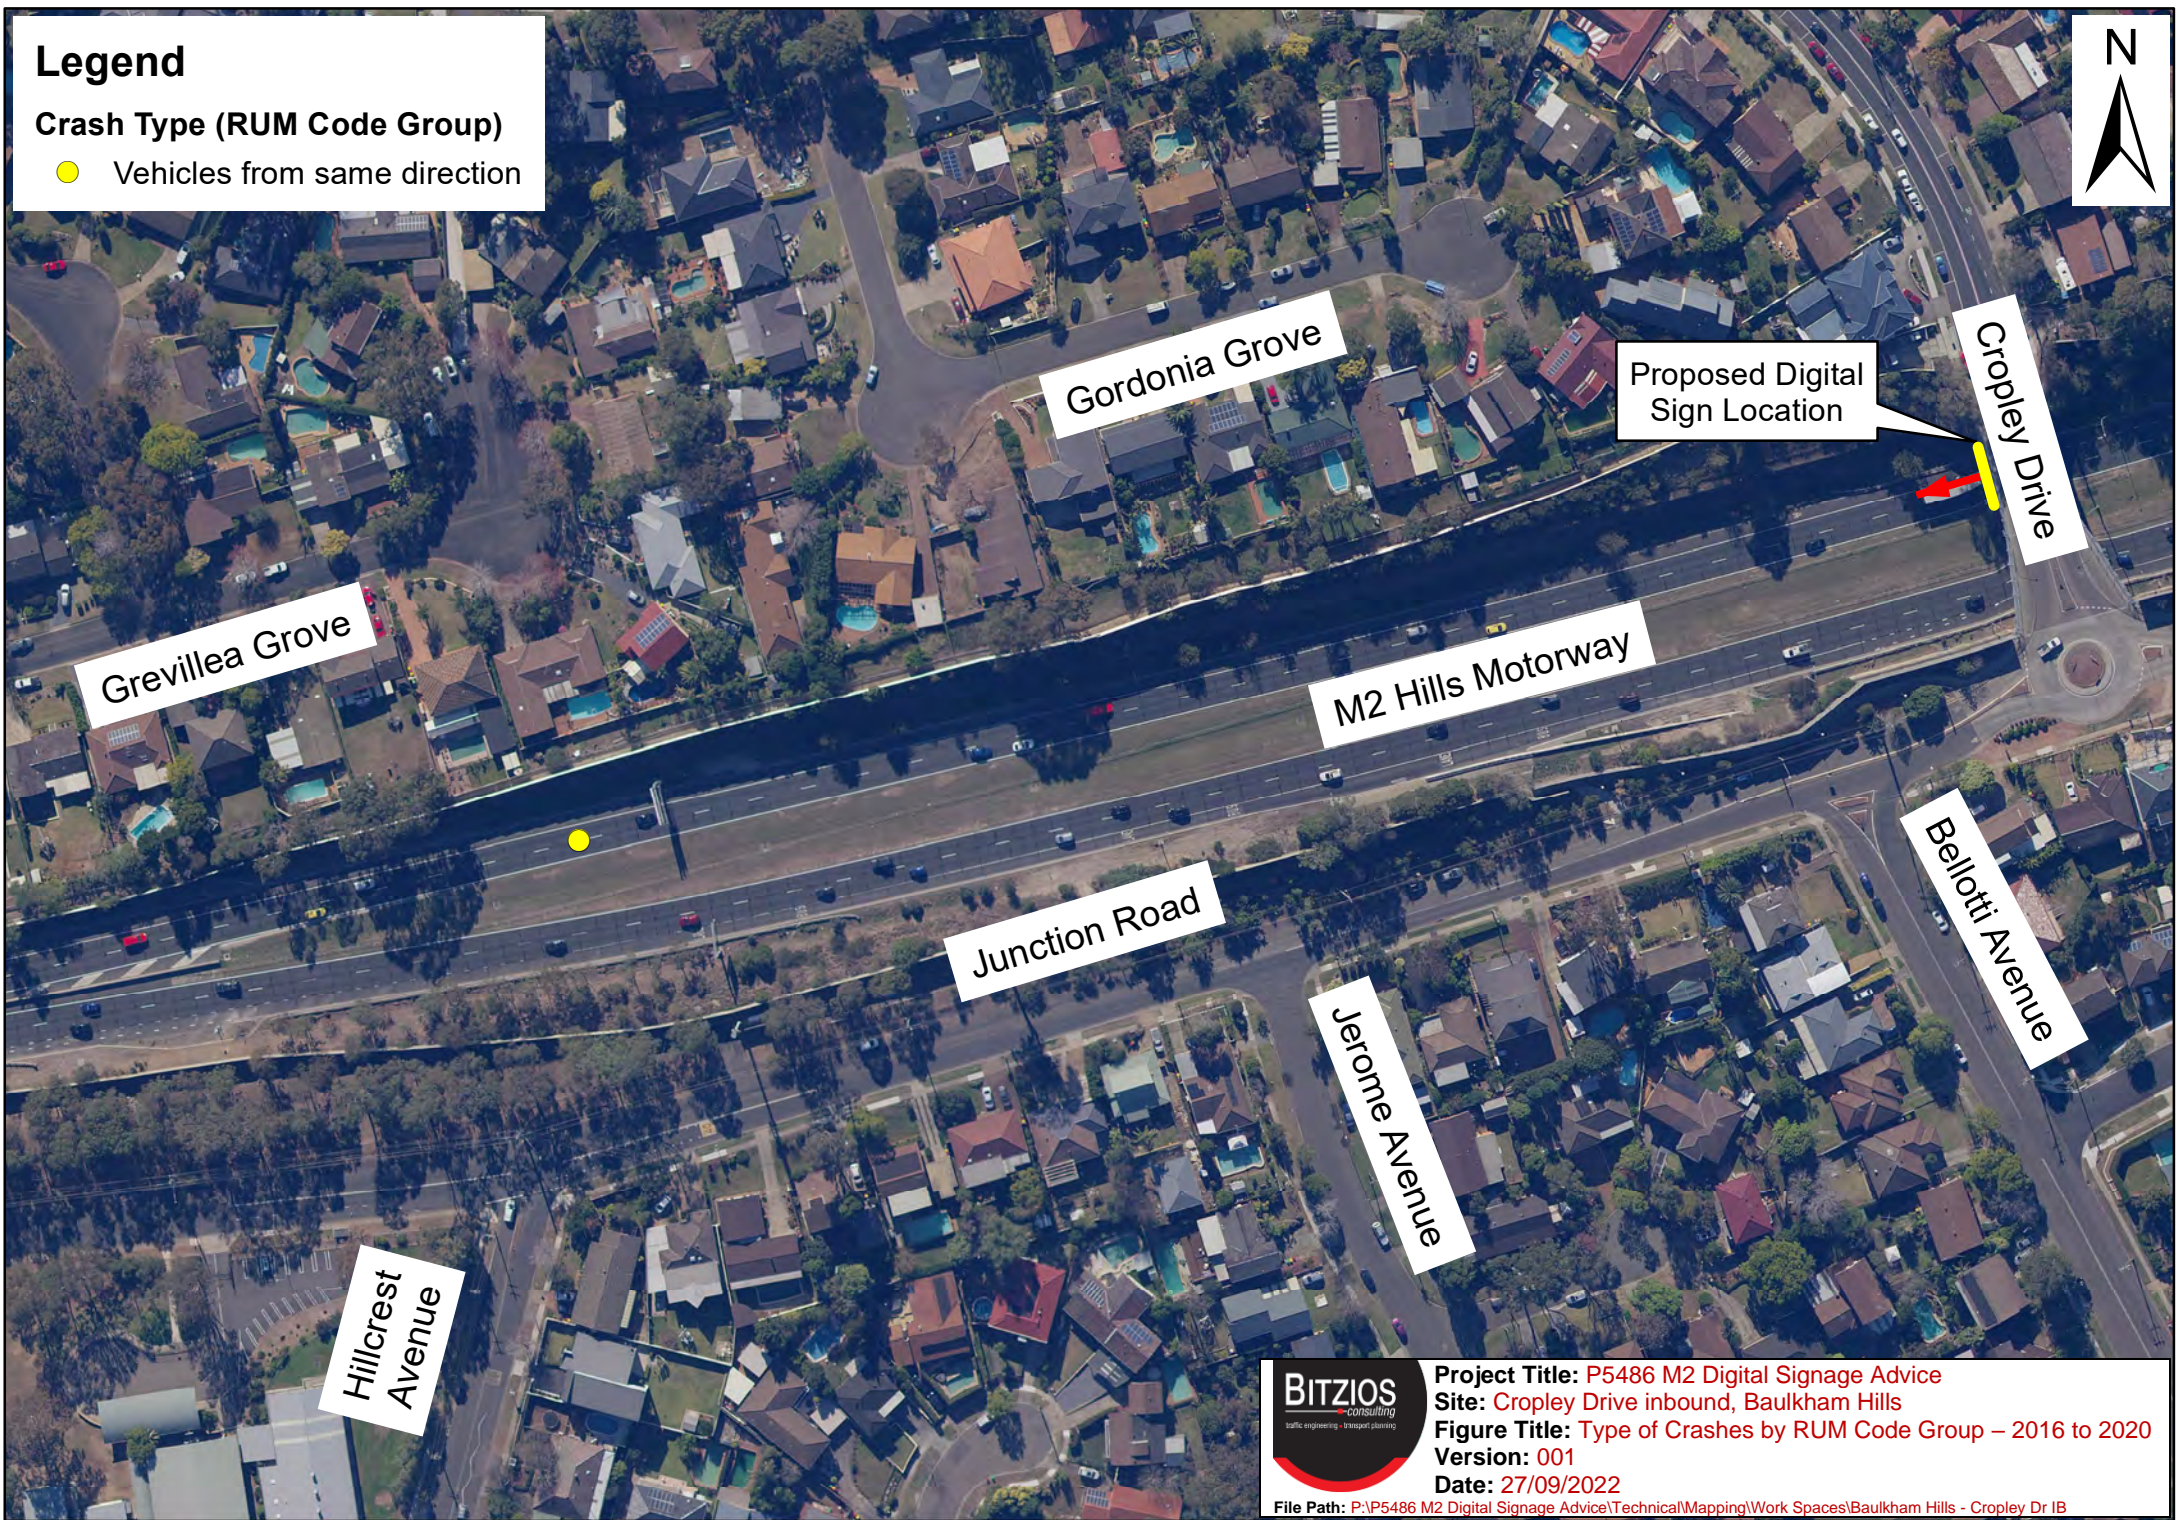
Project Title: P5486 M2 Digital Signage Advice
Site: Cropley Drive inbound, Baulkham Hills
Figure Title: Type of Crashes by RUM Code Group – 2016 to 2020
Version: 001
Date: 27/09/2022

Crash Type (RUM Code Group)

- Vehicles from same direction

As shown in the above table, **only one crash was reported between January 2016 and December 2020**. It occurred in October 2020 in wet road surface and rainy conditions, approximately 315m before the Cropley Drive overpass. The crash was classified as ‘rear end’ and resulted in a towaway.
