Our ref: 7087-G2 Rev 1
8 March 2023

Tom Thumb Learning Area, Front Valley, Perisher Ski Resort Geotechnical Assessment

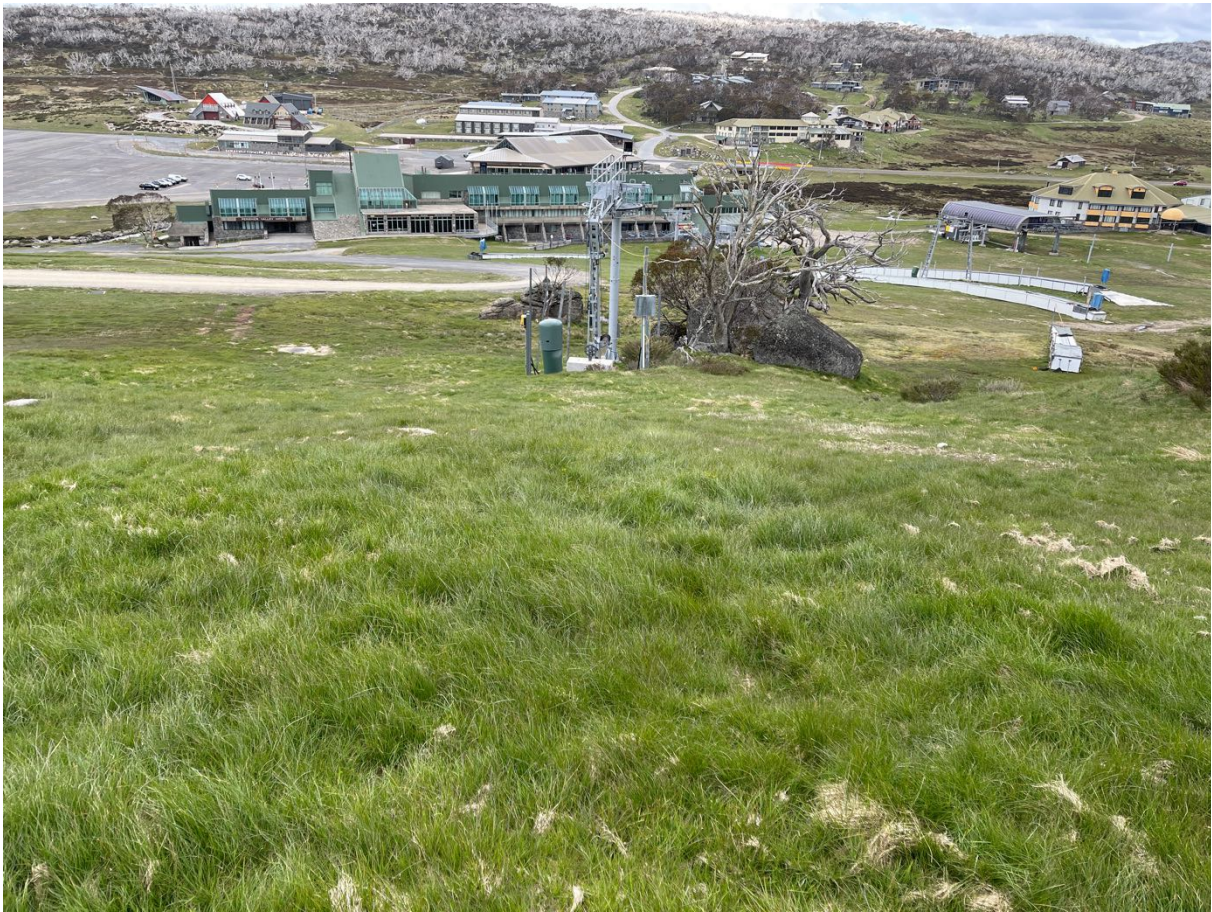
Photo 2

Granite rocks can be seen outcropping in the site vicinity as two tor outcrops to be removed as part of the development, and numerous shallow outcrop just under the grass cover across the middle and upper slopes of the site. Numerous granite boulders were observed at the toe of the aerial jump.

General view looking downhill showing two rock outcrop areas to be removed.

Removal of the J-bar, moving of ski conveyors, removal of trees and tor outcrops, and associated minor works as described above is not considered to present a significant geotechnical constraint (e.g., disturbance, significant load bearing).
