Our ref: 7087-G2 Rev 1  
8 March 2023

Vail Resorts  
PO Box 42  
Perisher Valley NSW 2624

## **Tom Thumb Learning Area, Front Valley, Perisher Ski Resort Geotechnical Assessment**

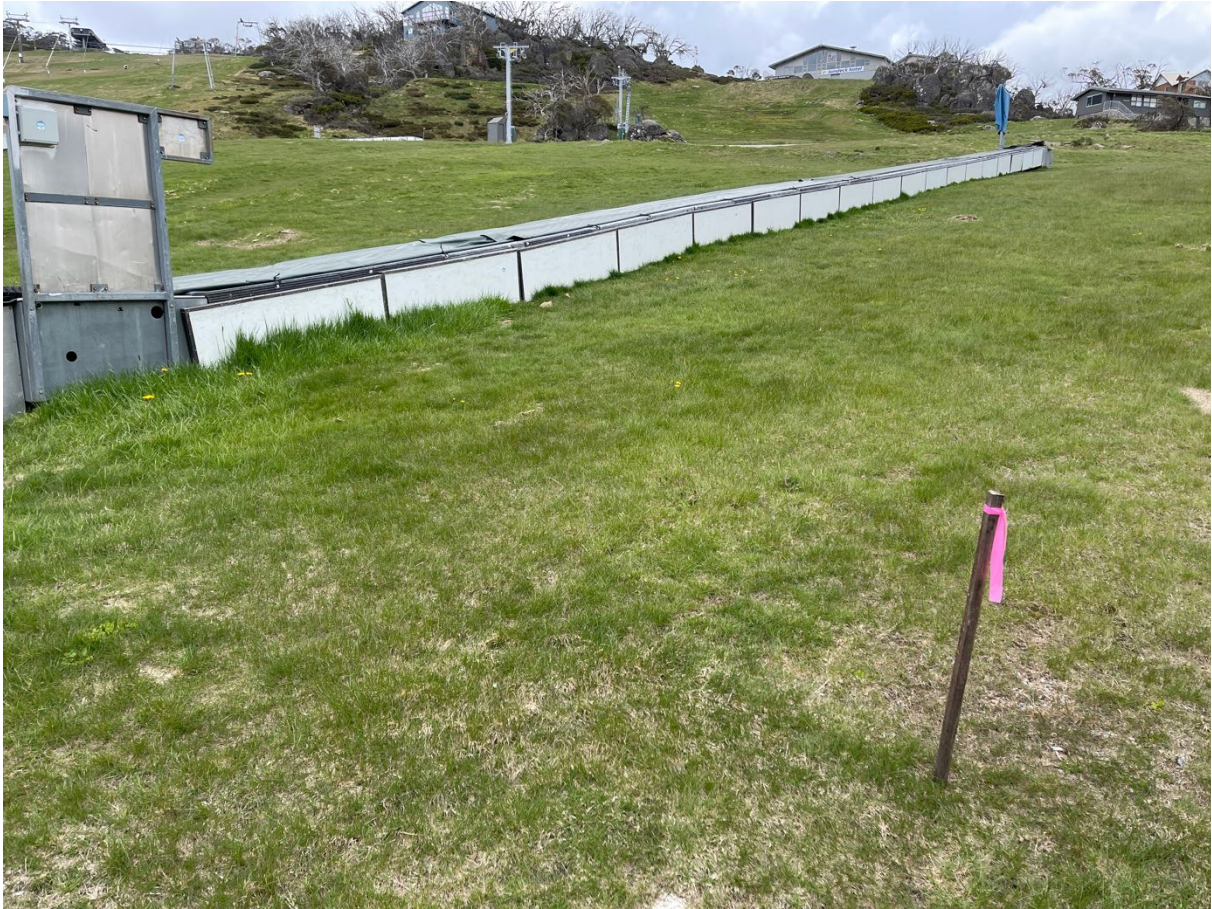
**Photo 1**

General view of site looking upslope, ski conveyor shown in foreground, aerial jump shown in background.

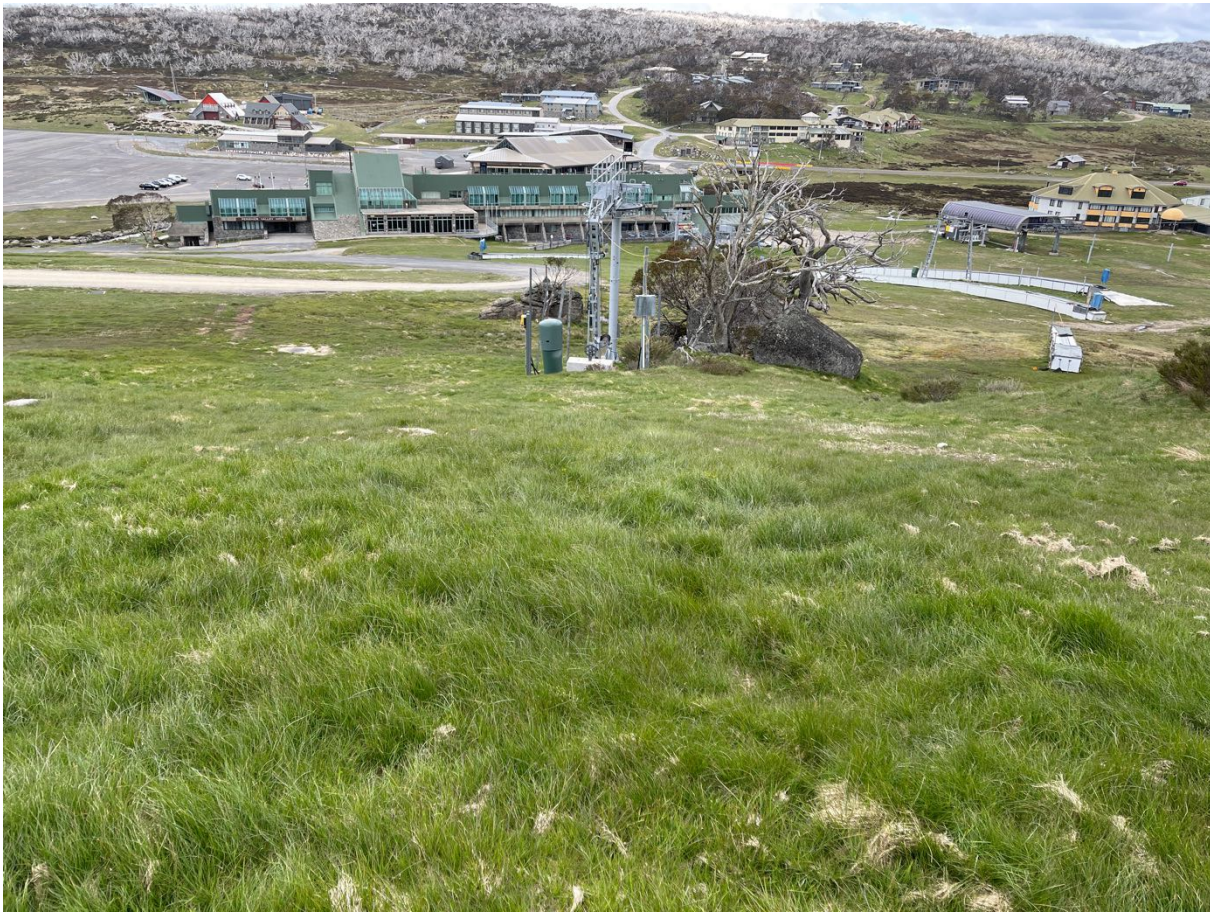
**Photo 2**

Granite rocks can be seen outcropping in the site vicinity as two tor outcrops to be removed as part of the development, and numerous shallow outcrop just under the grass cover across the middle and upper slopes of the site. Numerous granite boulders were observed at the toe of the aerial jump.

General view looking downhill showing two rock outcrop areas to be removed.

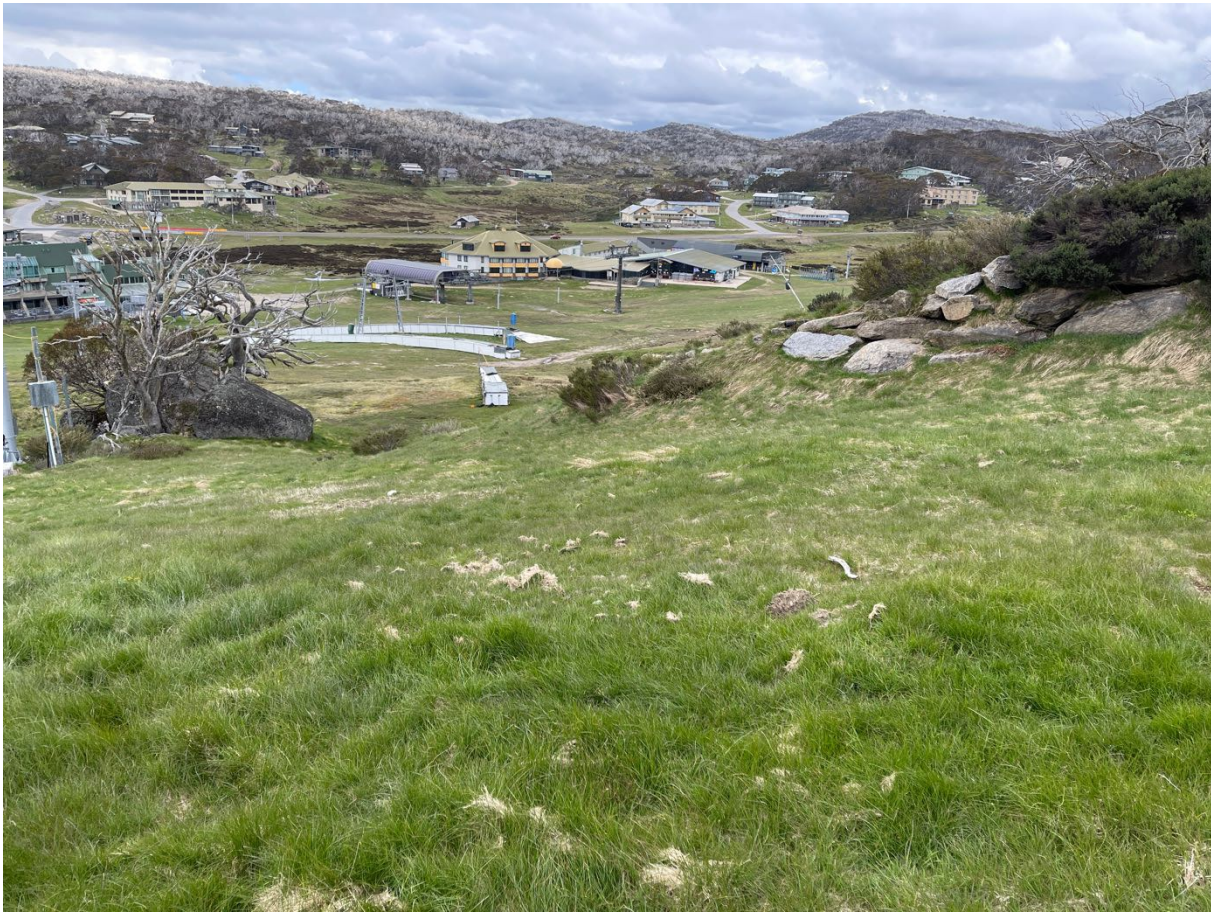
**Photo 3**

Continuation of Photo 2 shown ski conveyors in background, upper rock area to be removed to the left, and toe of aerial jump to the right.

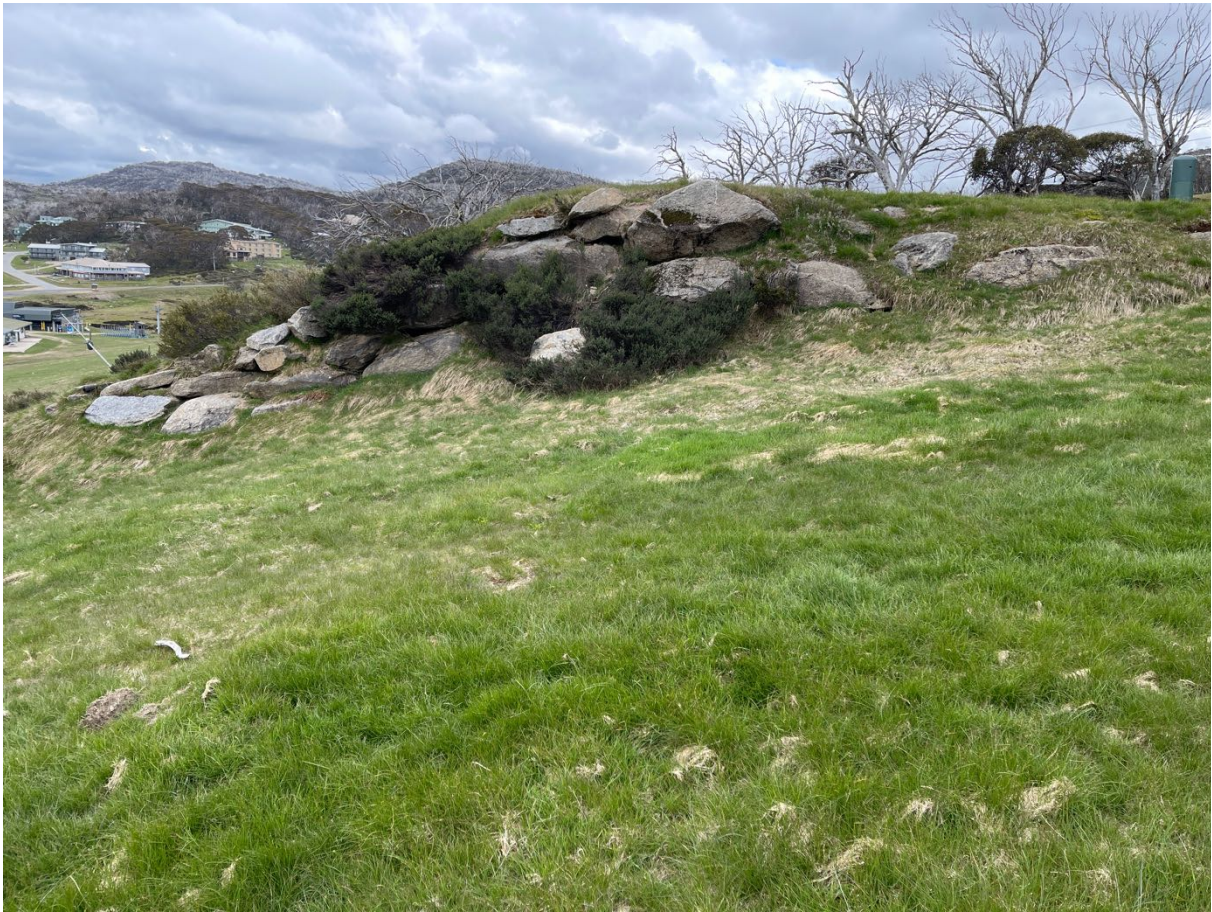
**Photo 4**

Surface flows are expected to follow the ground surface contours with likely risk of ponding in the depression formed at the toe of the aerial jump formed by the original earthworks.

Continuation of Photo 3 showing side view of aerial jump

Cutting of the aerial jump and filling the depression at the base will result in approximate reinstatement of original ground surface levels in that part of the site and this is also not considered to present a significant geotechnical constraint, provided that the following recommendations are adhered to:

- Area to be filled must first be stripped of topsoil and loose / softened soil down to medium dense or better sandy soils or stiff or better clayey soils, or weathered granite.
- Water seepage into the area to be filled should be controlled by installation of temporary diversion drains, to ensure the area remains dry.
- Subgrade preparation should comprise constructing horizontal benches of width compatible with the compaction and earthmoving plant. Proof rolling to be carried out using minimum 8 tonne roller, and areas showing heave should be over-excavated minimum 0.3m depth and replaced with suitable fill.

- Suitable fill to be compacted in layers not exceeding 250mm loose thickness to a dry density ratio (AS1289.5.4.1–2007) not less than 95% Standard. Suitable fill could comprise selected material from the aerial jump and ideally would comprise well graded soils with a maximum particle size of 150mm and free of deleterious or organic matter. Predominantly sandy soils or cohesive soils could also be considered as suitable fill. Larger rocks and boulders should be removed.
- Filling should be over-placed (i.e., extend beyond the design batter slope), compacted, and then trimmed to the design batter such that the exposed surface comprises compacted material.
